Inspection Photos

Location Name: LORENCITO 3-22-34-66

API#: 05-071-06662

INSP. #: 695100931

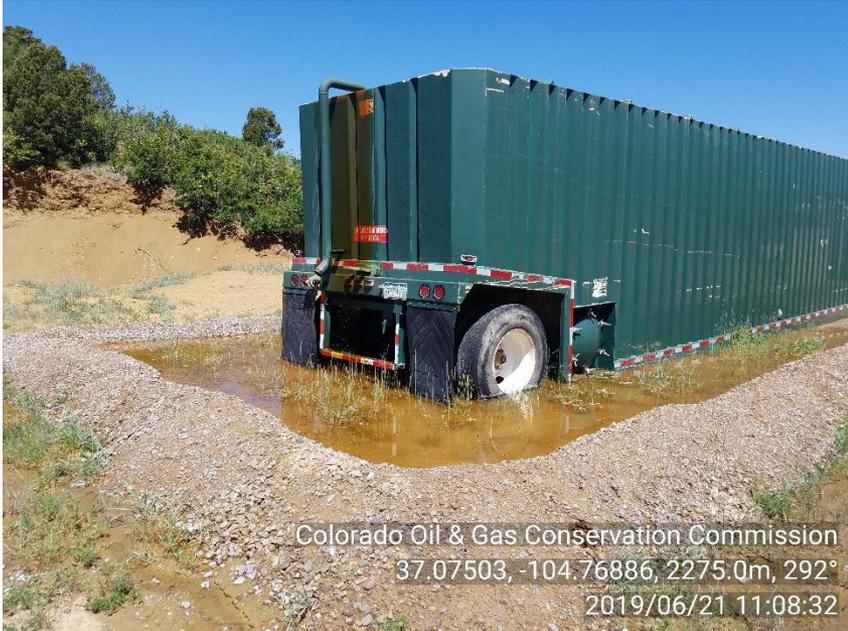
PHOTO 3: PRODUCED WATER TANK IS FULL AND IS RUNNING OVER INTO SECONDARY CONTAINMENT SPOKE WITH JACK WISEMAN BY PHONE TO HAVE FLUID LEVEL LOWERED. LOWER FLUID LEVEL PER RULE 902.b. Control and contain spills/releases and clean up per Rule 906.a. E&P Waste not properly stored, handled, transported, treated, recycled, or disposed per Rule 907. Contact COGCC EPS staff. CA DATE 6/21/19.

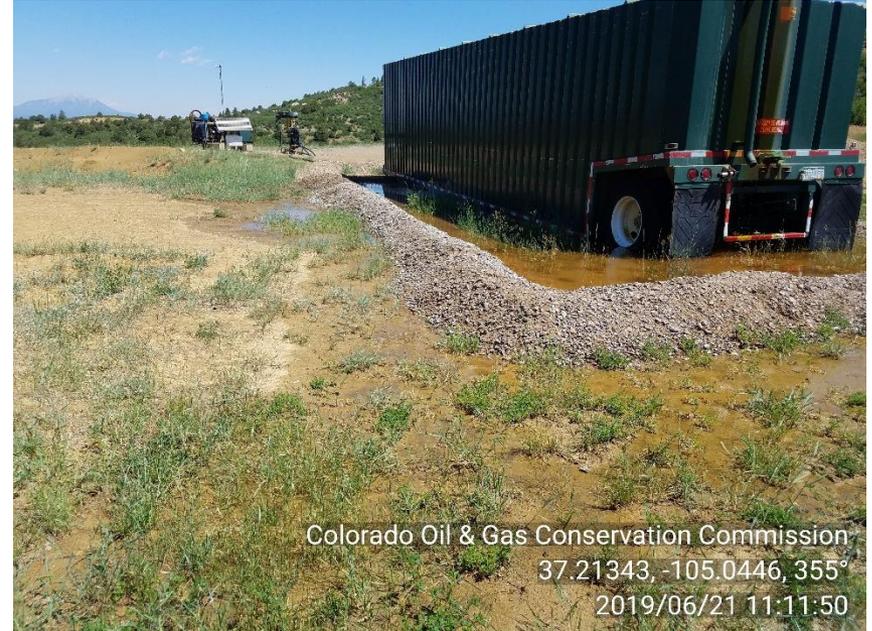
PHOTO 4: INADEQUATE MATERIAL AND COMPACTION USED IN BERM CONSTRUCTION. USE ADEQUATE MATERIAL WITH SUFFICIENT COMPACTION TO PREVENT FLUID FROM MIGRATING THROUGH BERMS. Repair or install berms or other secondary containment devices per Rule 906.d.(1). CA DATE 7/21/19.

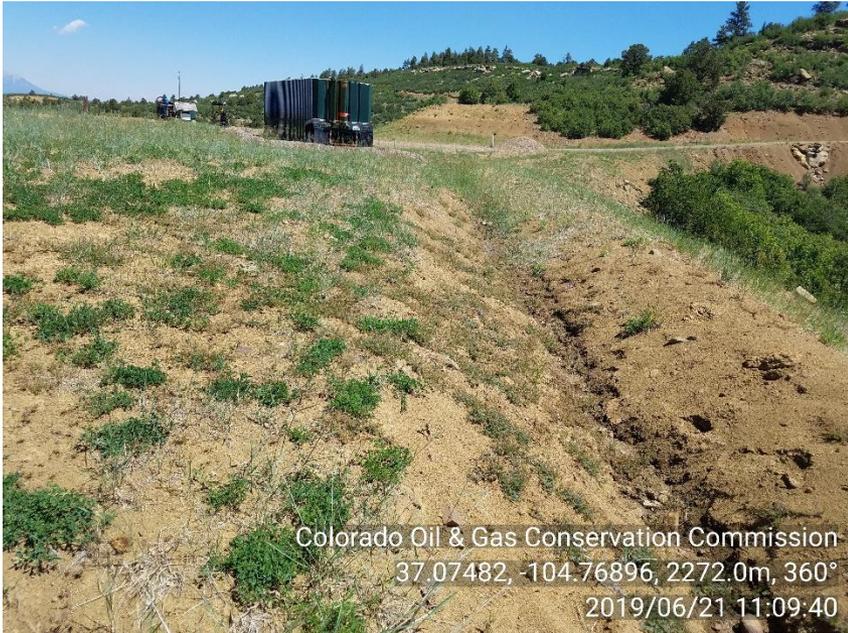
PHOTO 5. PHOTO SHOWING PRODUCED WATER TRAVELING DOWN DRAINAGE DITCH APP. 120' FROM BACK OF TANK. LOWER FLUID LEVEL PER RULE 902.b. Control and contain spills/releases and clean up per Rule 906.a. E&P Waste not properly stored, handled, transported, treated, recycled, or disposed per Rule 907. Contact COGCC EPS staff. CA DATE 6/21/19.

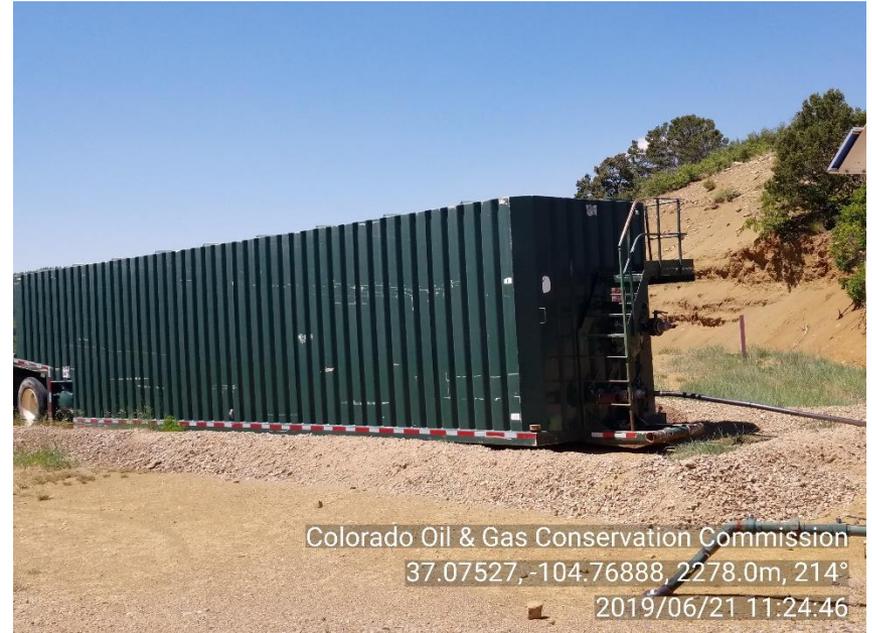
PHOTO 6: NO NFPA STICKER POSTED ON PRODUCED WATER TANK. ALSO CAPACITY OF TANK IS NOT POSTED. COMPLY WITH RULE 210. d.

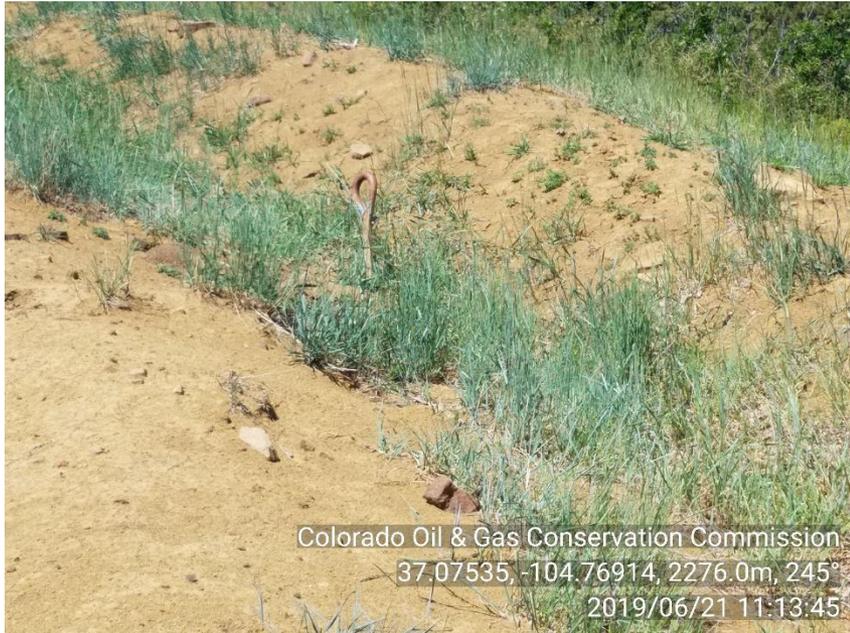
PHOTO 7: GUY LINE ANCHOR NOT MARKED. INSTALL GUY LINE MARKER IN ACCORDANCE WITH RULE 1003.a.

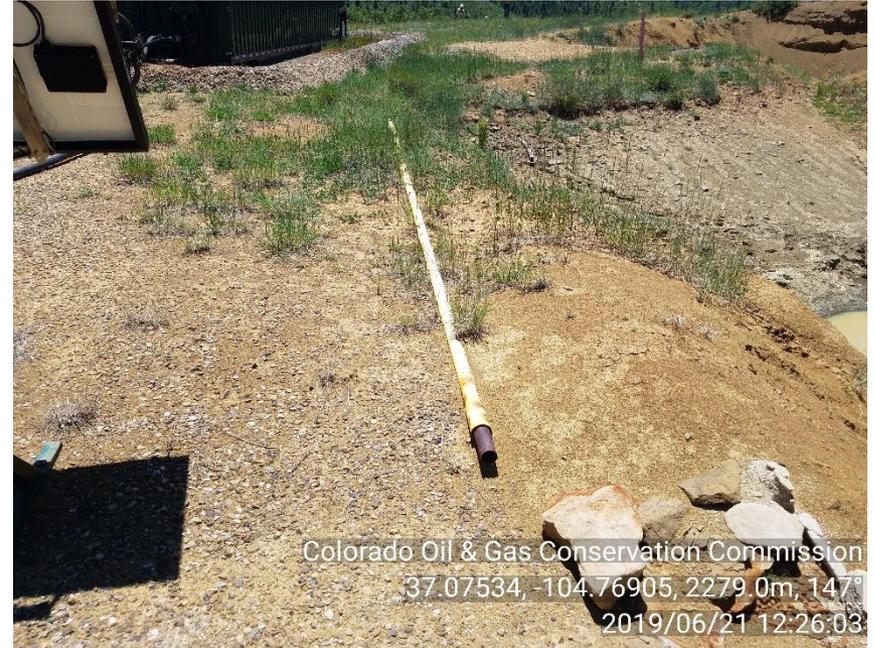
PHOTO 8: UNUSED EQUIPMENT STORED ON LOCATION. REMOVE UNUSED EQUIPMENT IN ACCORDANCE WITH RULE 603.f. CA DATE 7/21/19
