Inspection Photos
Operator: BP America
Location/API #: 067-06285
Date: 6-11-2019

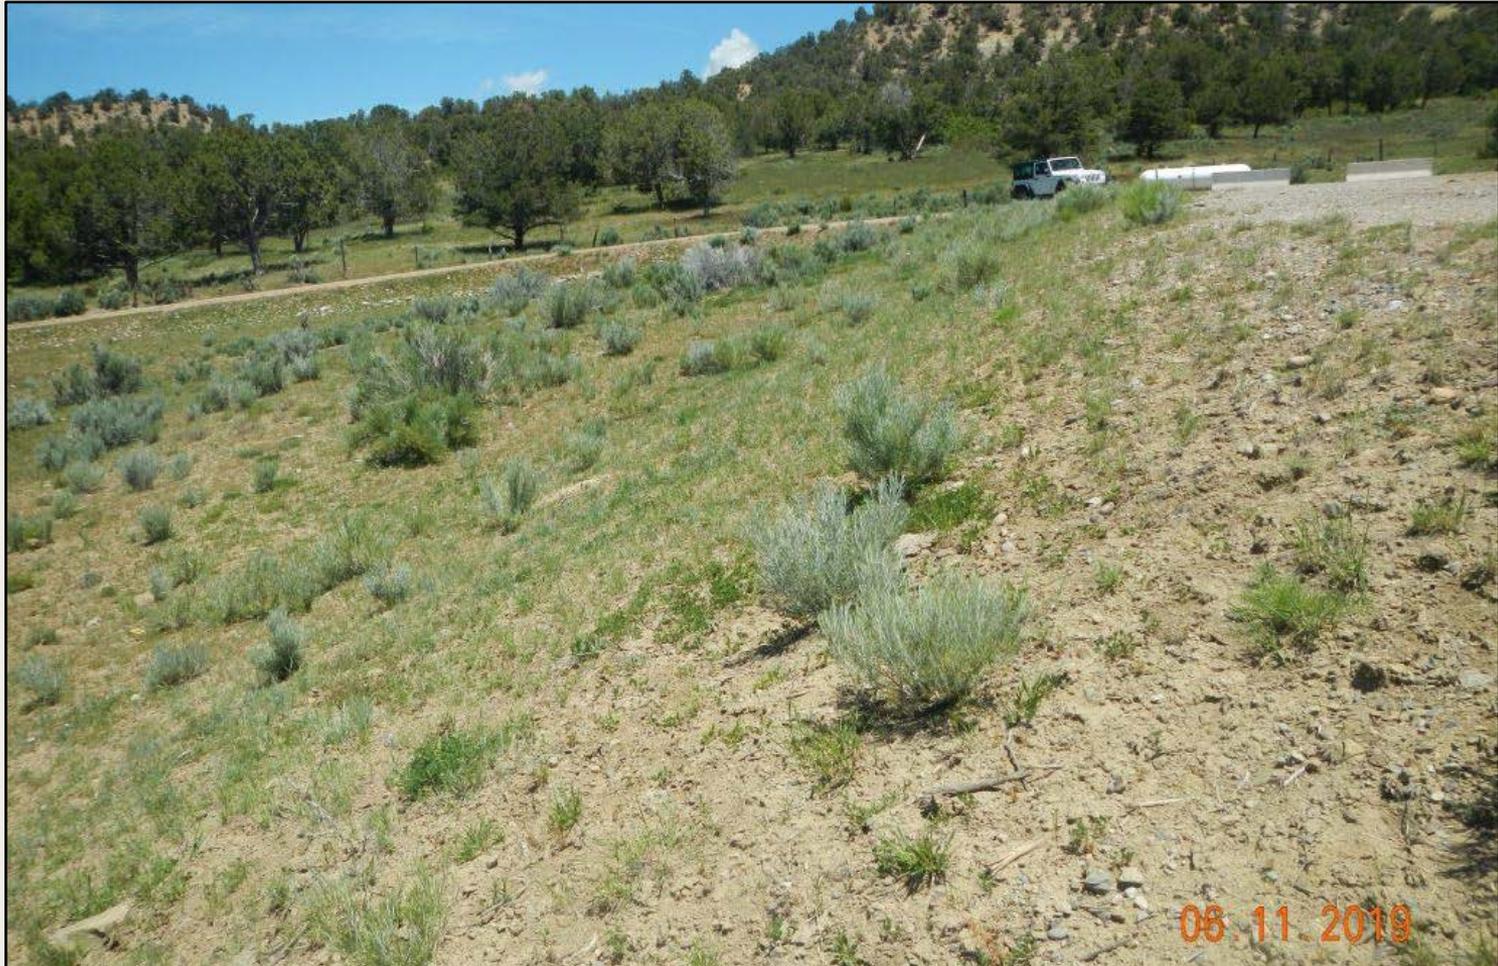
Photo 1. View of the southern project area from the southwestern corner facing eastward.

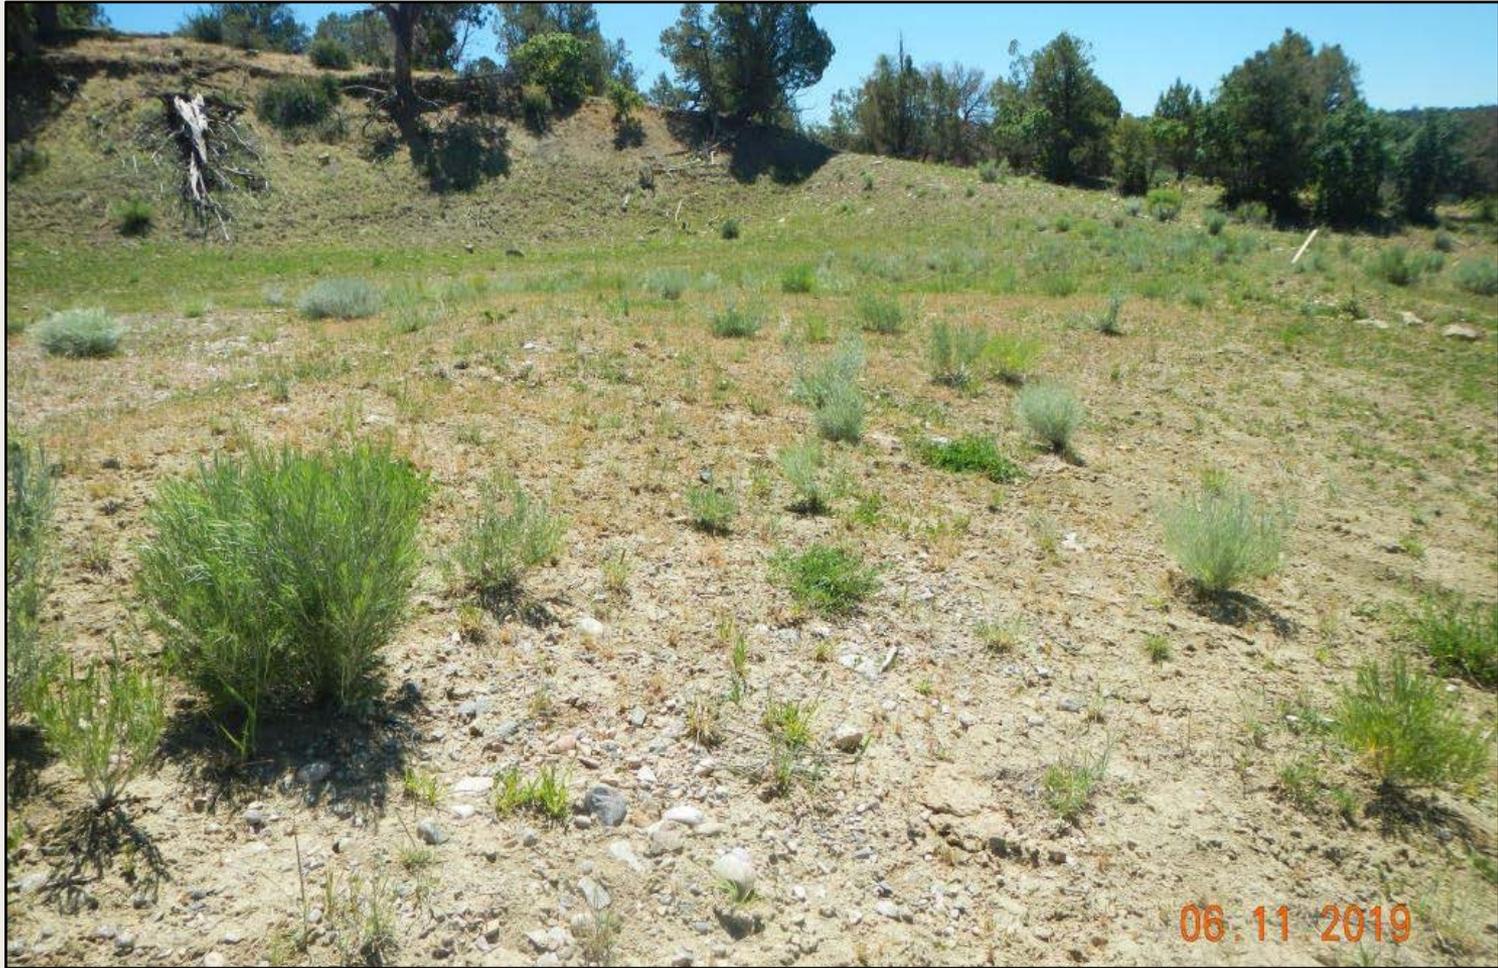
Photo 2. View of the western project area from the northwestern corner facing southward.

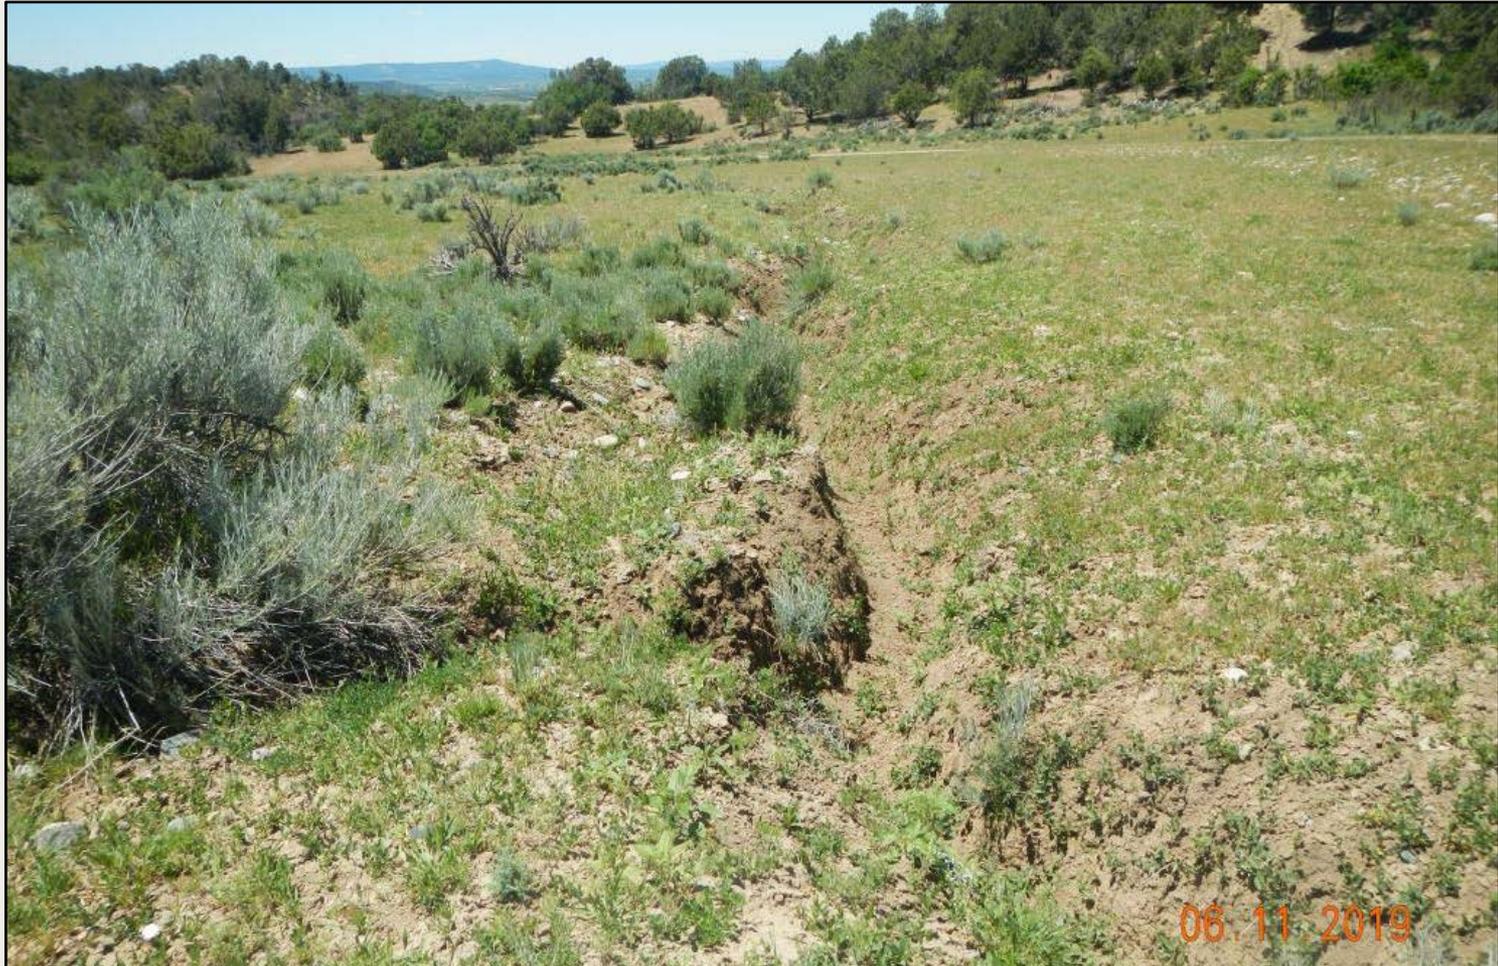
Photo 3. View of head-cut erosion and erosional channeling downstream from culvert outlet along the access road. This appears to be a result of concentrated stormwater flows exiting the culvert.
