**Inspection Photos: June 24, 2019**  
**Location Name: EWS #4 Tank Facility – Lightning Strike/Fire**  
**SWSW Section 17 – Township 2 North - Range 63 West**  
**Weld County**

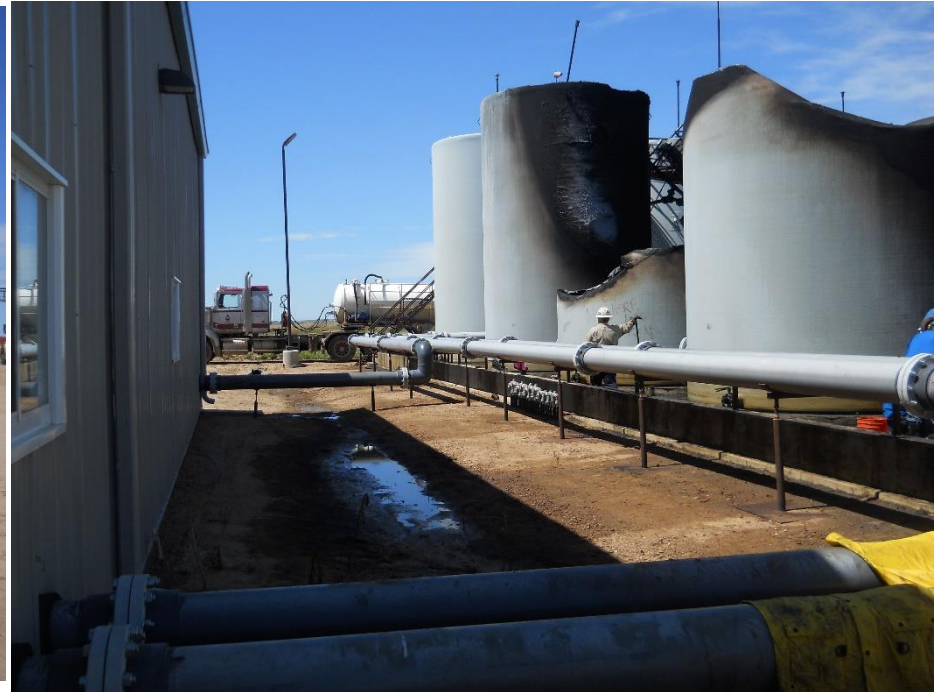
**North side building showing tank damage. All 28 FG tanks damaged/destroyed. 5 steel tanks (oil) undamaged. Photo looking east.**

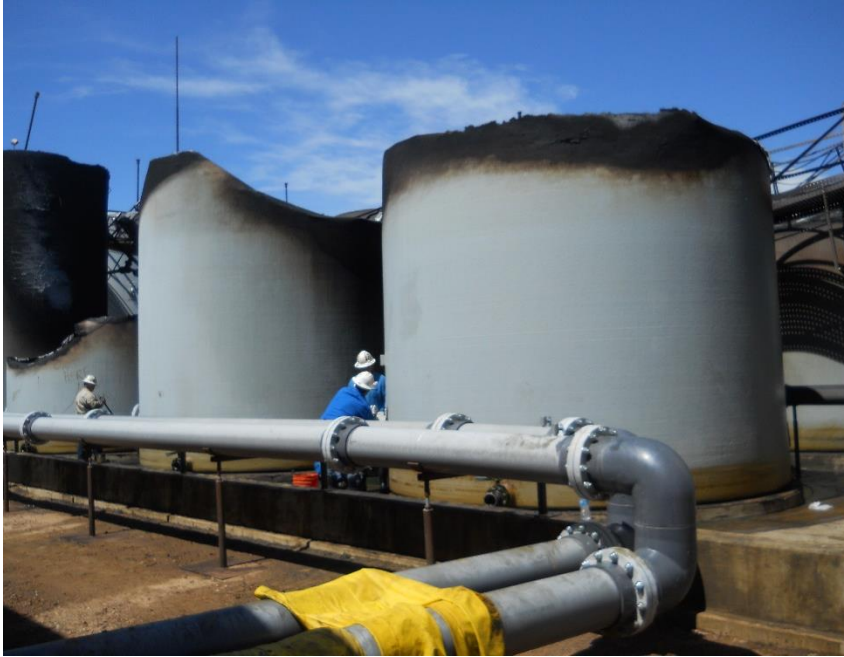
**North side building showing tank damage. All 28 FG tanks damaged/destroyed. Crews cleaning out tanks in preparation for removal. Photo looking north.**

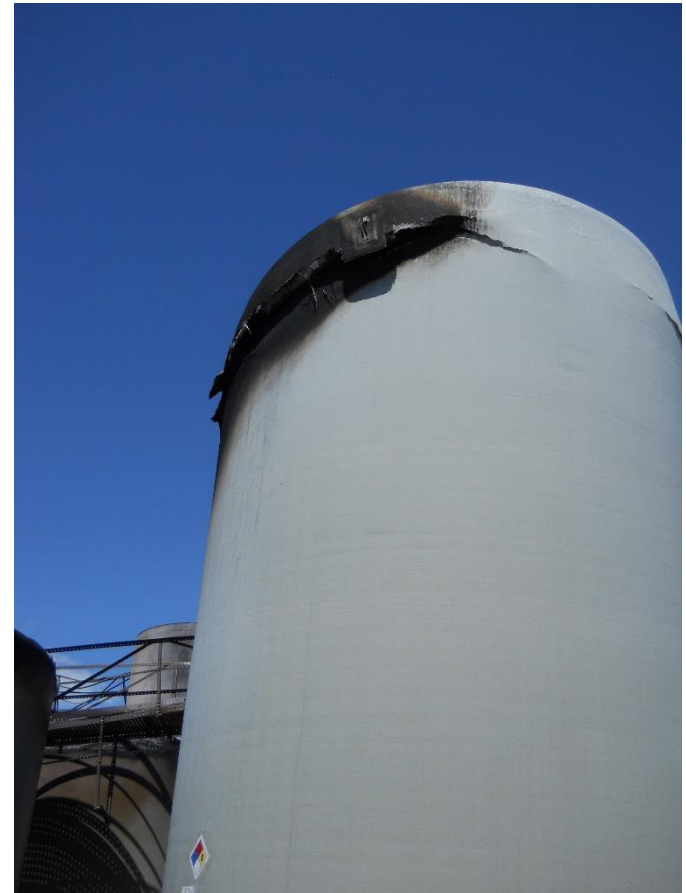
**North side building showing tank damage. Photo looking north.**

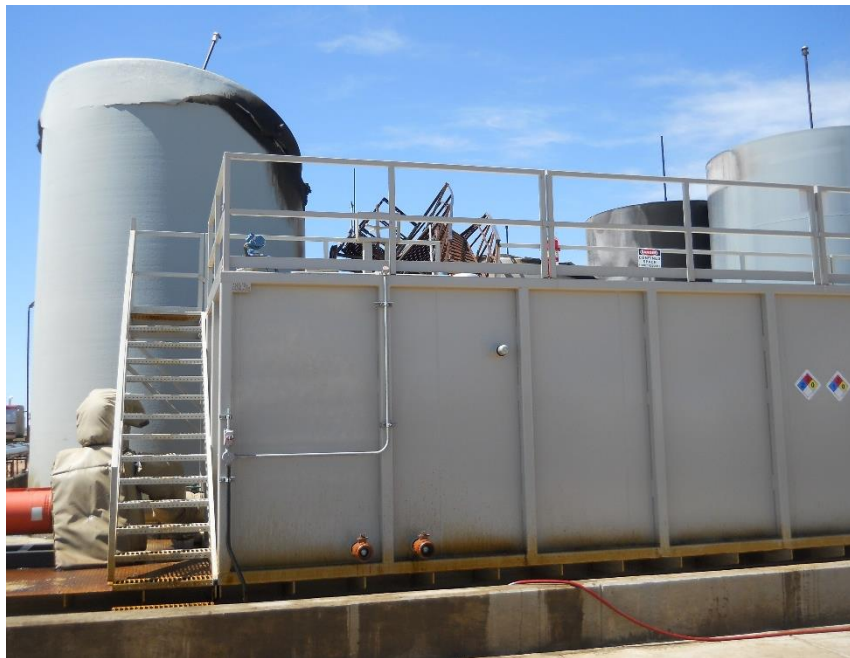
**Damaged tanks. Tank on left same tank as in previous photograph. Photo looking east from off-loading area.**

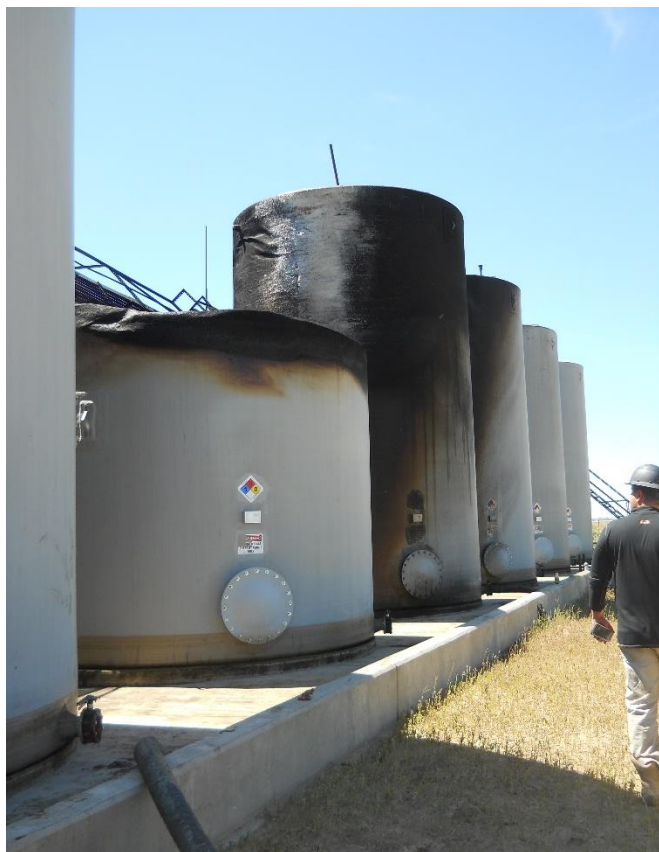
**Damaged tanks. North end of TB. Photo looking west.**

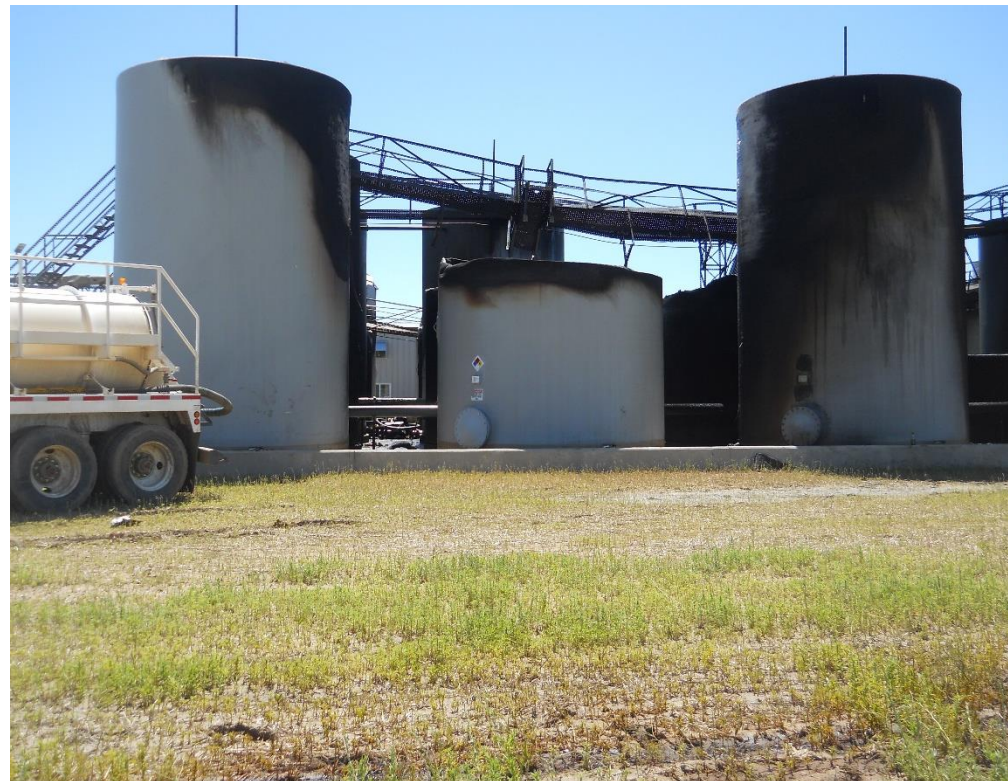
**Damaged tanks. North end of TB. Photo looking south.**

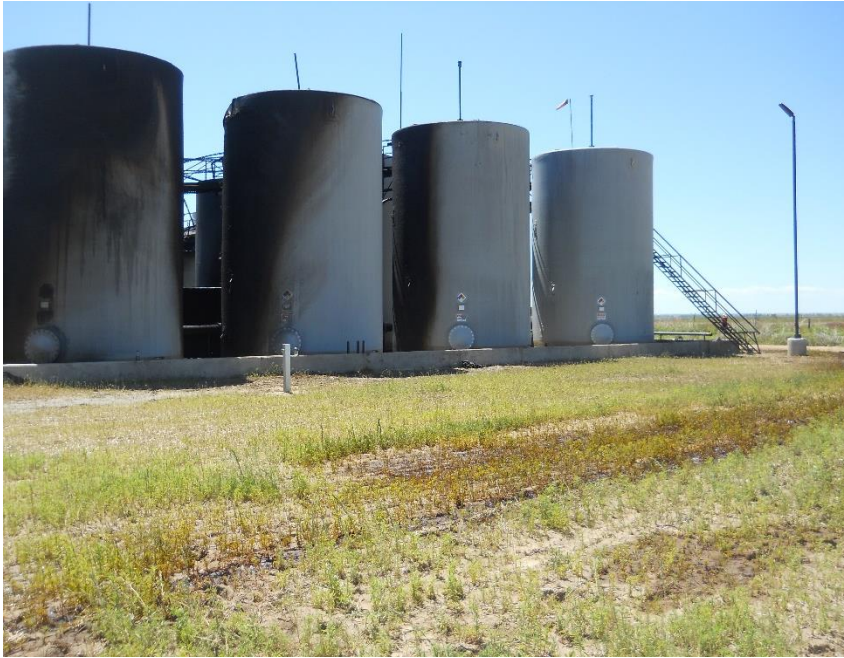
**Northwest end of TB showing little or no tank damage. Note stained area north of TB. Photo looking southwest**

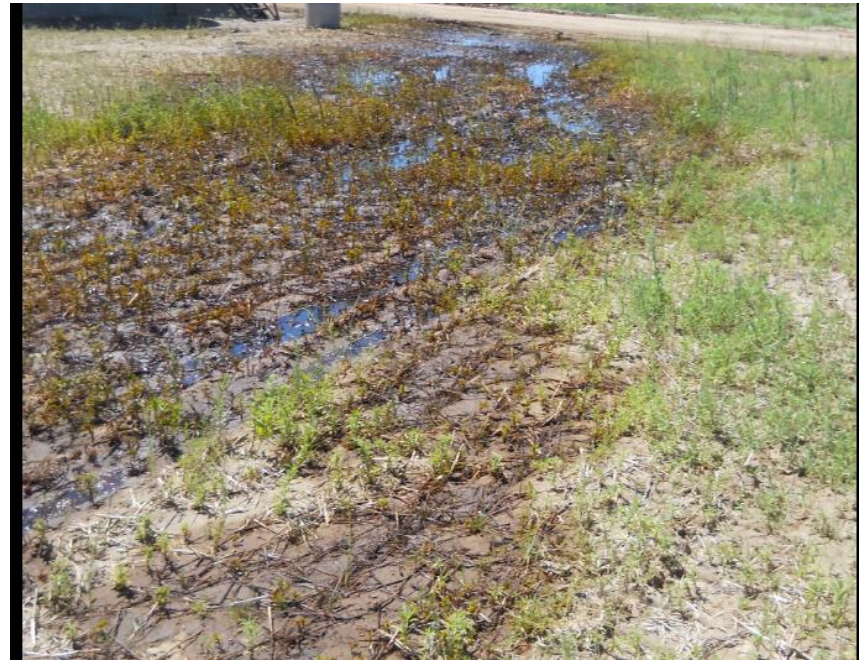
**Oil stained area north of TB.**

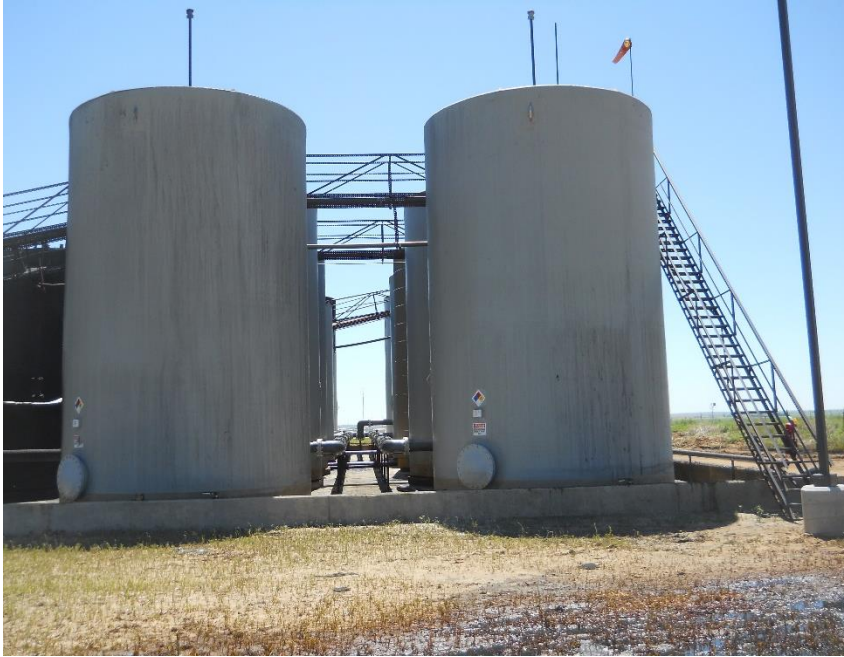
**Northwest end of TB showing undamaged tanks. Photo looking south.**

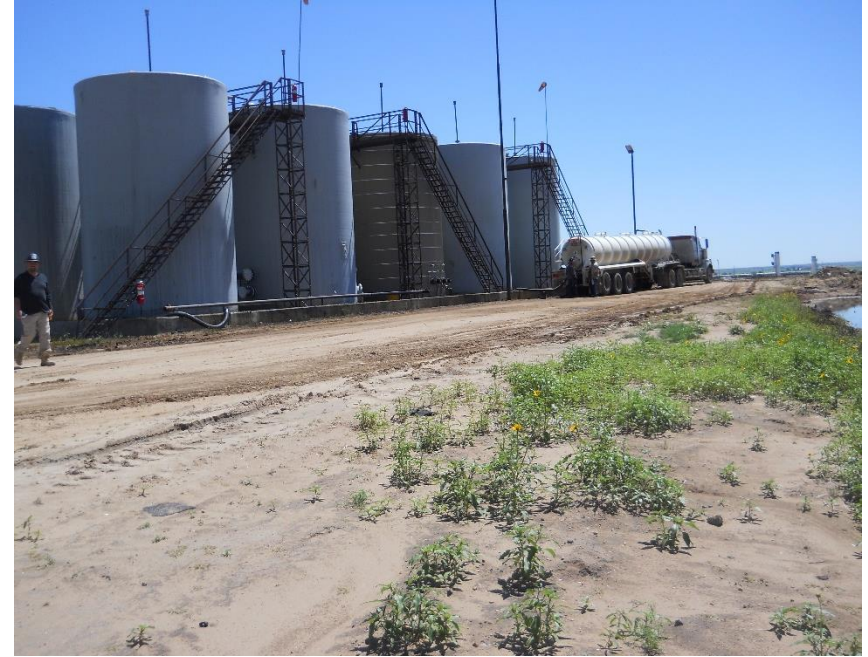
**West side of TB showing undamaged tanks. Photo looking southeast.**

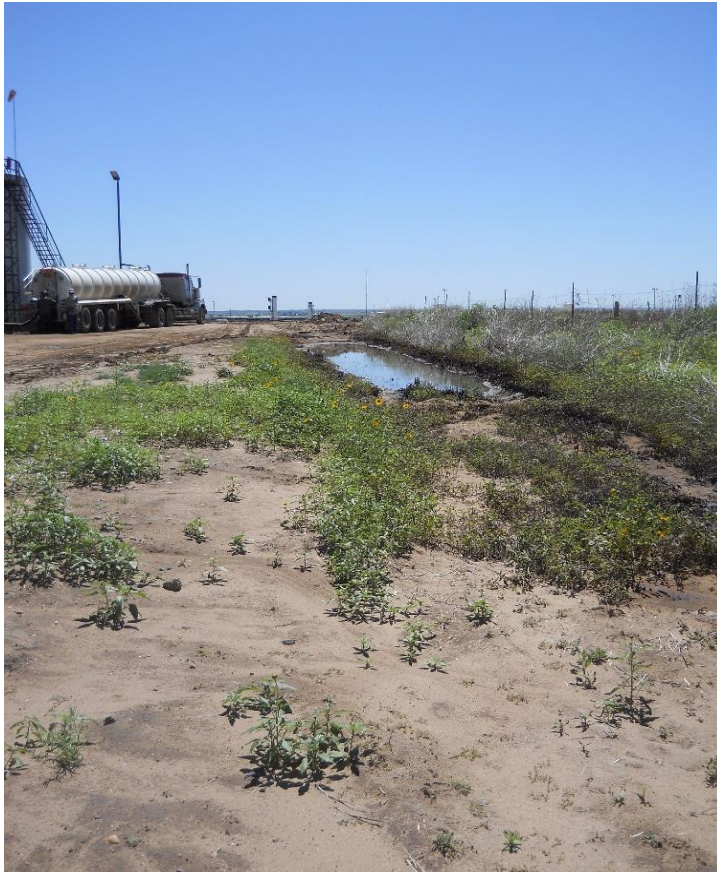
**Fluid collection area west of TB (storm water control ditch). Note staining. Photo looking south**

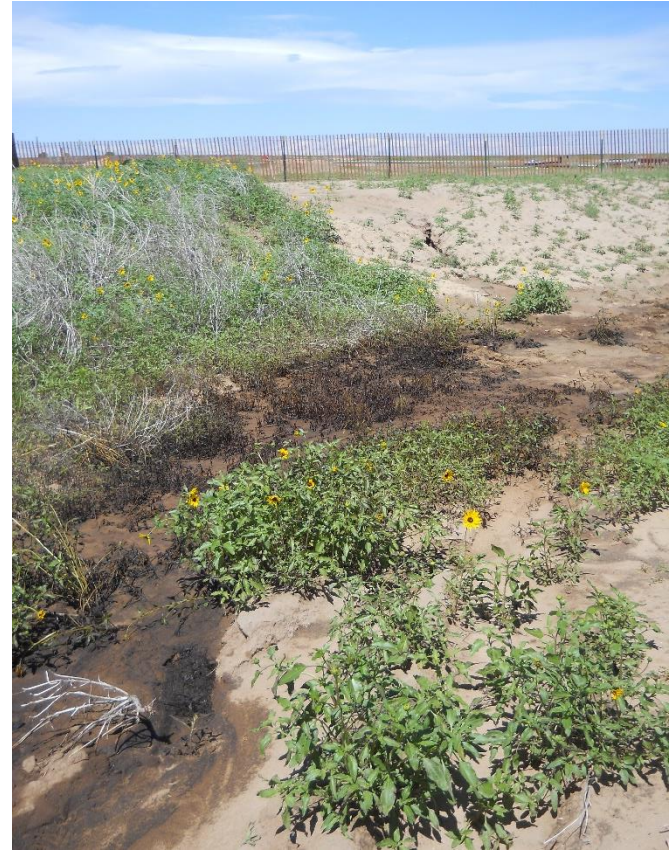
**Storm water control ditch. Note staining. Photo looking north.**

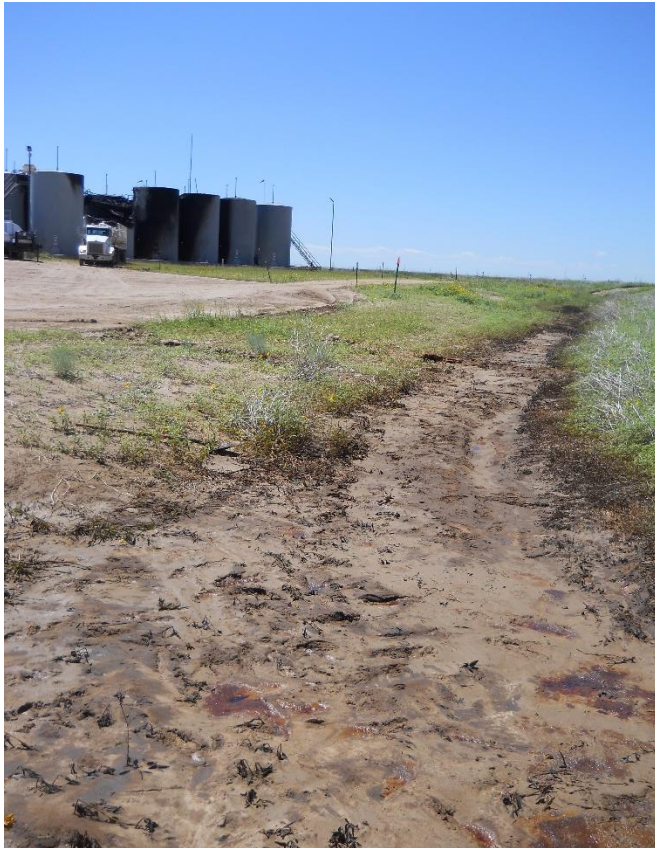
**Storm water ditch looking to south from location in previous photo. Note staining.**

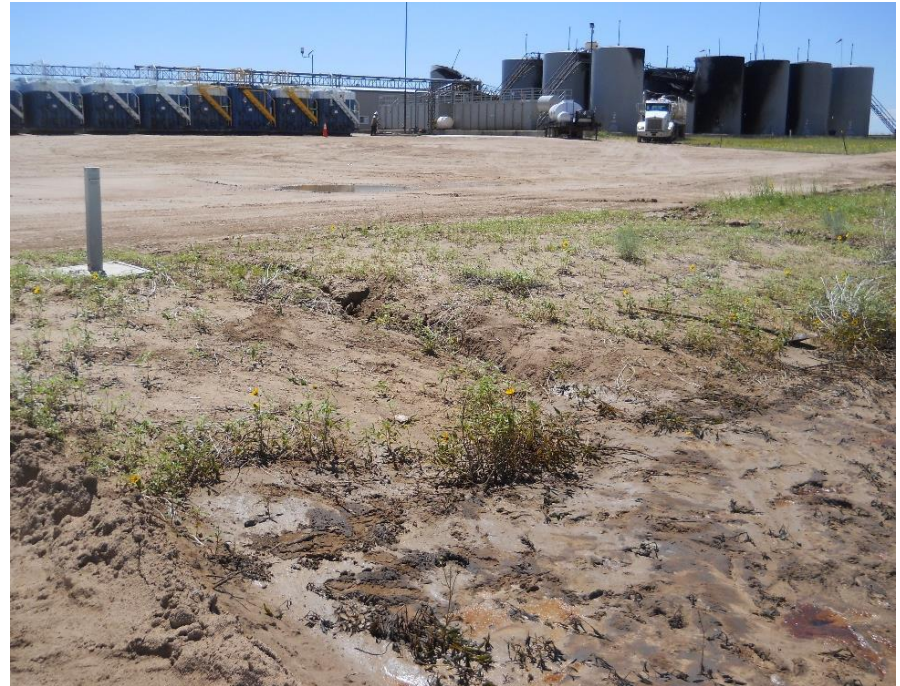
**Storm water ditch northeast side of facility. GW monitoring location. Ditch passes under road through culvert to east side. Note staining. Photo looking south west.**

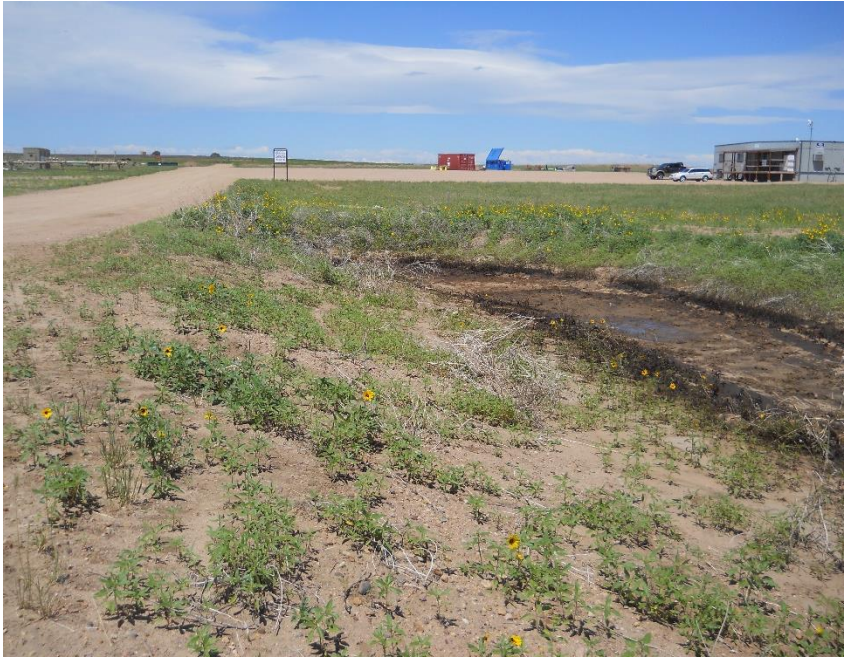
**Storm water ditch passes under road through culvert to east side. Note staining. Photo looking north.**

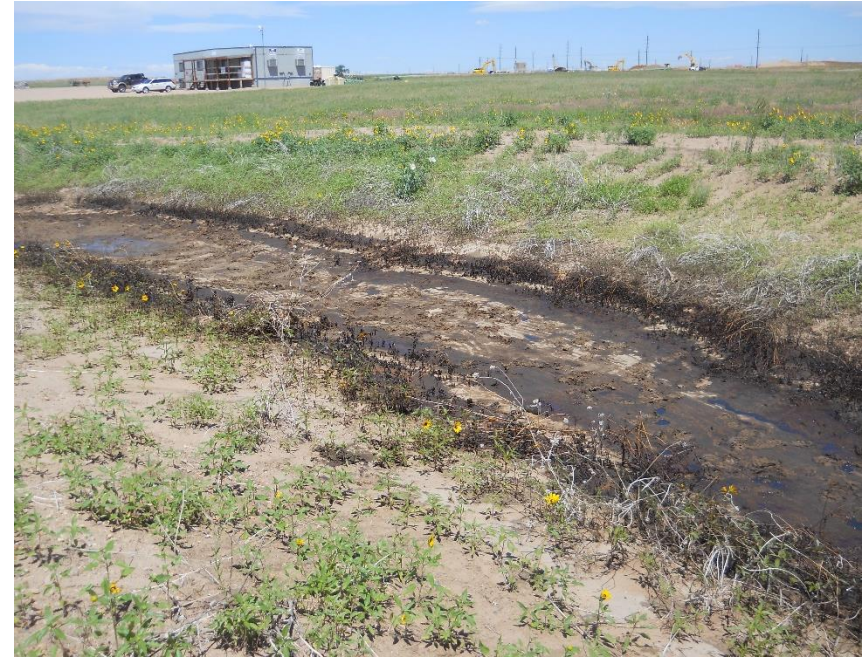
**Storm water ditch east side. Note staining. Photo looking north.**

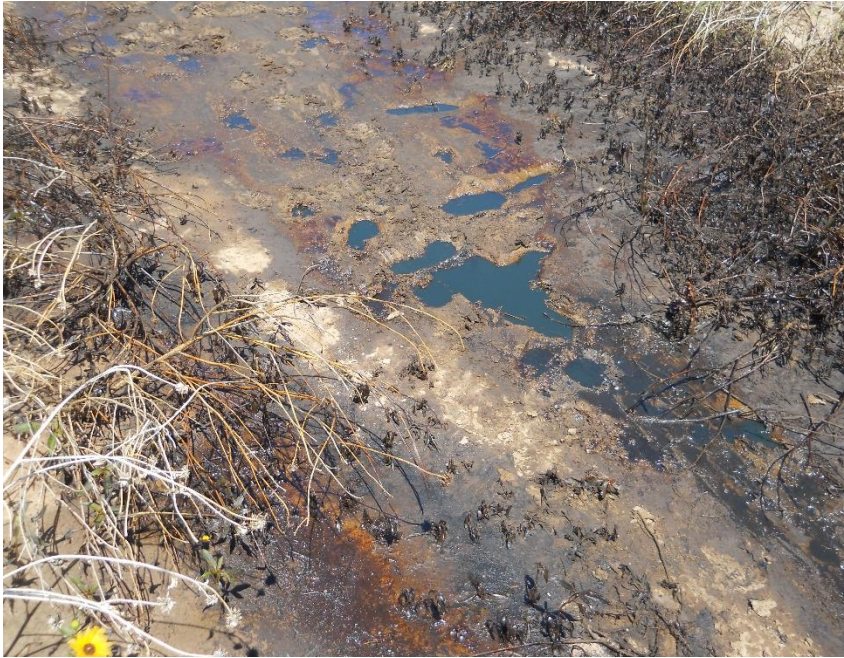
**Detail showing oily fluid in storm water ditch eastern side of facility.**

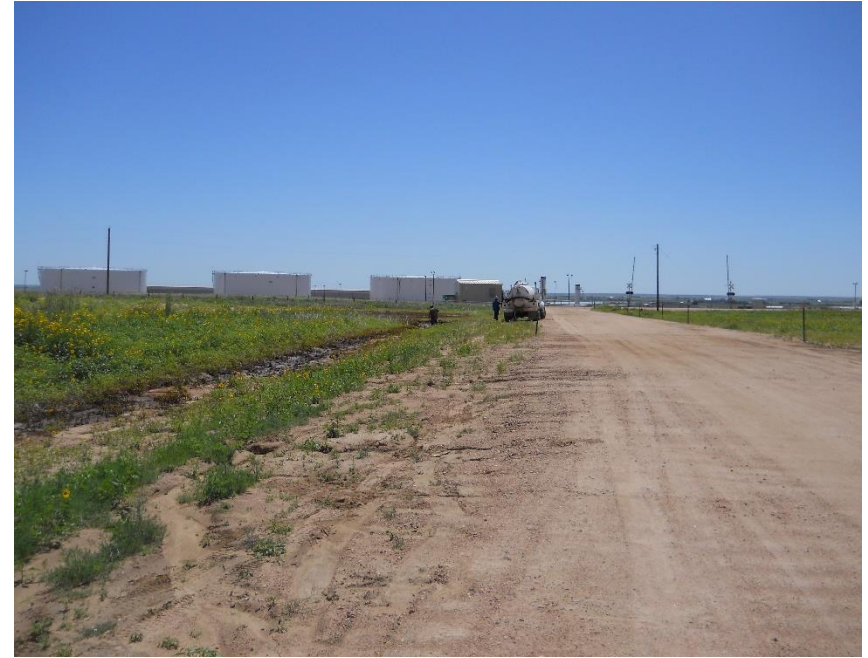
**Storm water ditch on east side of facility. Crew removing fluids from ditch. Photo looking south.**

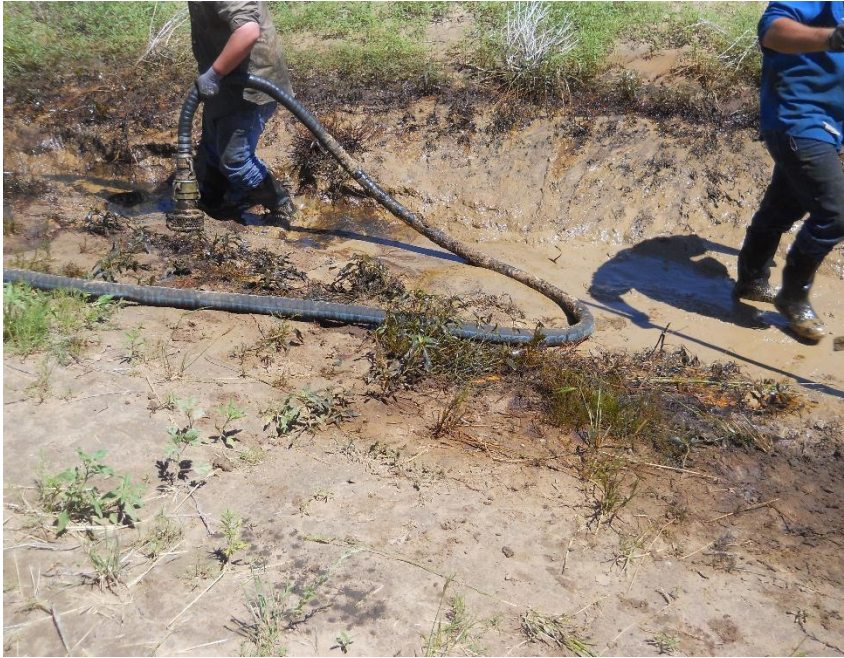
**Fluid removal from storm water ditch.**

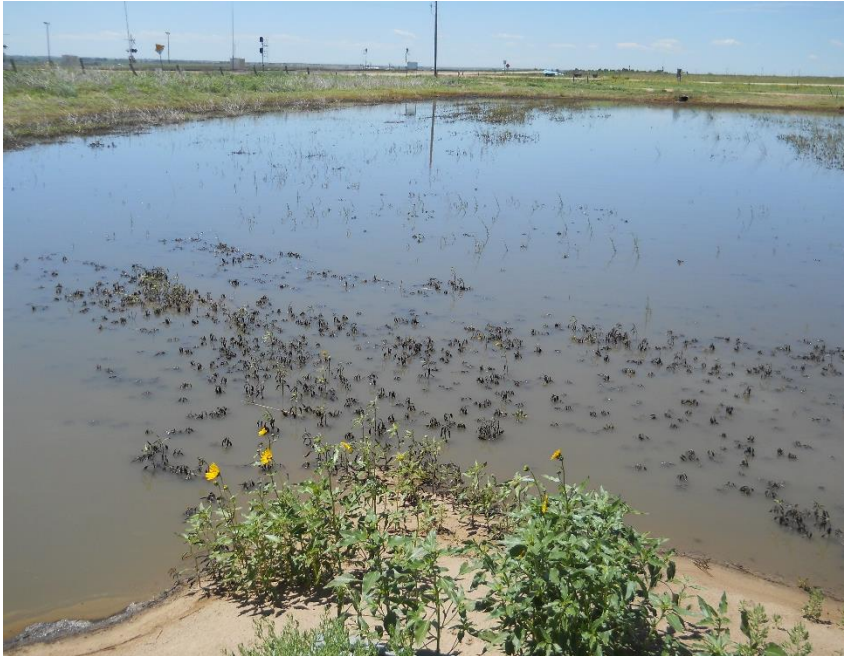
**Storm water retention pond from east side looking to west. No sheen or floating oil observed. Photo looking west.**

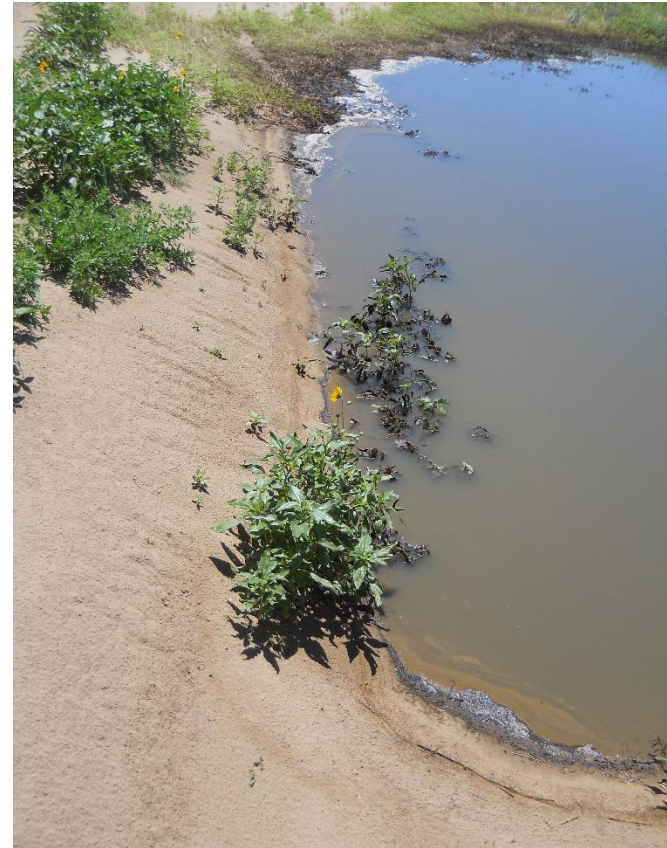
**East side of storm water retention pond. Note stained vegetation. Photo looking south.**
