Pit Status Evaluation Form

| Pit Name: STATE OF COLORADO YB3-4,5-6 | Facility ID: 102308 |
| Form 15 Pit Permit Doc #: 698554 | Permit Date: 3/23/1983 |

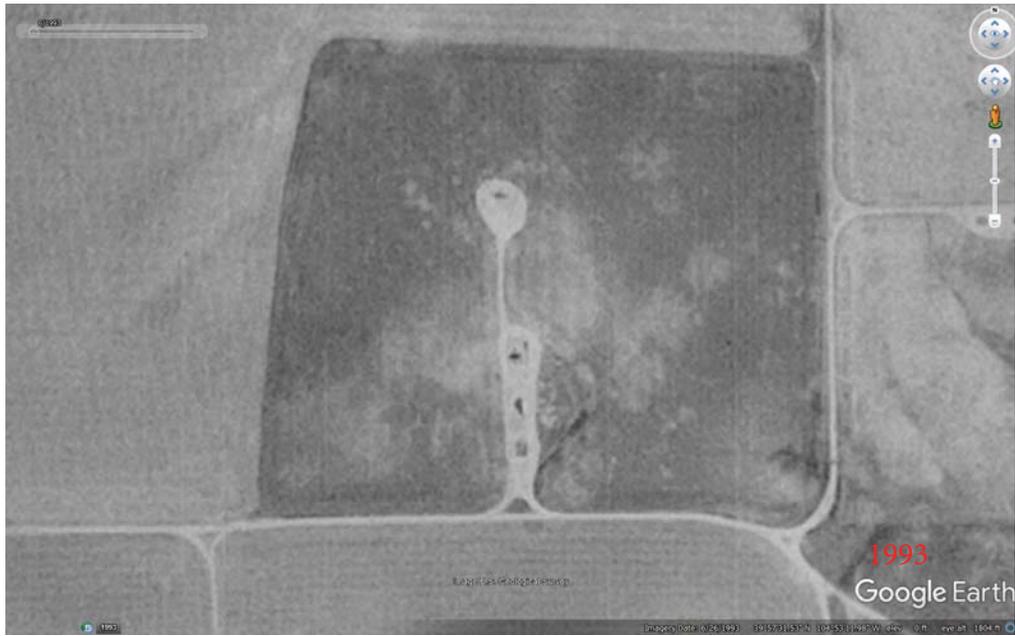
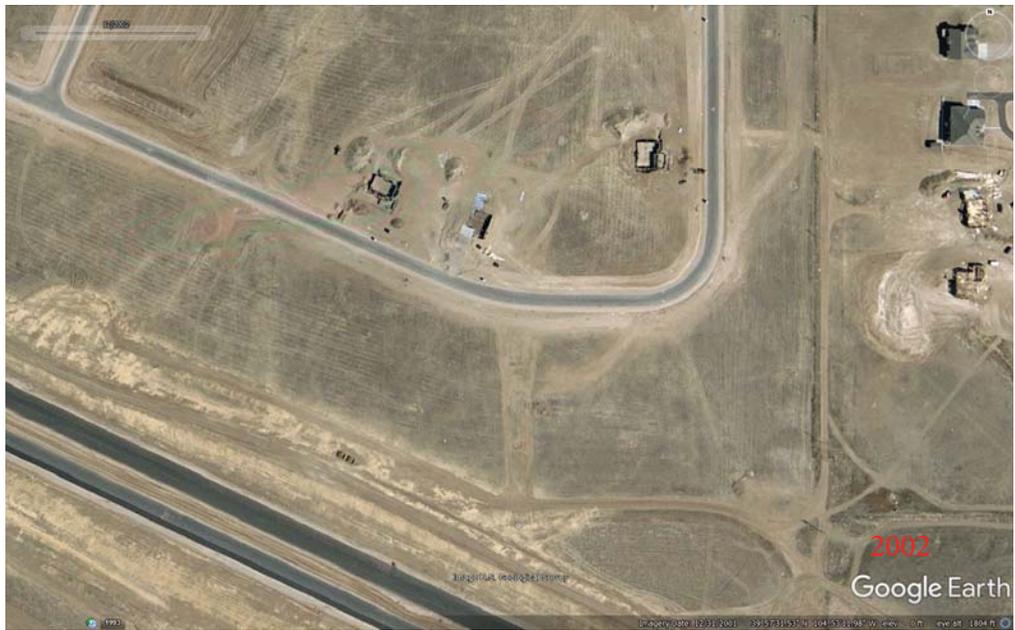
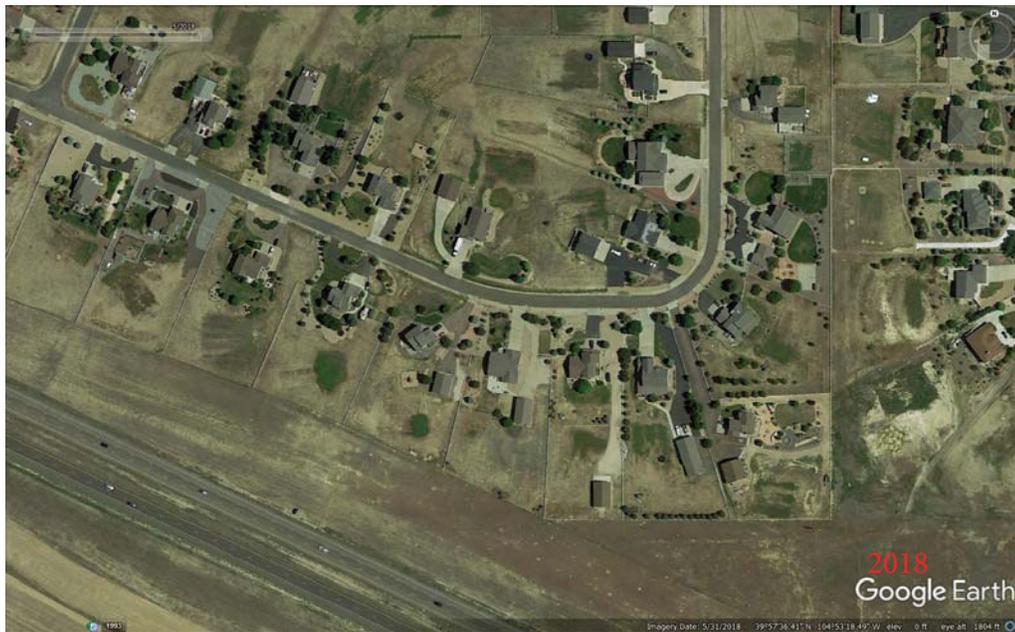
| <input checked="" type="checkbox"/> | Aerial Photo Verification (photos attached) | |

Duplicate of pit 113831. Records document an unlined earthen produced water pit on location. Pit was closed under remediation project #1757, resolved 10/30/2002. Pit status has been changed to closed.
