Inspection Photos

API: 05-017-07453

Operator: RESOURCE DEVELOPMENT

Inspection Date: 6/21/2019

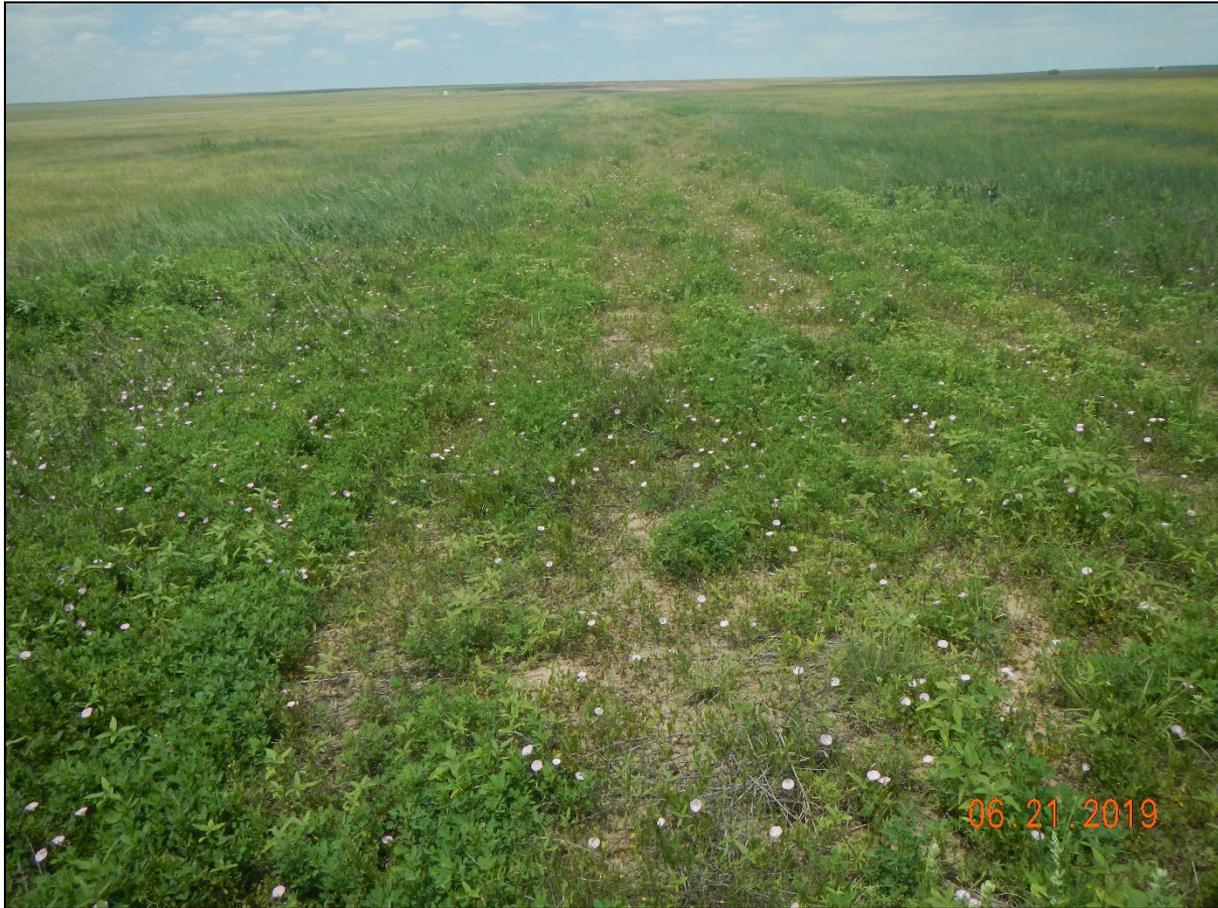
Photo 1. Facing west along the former access road. There is weedy areas along the road.

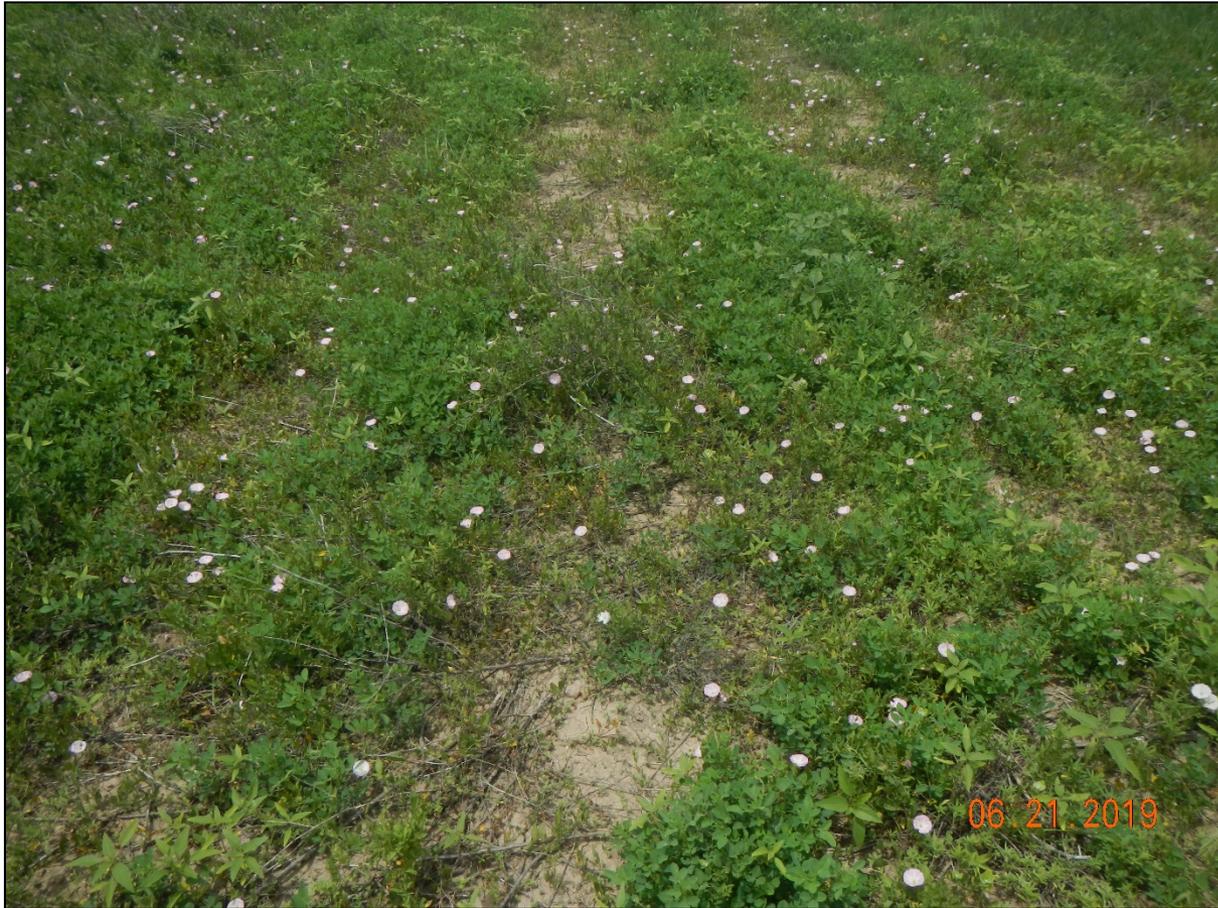
Photo 2. View of vegetation along the road. There was Field bindweed and Kochia along the road which was not found in the adjacent pasture.

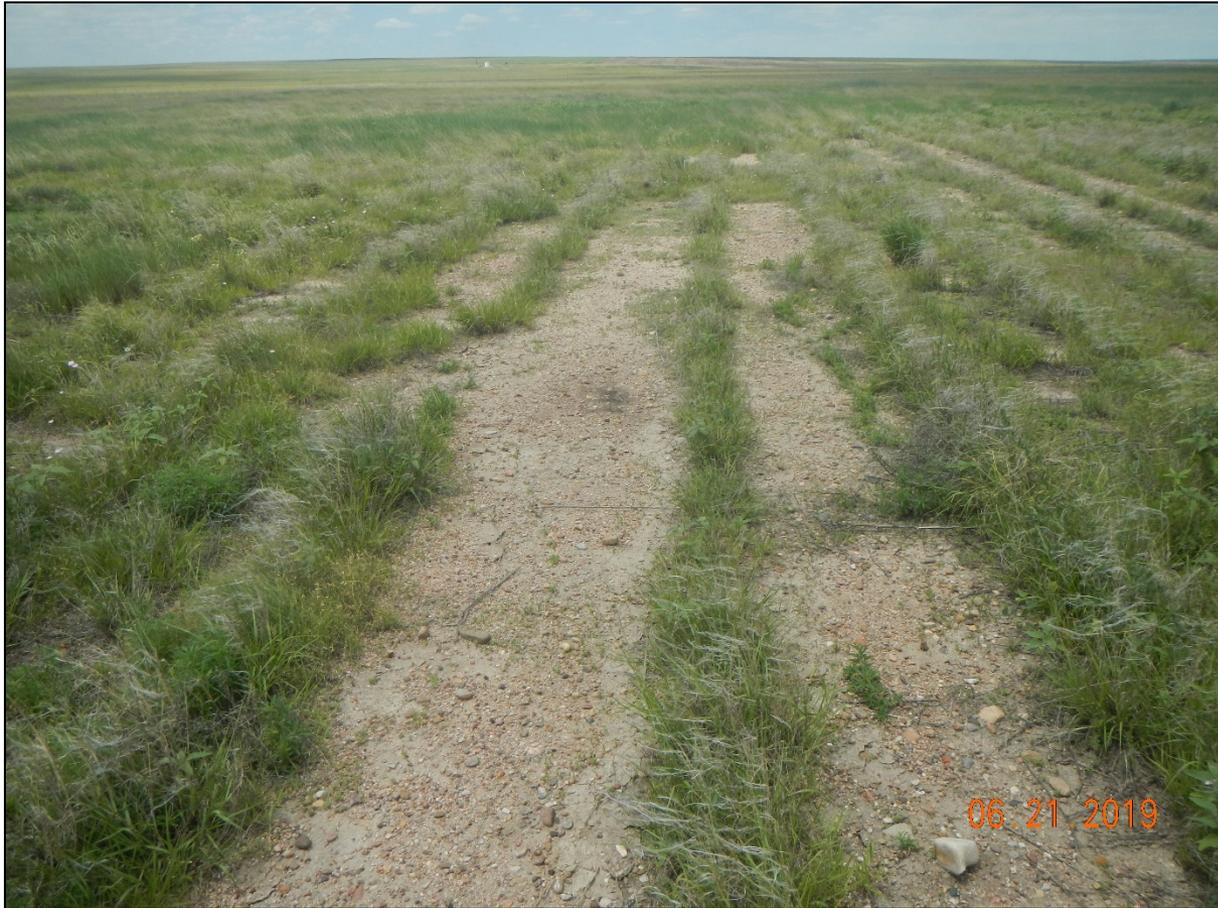
Photo 3. Facing west at the location. There is areas with no vegetation growth and possible soil compaction.

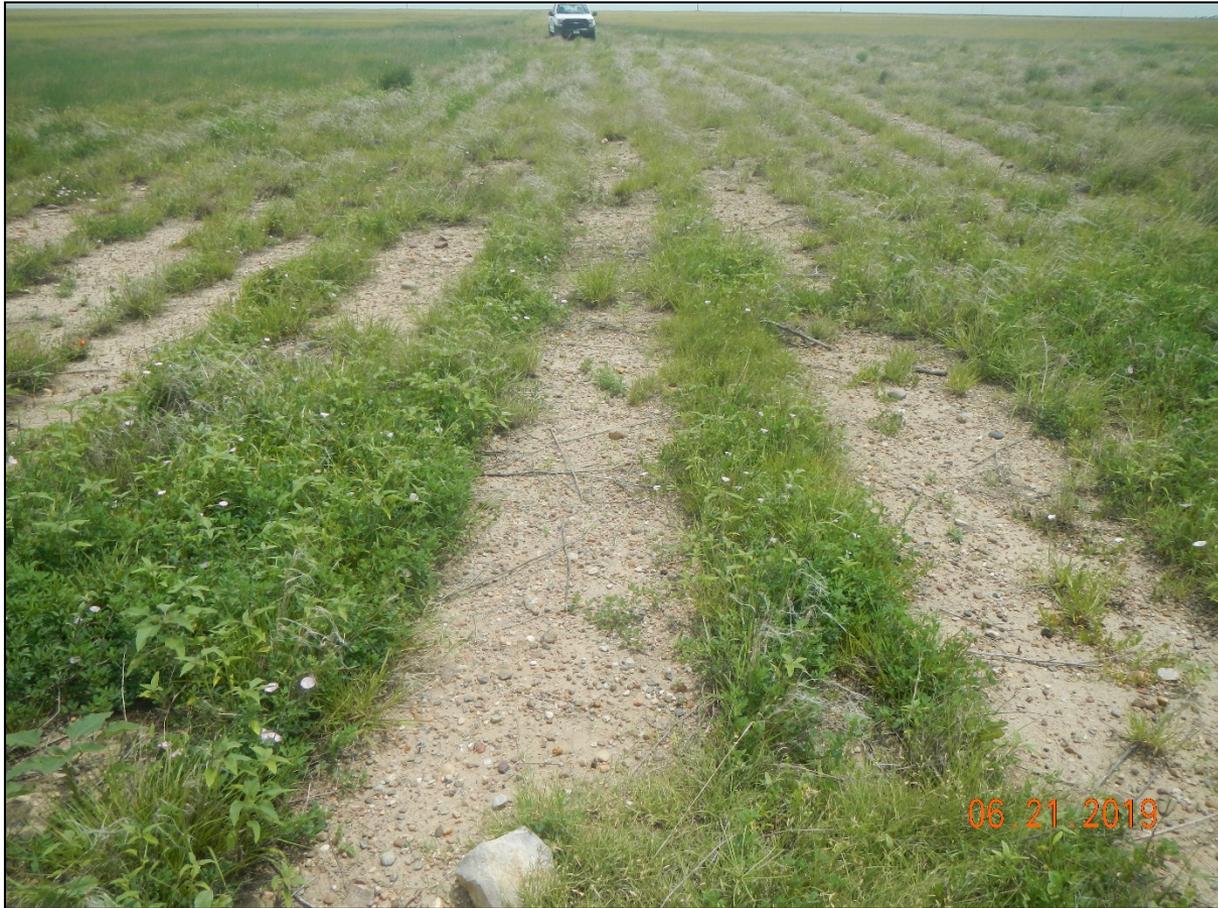
Photo 4. Facing east at the location. There is areas with no vegetation growth and possible soil compaction.

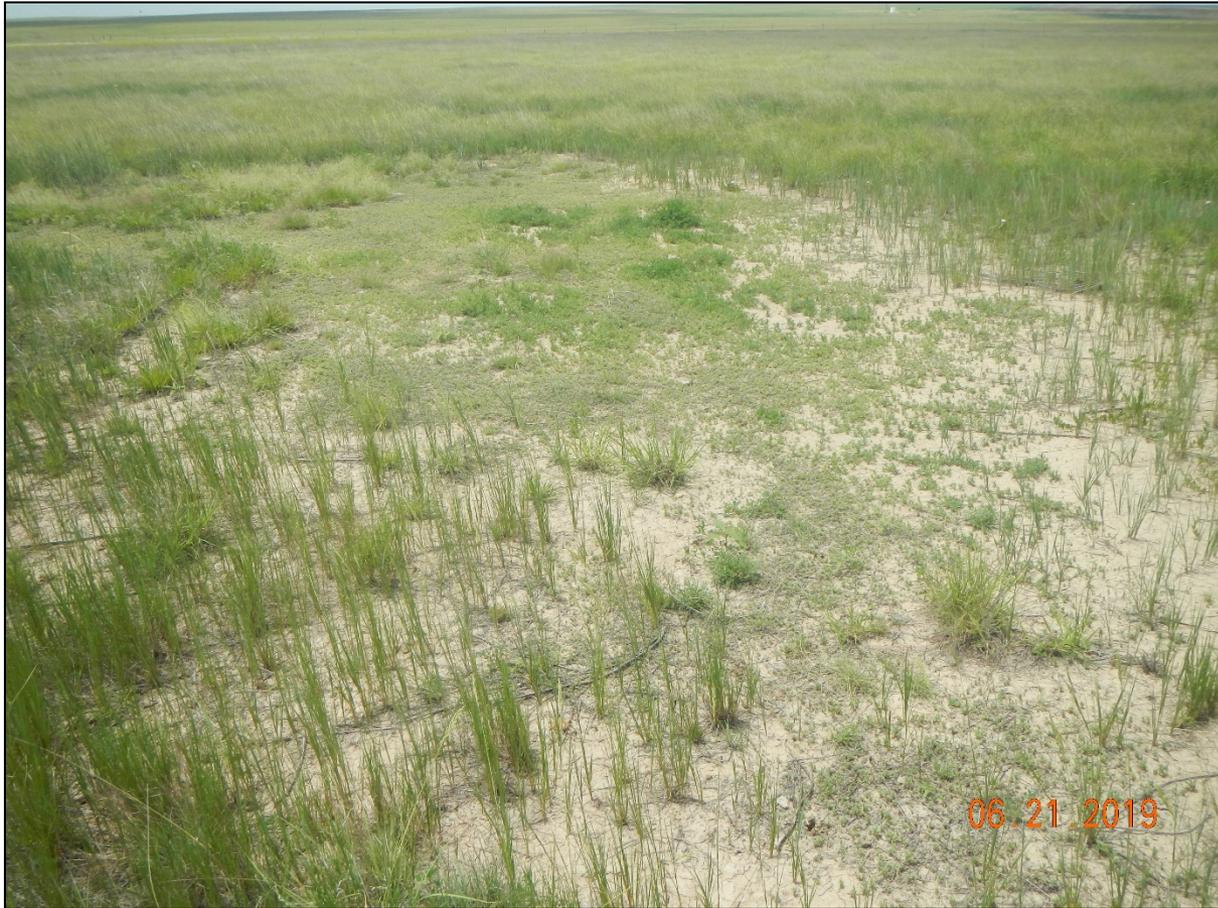
Photo 5. This area approximately 100'x20' has minimal desirable vegetation growth.

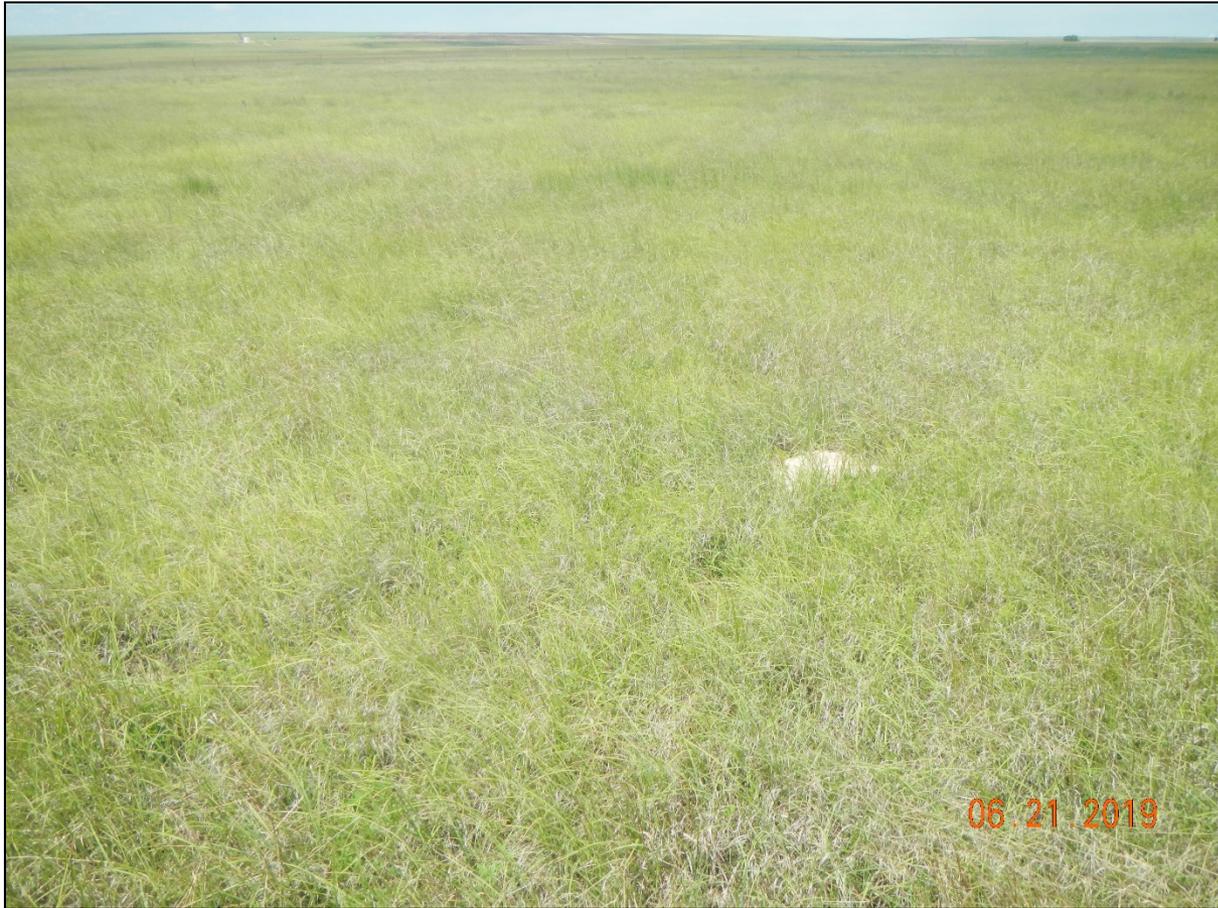
Photo 6. Facing west at the surrounding undisturbed pasture.

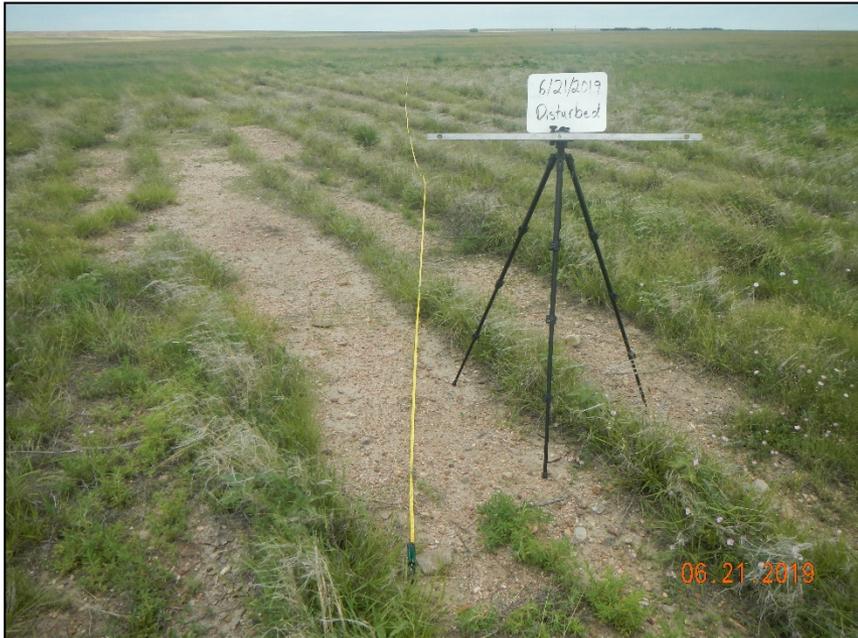
Photo 7. Transect on location facing NW.

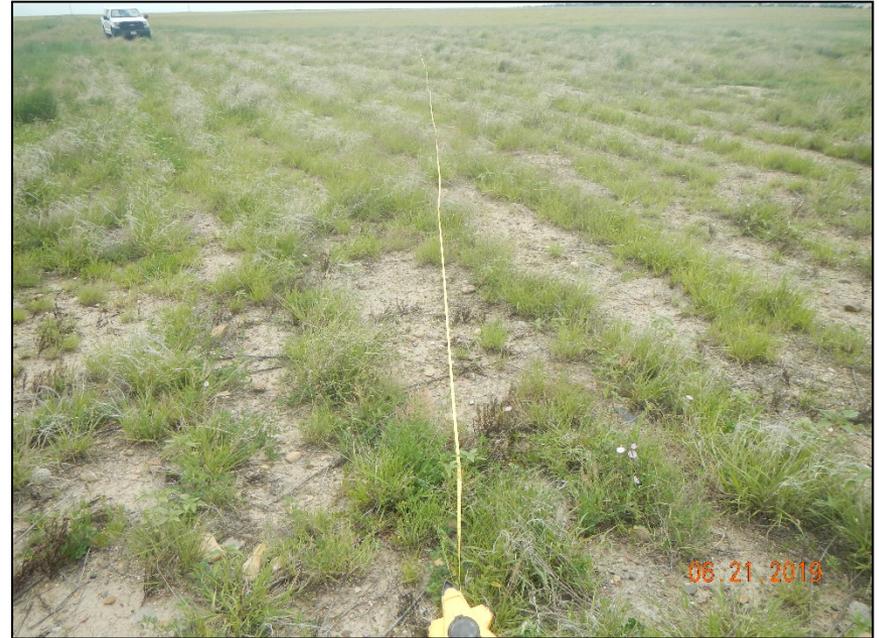
Photo 8. Transect on location facing SE.

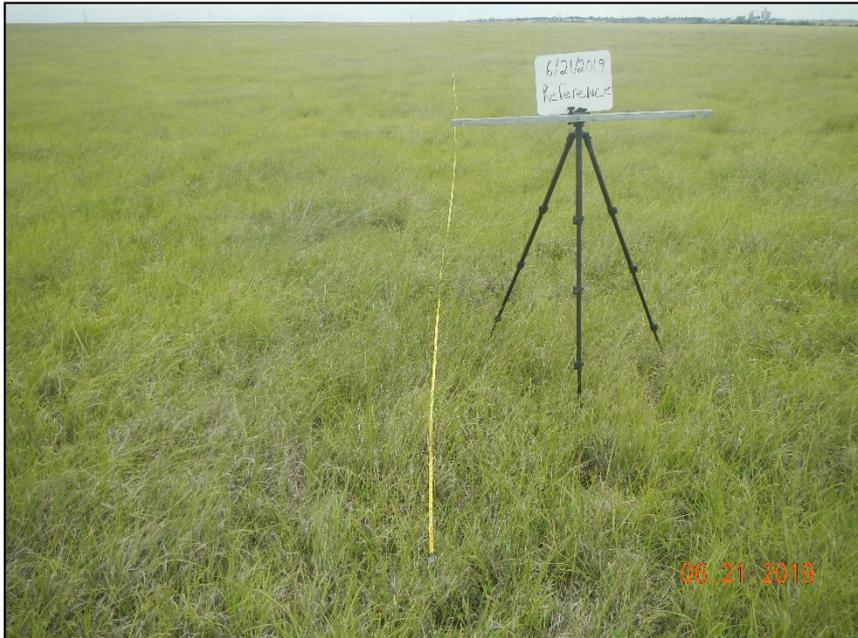
Photo 9. Transect Reference facing SE.

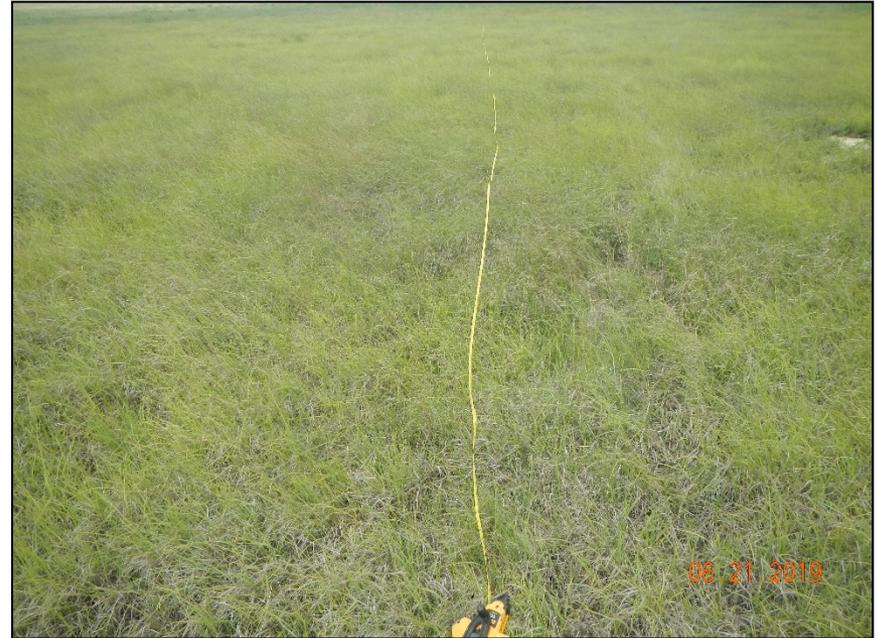
Photo 10. Transect Reference facing NW.
