Inspection Photos
Location Name: Falcon Seaboard 11-90-12 #5
API: 05-051-06139

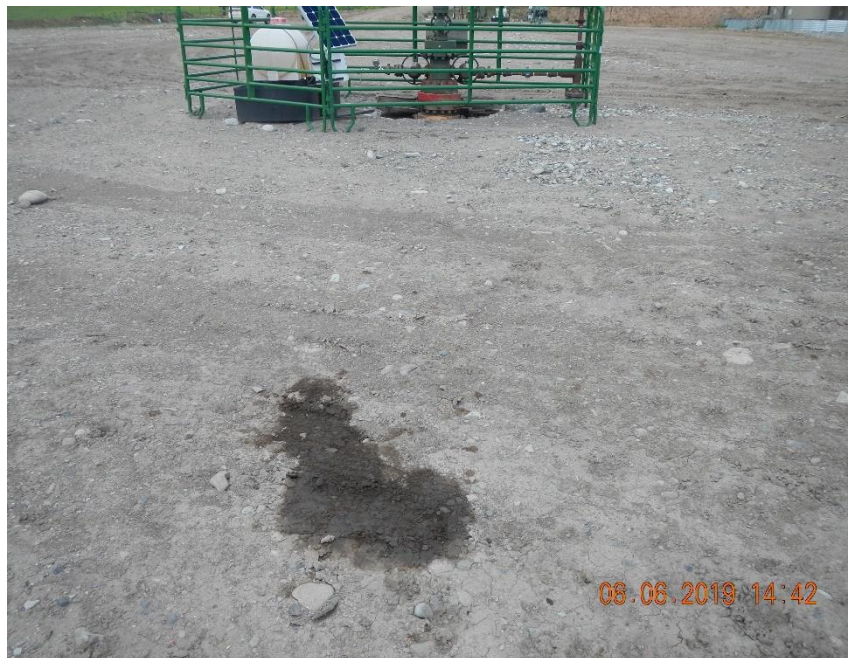
Stained soil to the southwest of the #5 well head.

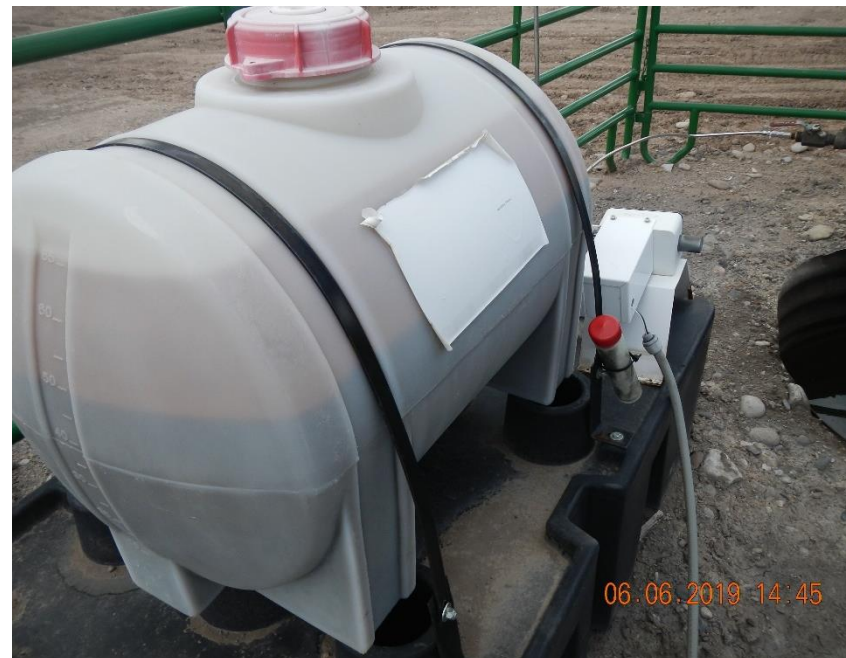
Illegible label on chemical injection system for #3 well head.

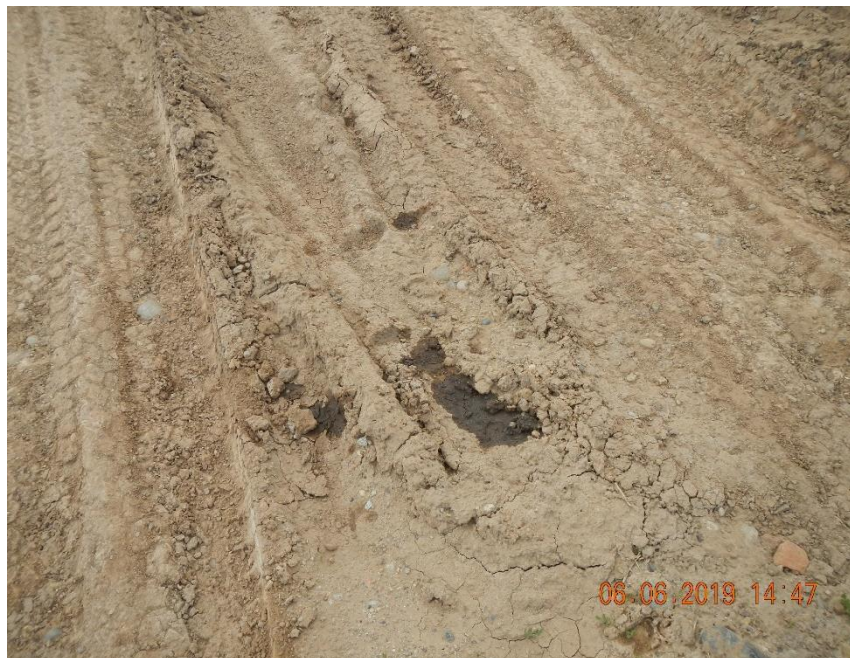
Stained soil near truck load out.
