# Inspection Photos

07/01/2019

Operator: FOUNDATION ENERGY  
MANAGEMENT LLC # 10112

Location ID: 447523  
Weld County, CO

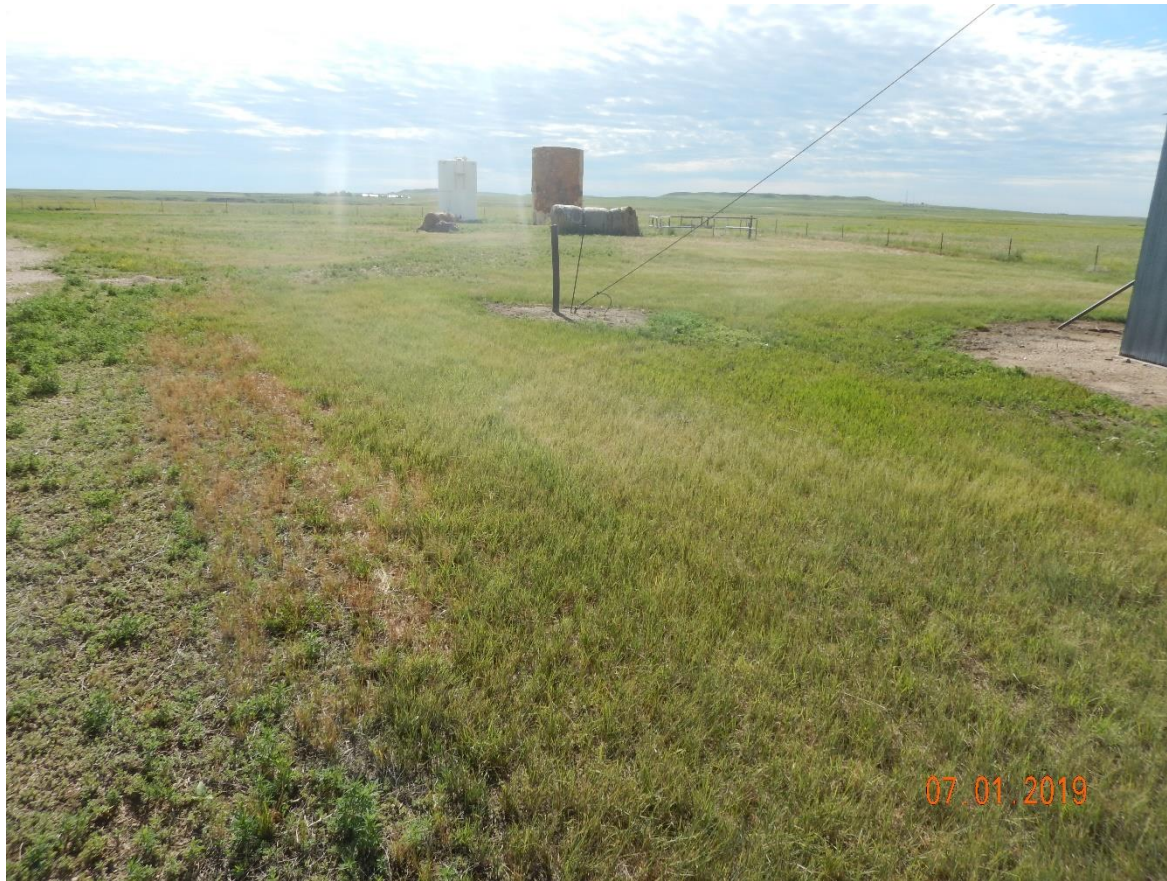
**Photo 1:** Photo taken from the southwest end of the location, facing east. Photo shows equipment remaining on location.

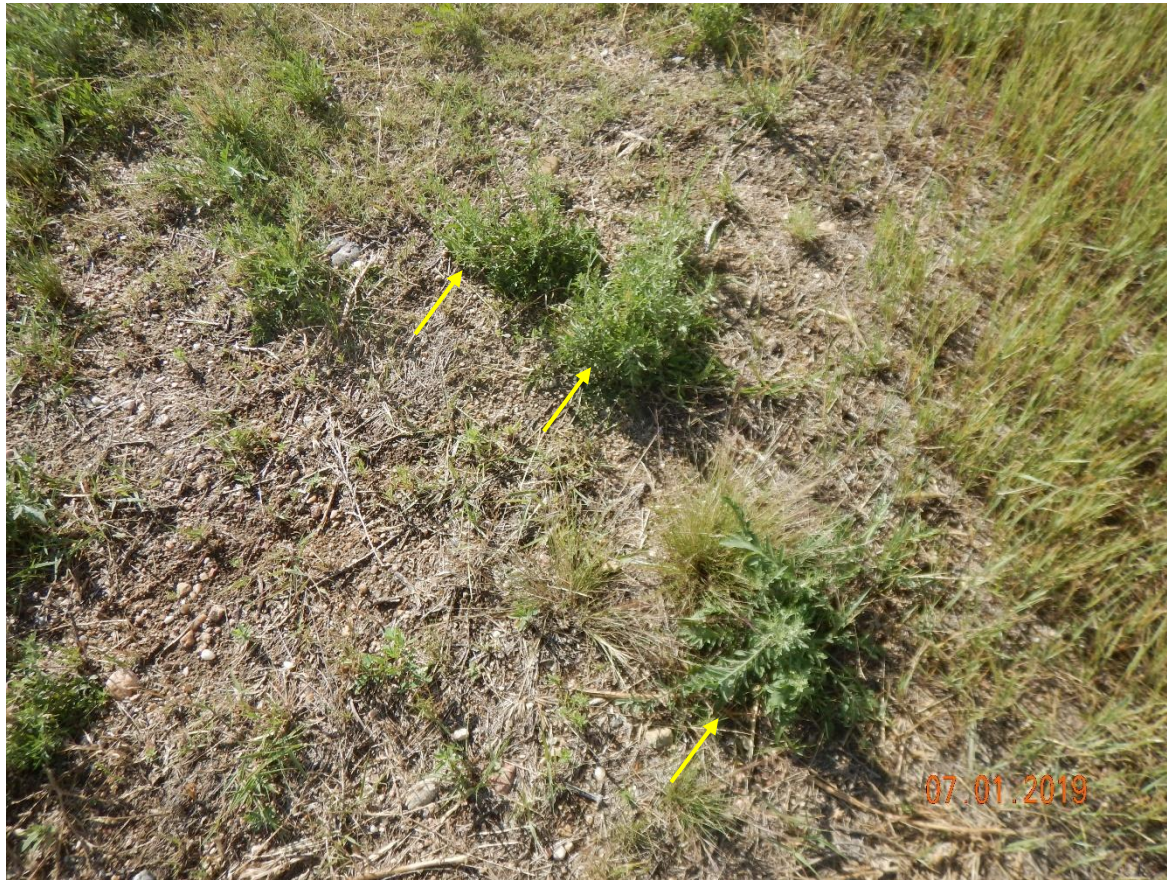
**Photo 2:** Photo taken from the south end of the location. Photo shows Diffuse knapweed continues to establish on the location.

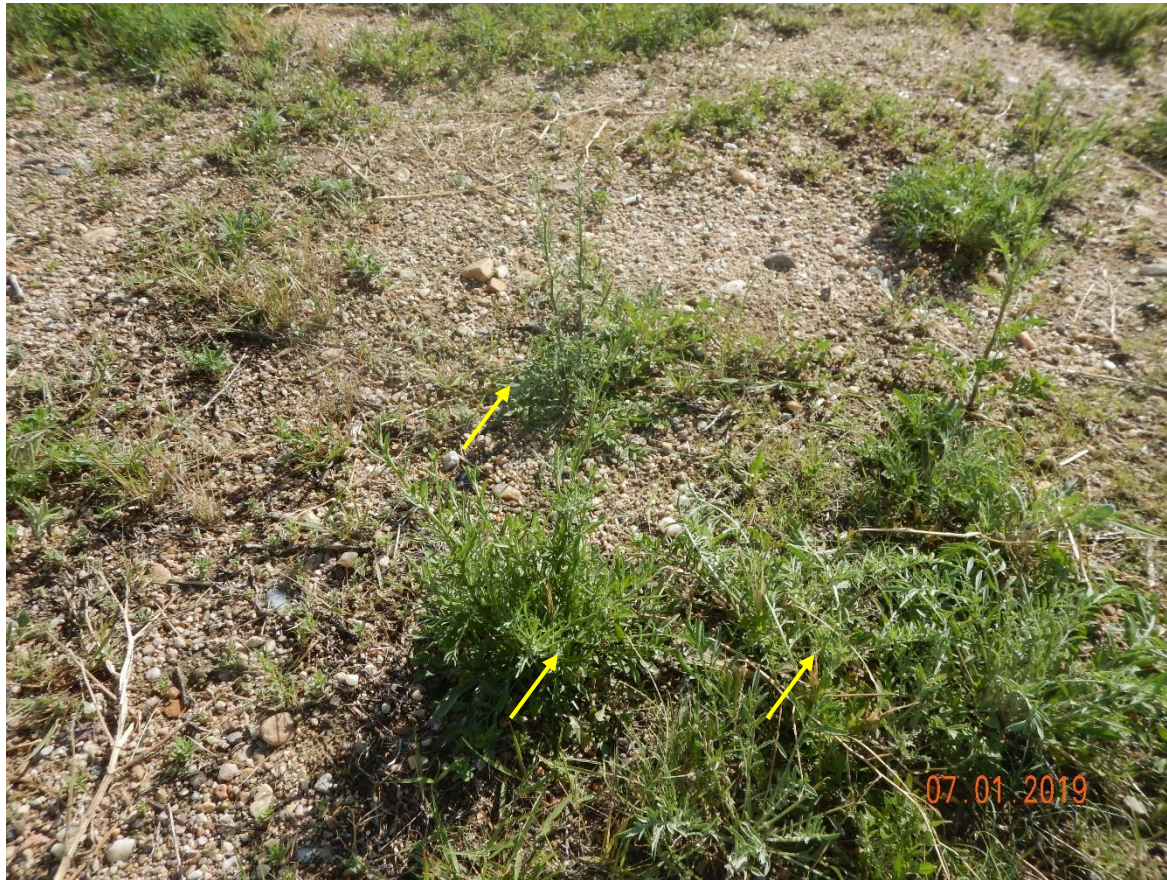
**Photo 3:** Photo taken from the south end of the location. Photo shows Diffuse knapweed continues to establish on the location.

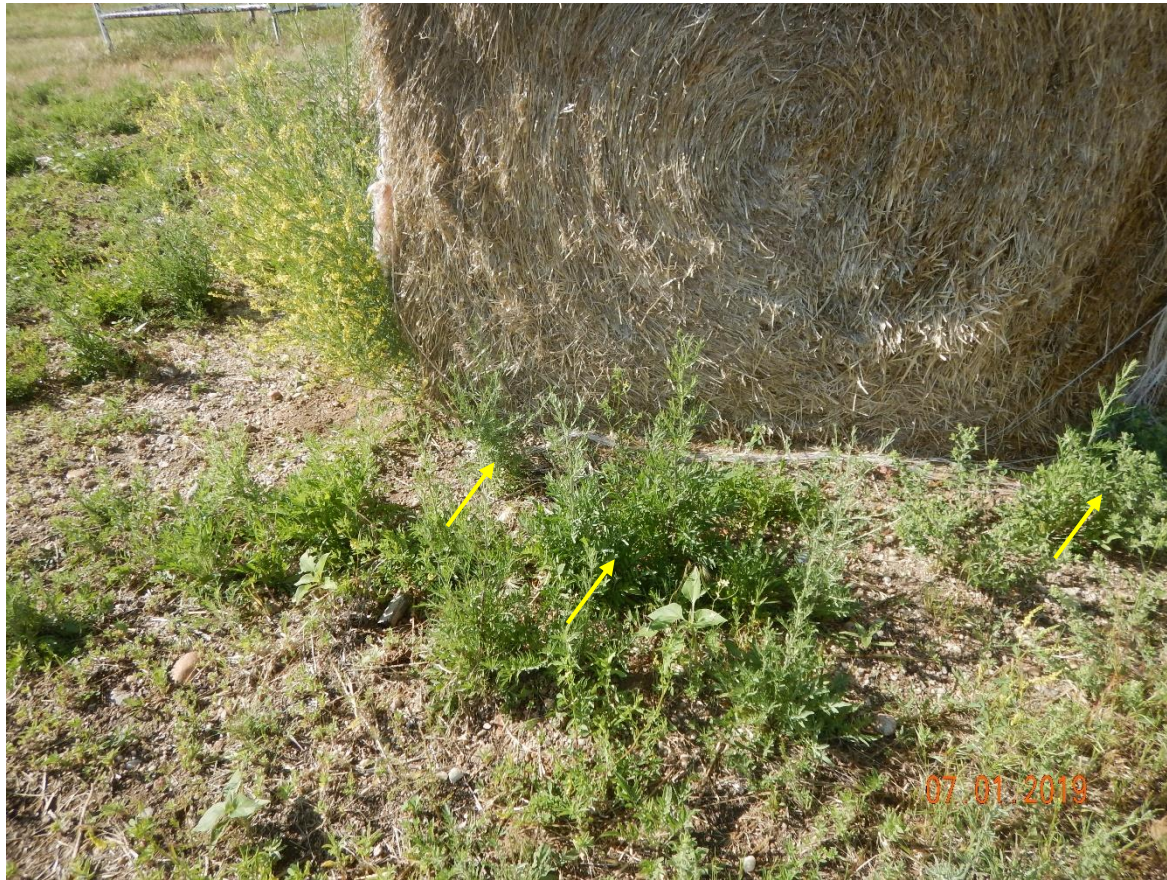
**Photo 4:** Photo taken from the south end of the location. Photo shows Diffuse knapweed continues to establish on the location.

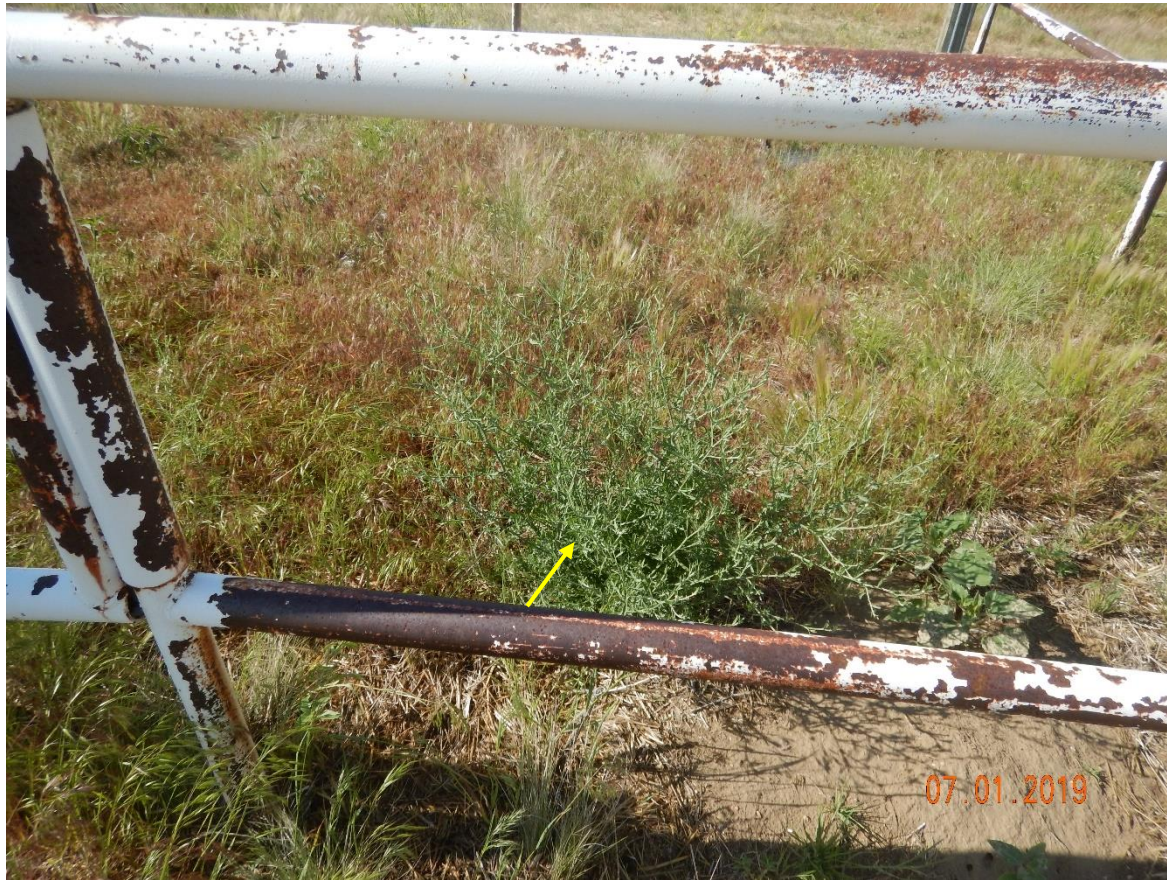
**Photo 5:** Photo taken from the south end of the location. Photo shows Diffuse knapweed continues to establish on the location.

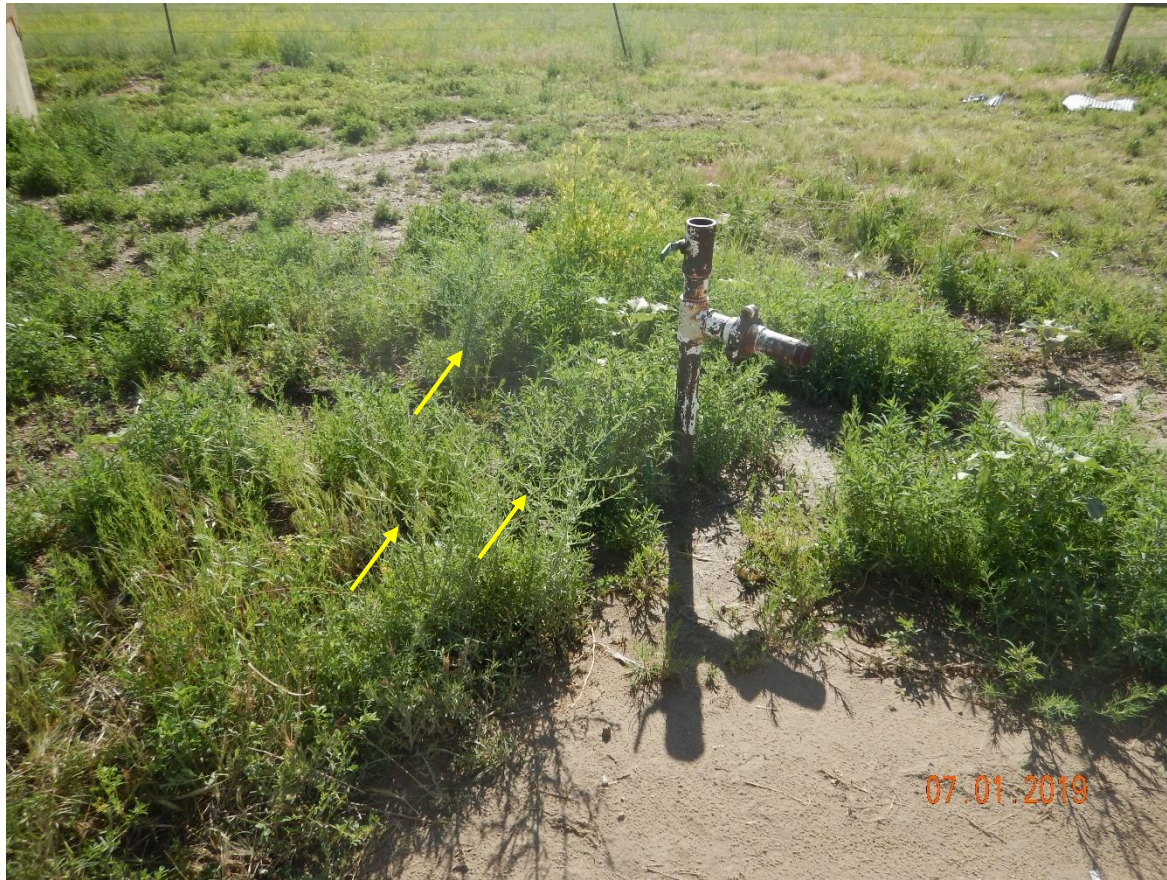
**Photo 6:** Photo taken from the south end of the location. Photo shows Diffuse knapweed continues to establish on the location. Photo also shows riser equipment has not been removed.

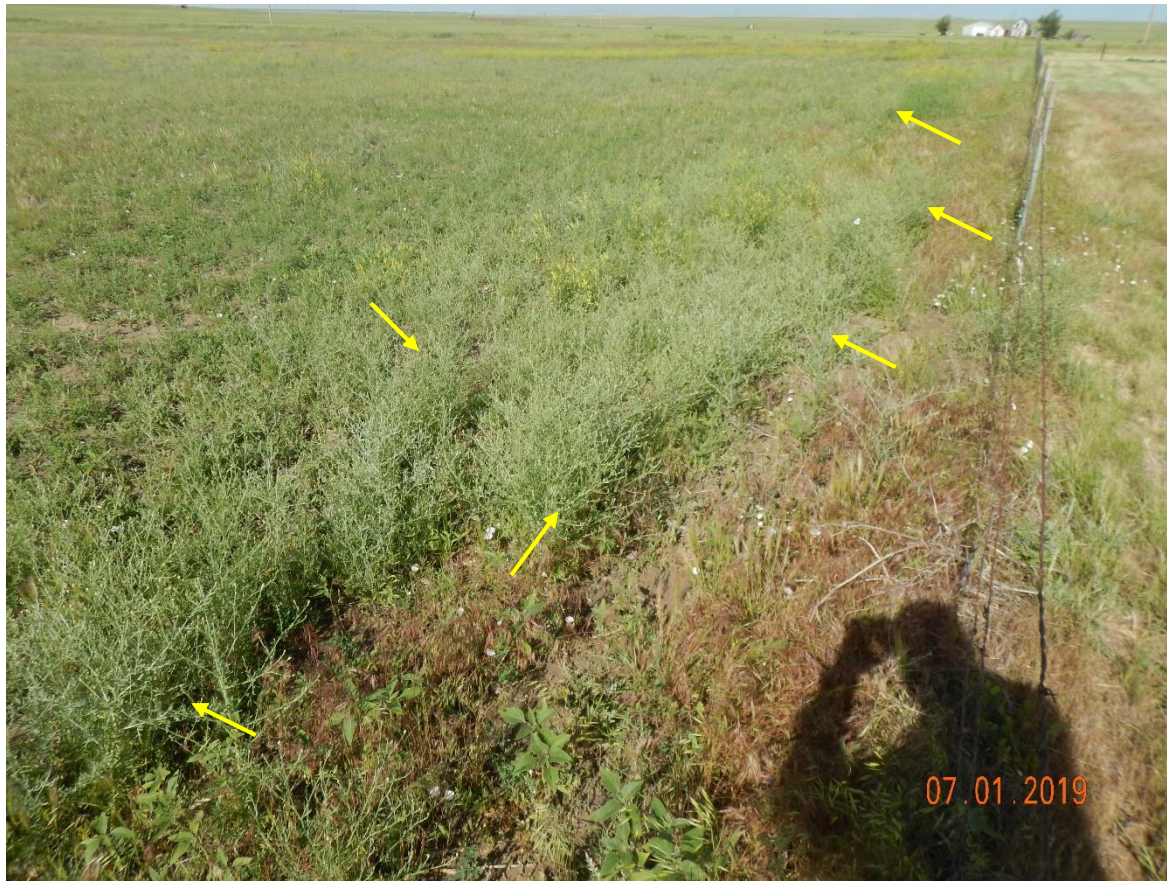
**Photo 7:** Photo taken from the south end of the location, facing southwest. Photo shows Diffuse knapweed has continued to establish on the location and spread onto the adjacent lands.

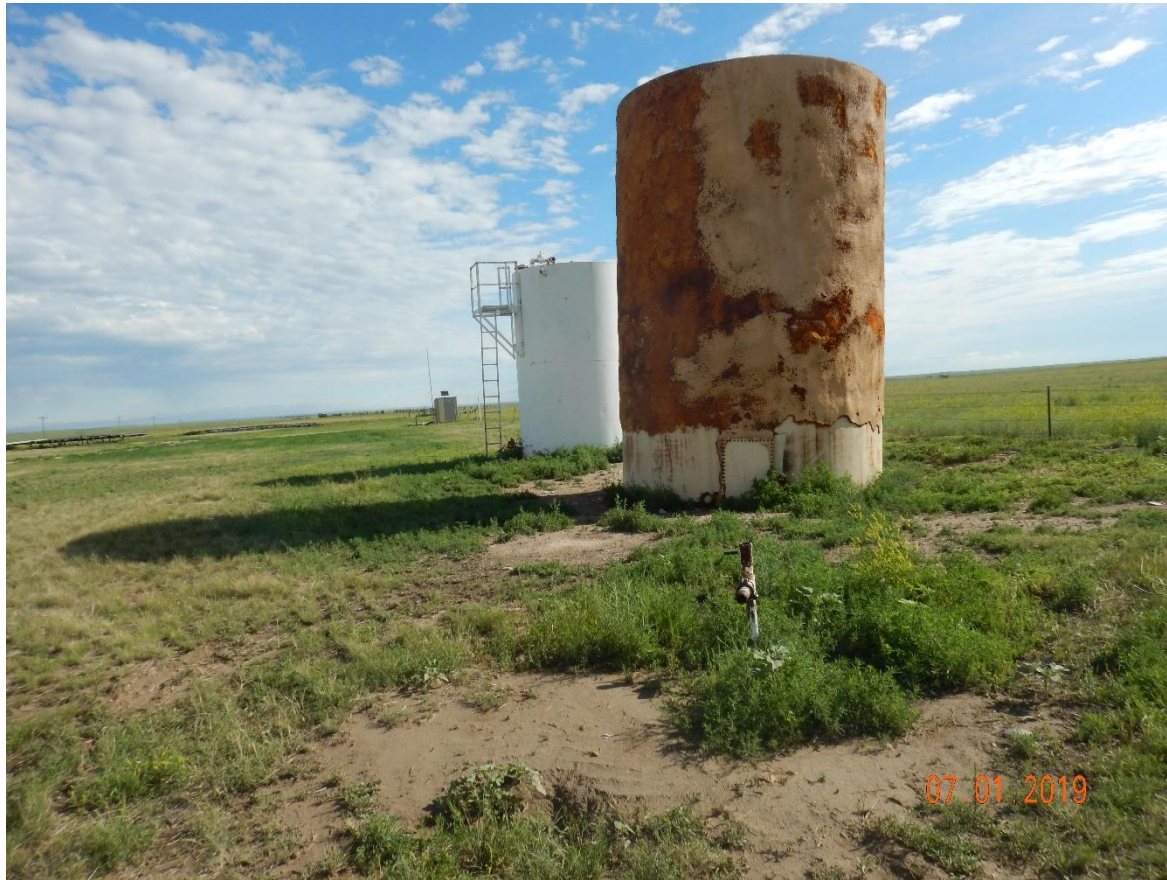
**Photo 8:** Photo taken from the southeast end of the location. Photo shows equipment has not been removed from the location, and location has not been reclaimed.

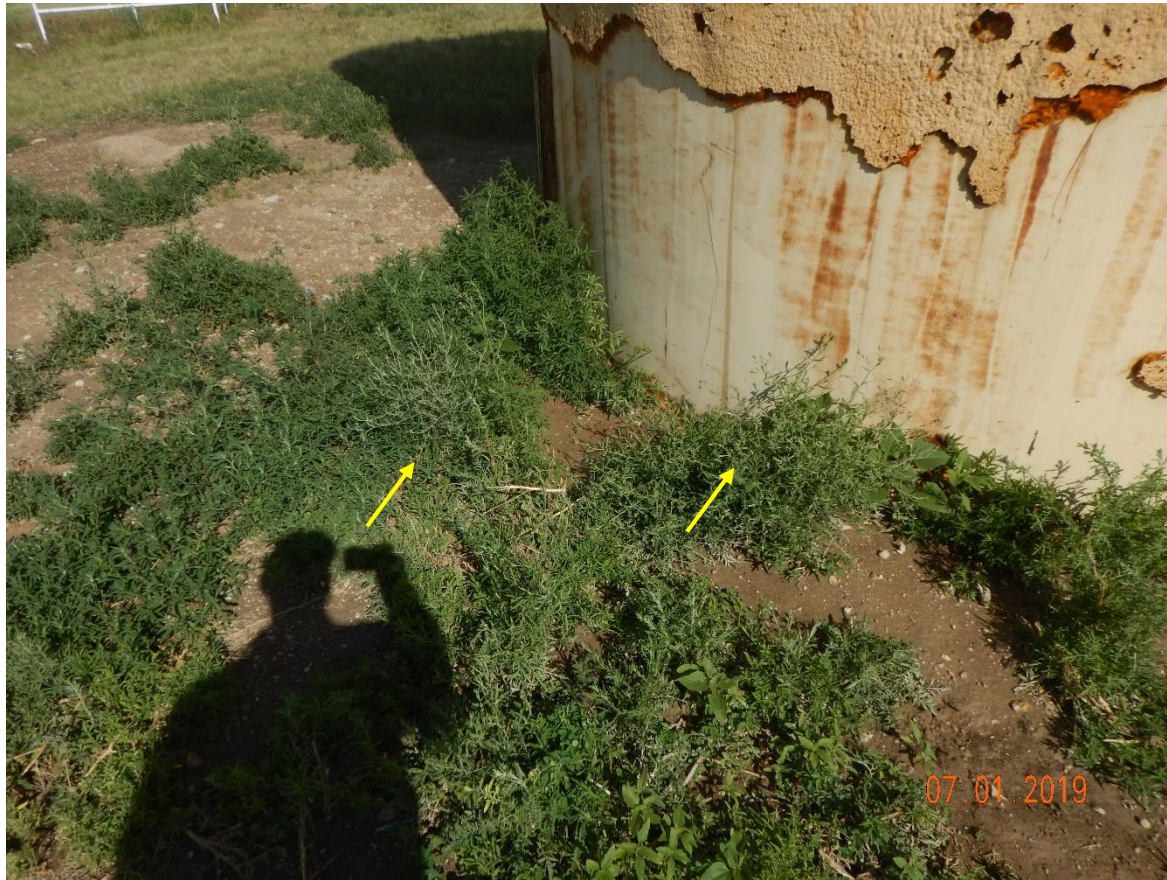
**Photo 9:** Photo taken from the tanks on the east end of the location. Photo shows Diffuse knapweed continues to establish on the location. Photo also shows equipment has not been removed.

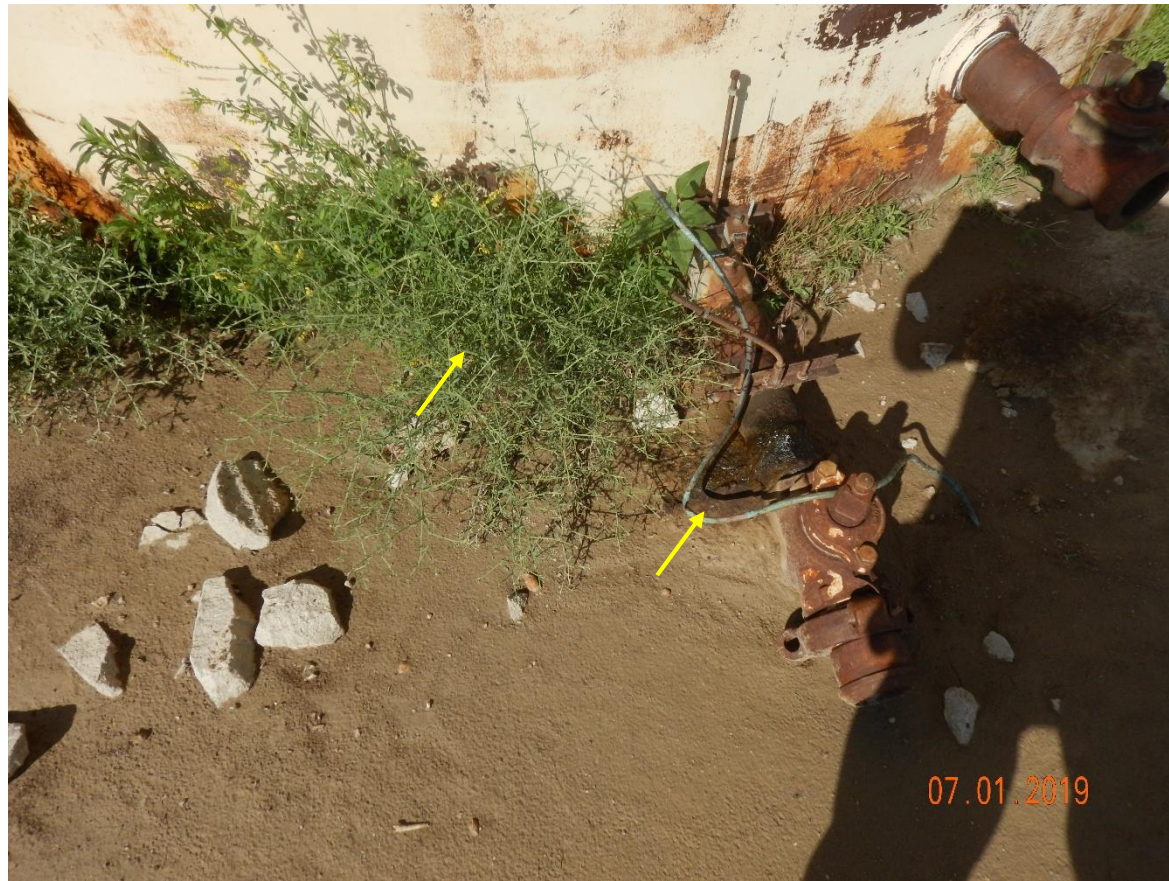
**Photo 10:** Photo taken from the tanks on the east end of the location. Photo shows Diffuse knapweed continues to establish on the location. Photo also shows equipment has not been removed. Photo also shows tank appears to be leaking and staining the soils.

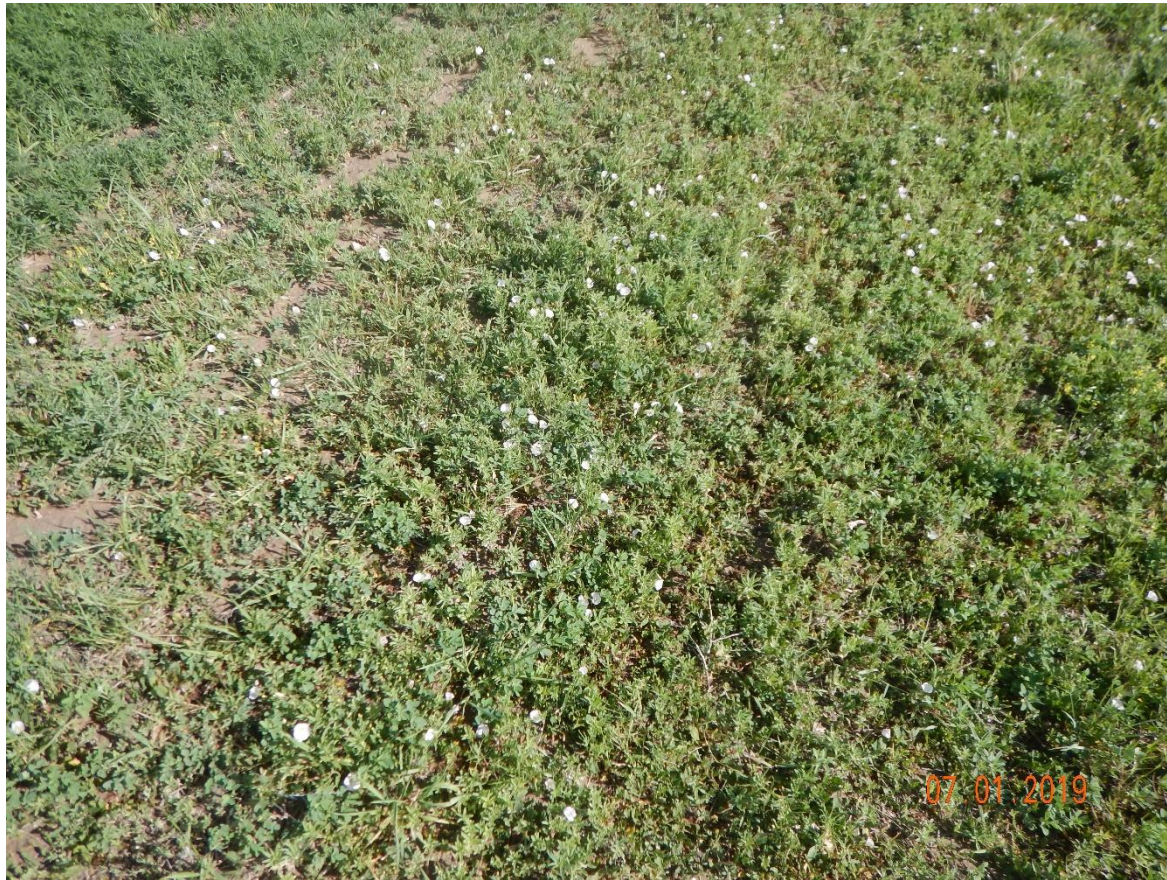
**Photo 11:** Photo taken from the east end of the location. Photo shows Field Bindweed establishing on location.

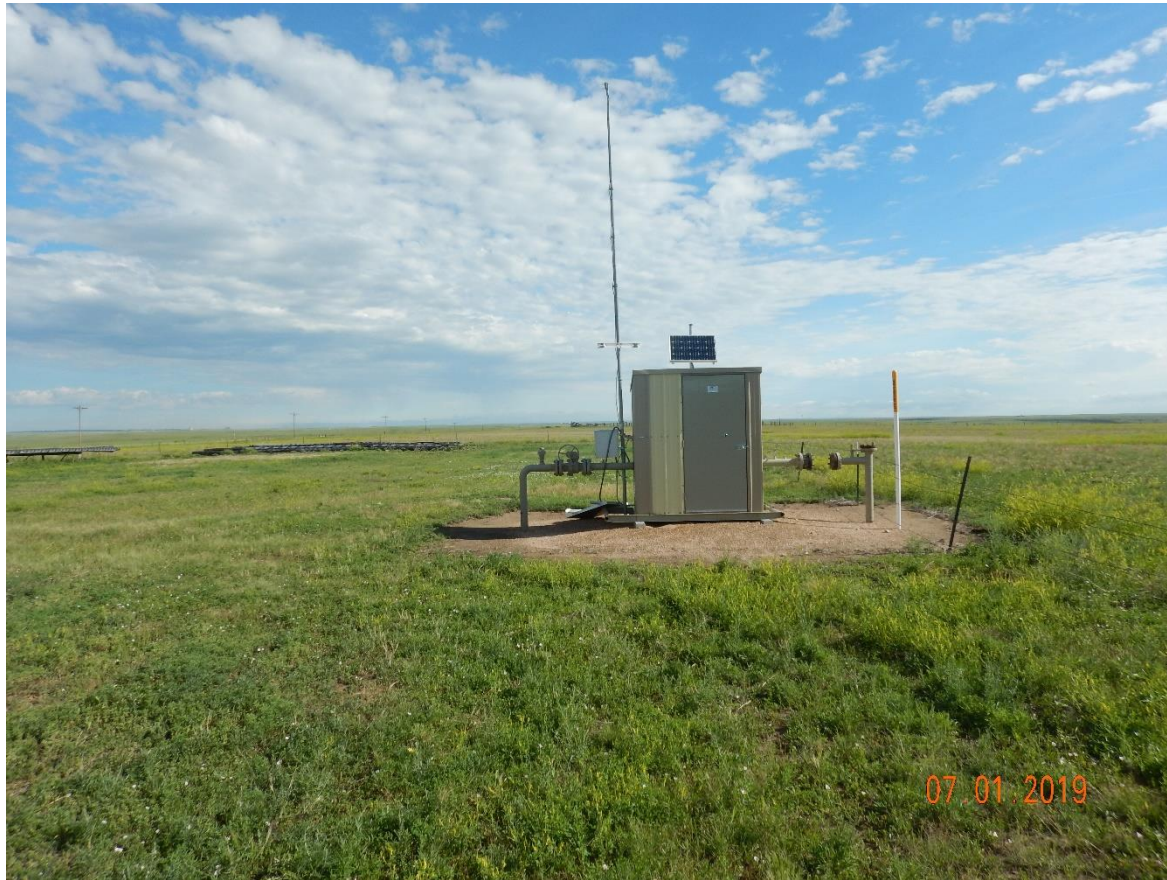
**Photo 12:** Photo taken from the east end of the location, facing north. Photo shows equipment has not been removed from the location, or reclamation conducted.

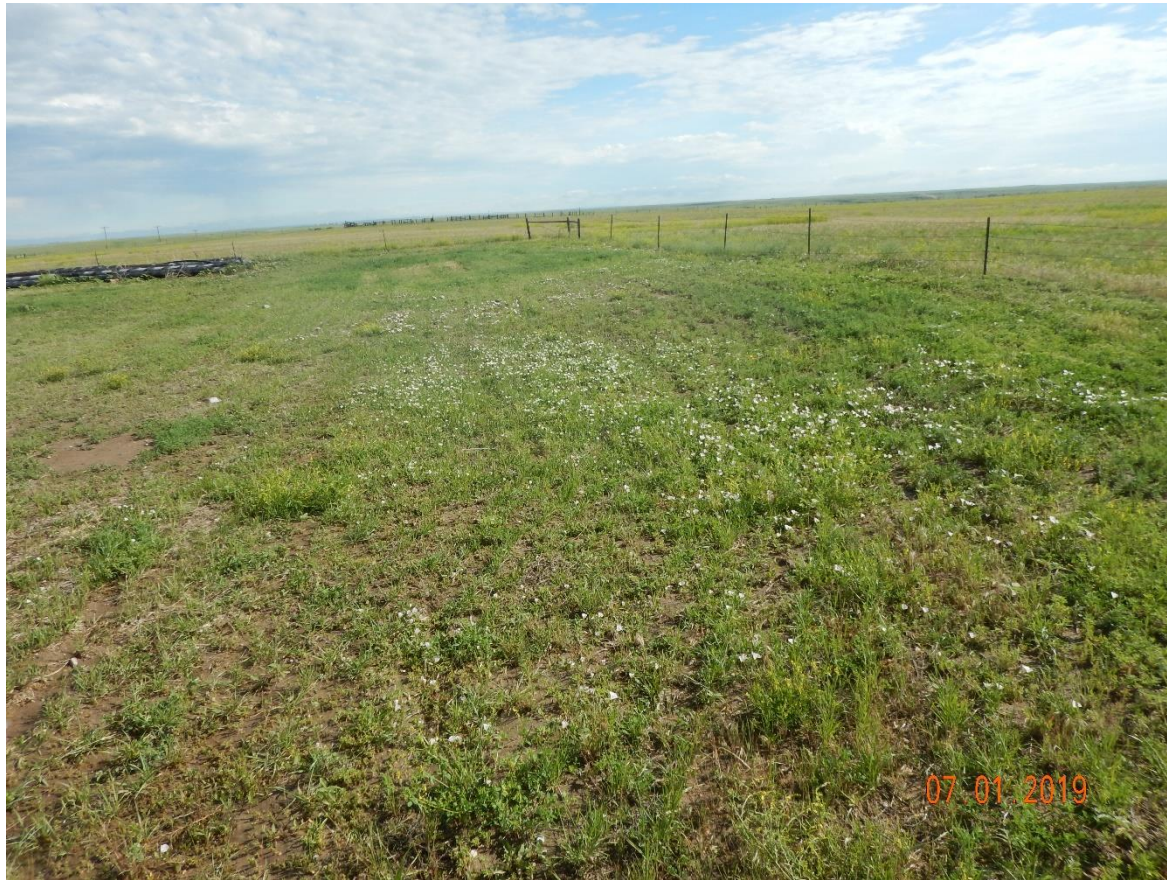
**Photo 13:** Photo taken from the northeast end of the location. Photo shows Field bindweed (white flowers) establishing on the location.

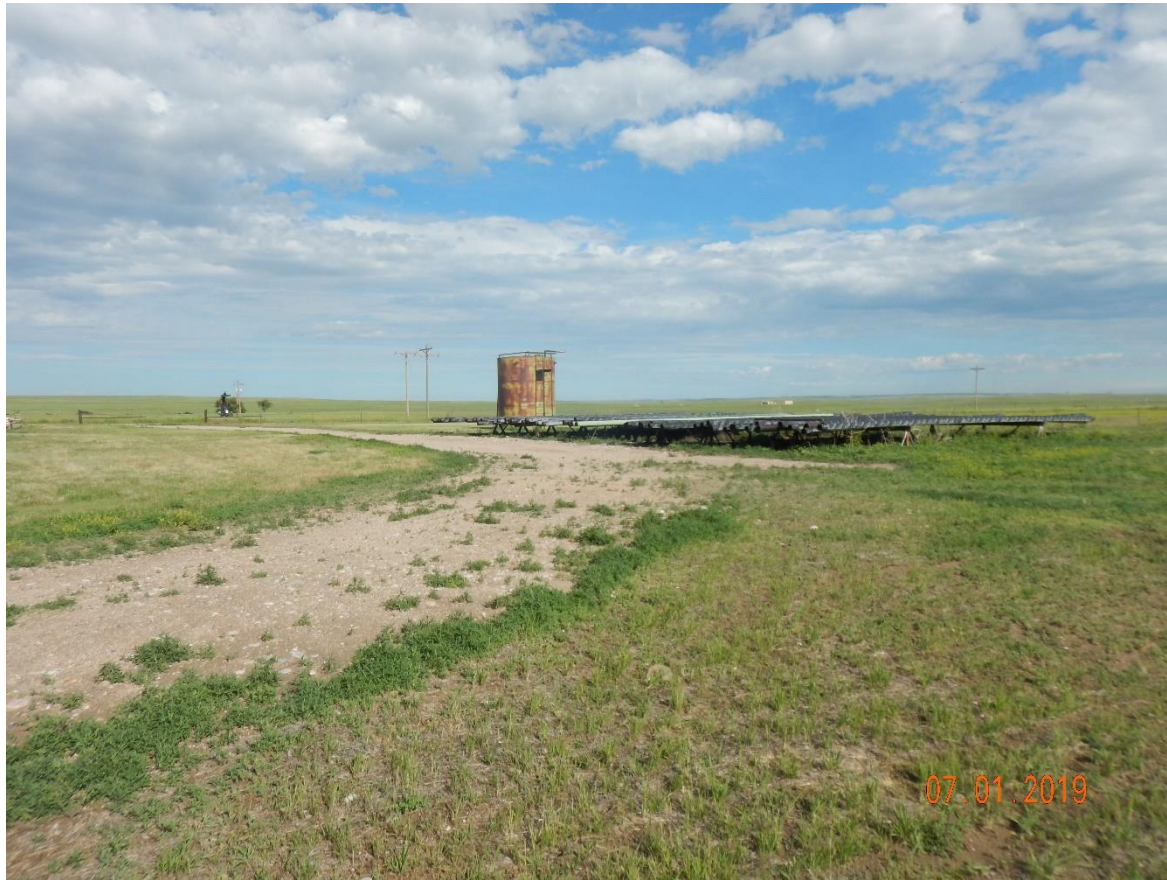
**Photo 14:** Photo taken from the north east end of the location, facing northwest. Photo shows equipment remaining on the location, and location has not been reclaimed.

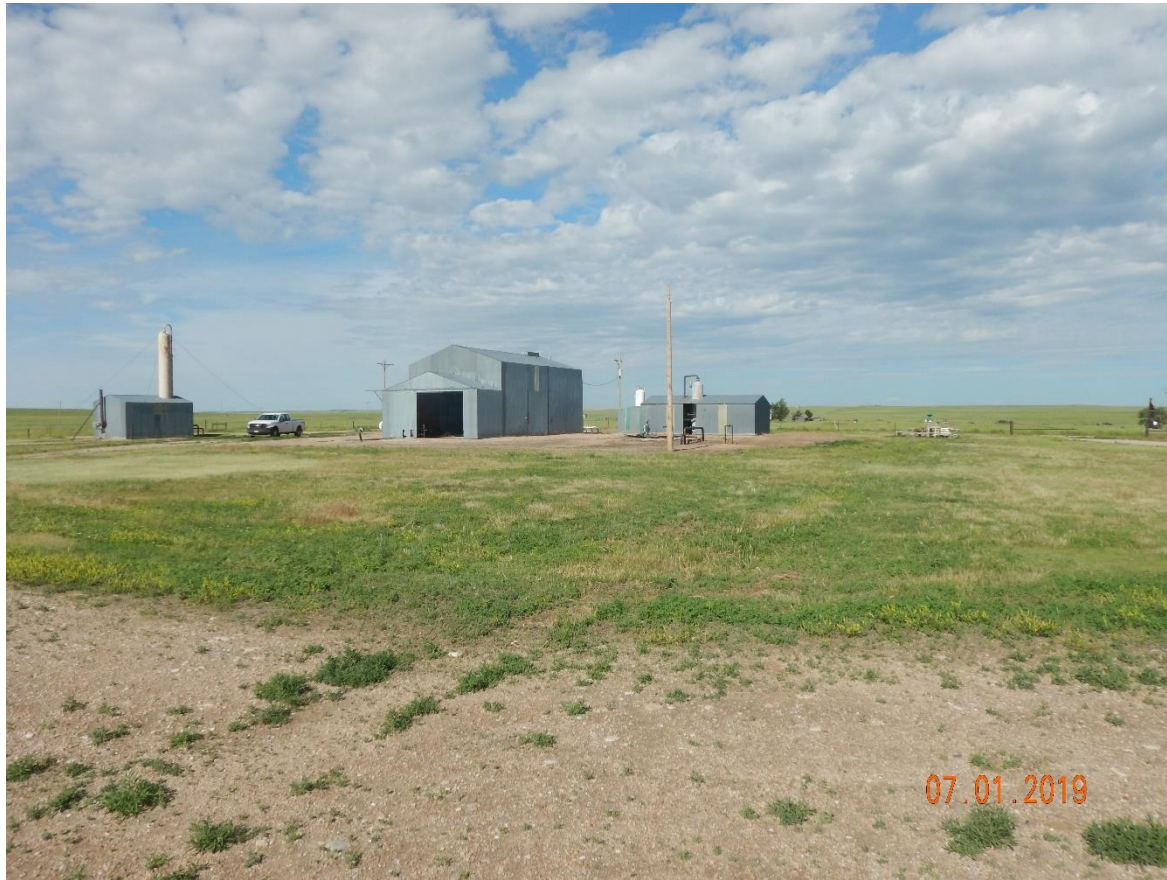
**Photo 15:** Photo taken from the north east end of the location, facing west. Photo shows equipment remaining on the location, and location has not been reclaimed.

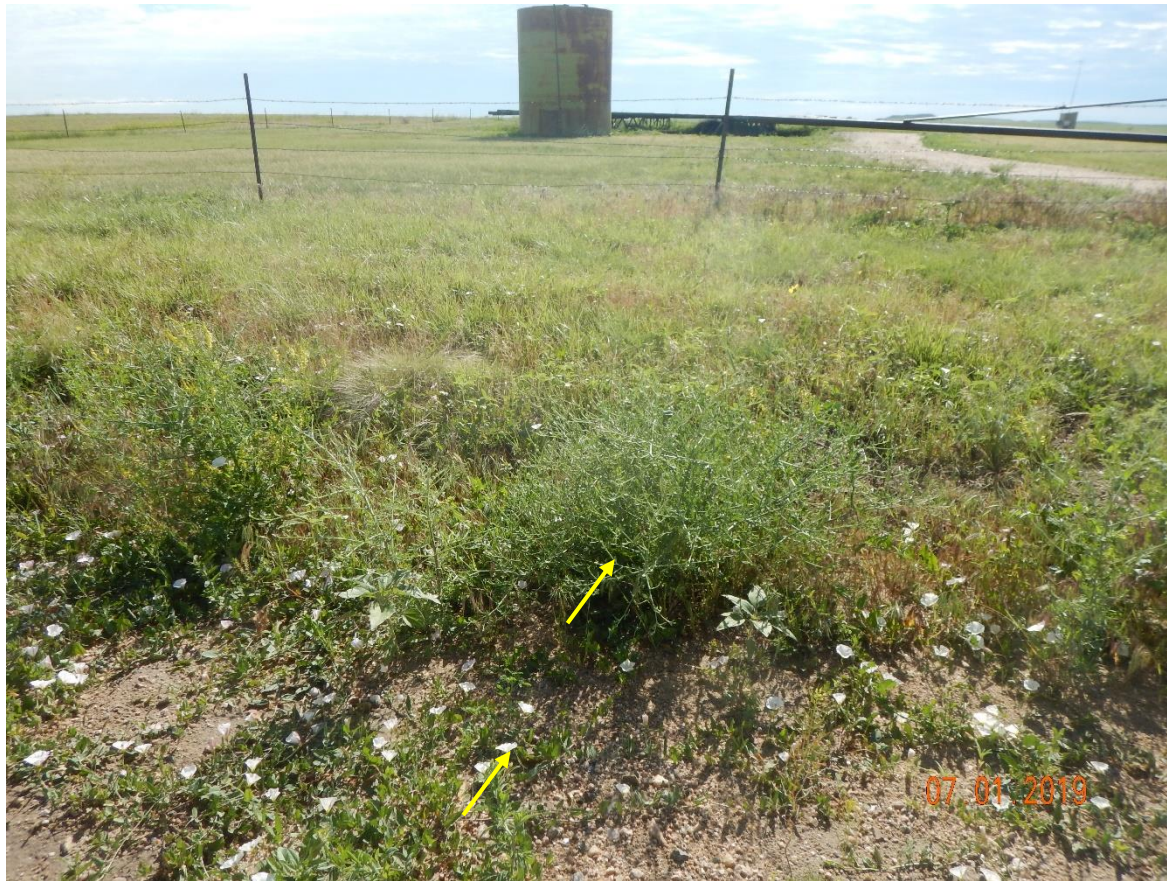
**Photo 16:** Photo taken from the roadside ditch on the northwest end of the location. Complainant stated that weeds have spread from the location onto the adjacent lands and the ditch. Photo shows Diffuse knapweed and Field Bindweed.

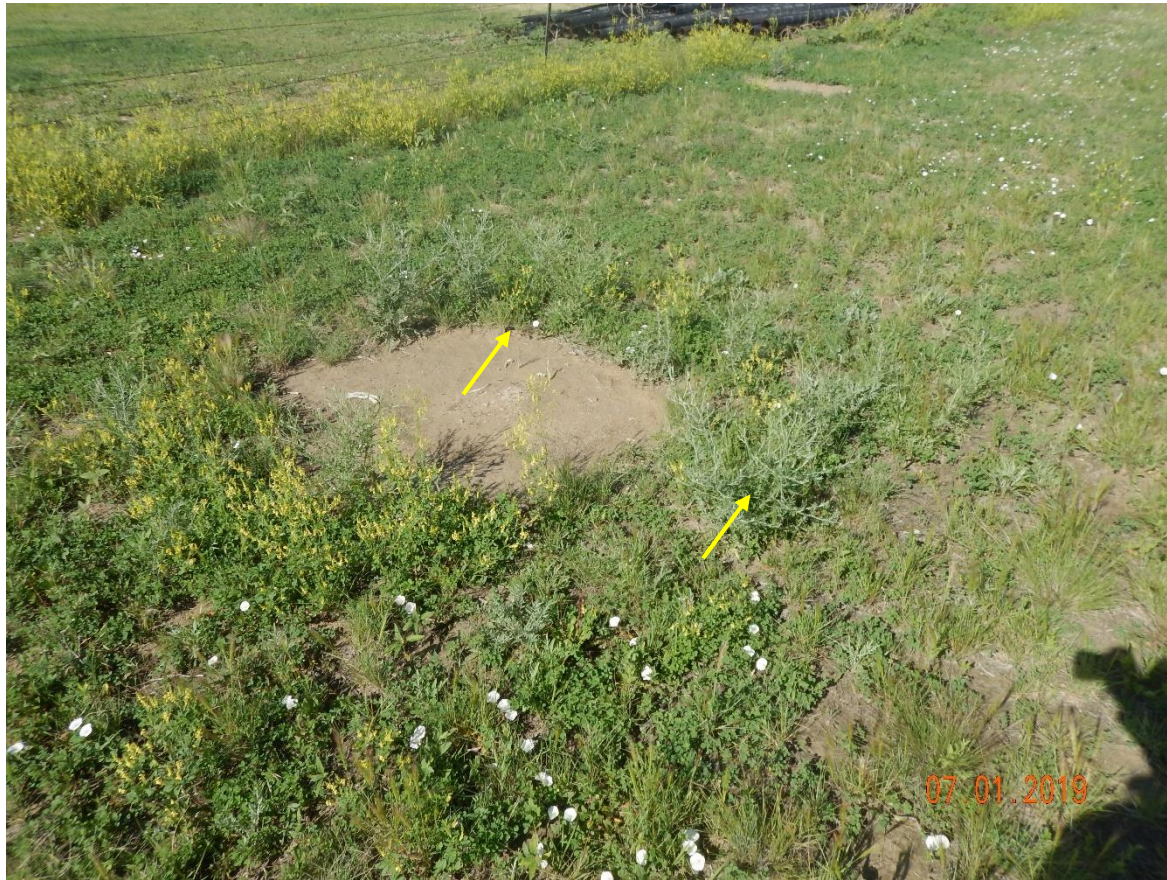
**Photo 17:** Photo taken from the adjacent lands to the north of the location. Photo shows noxious weeds have not been managed and continues to spread from the location.

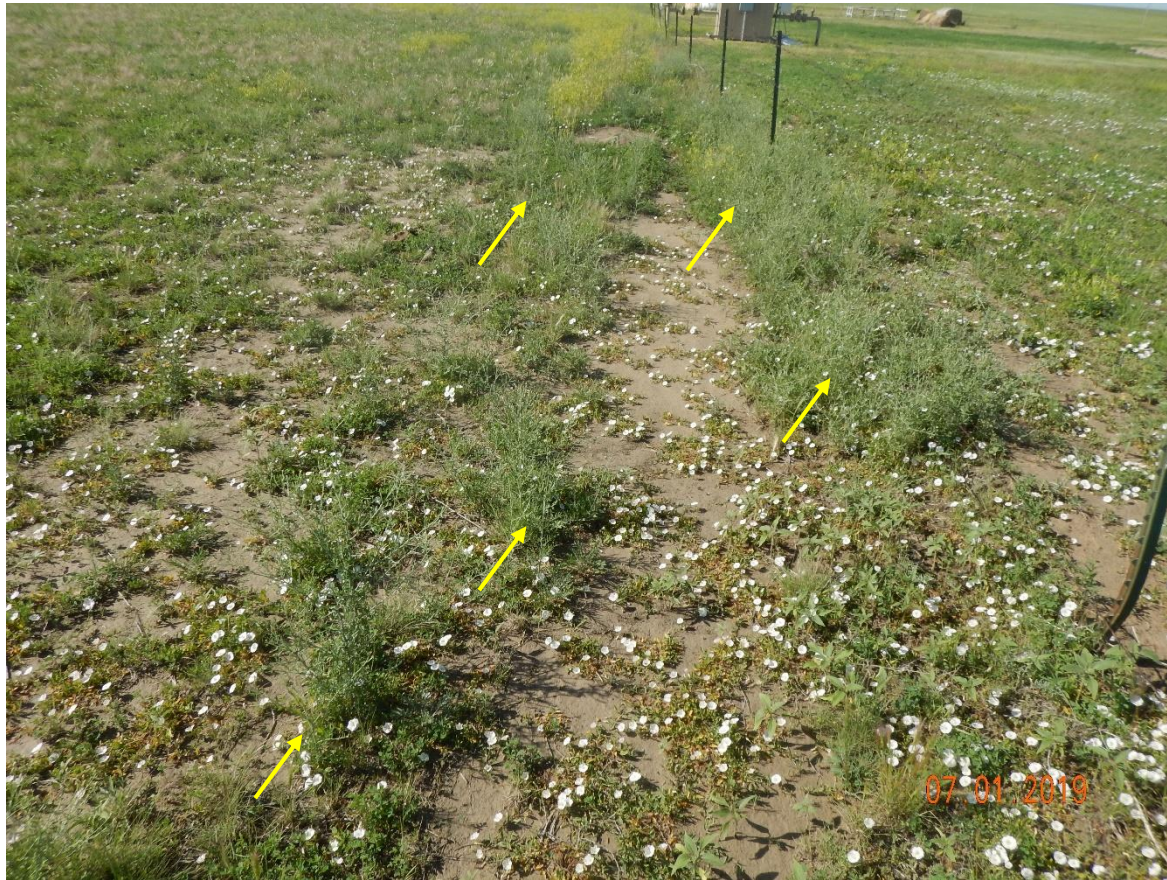
**Photo 18:** Photo taken from the adjacent lands to the east of the location, facing south. Photo shows noxious weeds have not been managed and continues to spread from the location.

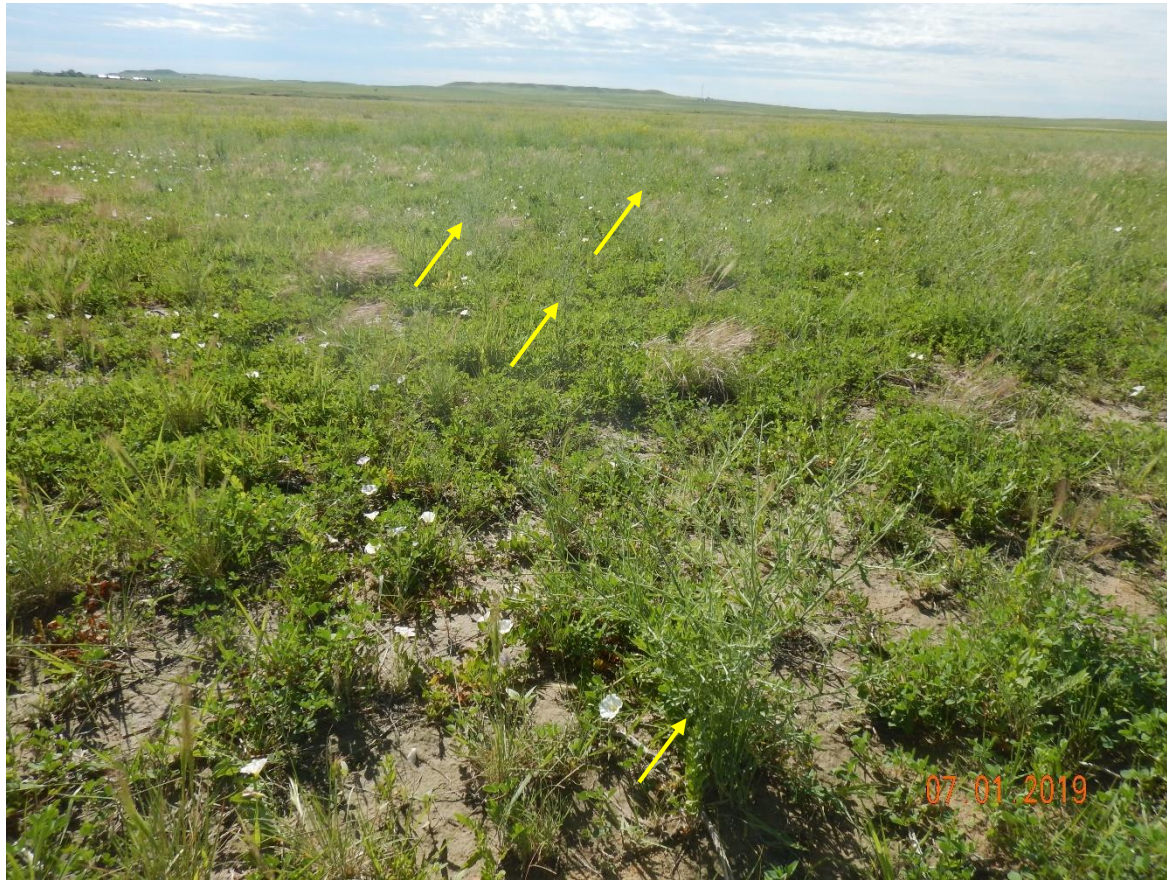
**Photo 19:** Photo taken from the adjacent lands to the east of the location, facing east. Photo shows noxious weeds have not been managed and continues to spread from the location.

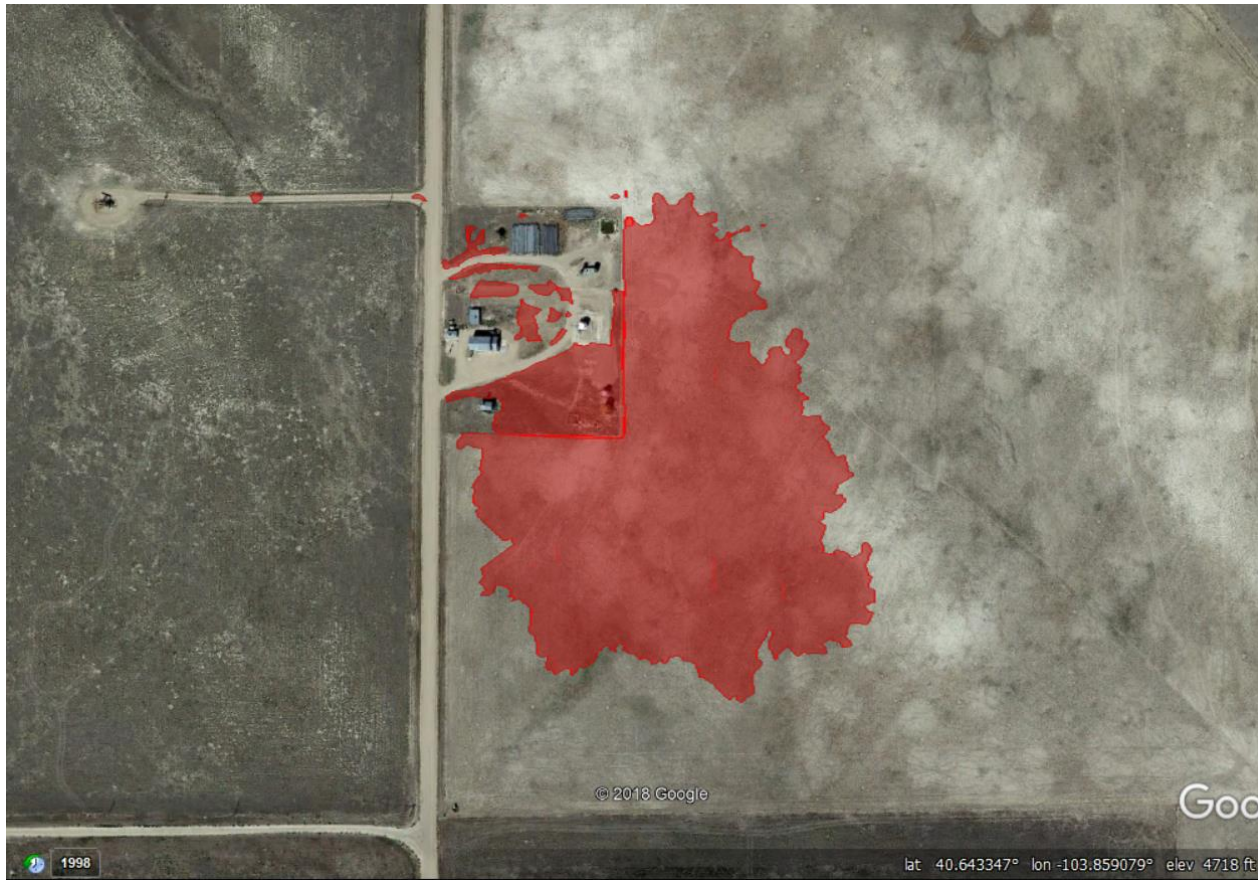
**Photo 20:** Photo copied from photo documentation within a previous inspection. Photo shows areas where diffuse knapweed was mapped on the location and the adjacent lands. Diffuse knapweed has continued to spread throughout the location and now includes portions of the location to the northeast.
