Inspection Photos
Location Name: Beaver Creek 0881 1-3H34
Location ID: 451938

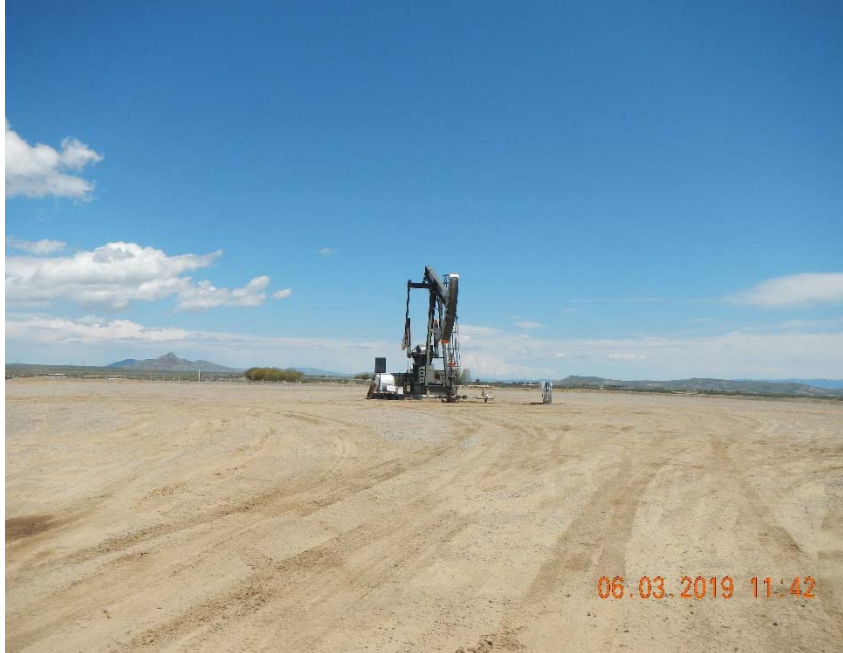
Photo 1. Overview of location taken at entrance facing north.

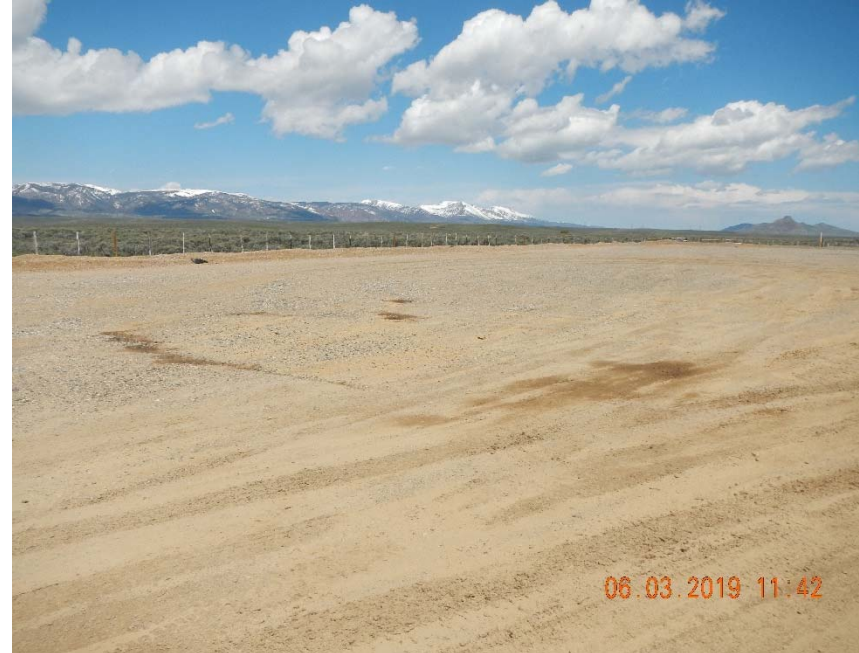
Photo 2. Stained soil on location.

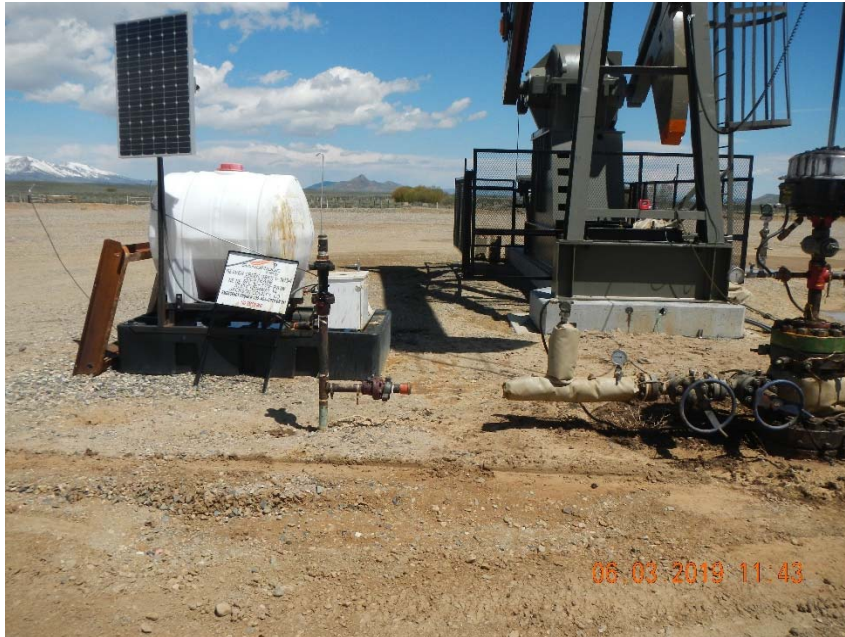
Photo 3. Stained soil at wellhead, chemical containment full of stormwater.

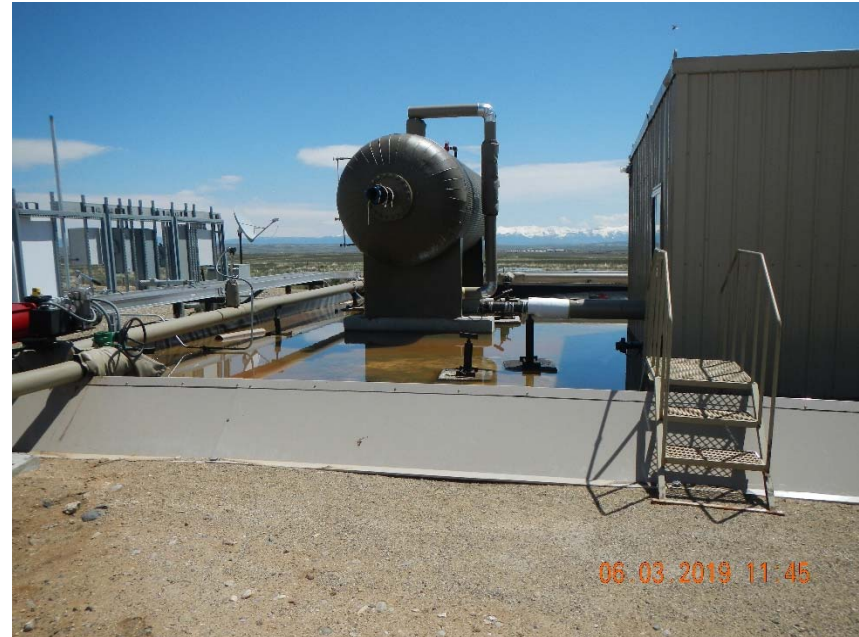
Photo 4. Unused triplex jet pump with secondary containment holding stormwater.
