Inspection Photos

API: 05-071-06340

Operator: TIMBER CREEK OPERATING LLC

Inspection Date: 7/1/2019

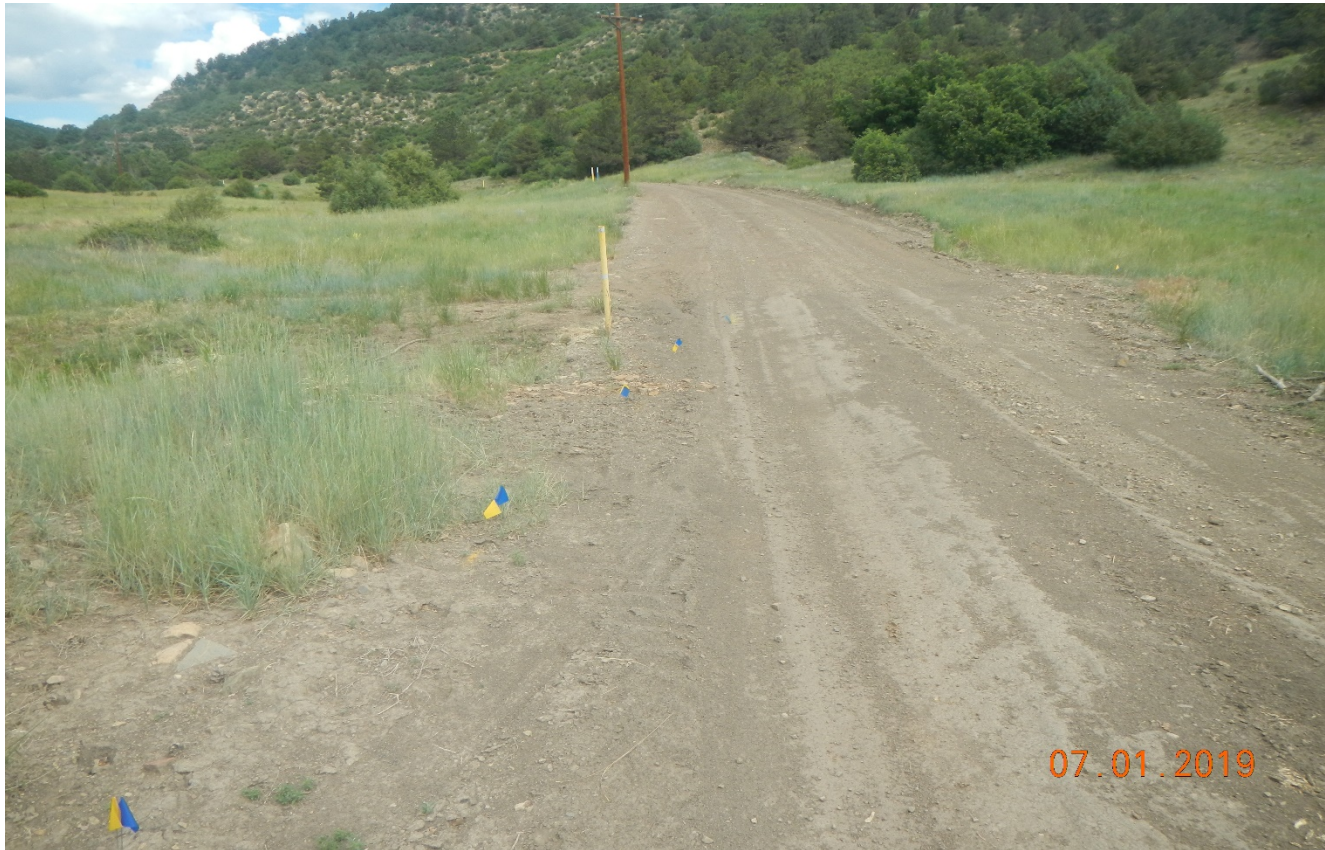
Photo 1. Facing northwest at mouth of the canyon.

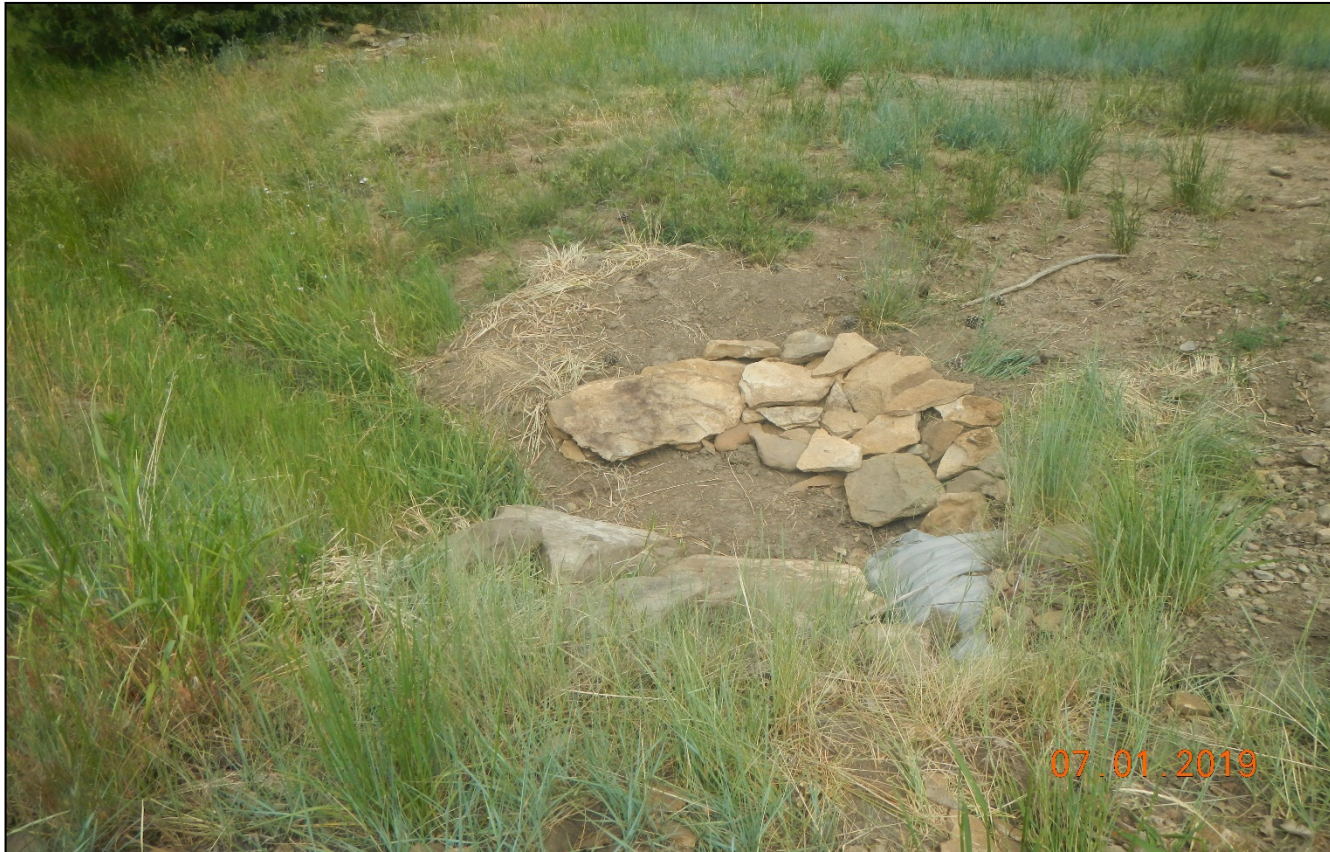
Photo 2. Culvert has been cleaned out since previous inspection.

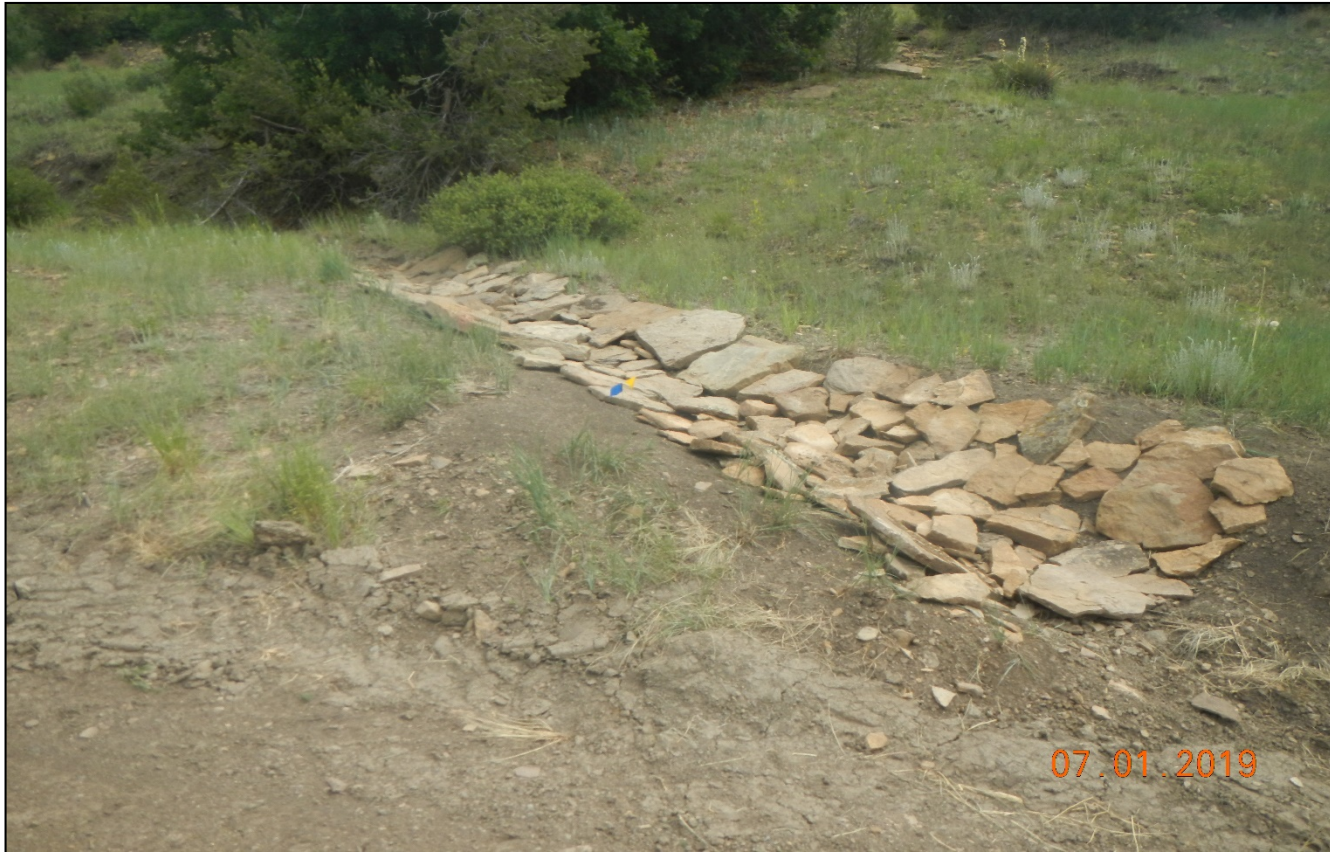
Photo 3. Rock rip/rap was placed in drainage channel.

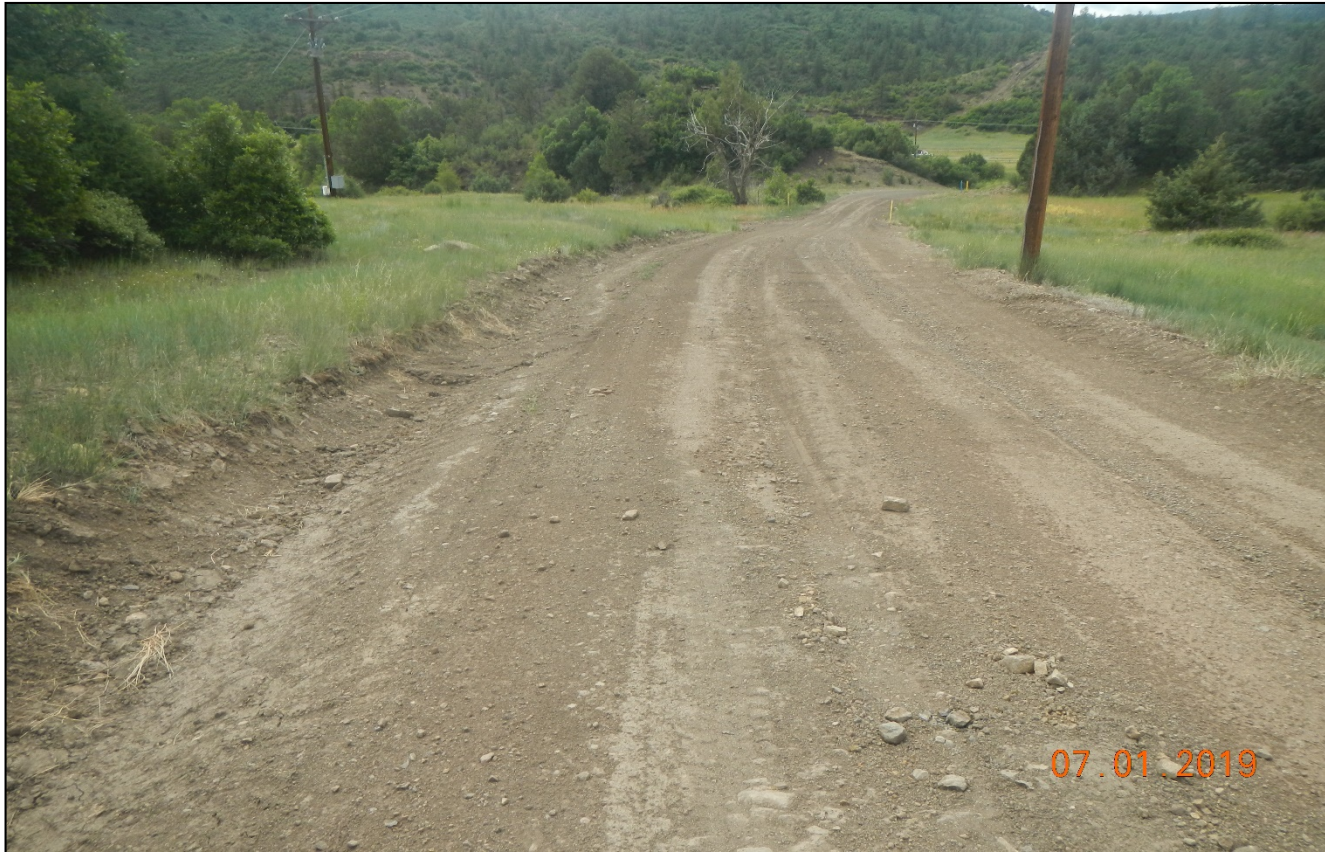
Photo 4. The side of the road has been regraded. The side may need erosion controls to prevent erosion. (e.g. check dams)

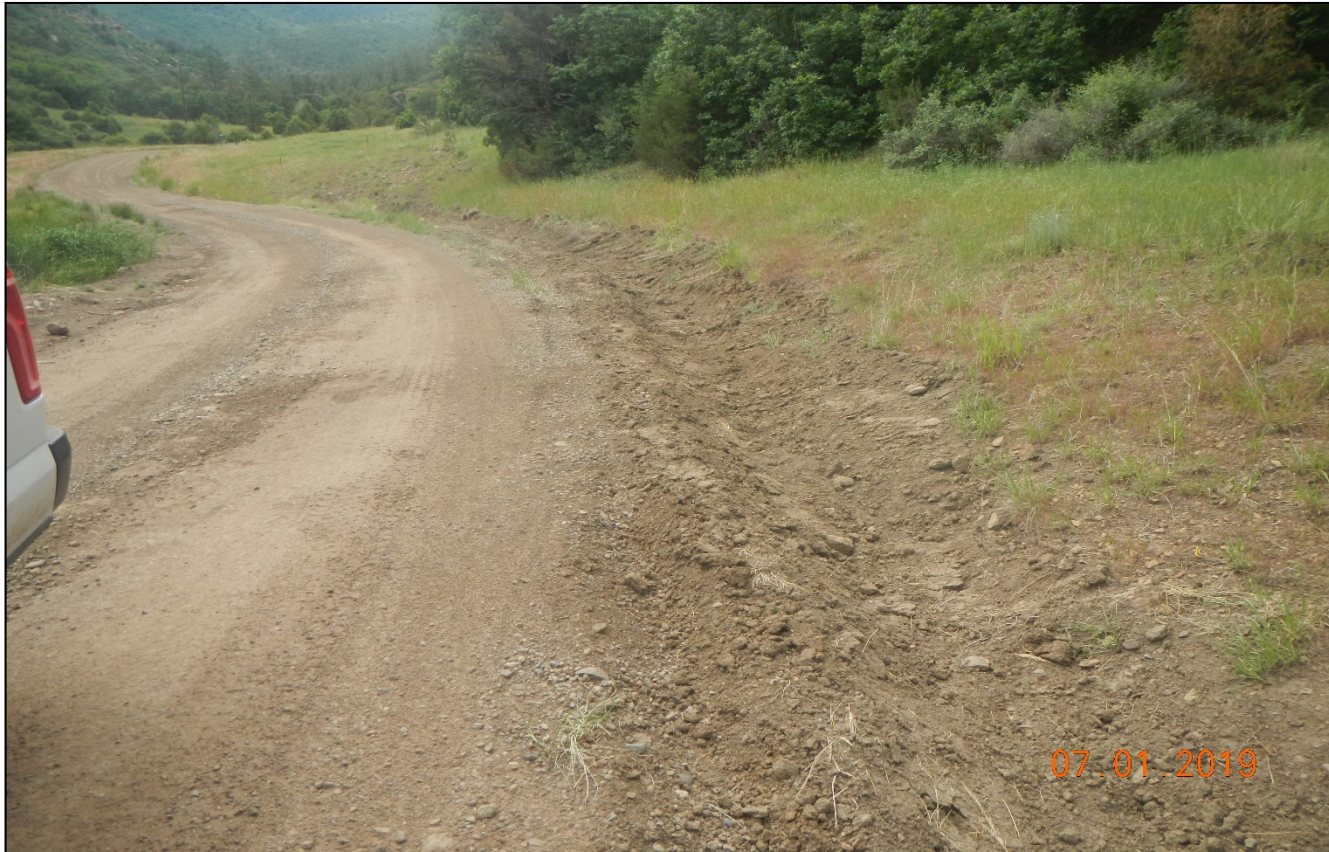
Photo 5. The erosion channel at the southeast side of the location has been repaired. The area may need erosion controls to prevent erosion. (e.g. check dams)

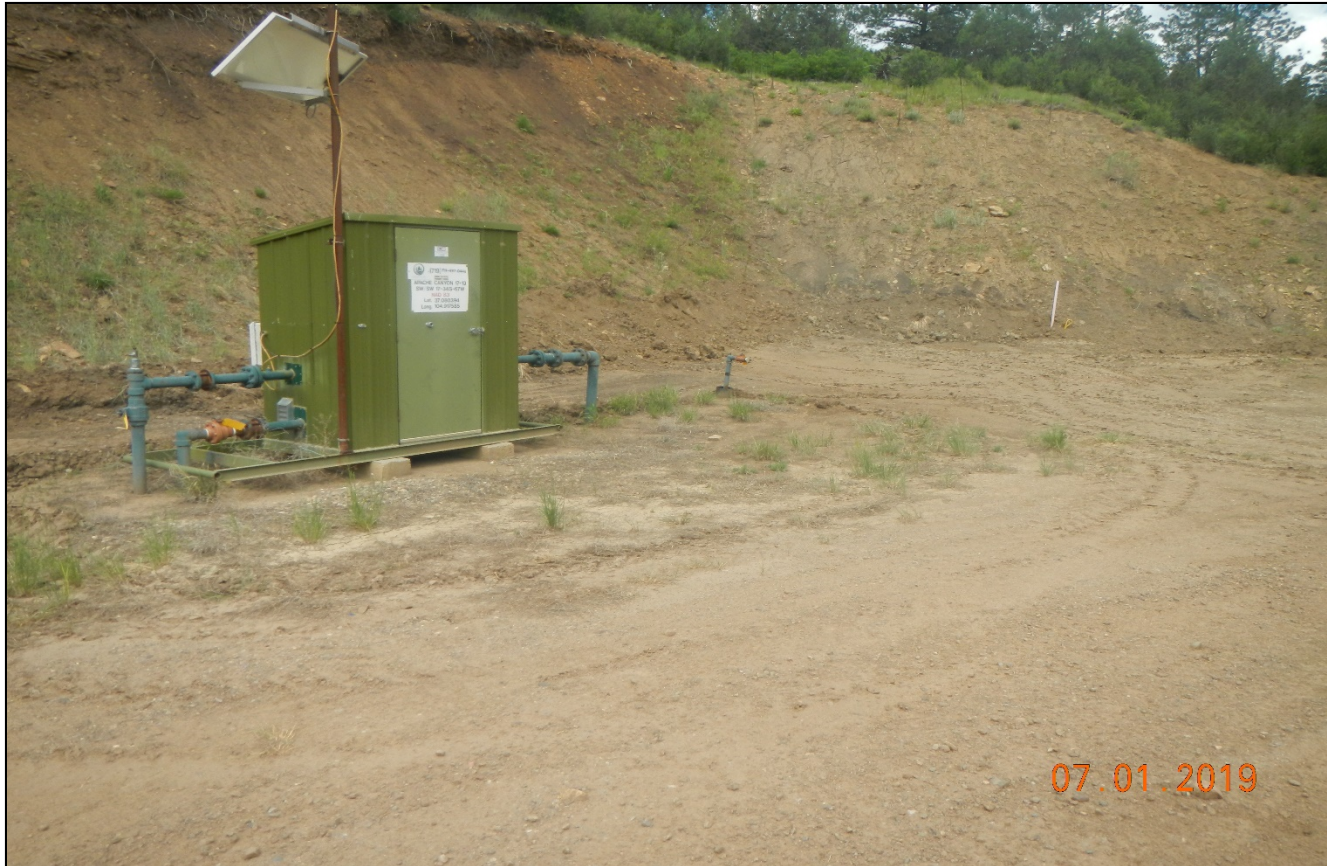
Photo 6. Facing toward the location. Sediment has been removed behind the equipment.
