Inspection Photos

API: 05-071-06223

Operator: TIMBER CREEK OPERATING LLC

Inspection Date: 7/1/2019

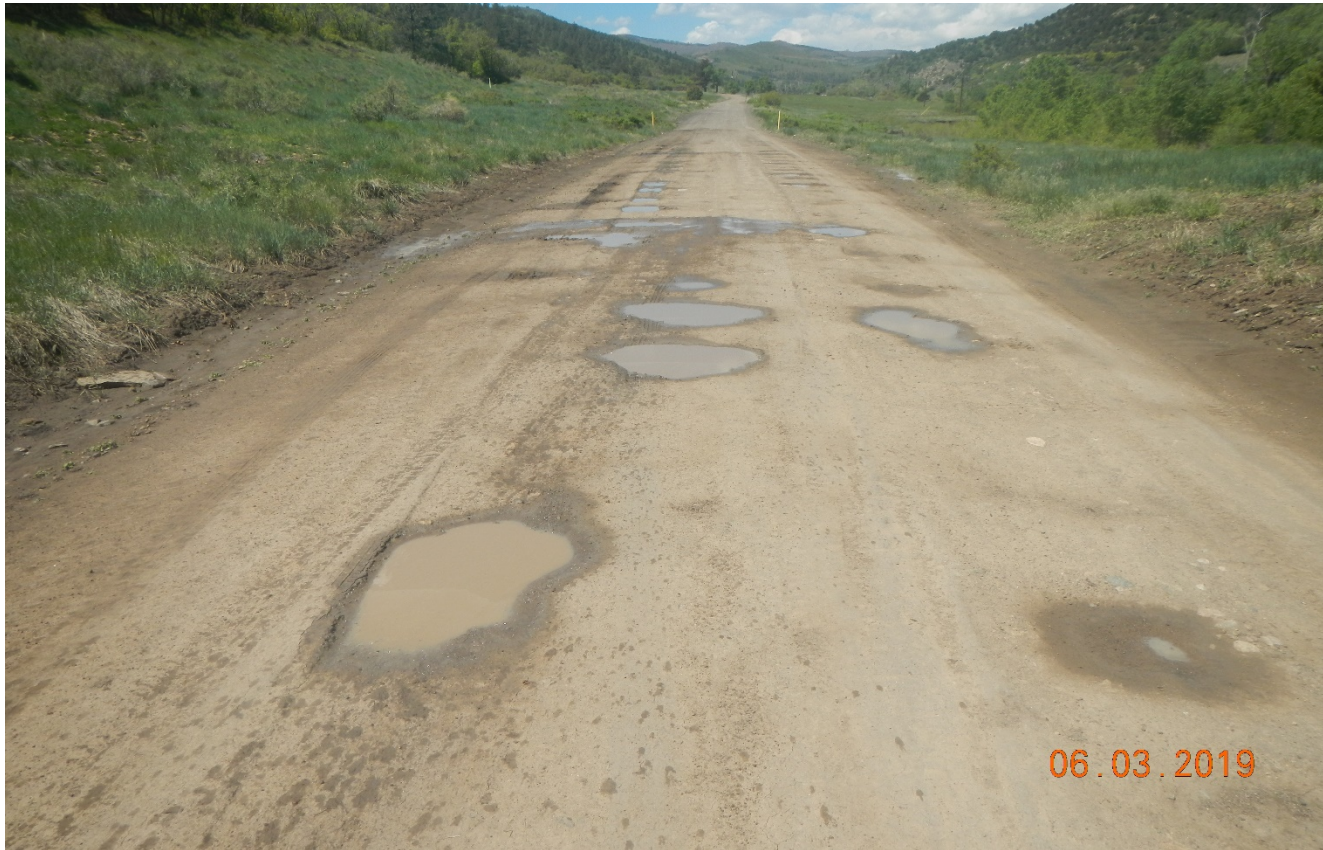
Photo 1. The main southfork road has areas of road damage that needs to be graded.

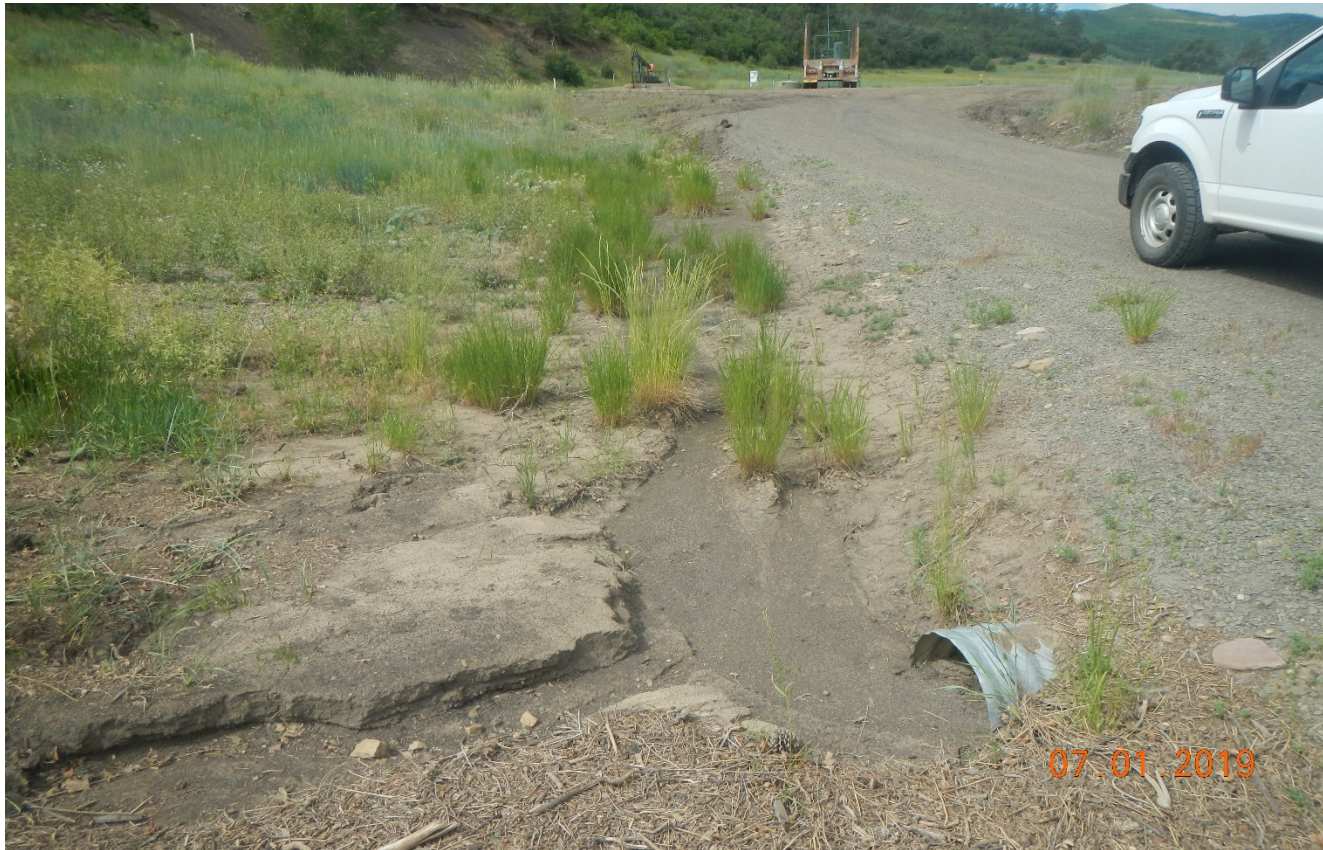
Photo 2. The culvert near the location is half full of sediment.

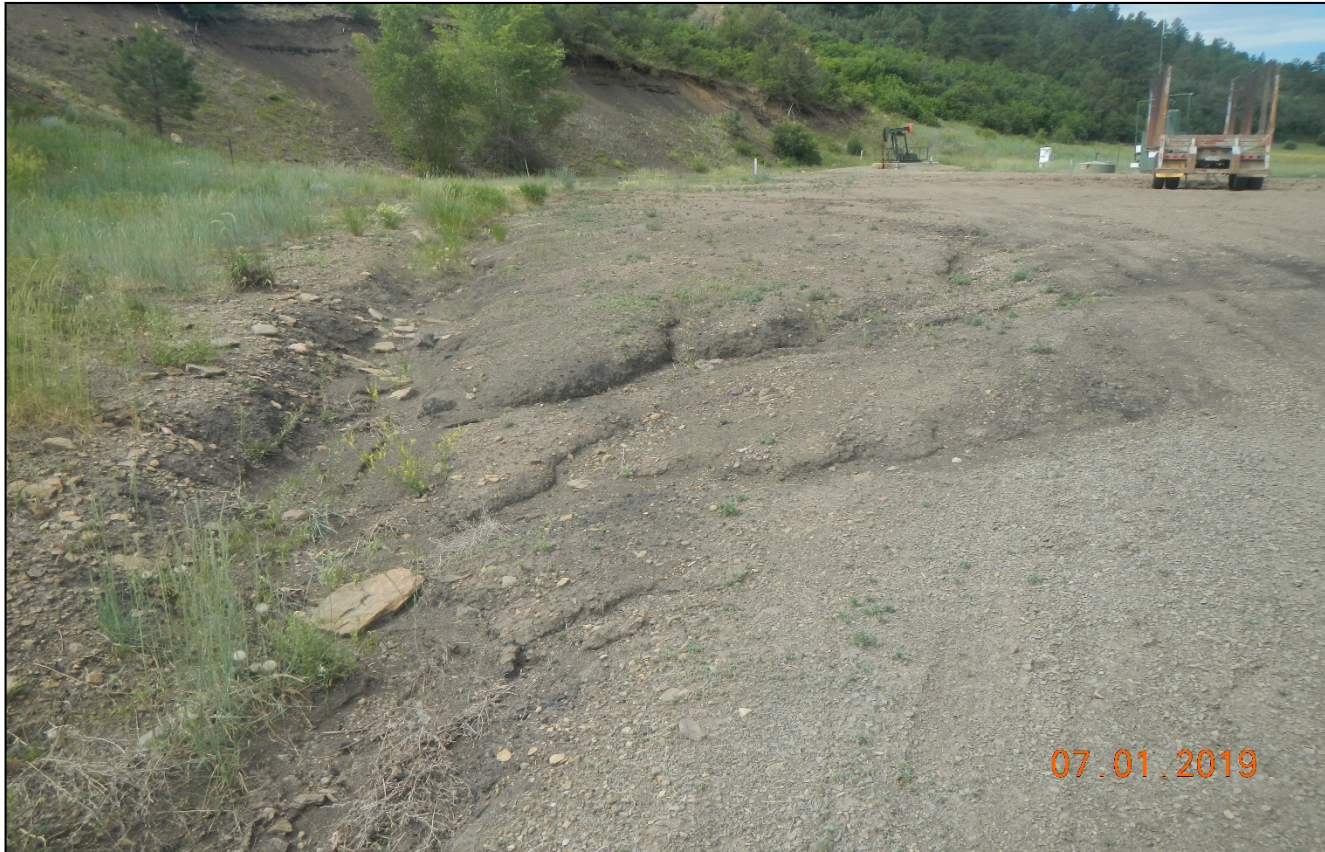
Photo 3. Facing southwest toward the location. There are erosion issues coming off the pad surface and is depositing sediment into the culvert along the access road.
