# Inspection Photos

API: 05-071-06130

Operator: TIMBER CREEK OPERATING LLC

Inspection Date: 7/1/2019

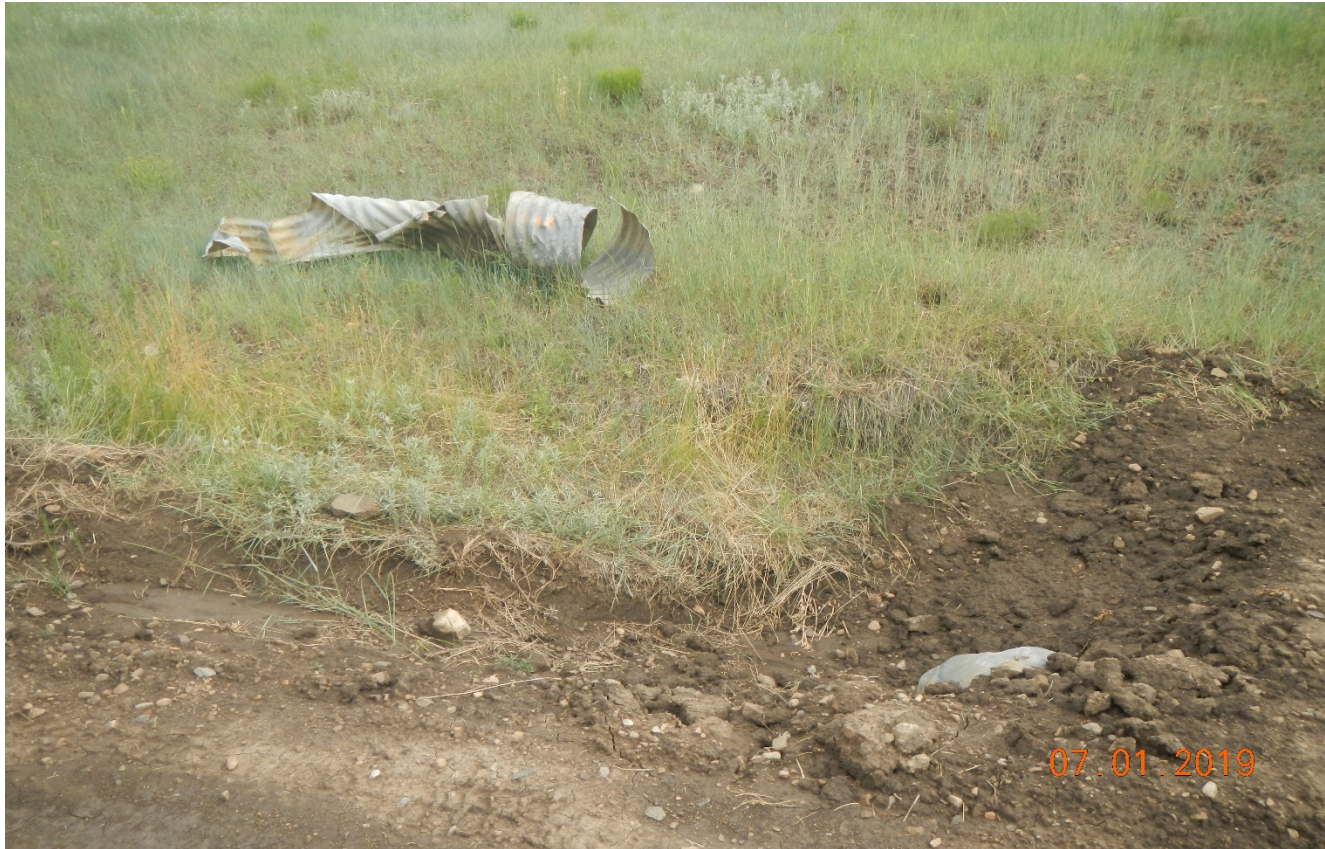
**Photo 1.** There were culverts cleaned out along the road. Scrap pieces of culvert remain near the culverts.

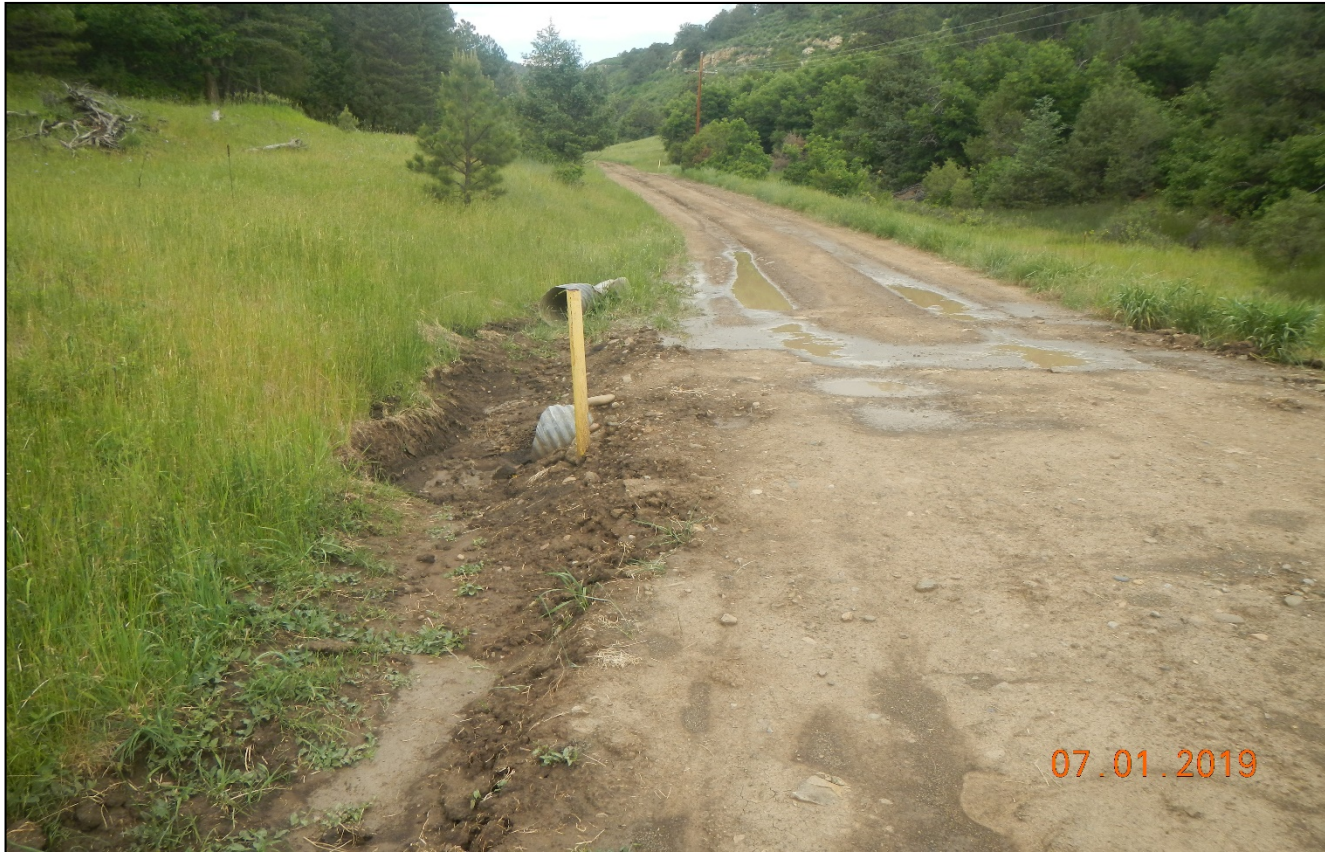
**Photo 2.** There were culverts cleaned out along the road. Scrap pieces of culvert remain near the culverts.

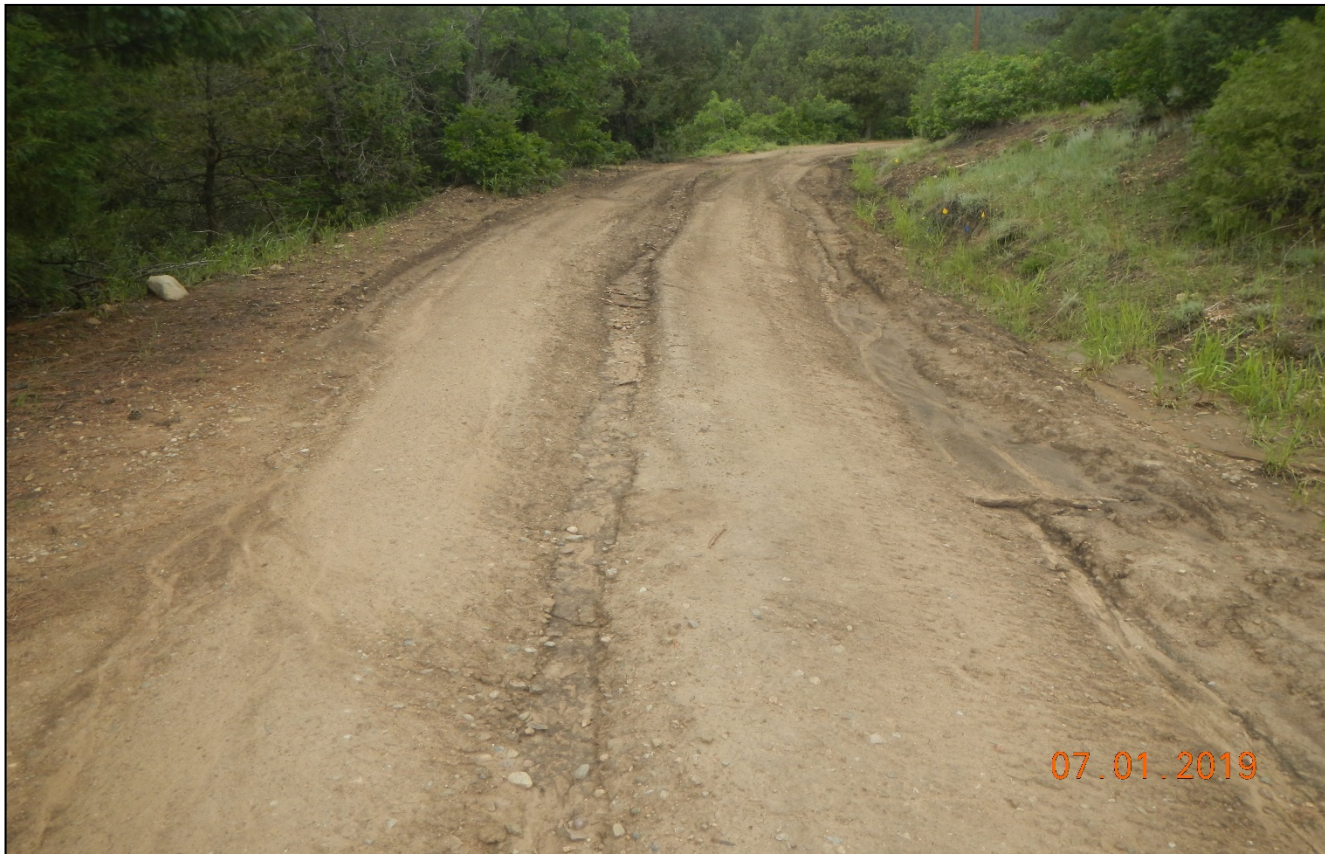
**Photo 3.** Vehicle ruts remain along the road which is a conveyance for stormwater erosion.

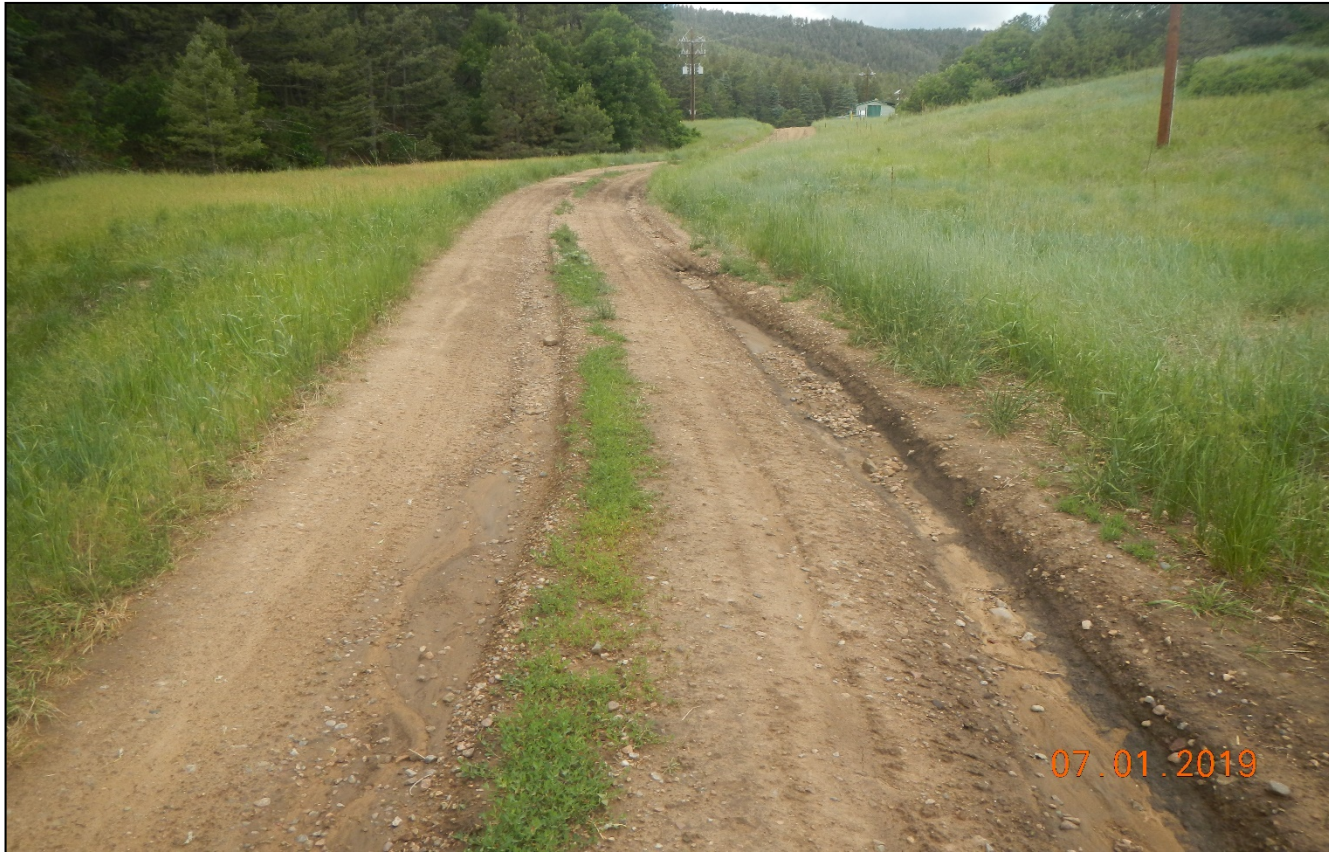
**Photo 4.** Vehicle ruts remain along the road which is a conveyance for stormwater erosion.

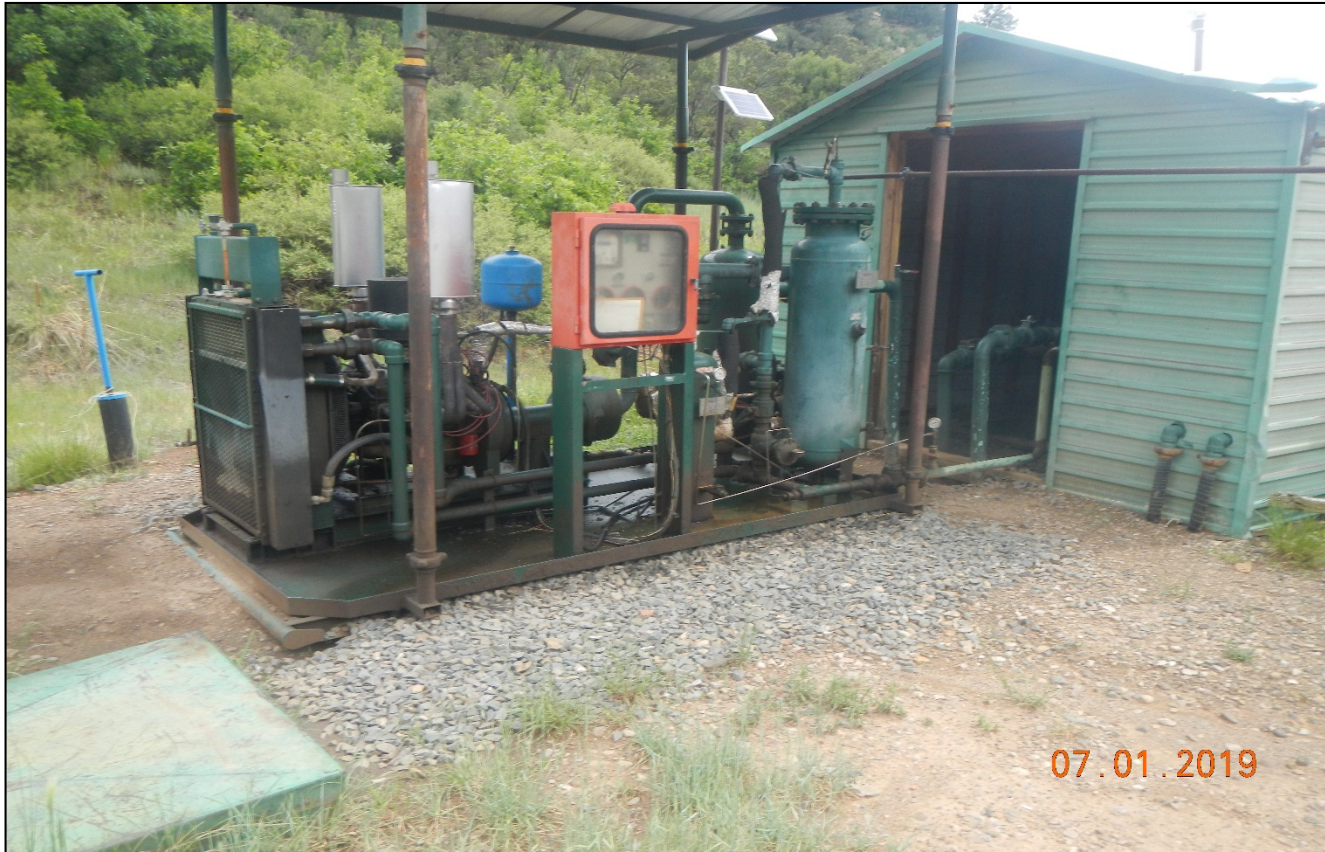
**Photo 5.** The oily waste appears to have been cleaned up since previous inspection.
