Inspection Photos

API: 05-071-07204

Operator: TIMBER CREEK OPERATING LLC

Inspection Date: 7/1/2019

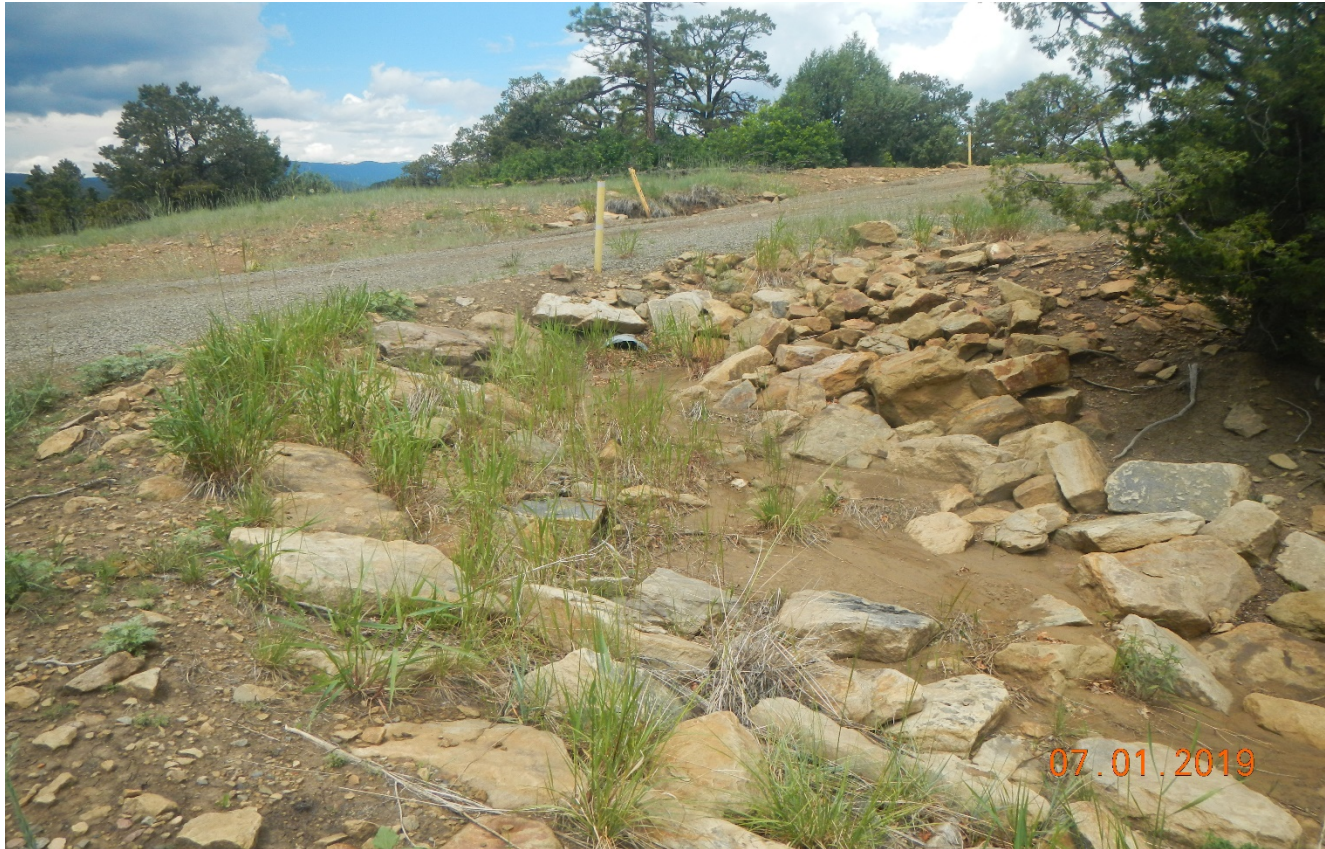
Photo 1. The culvert is full of sediment at outlet at the location. Did not check inlet.

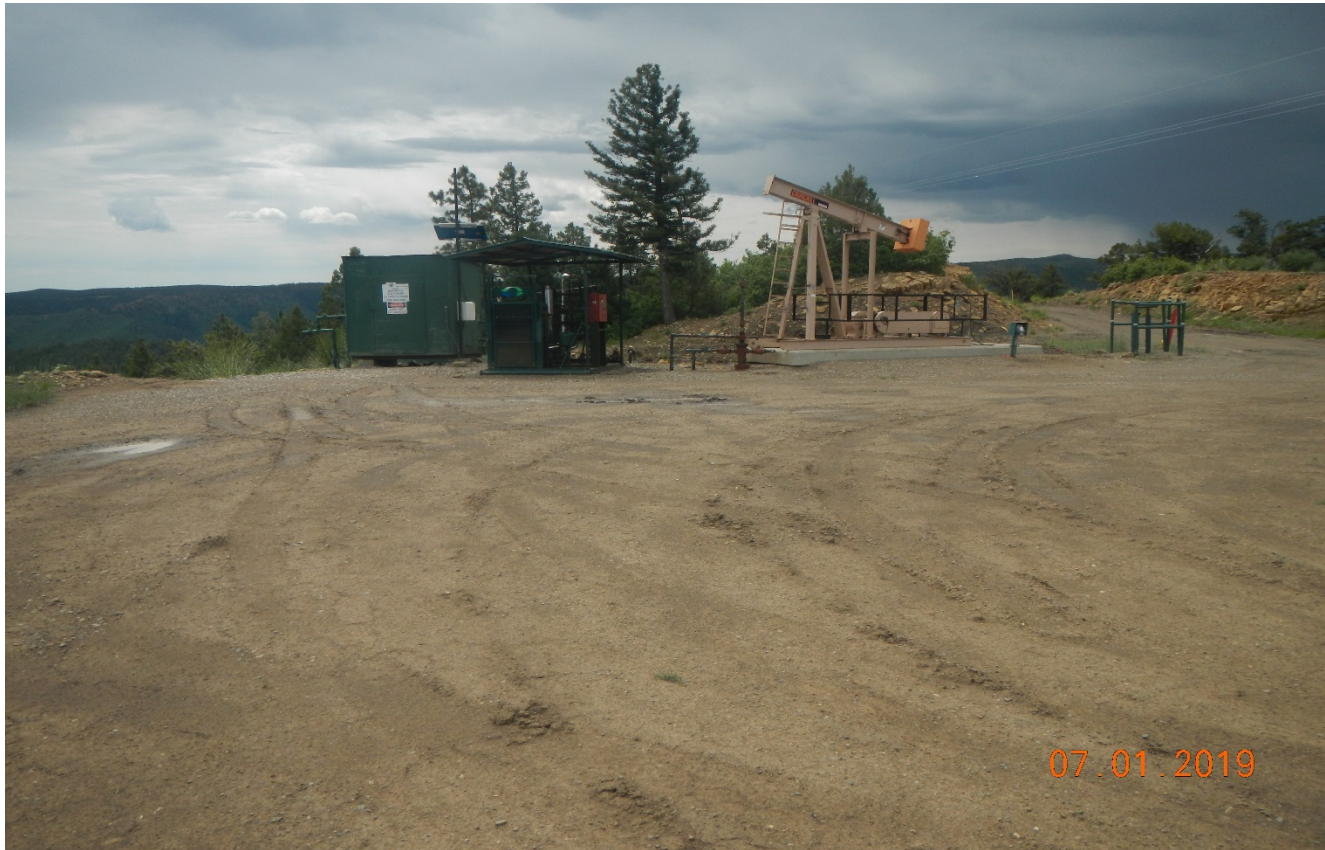
Photo 2. Facing toward the location.

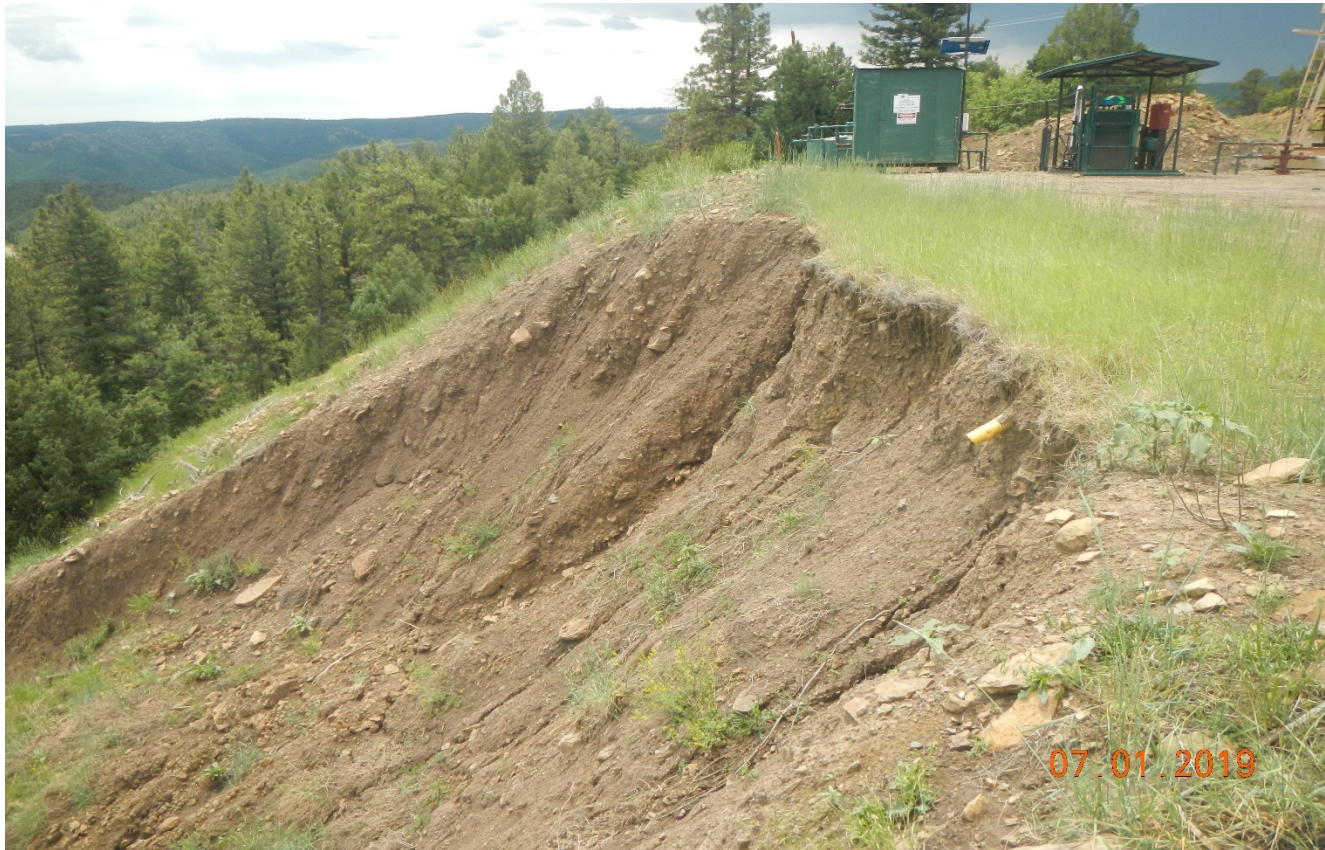
Photo 3. There is soil sloughing that occurred at the east side of the location.

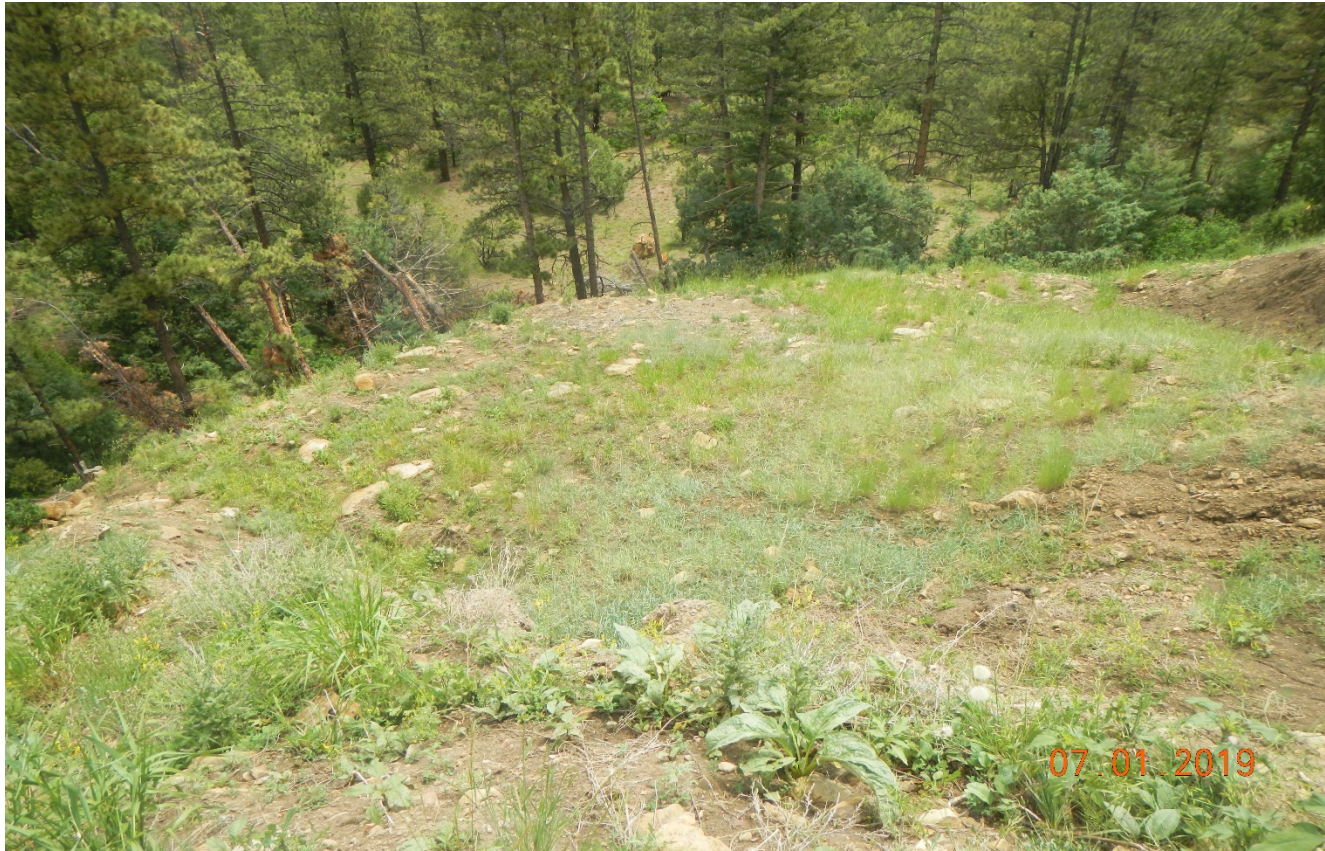
Photo 4. View of soil material that moved down the hill side.

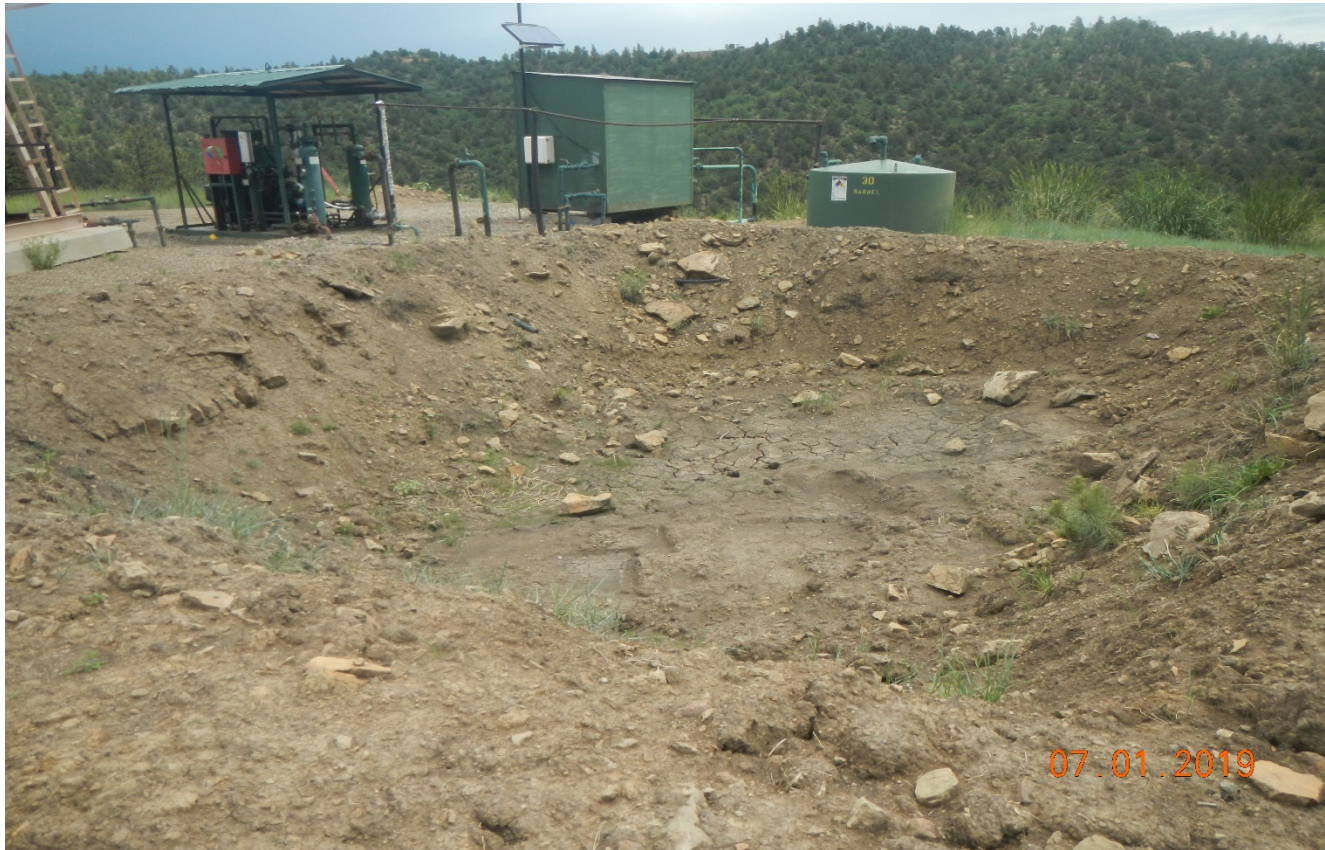
Photo 5. No freeboard marker was found in the pit.
