Inspection Photos
Location Name: Surprise Unit 0680 S9
Location ID: 445005

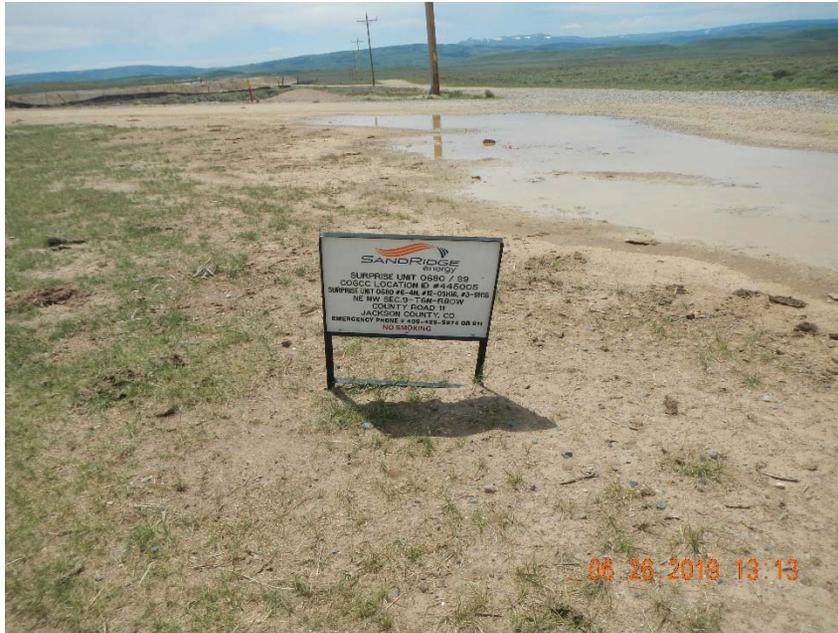
Photo 1. Battery sign at entrance, location wells not clearly listed.

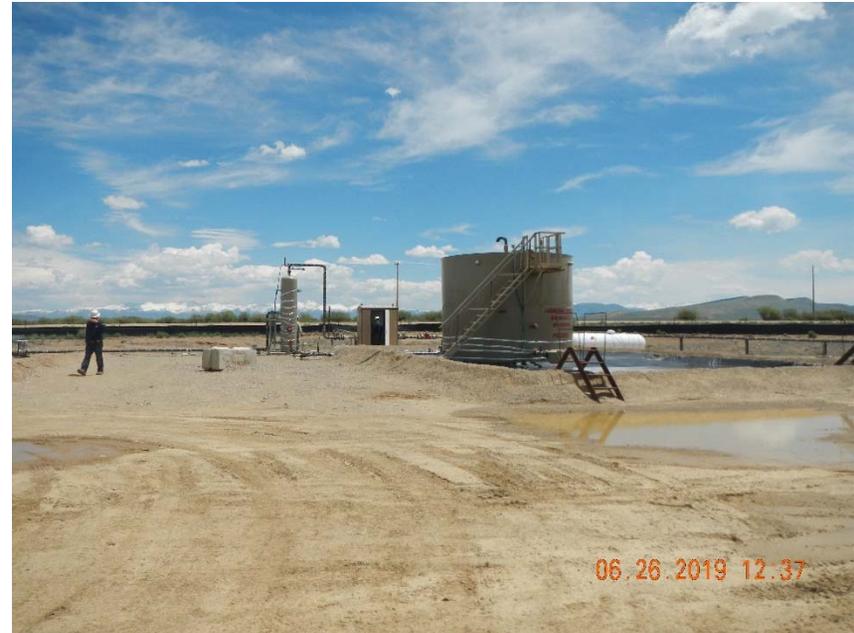
Photo 2. Condensate tank labeled as crude oil.

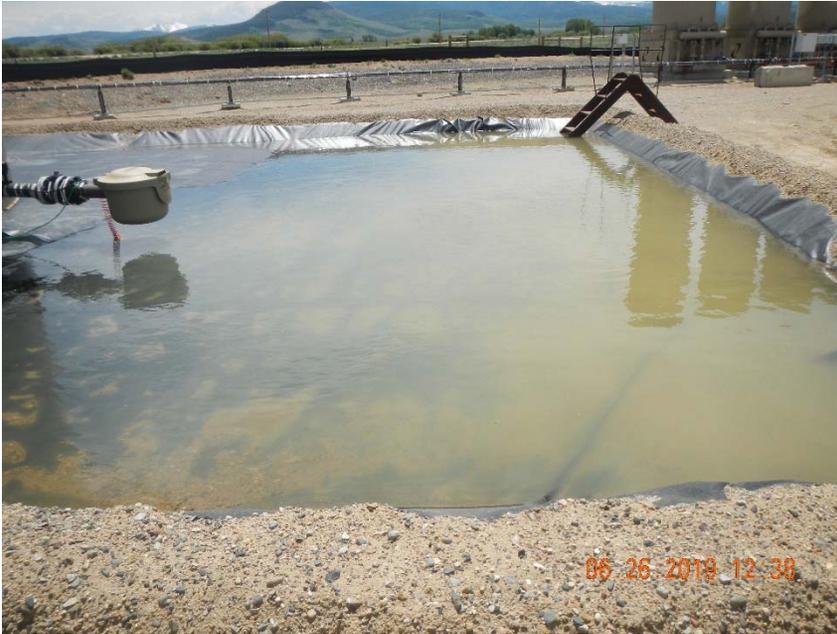
Photo 3. Stormwater in condensate tank berm.

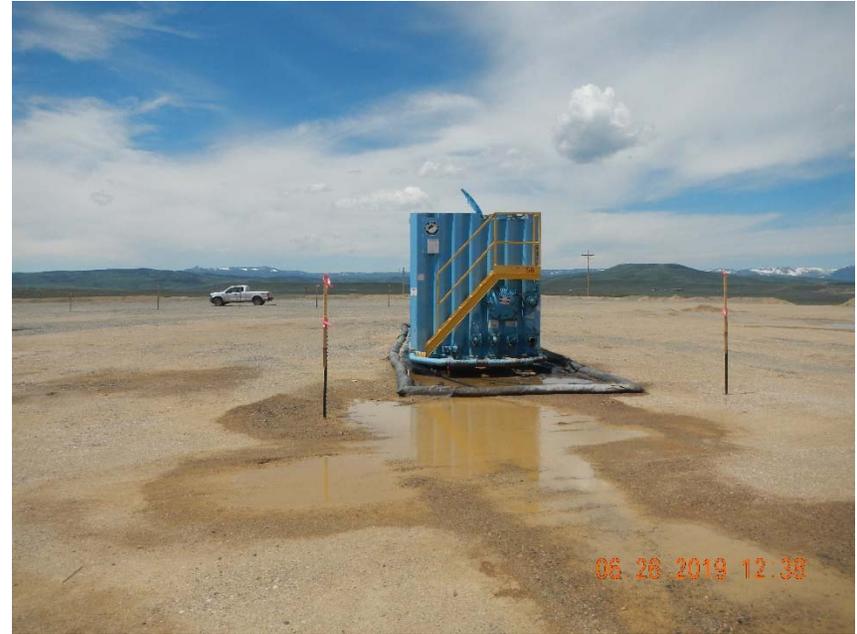
Photo 4. Frack tank stored on location.

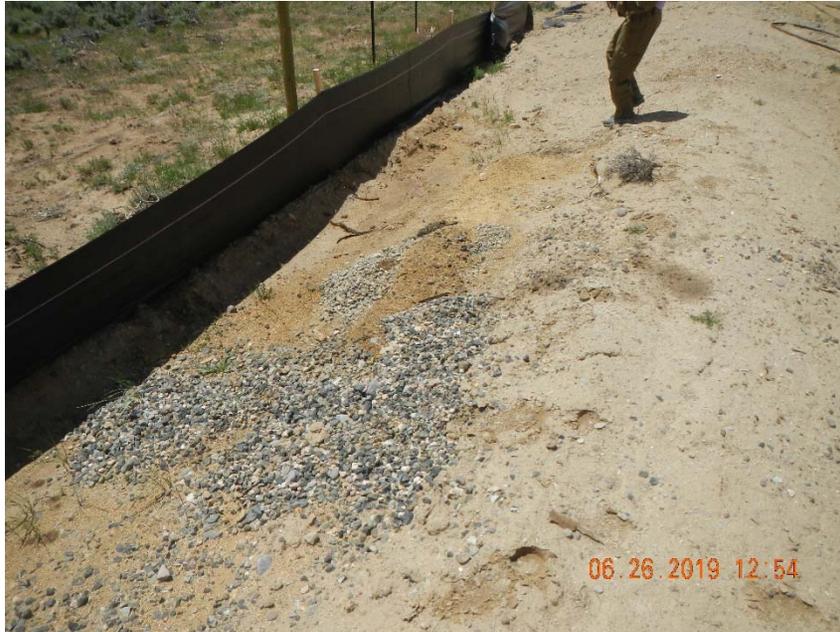
Photo 5. Drilling material pushed off edge of perimeter berm.

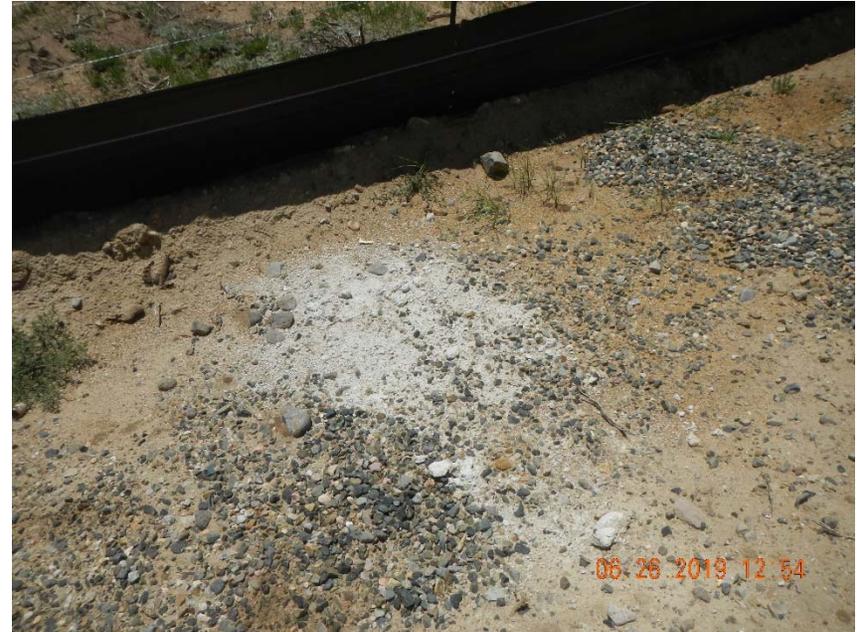
Photo 6. Close up of materials in photo 5.

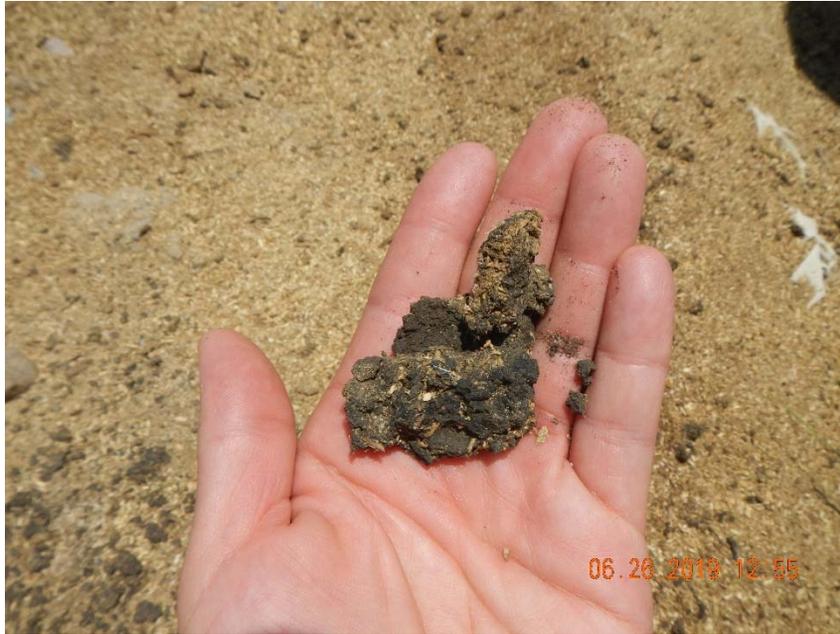
Photo 7. Close up of materials in photo 5.

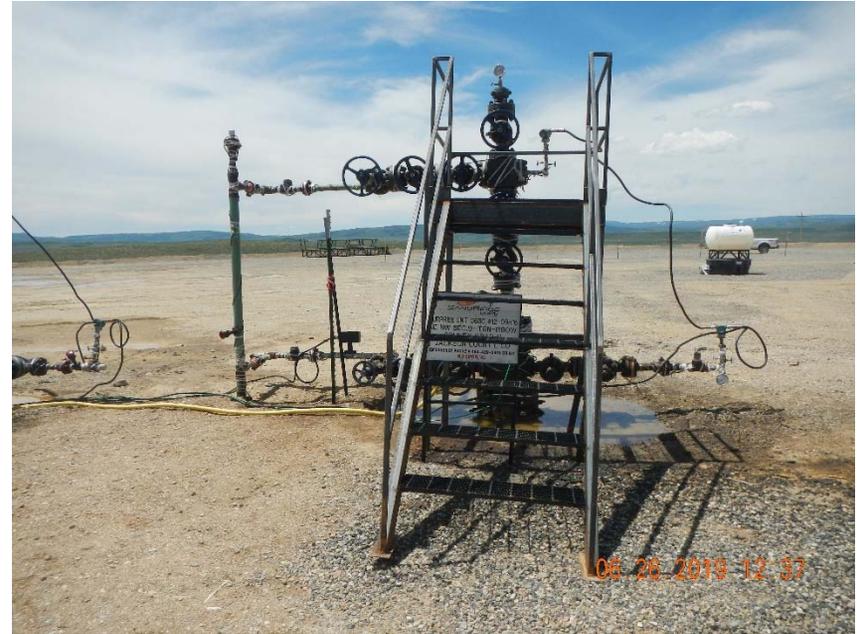
Photo 8. Stained soil at wellhead.

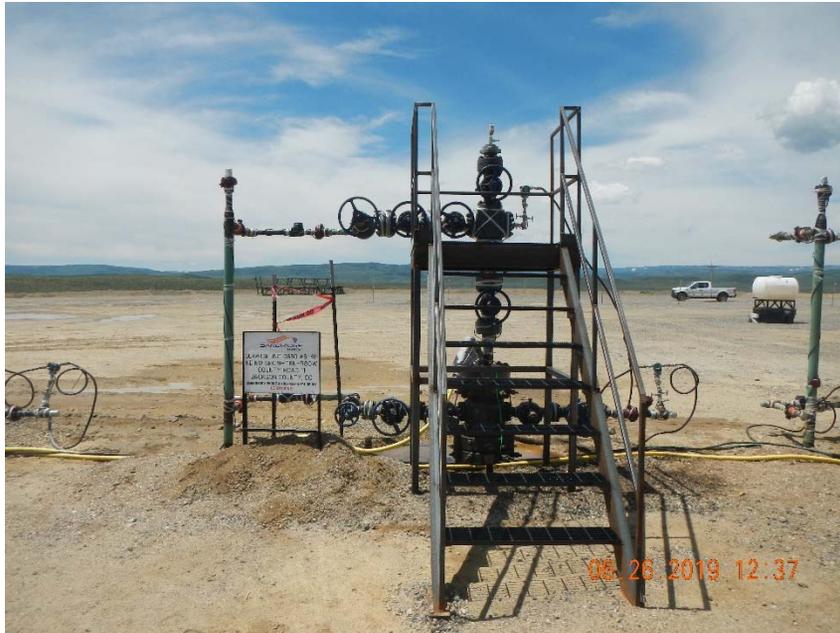
Photo 9. Stained soil at wellhead.

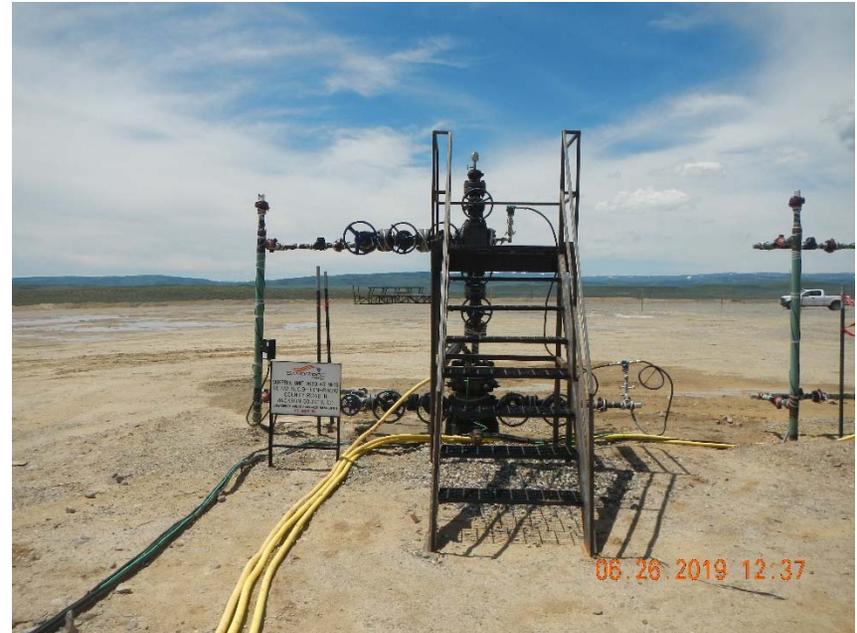
Photo 10. Stained soil at wellhead.

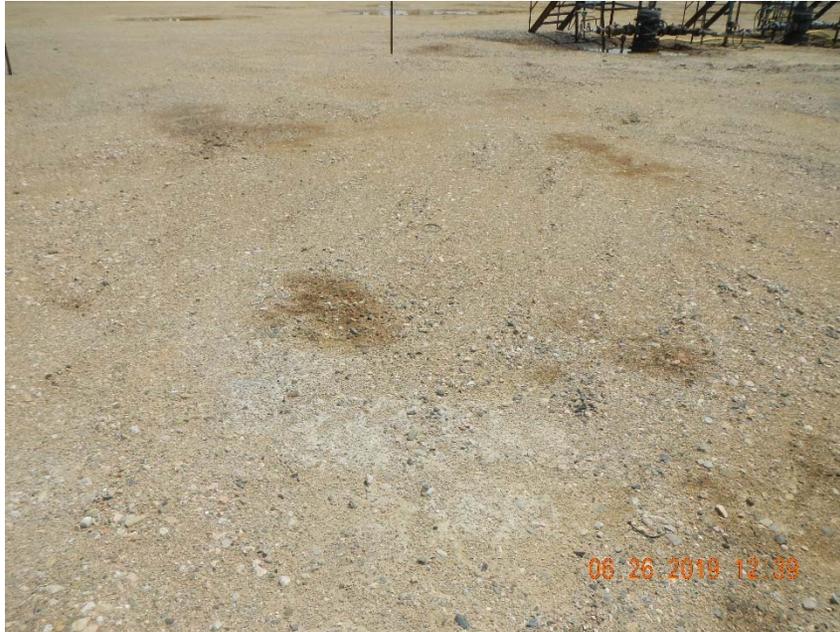
Photo 11. Example of soil staining seen on entire location.

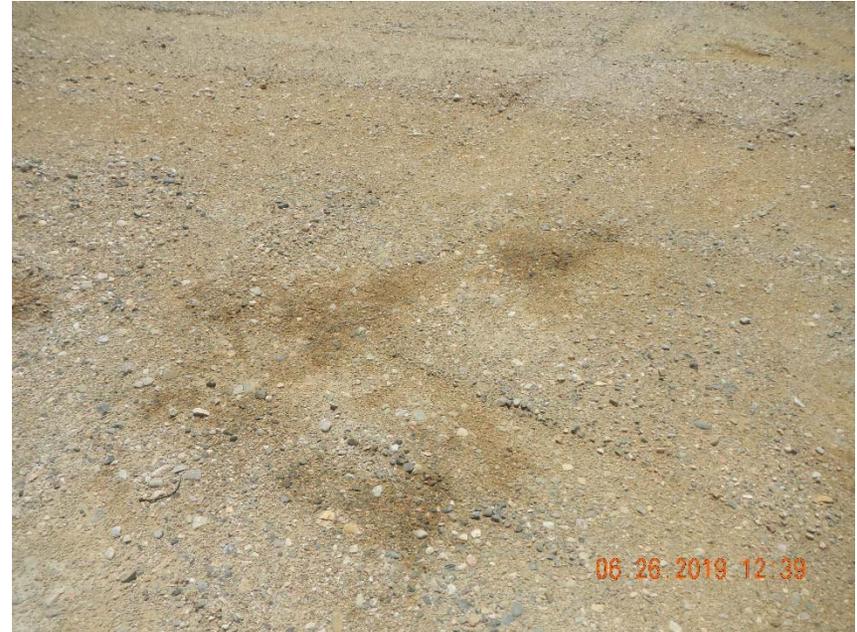
Photo 12. Example of soil staining seen on entire location.

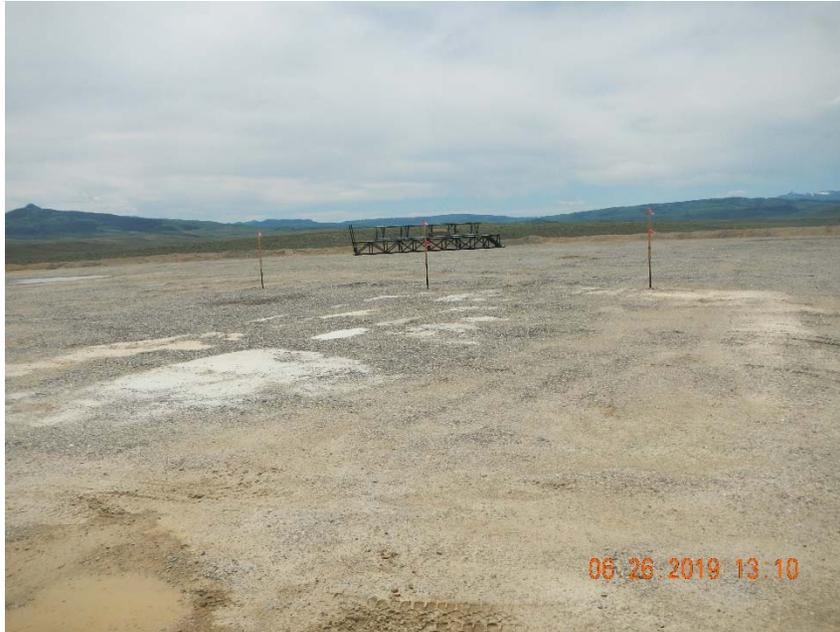
Photo 13. Frack sand spilled on location.

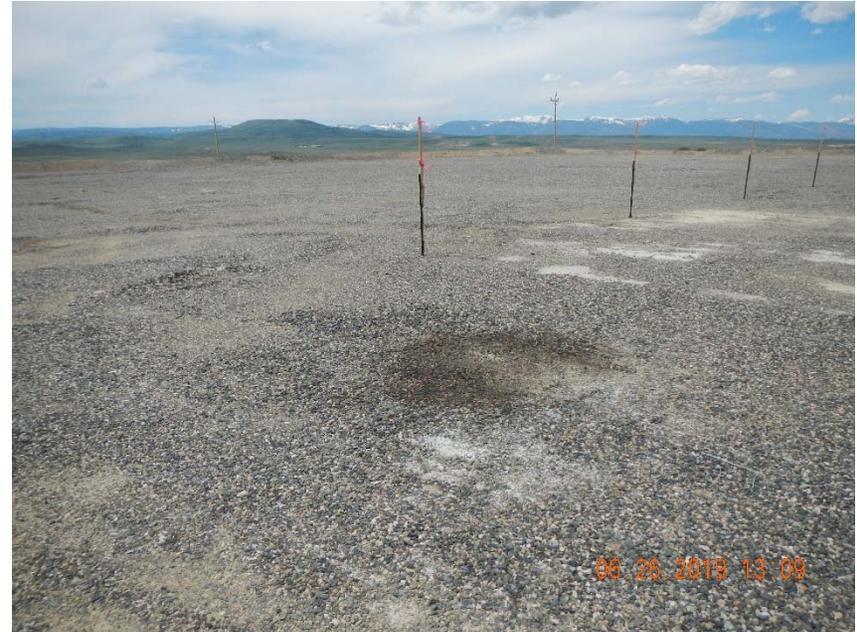
Photo 14. Frack sand spilled on location and an example of soil staining seen on entire location.
