**County:** Adams

**Township:** 1S      **Range:** 68W      **Section:** 10      **QQ:** SESE

**Updated Pit Status: Closed**

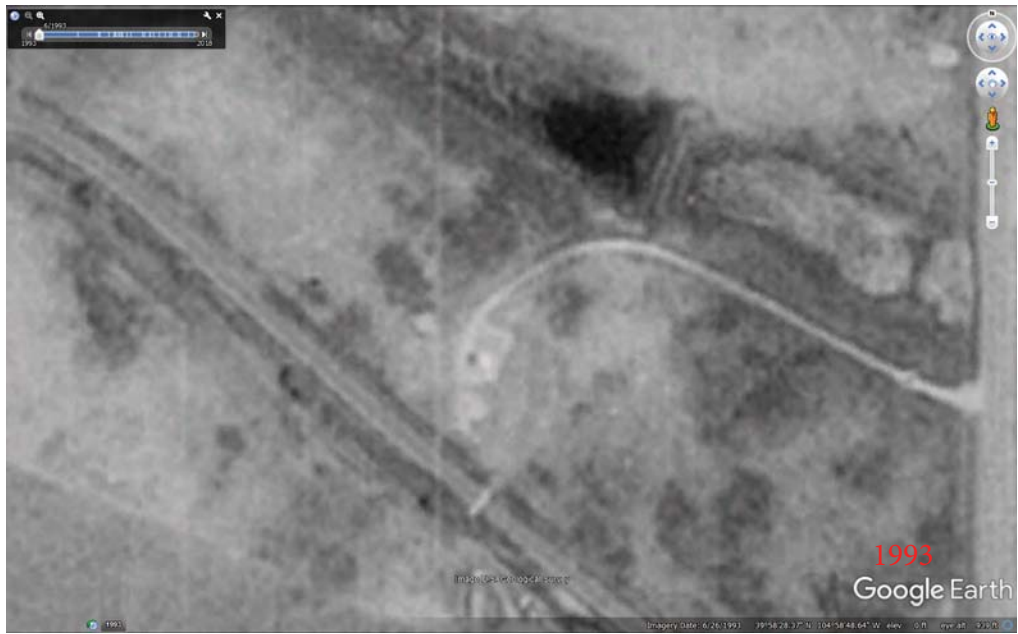
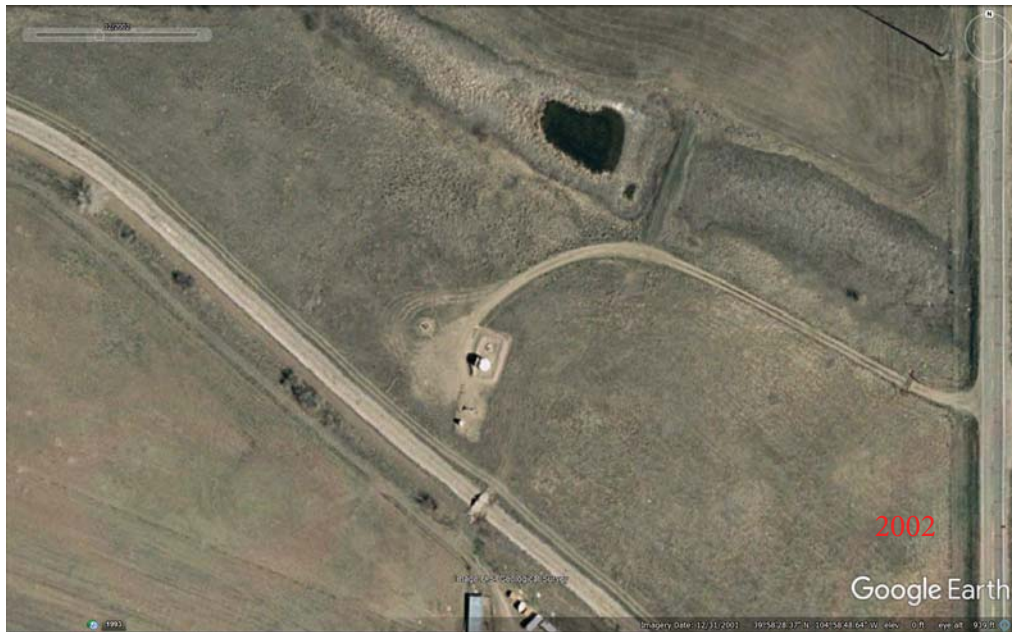
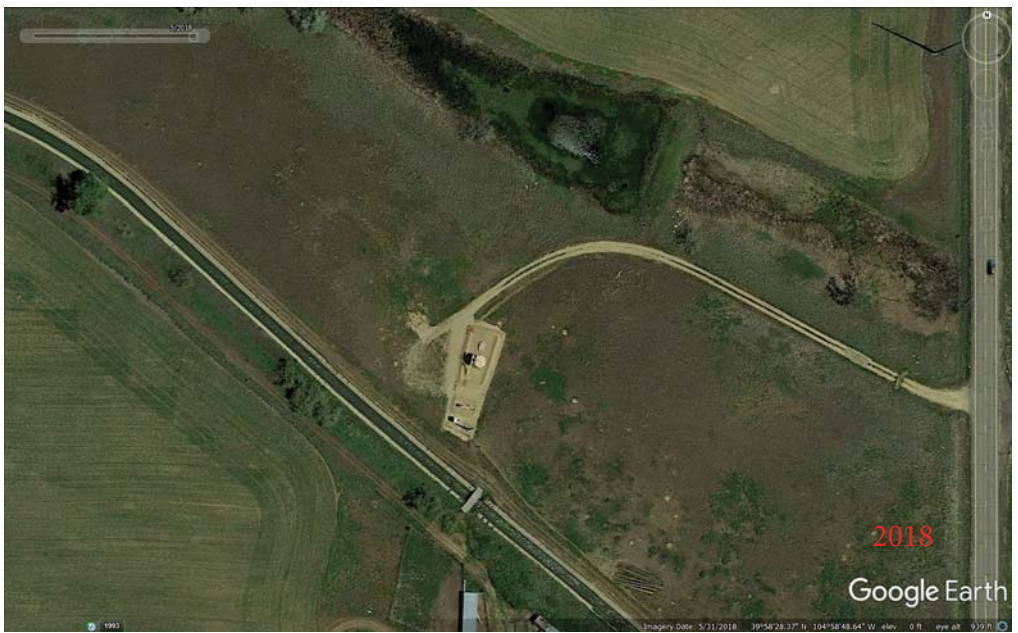
Based on records review and aerial photos, there is no evidence that there was a produced water pit on location. Inspection reports document a concrete water vault on location. The vault was removed under remediation project #11446 (closed 7/10/2018). Pit status has been changed to closed.

Vault removed under remediation project #11446, closed 7/10/2018
