Davis #2-5

Corrective Actions Taken on the Davis #2-5 for the COGCC compliance
INC.

Davis #2-5 07/03/19

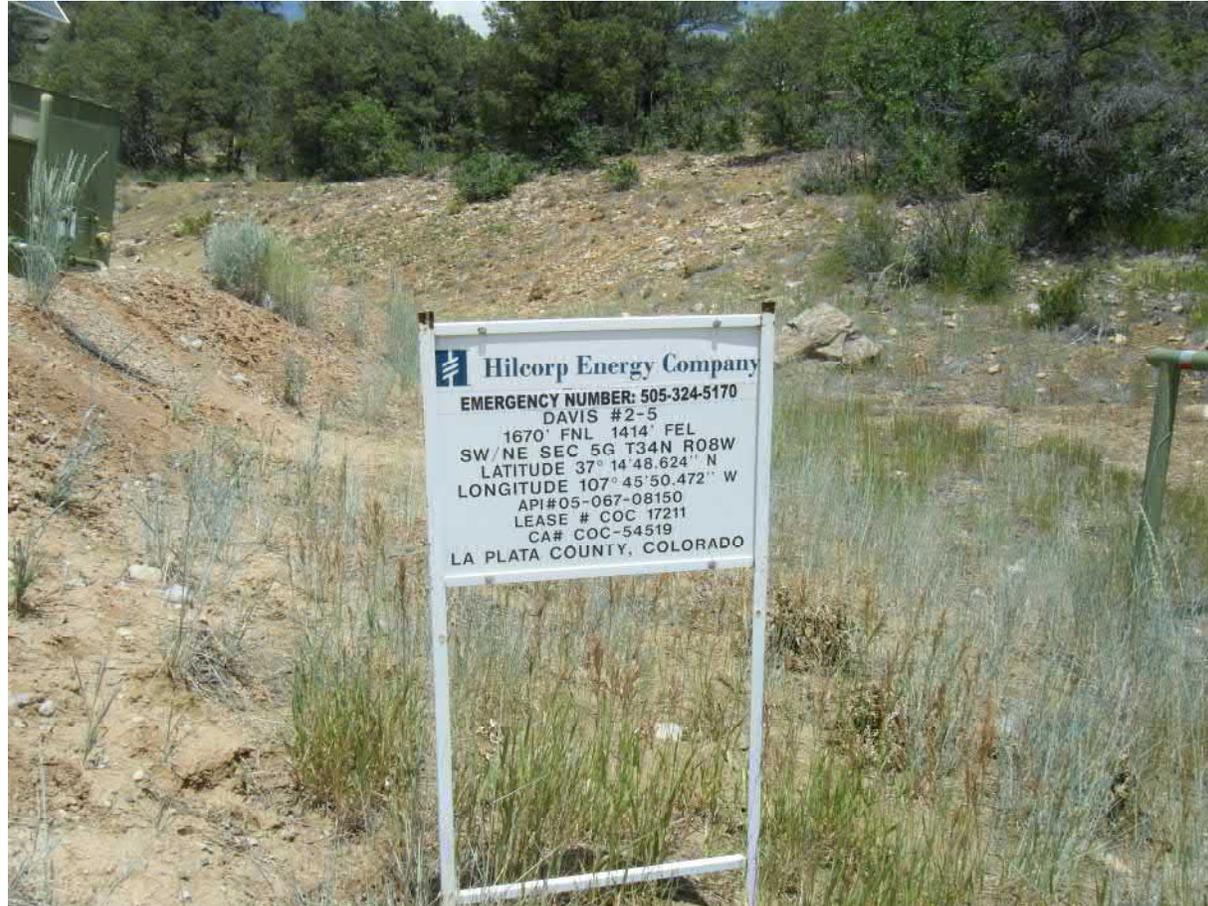
Storm Water management controls have been established to stabilize erosion along center and west side of access road. Check dams and diversions were installed to control water run off from location.

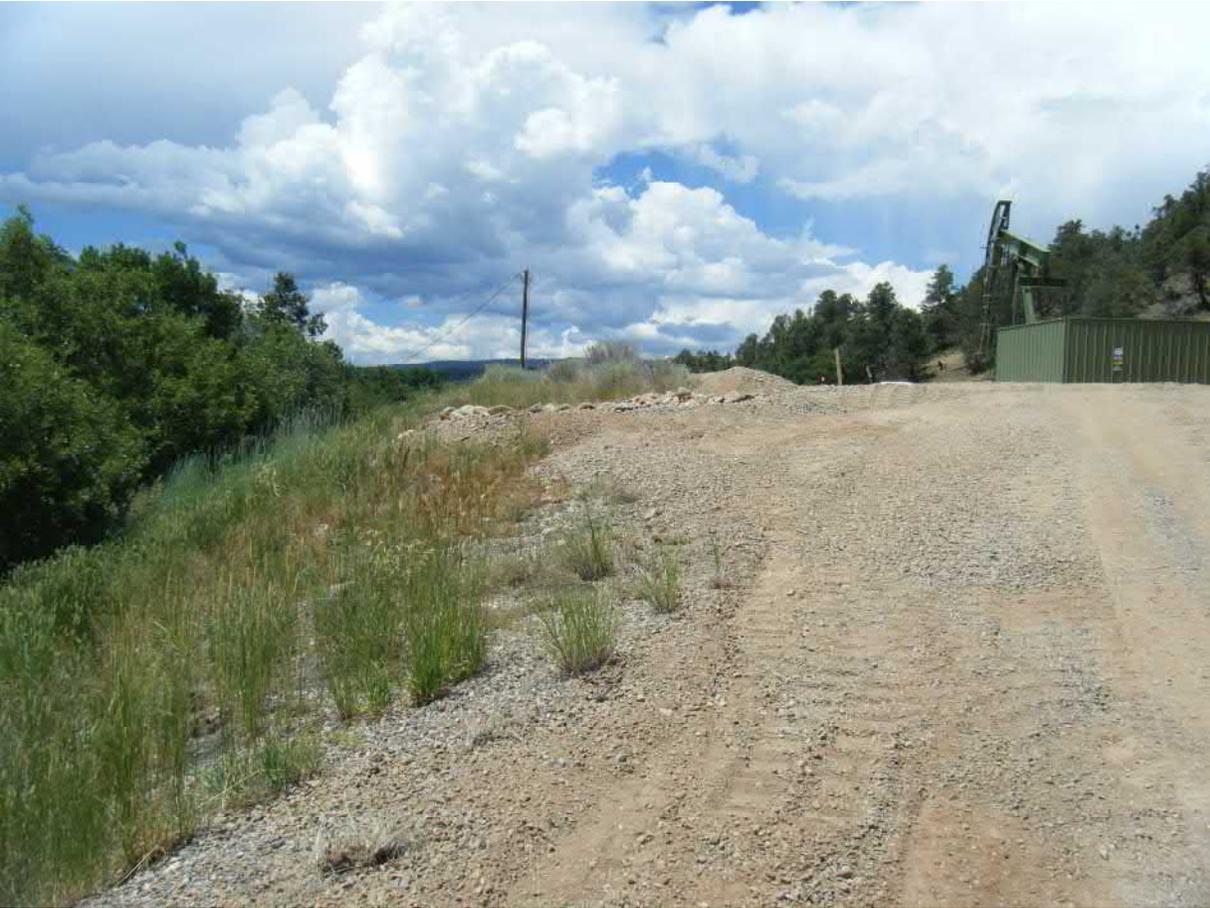
View pad looking north, northwest of access road.

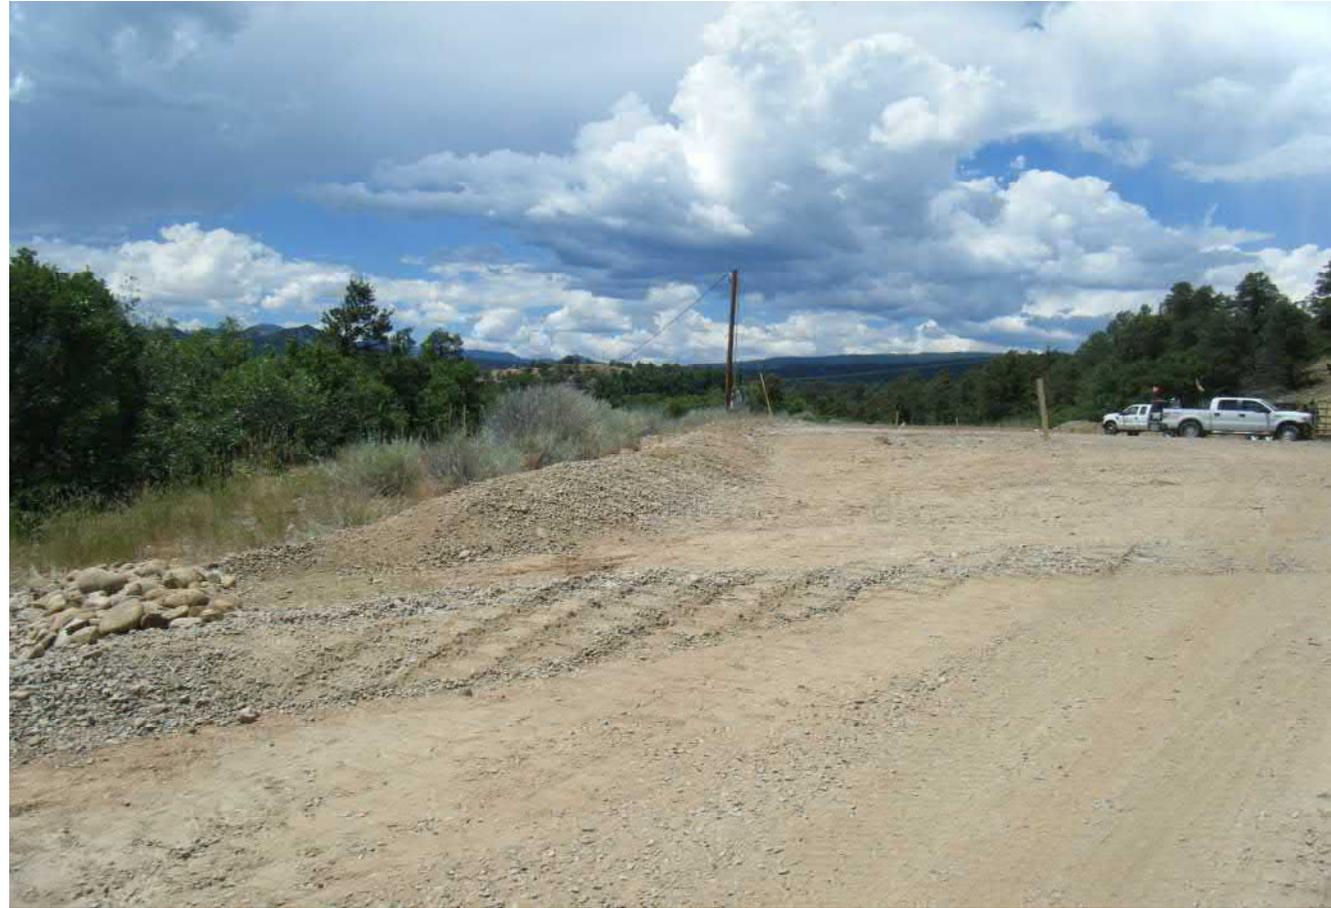
View of check dam and diversions looking north, northwest.

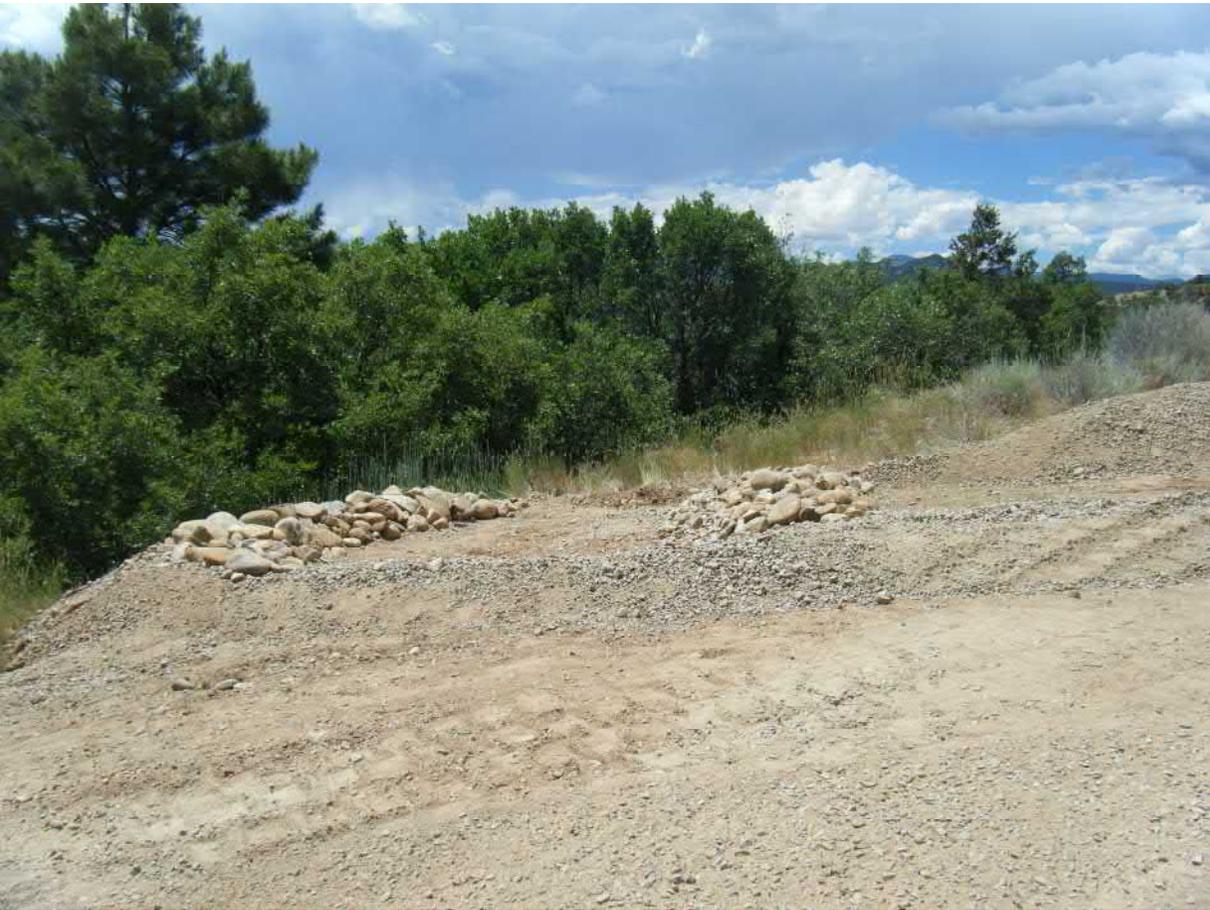
View of check dam and diversions looking north, northwest.

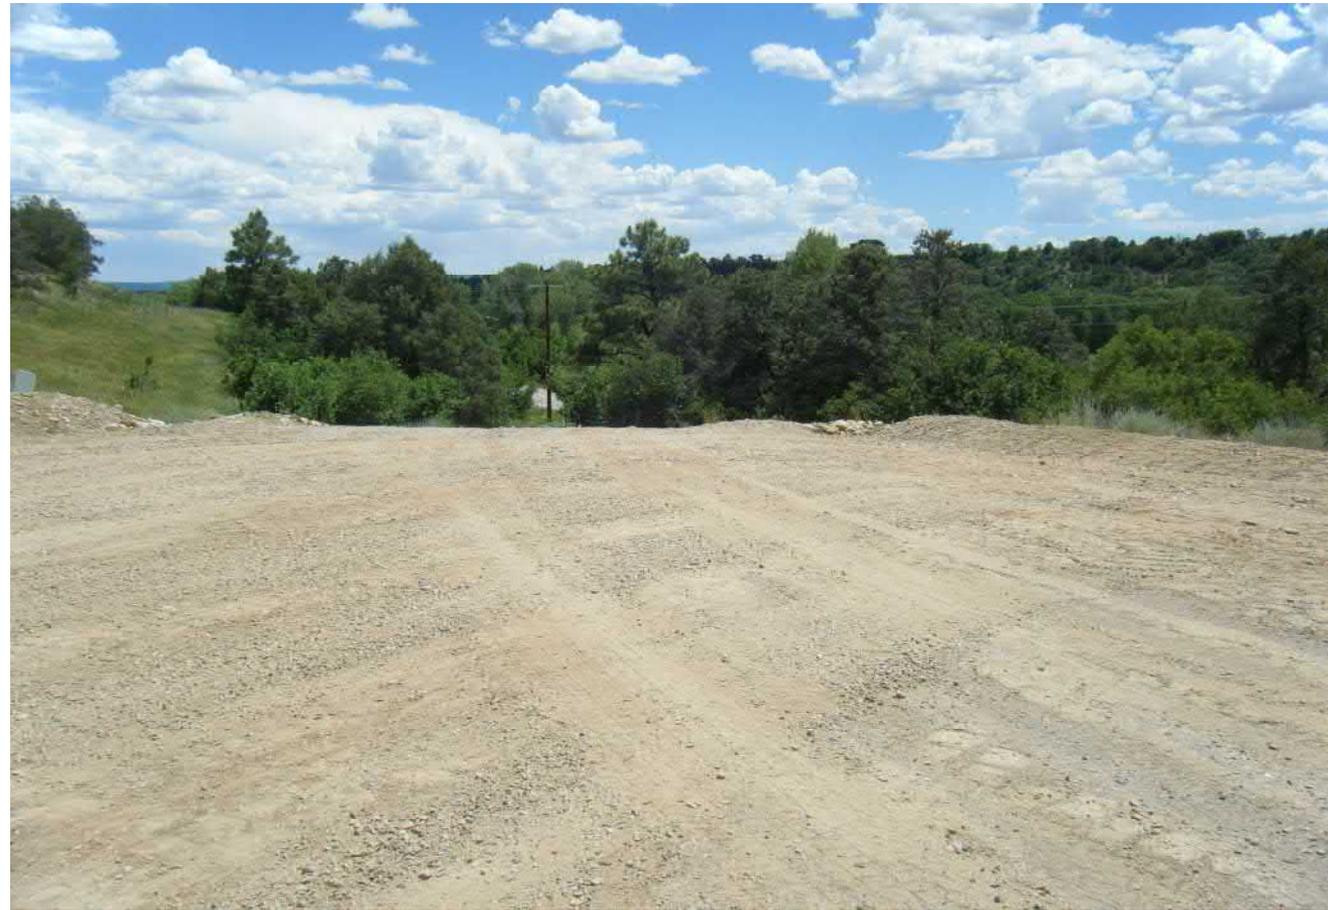
View of location entrance looking south, southwest.

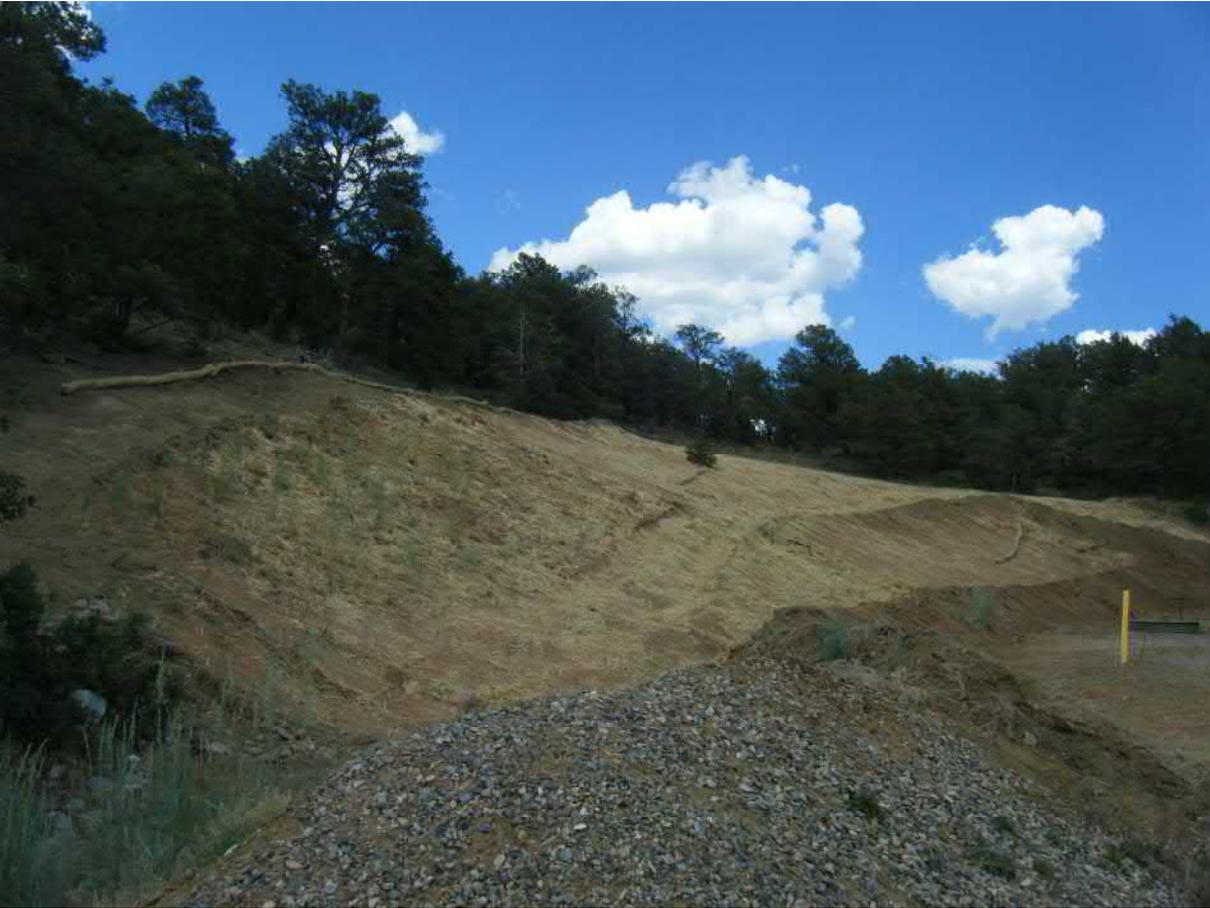
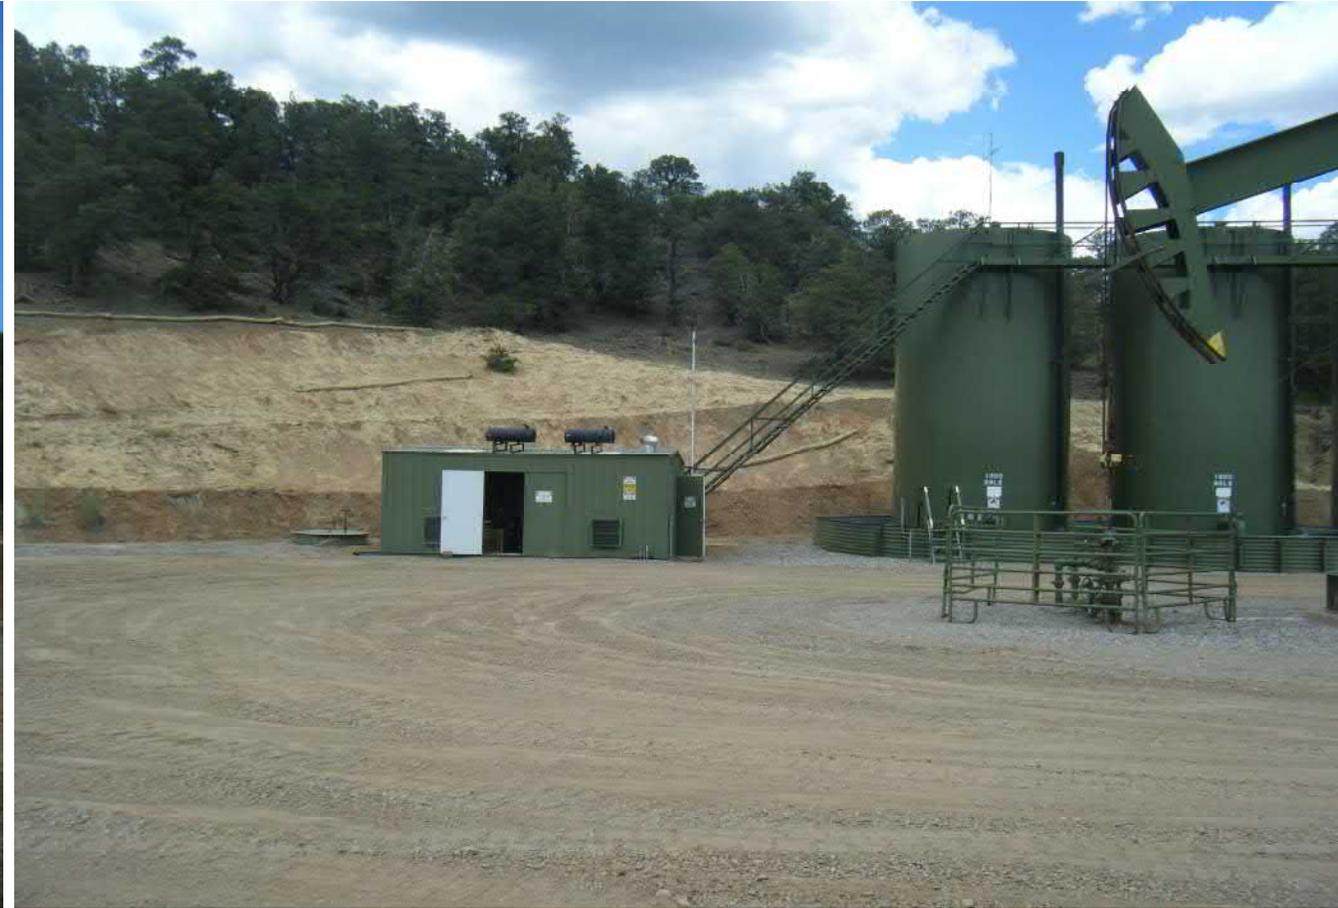
The green plastic debris (Synthetic erosion netting) identified on the cut slope has been removed and properly disposed of. Cut slope diversions have been cleaned and disturbed areas seeded. Wattles were installed to stabilize the cut slope from eroding while vegetation re-establishes.

View of project area looking North.
