Inspection Photos

Loc#324754

Operator: Sandridge

Inspection Number: 692401152

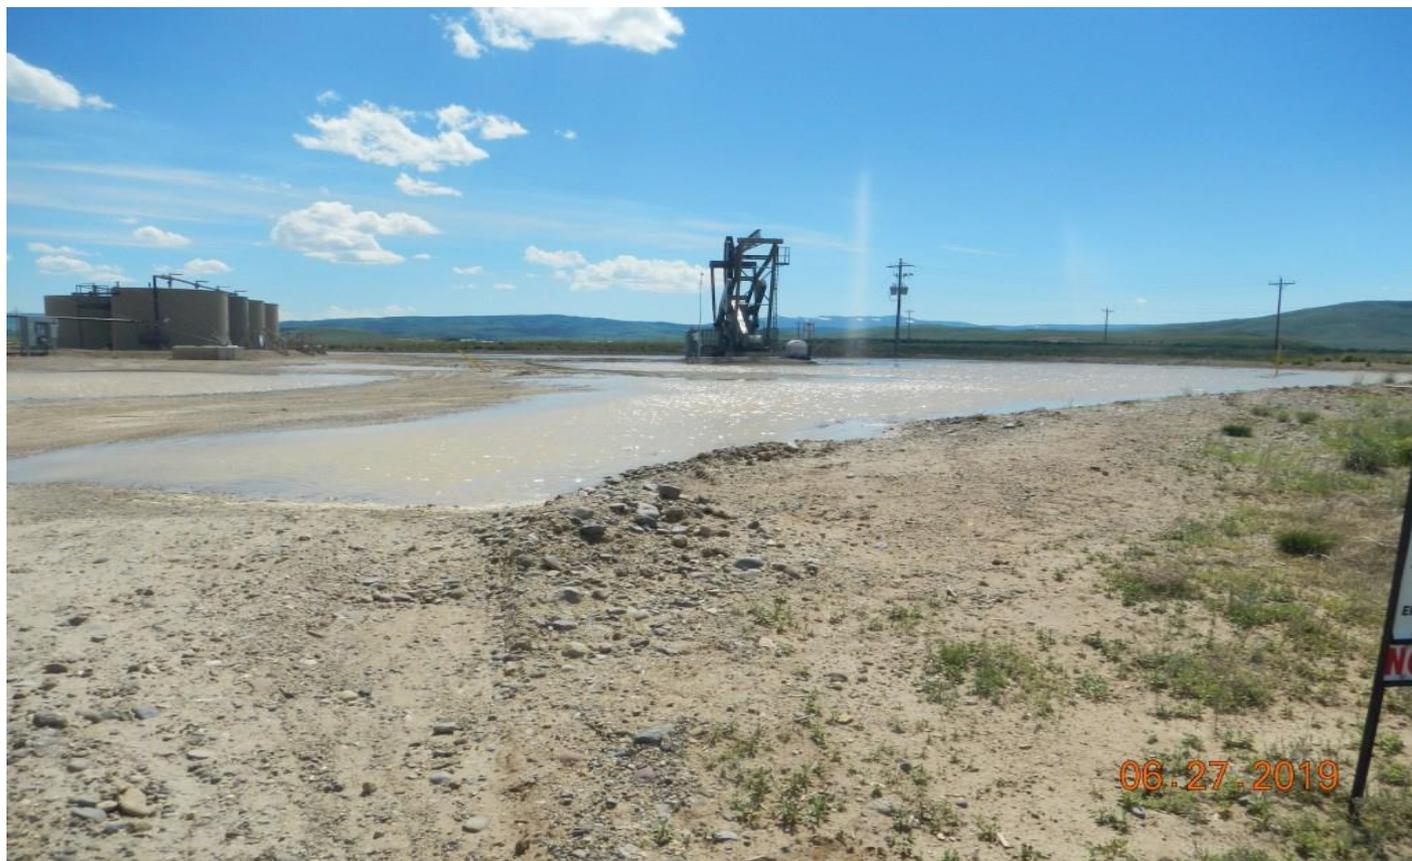
Photo#1:
Overview of Location from Entry to Southwest.

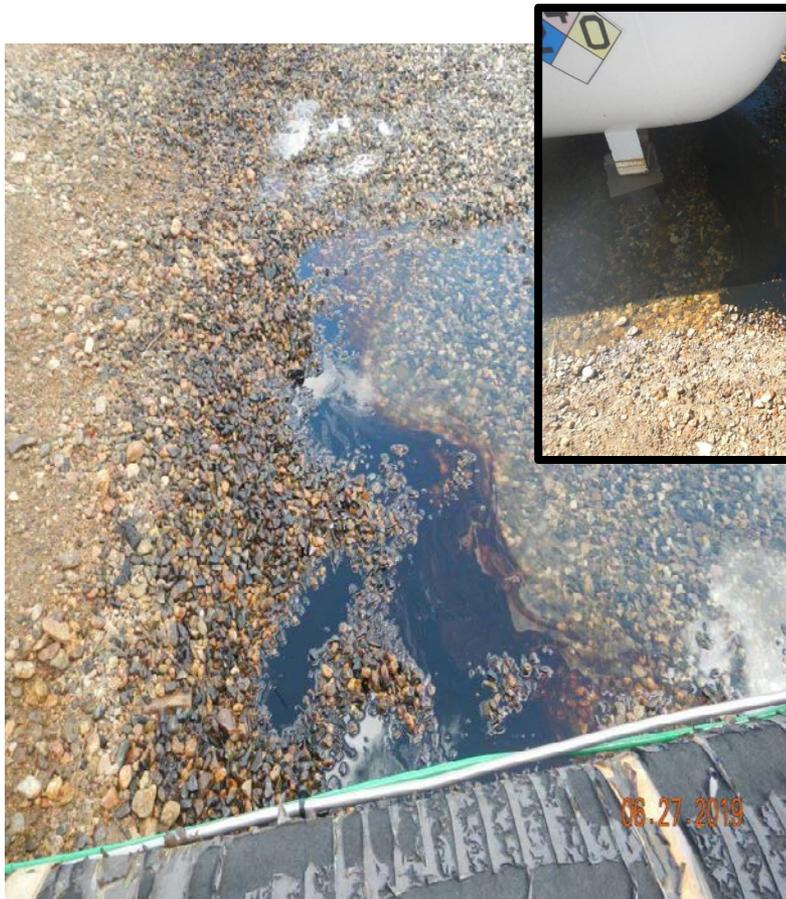
Photo#2:
Pooling oil and staining in tank containment.

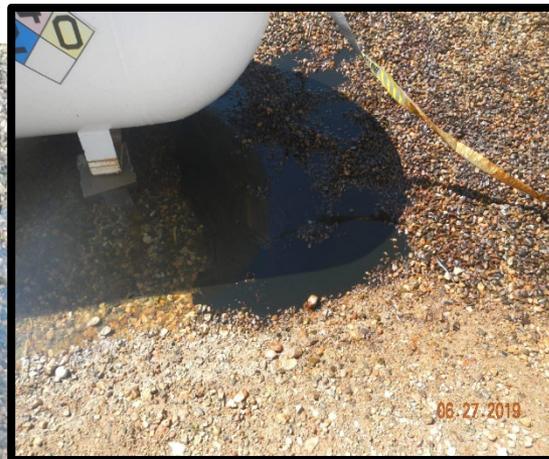
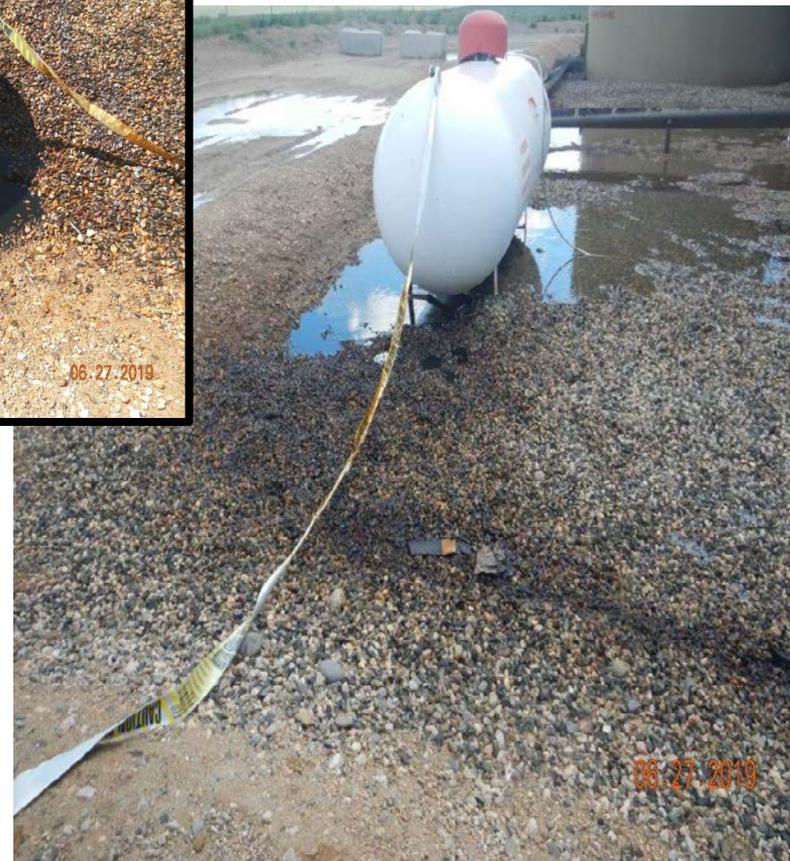
Photo#3:
Pooling oil and staining in tank containment

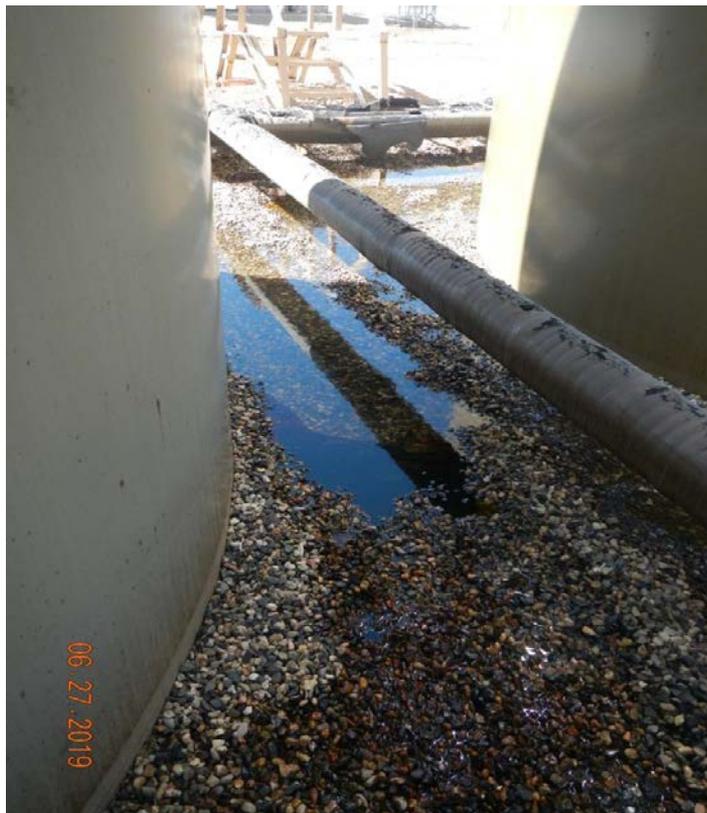
Photo#4:
Pooling oil and staining in tank containment

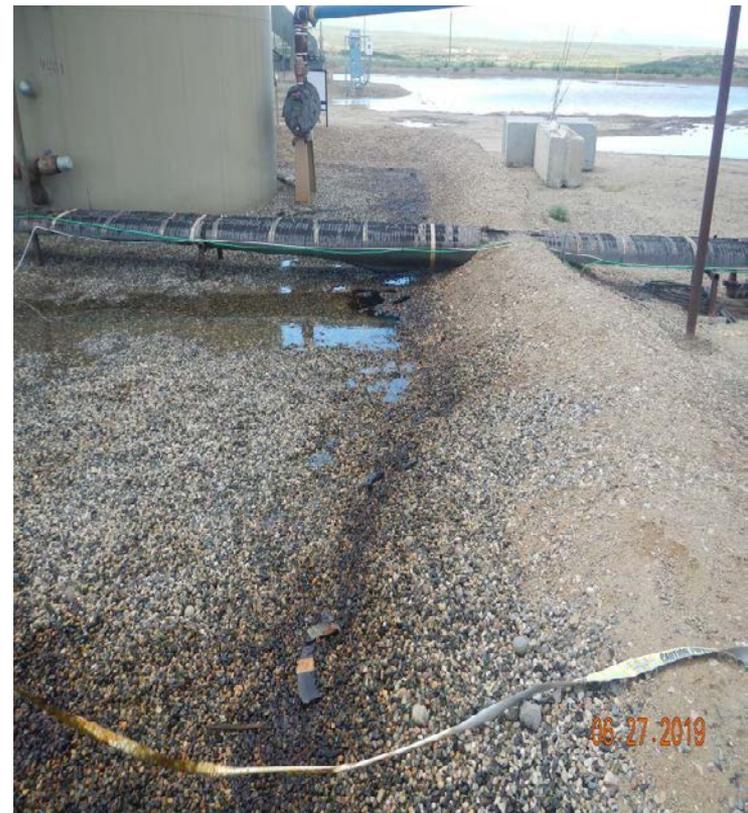
Photo#5:
Pooling oil and staining in tank containment

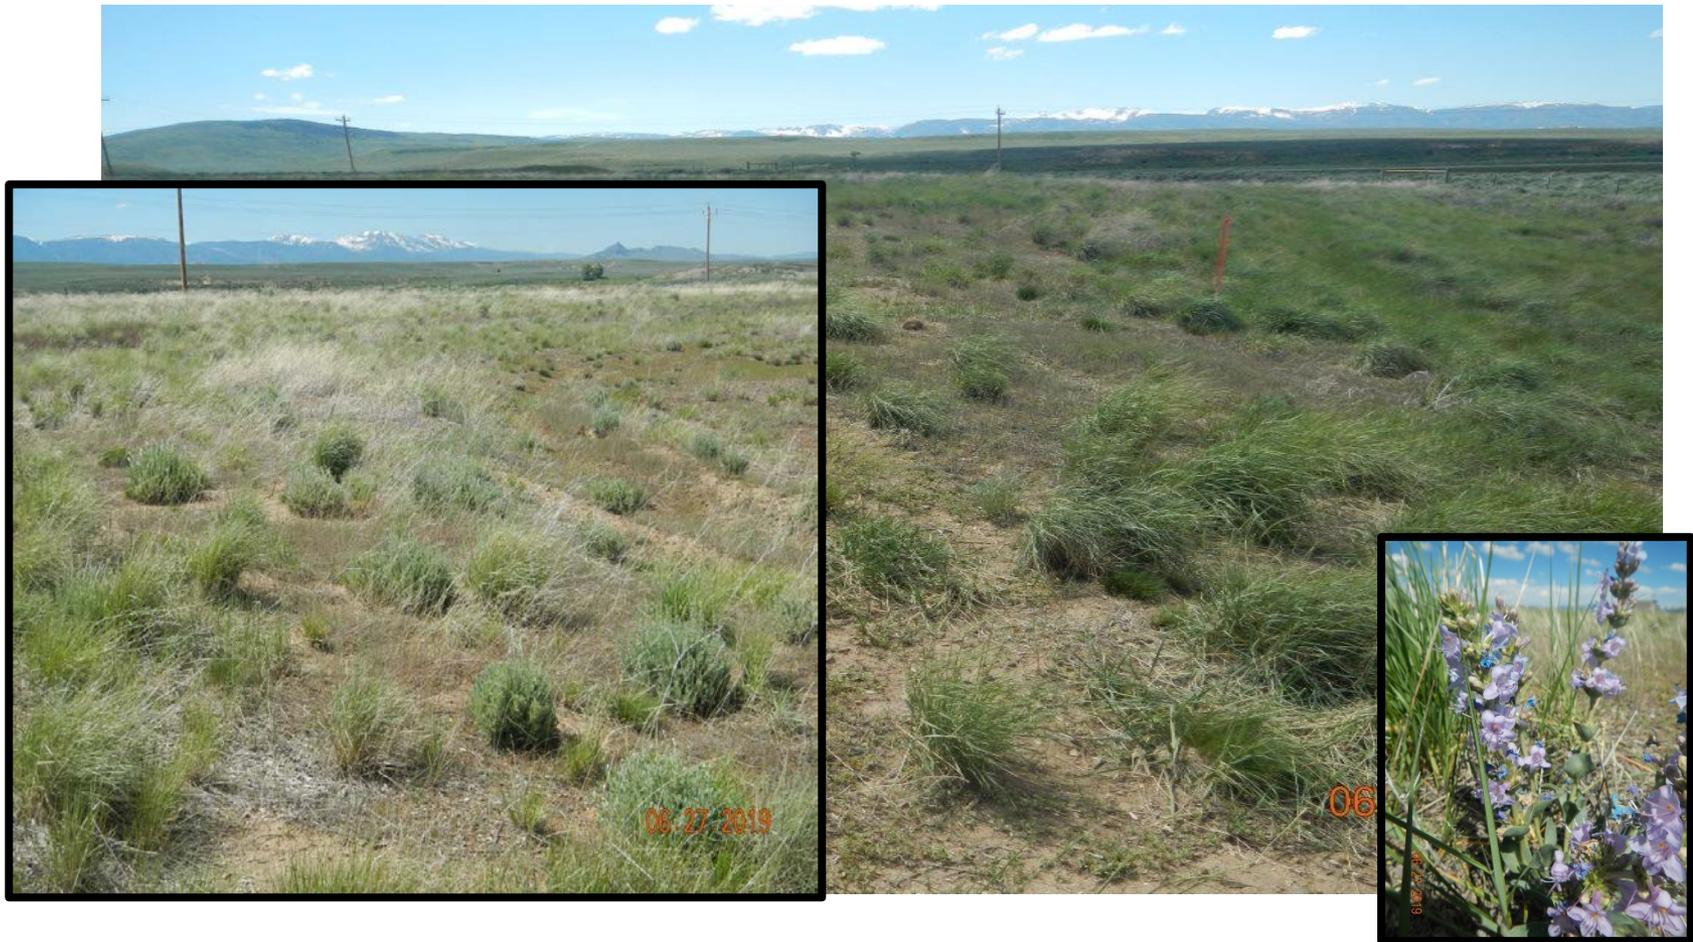
Photo#6:
Views of Interim Reclamation area.

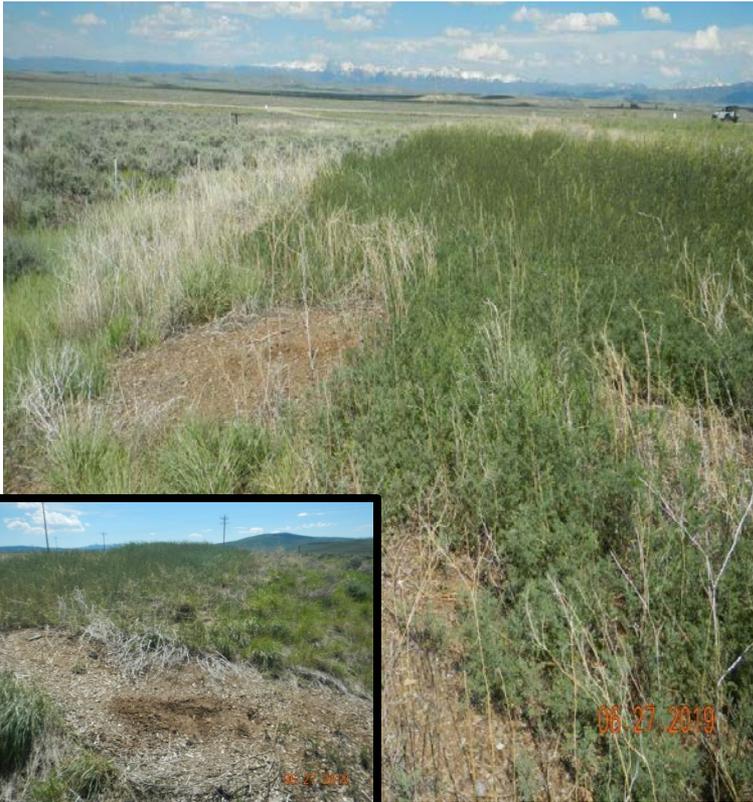
Photo#7:
Berm area of concern in NW portion of Interim.
Insert is close up of berm material.

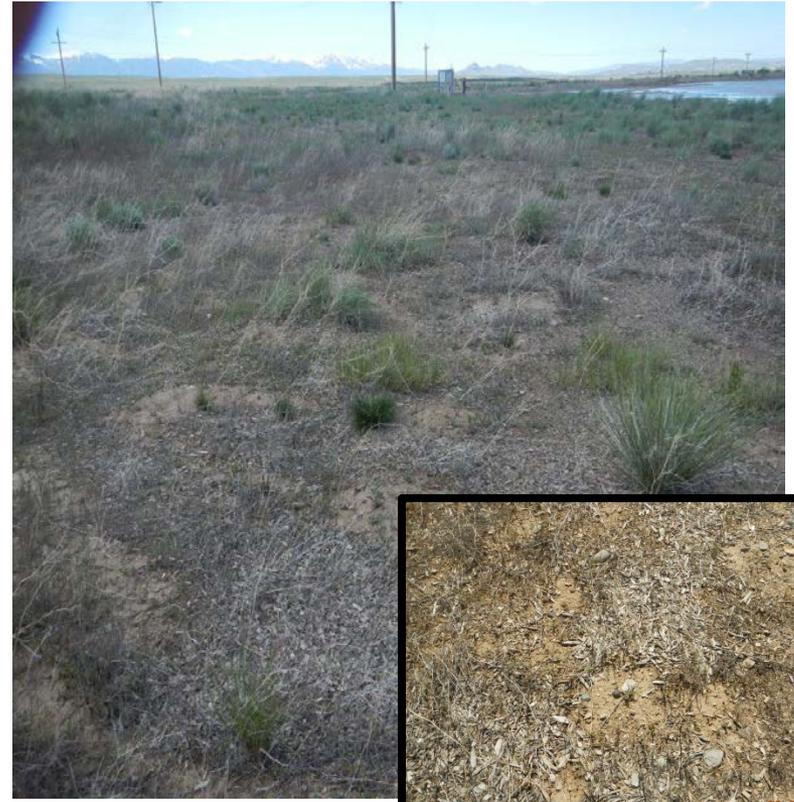
Photo#8:
Area of concern in South portion of Interim. Insert is
close up of chip material and ground conditions.

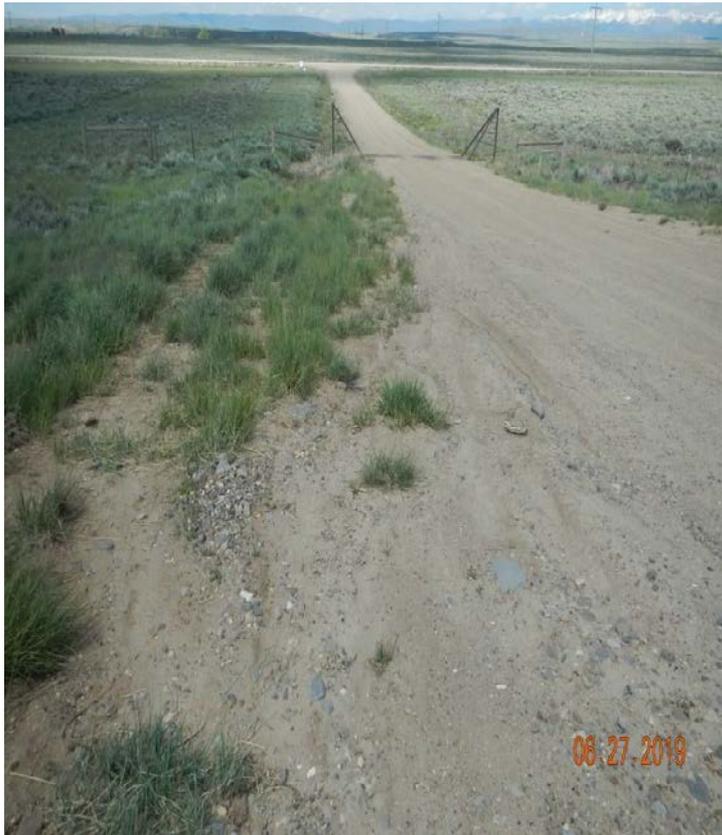
Photo#9:
Lack of BMPs along access road.

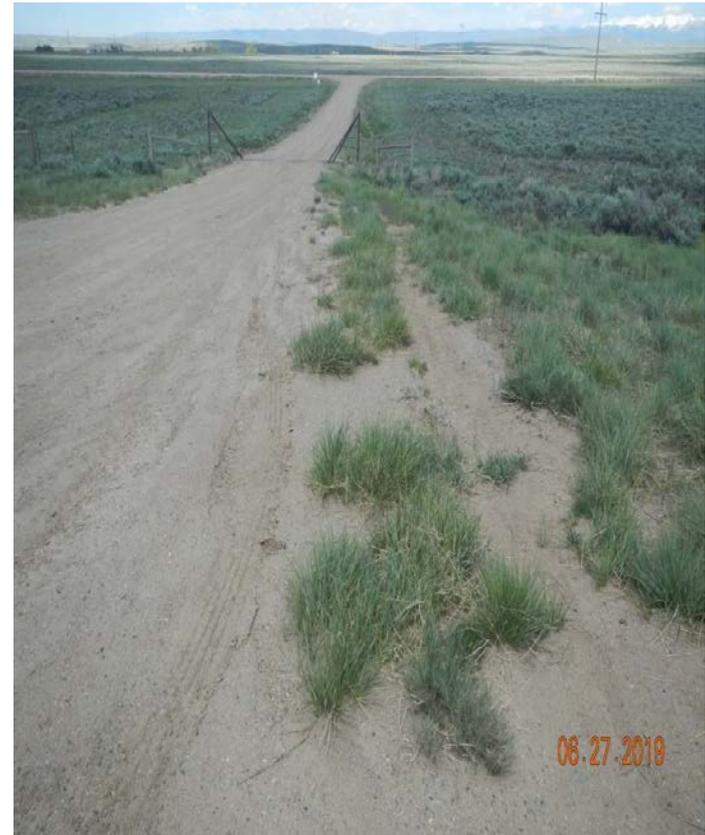
Photo#10:
Lack of BMPs along access road.

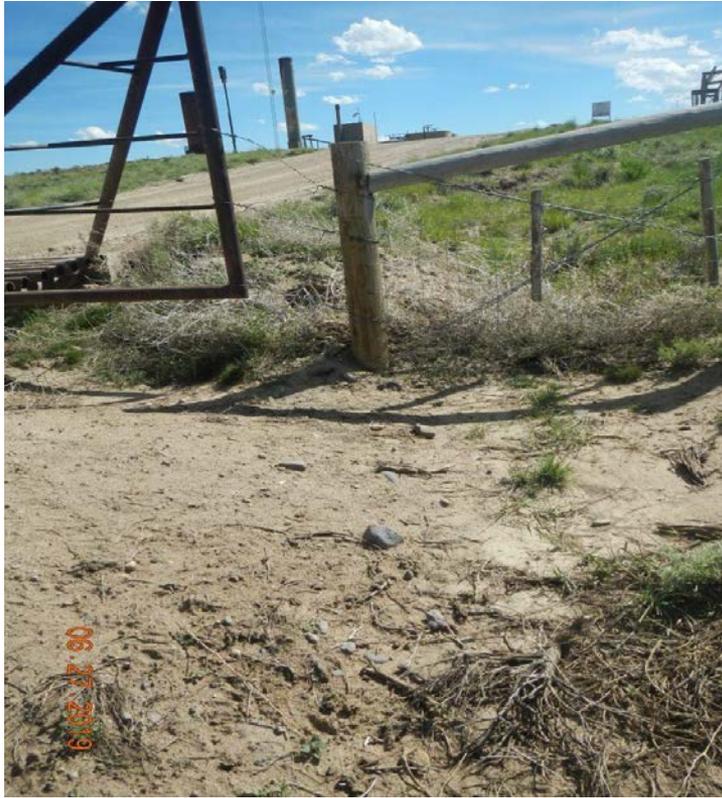
Photo#11:
Lack of BMPs at Cattle guard entry.

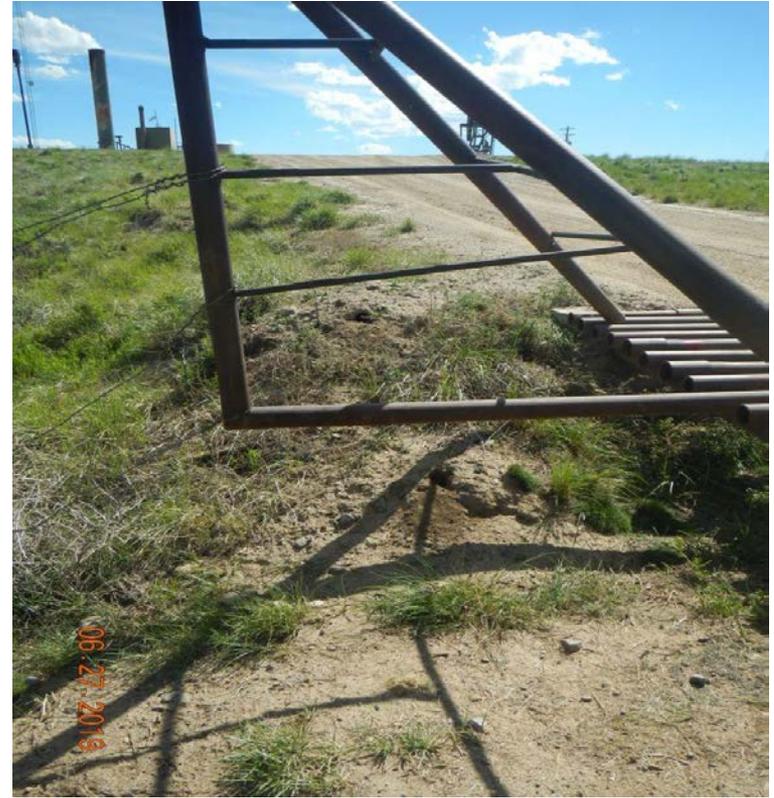
Photo#12:
Lack of BMPs at Cattle guard entry.

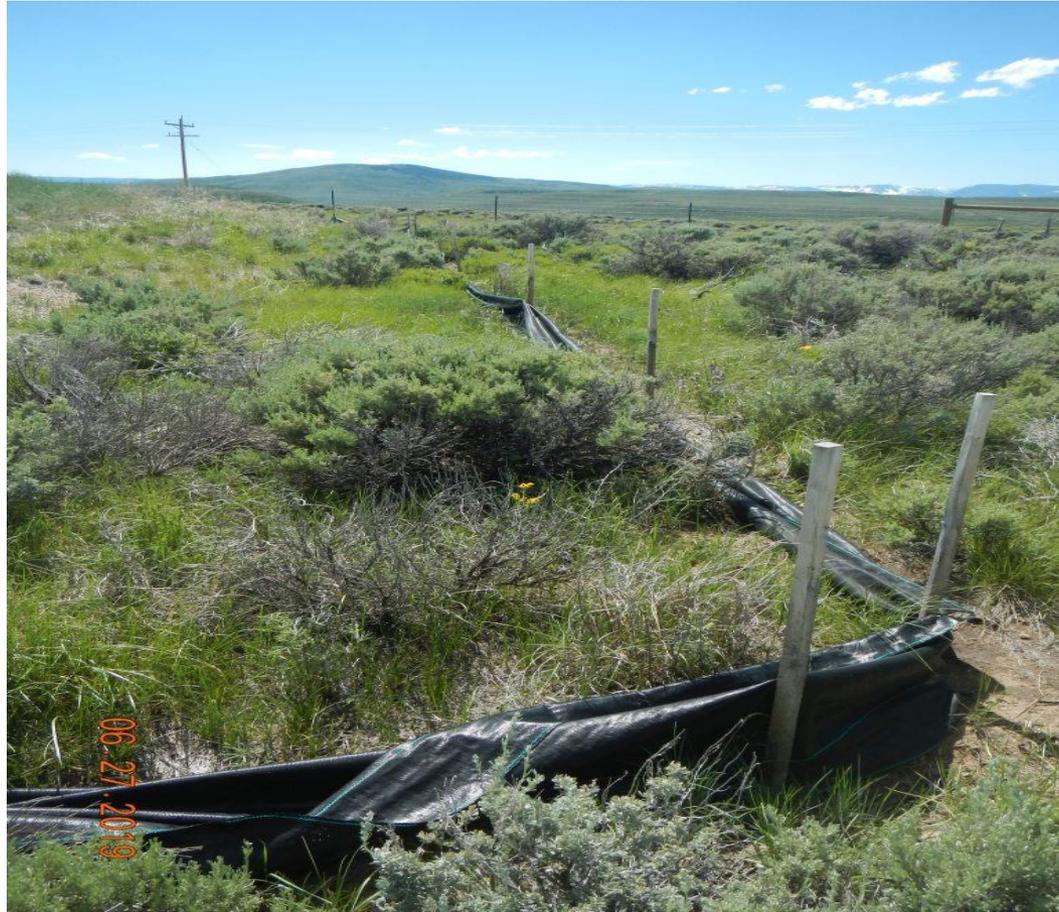
Photo#13:
Silt fence that has become Debris.
