Inspection Photos
Operator: Gunnison Energy
Spill or Release #: 464354
Date: 6-18-2019

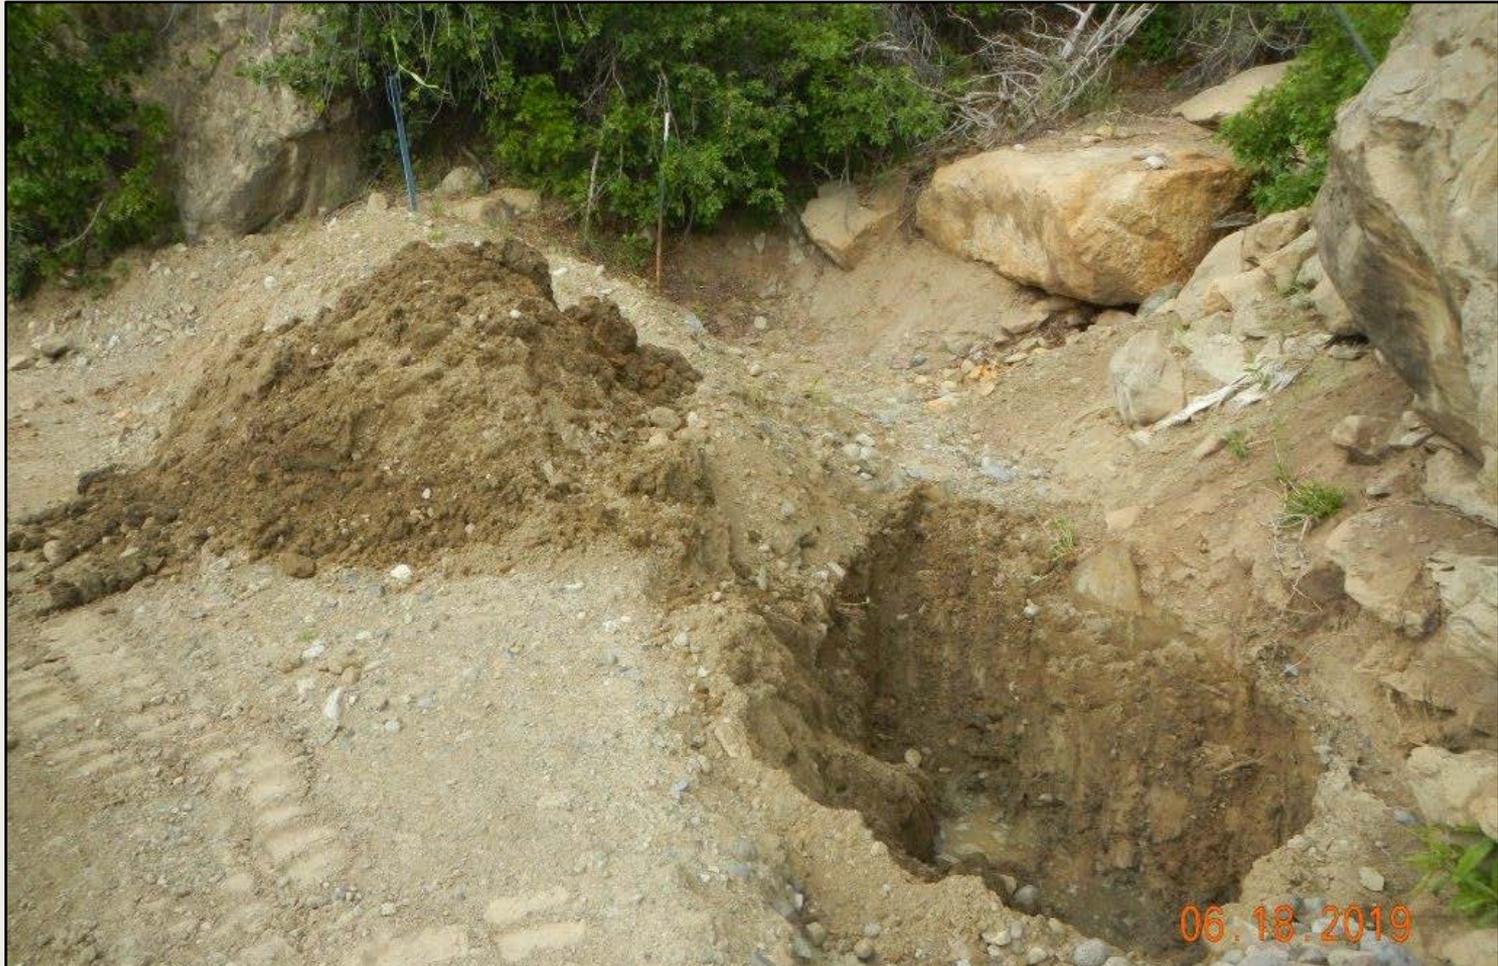
Photo 1. View of loose excavated soil and trench downstream from spill along access road. Stormwater controls are needed around stockpiled soils to prevent sediment transport.

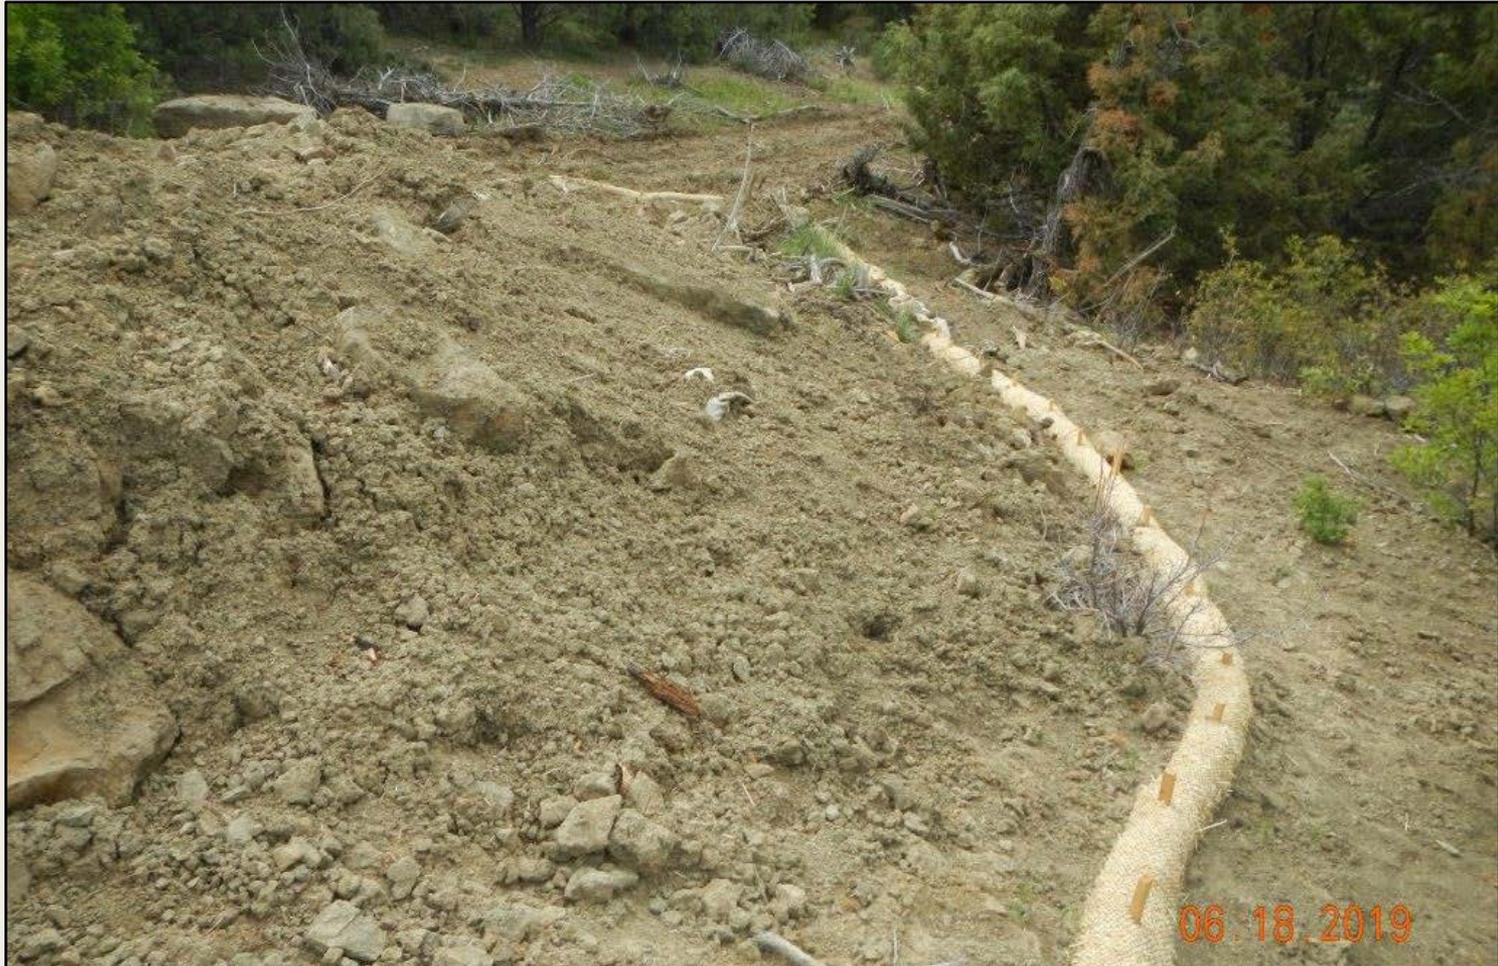
Photo 2. View of wattle at spill site. This wattle is not sufficient to contain volume of excavated soil above slope. Disturbed soils down-slope are not stabilized.

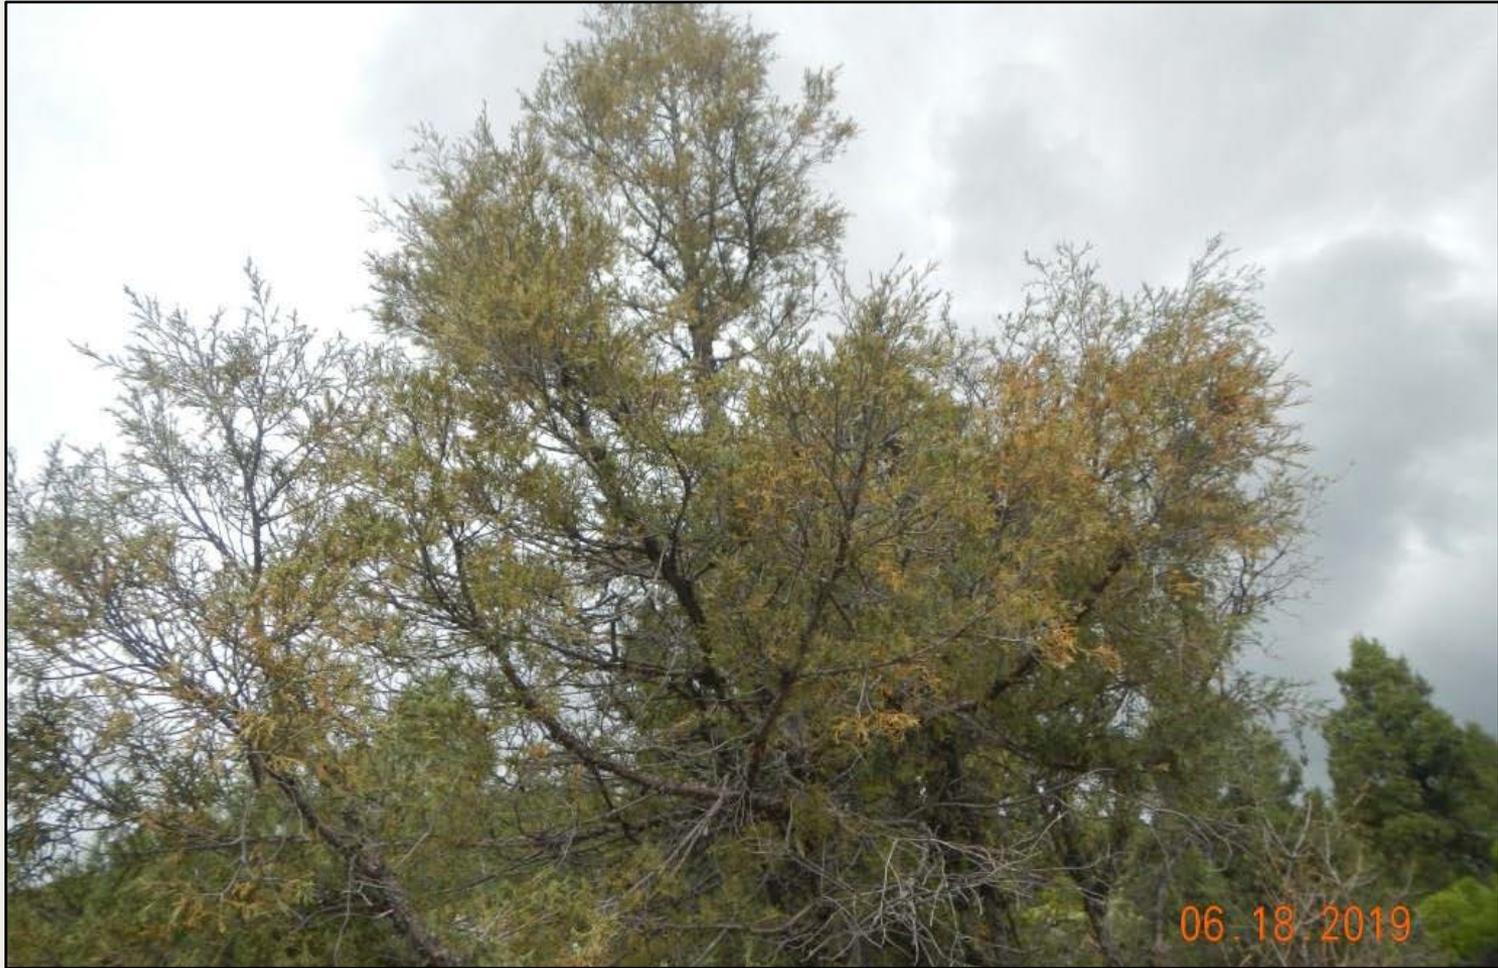
Photo 3. View of mature juniper tree that is discolored and appears to be dying as a result of impacts from spill.

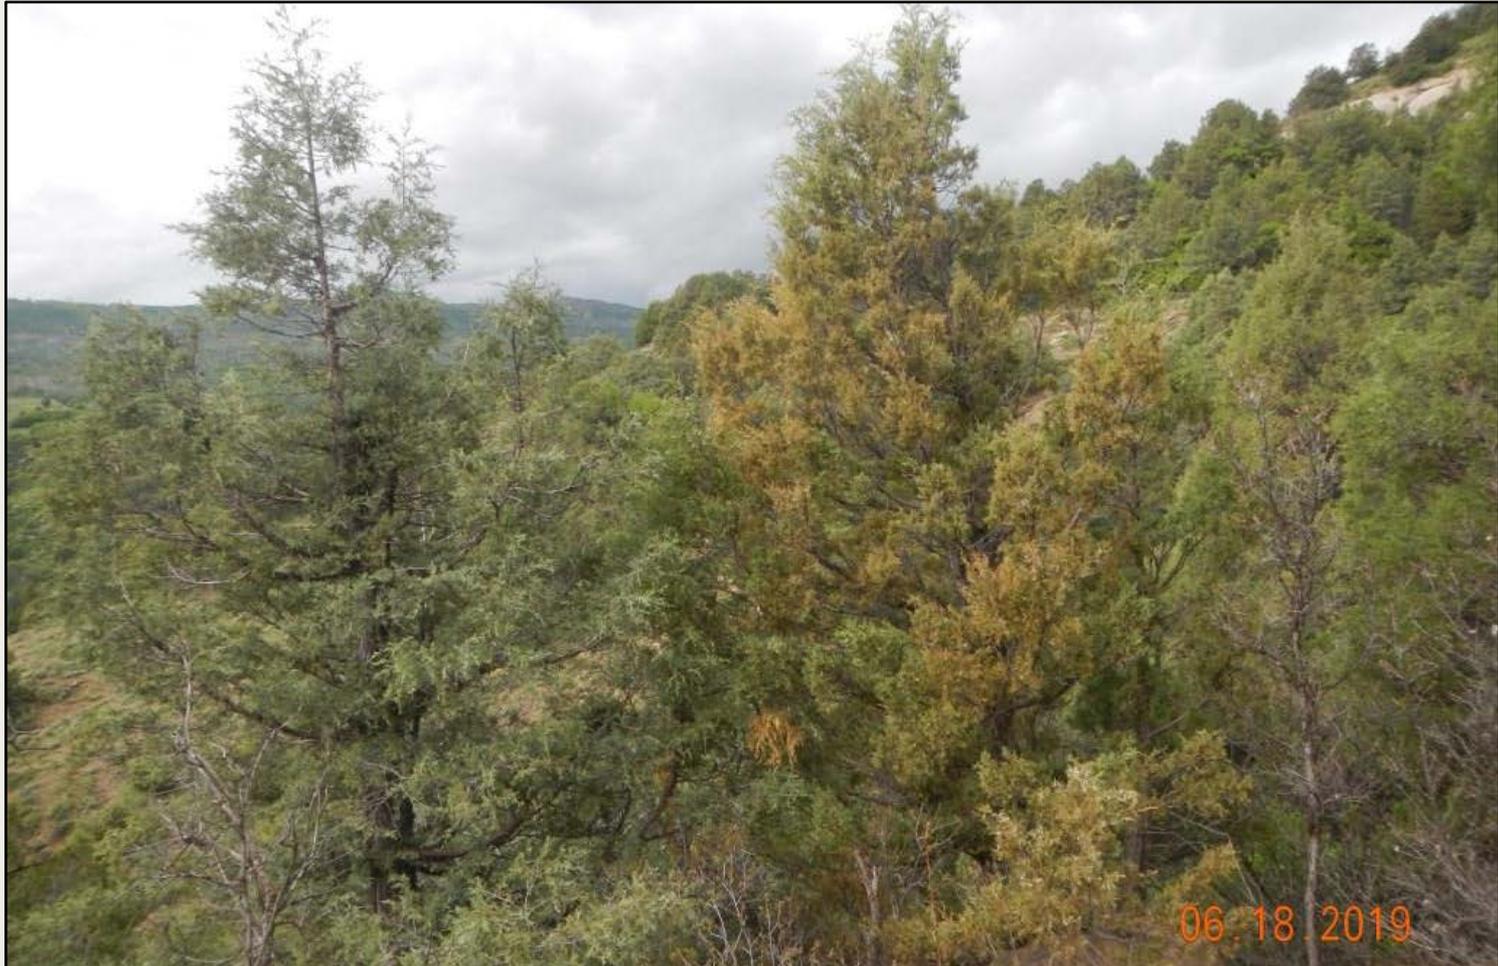
Photo 4. View of more trees in spill path that are discolored and dying.

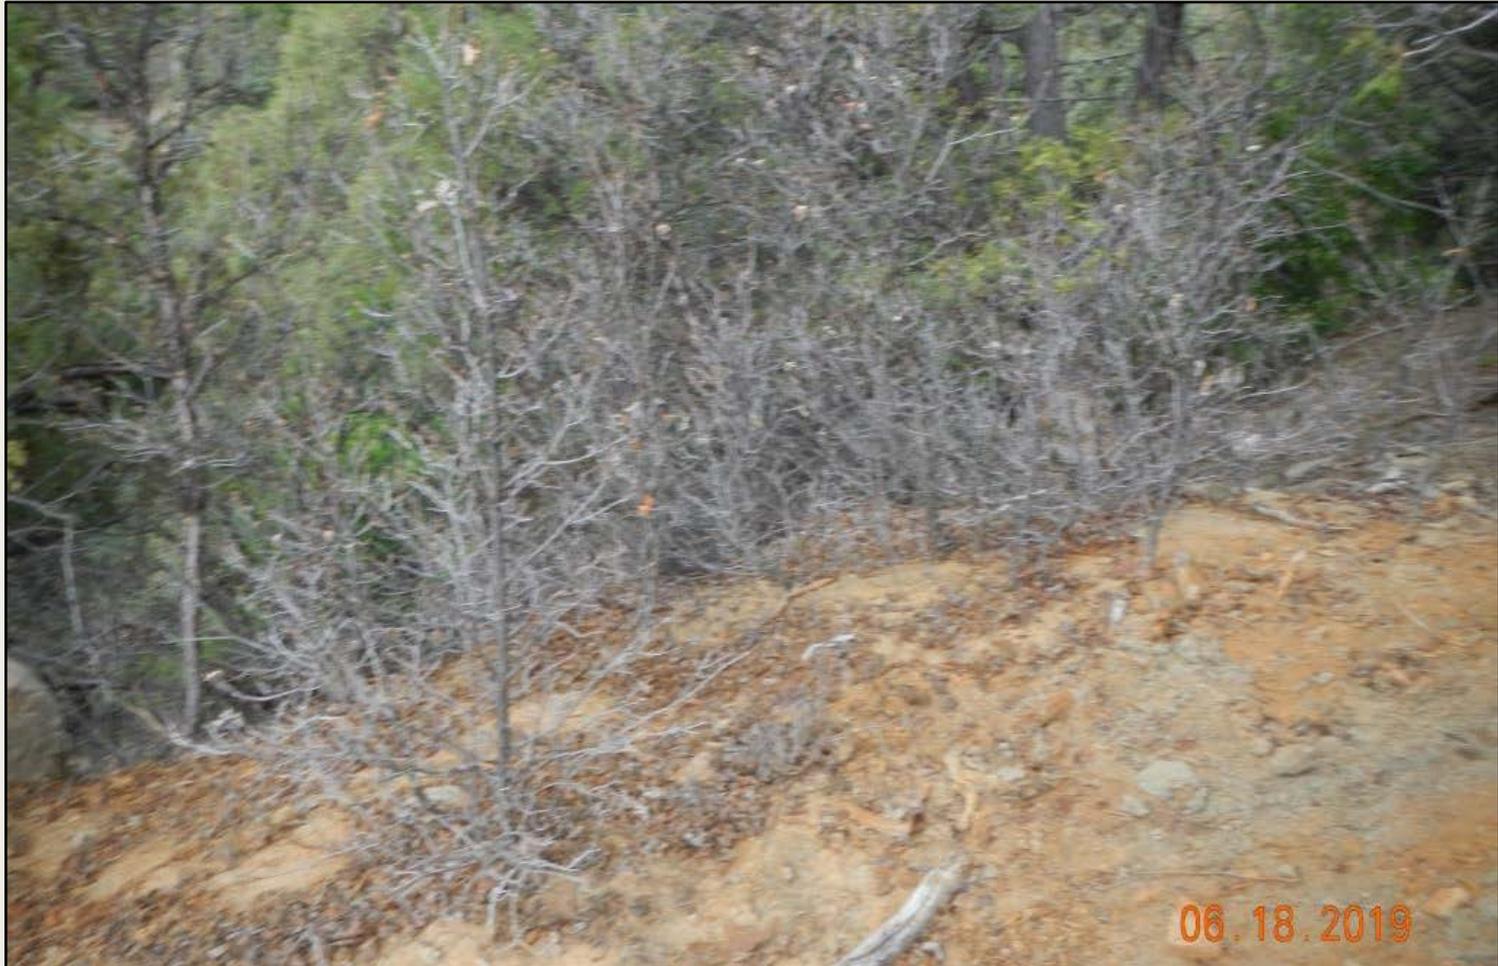
Photo 5. View of gambel oak shrubs that appear to be killed from spill. Soil is discolored.

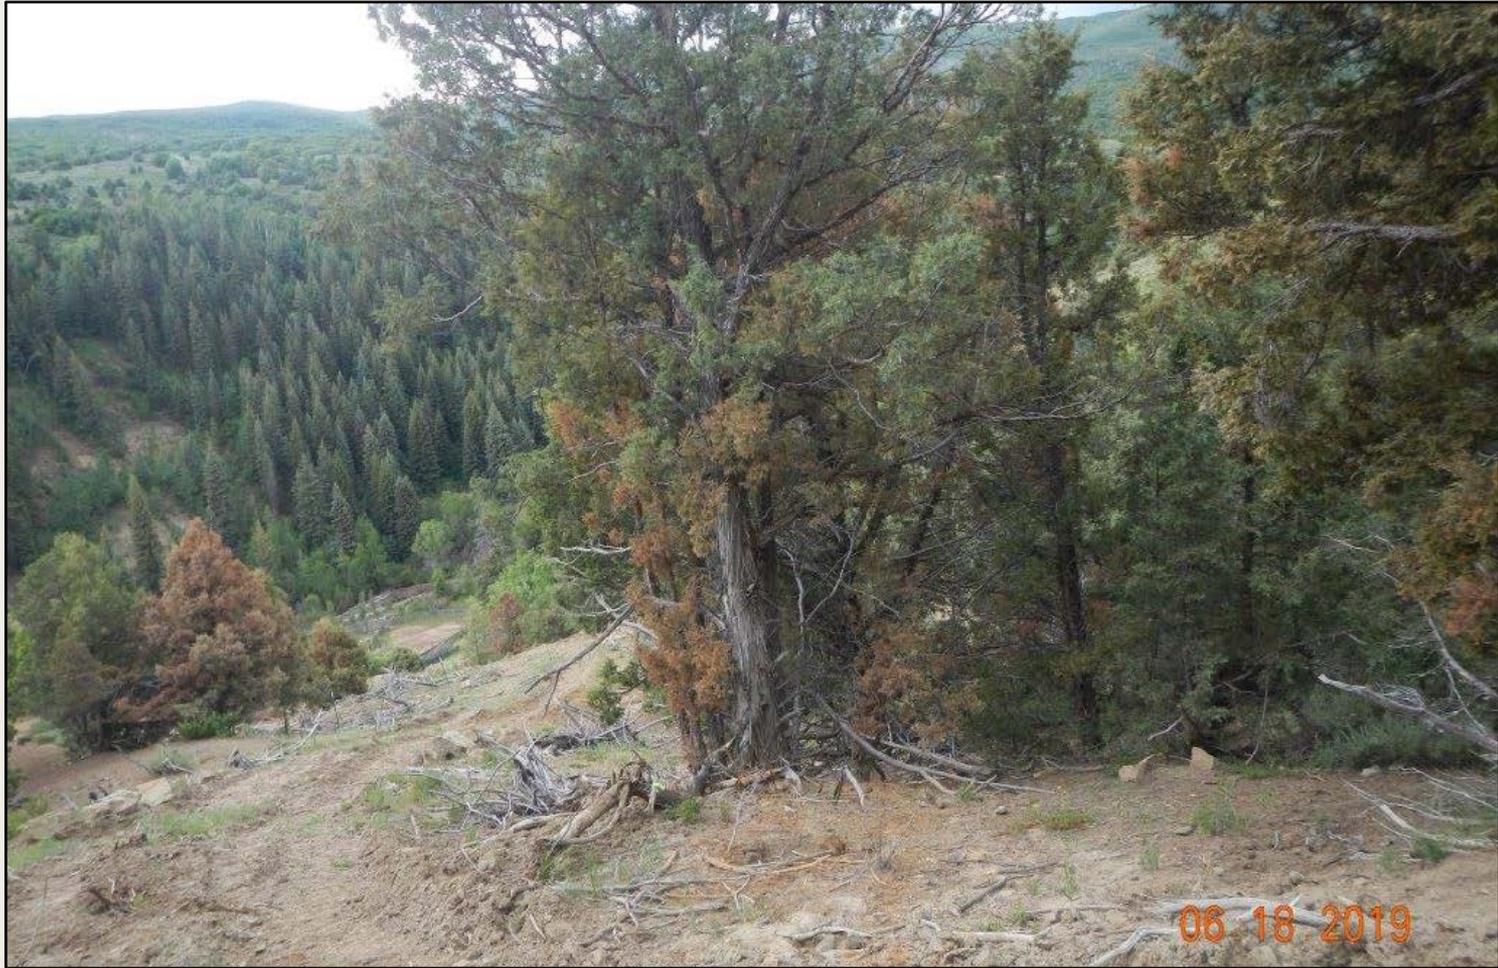
Photo 6. View of more trees that appear to be dying in the spill path.

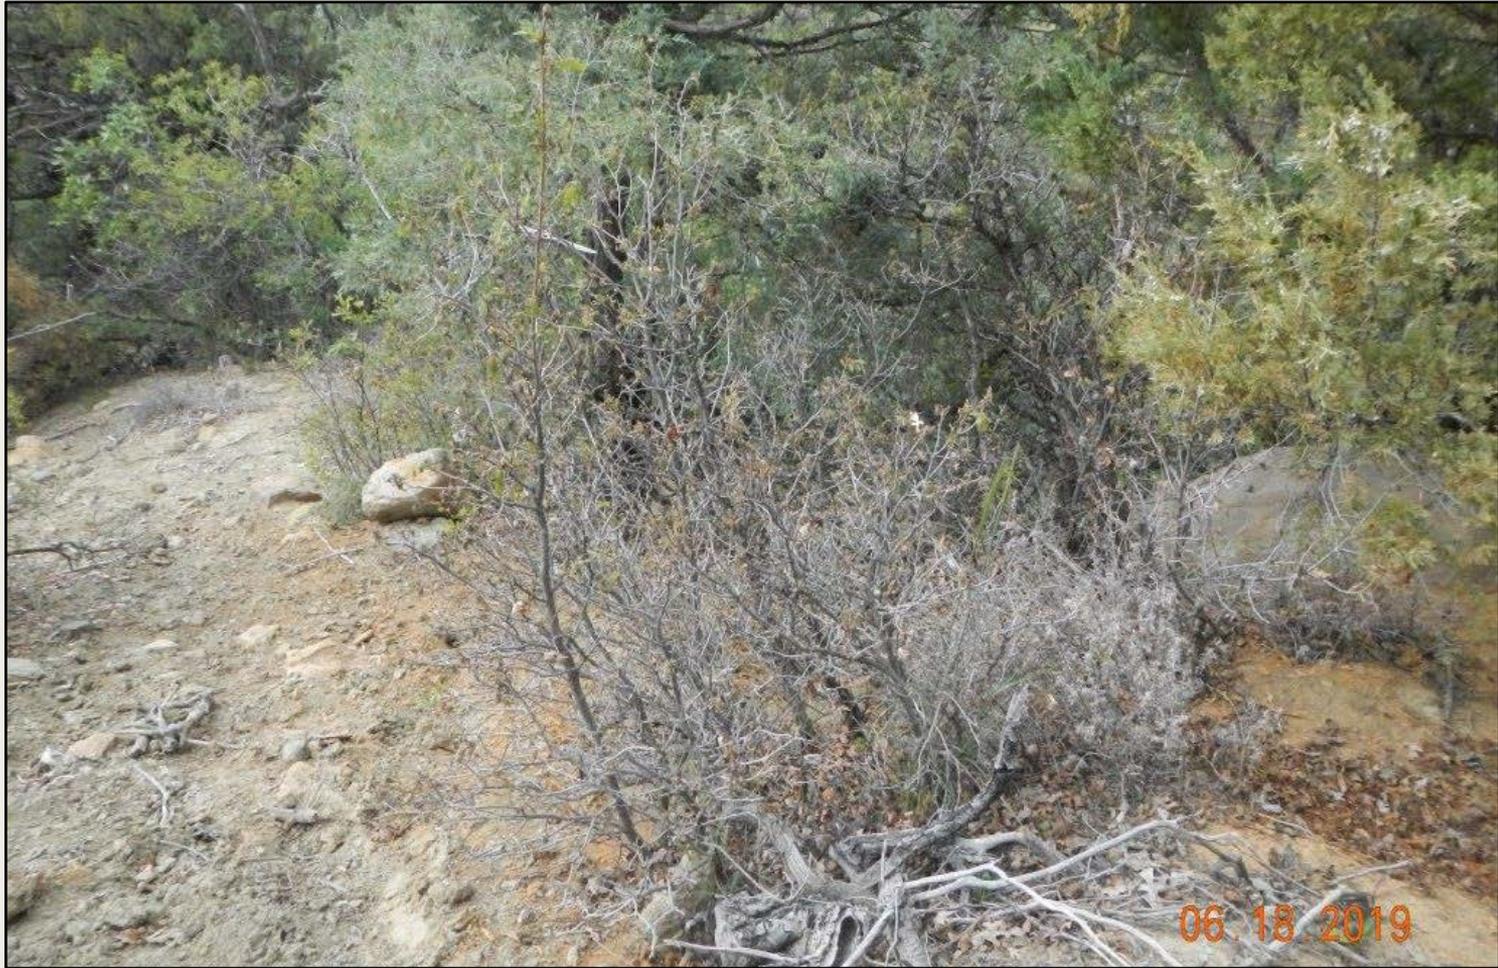
Photo 7. View of more oak shrubs that appear to be dying in the spill path.

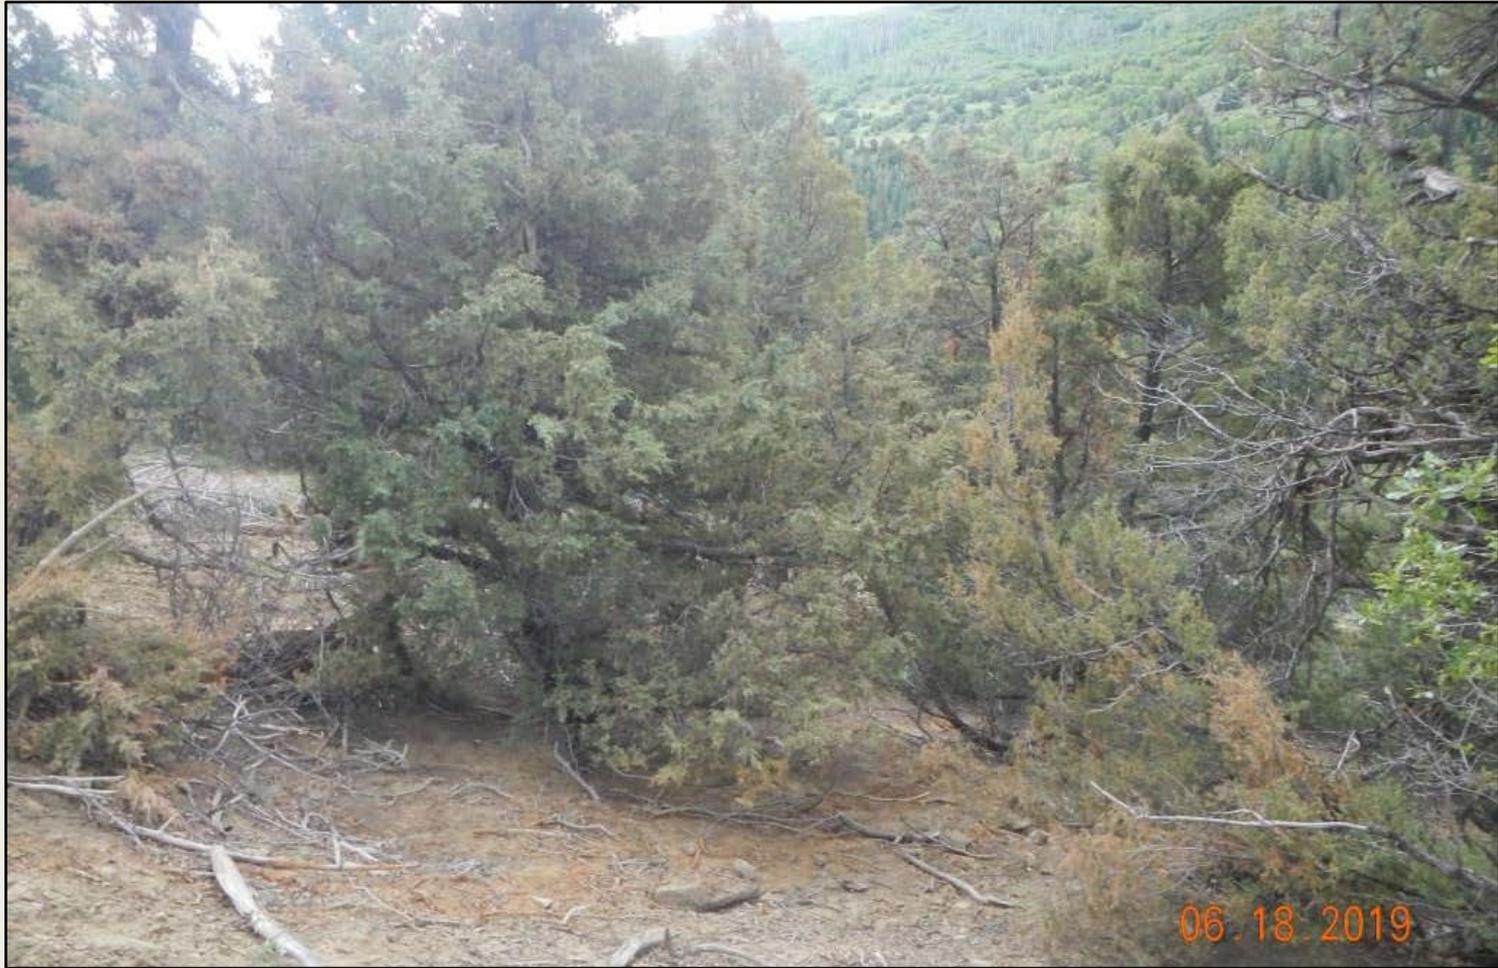
Photo 8. View of more trees that appear to be dying in the spill path.

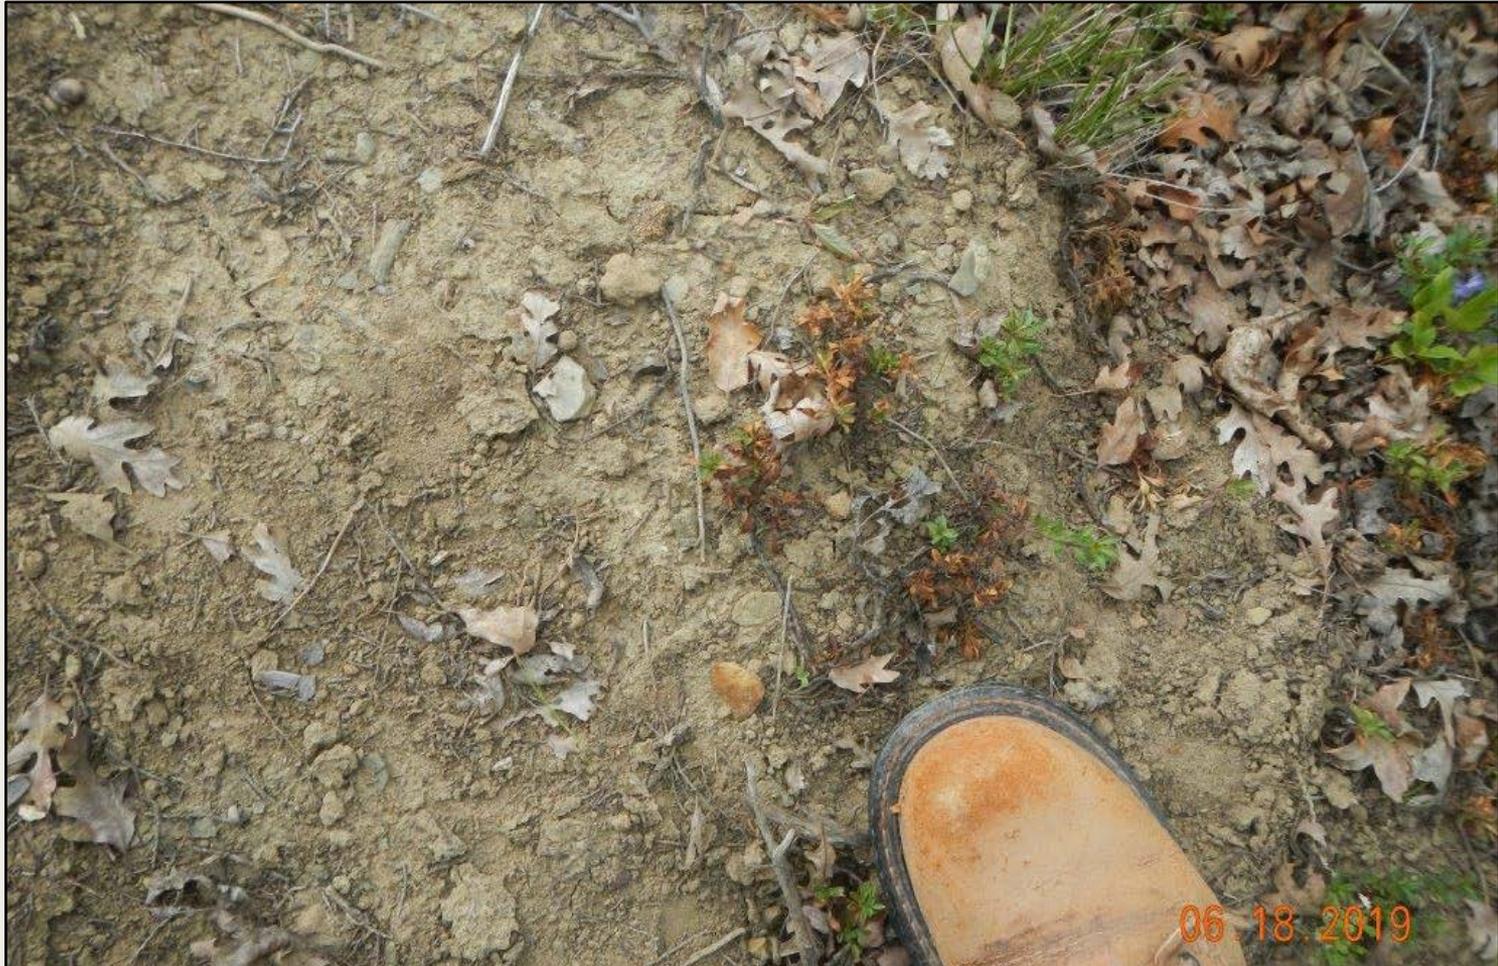
Photo 9. View of penstemon sp. dying within the spill path.

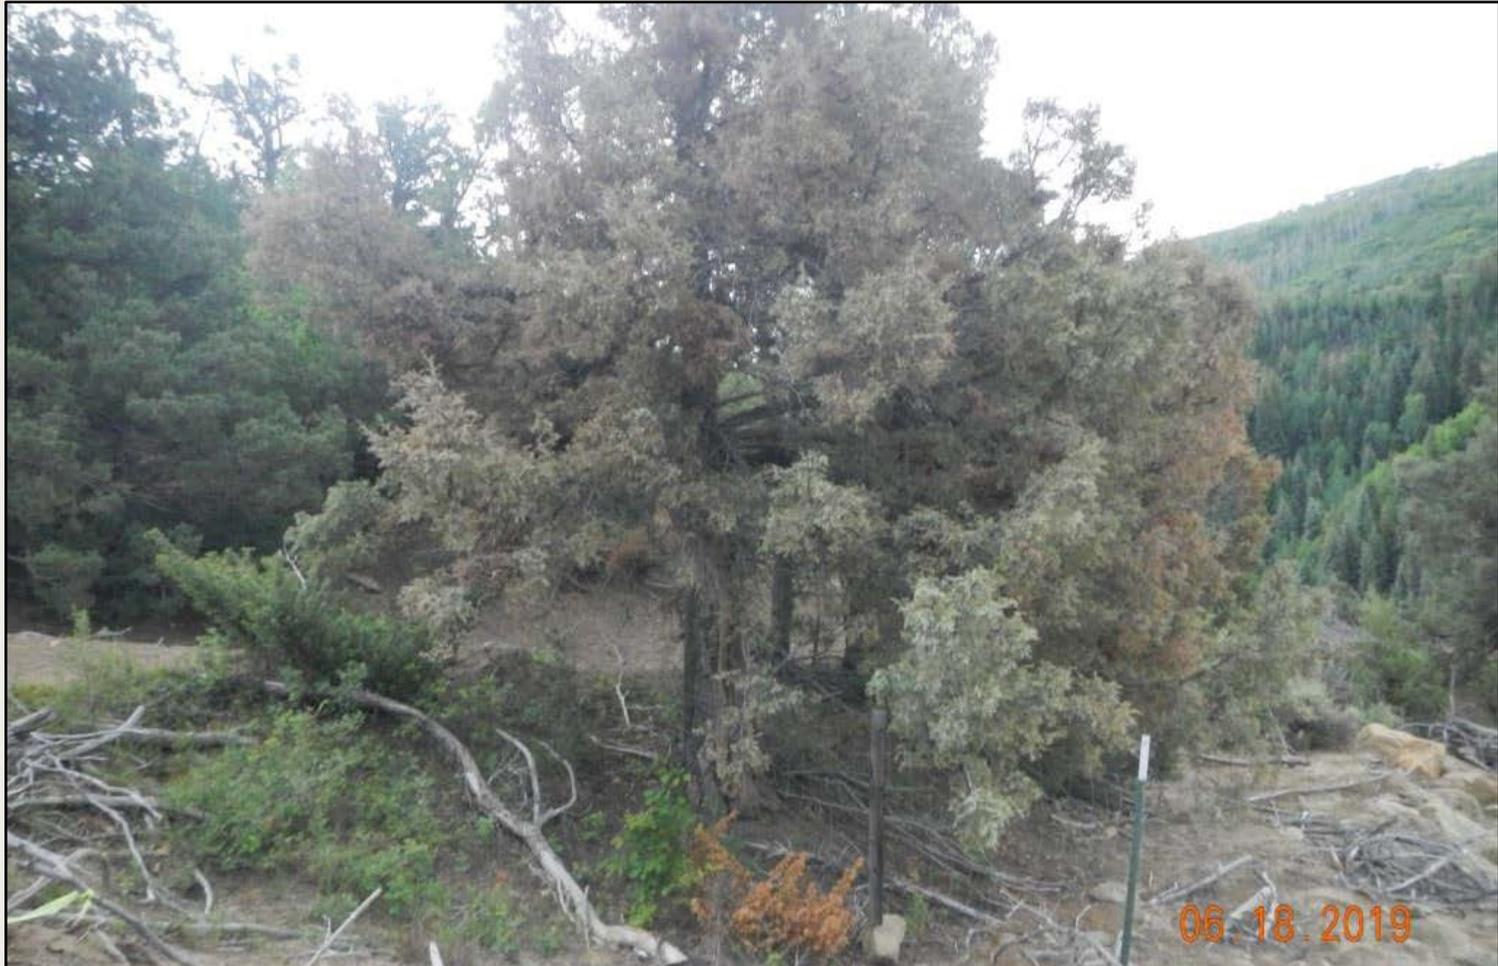
Photo 10. View of more trees that appear to be dying in the spill path.

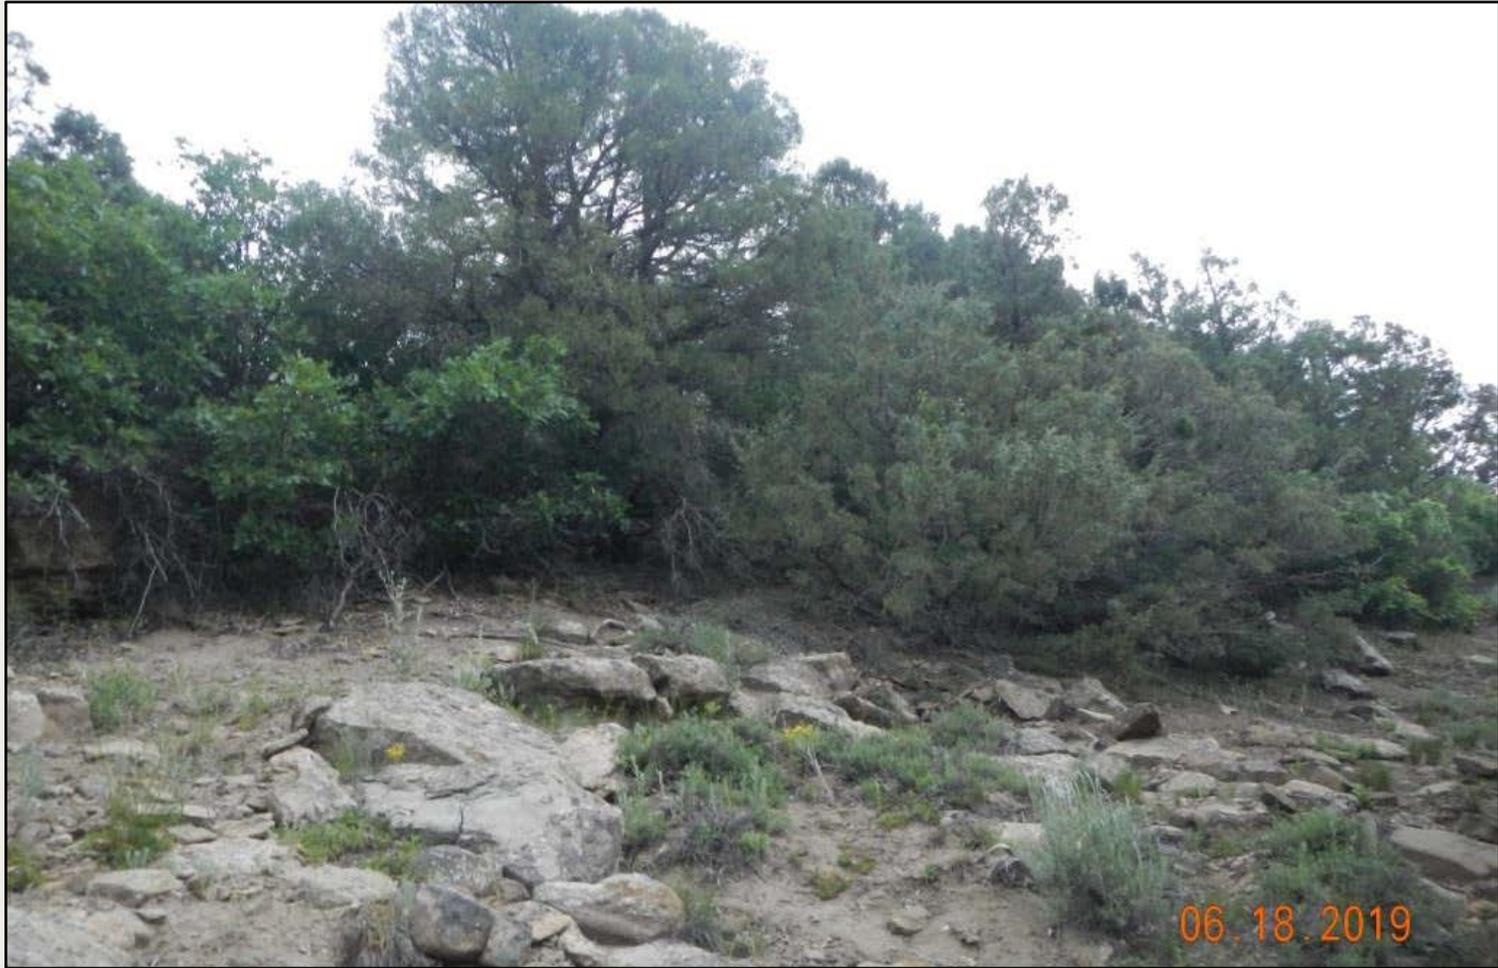
Photo 11. View of trees and vegetation outside of spill pathway that are green and appear healthy.

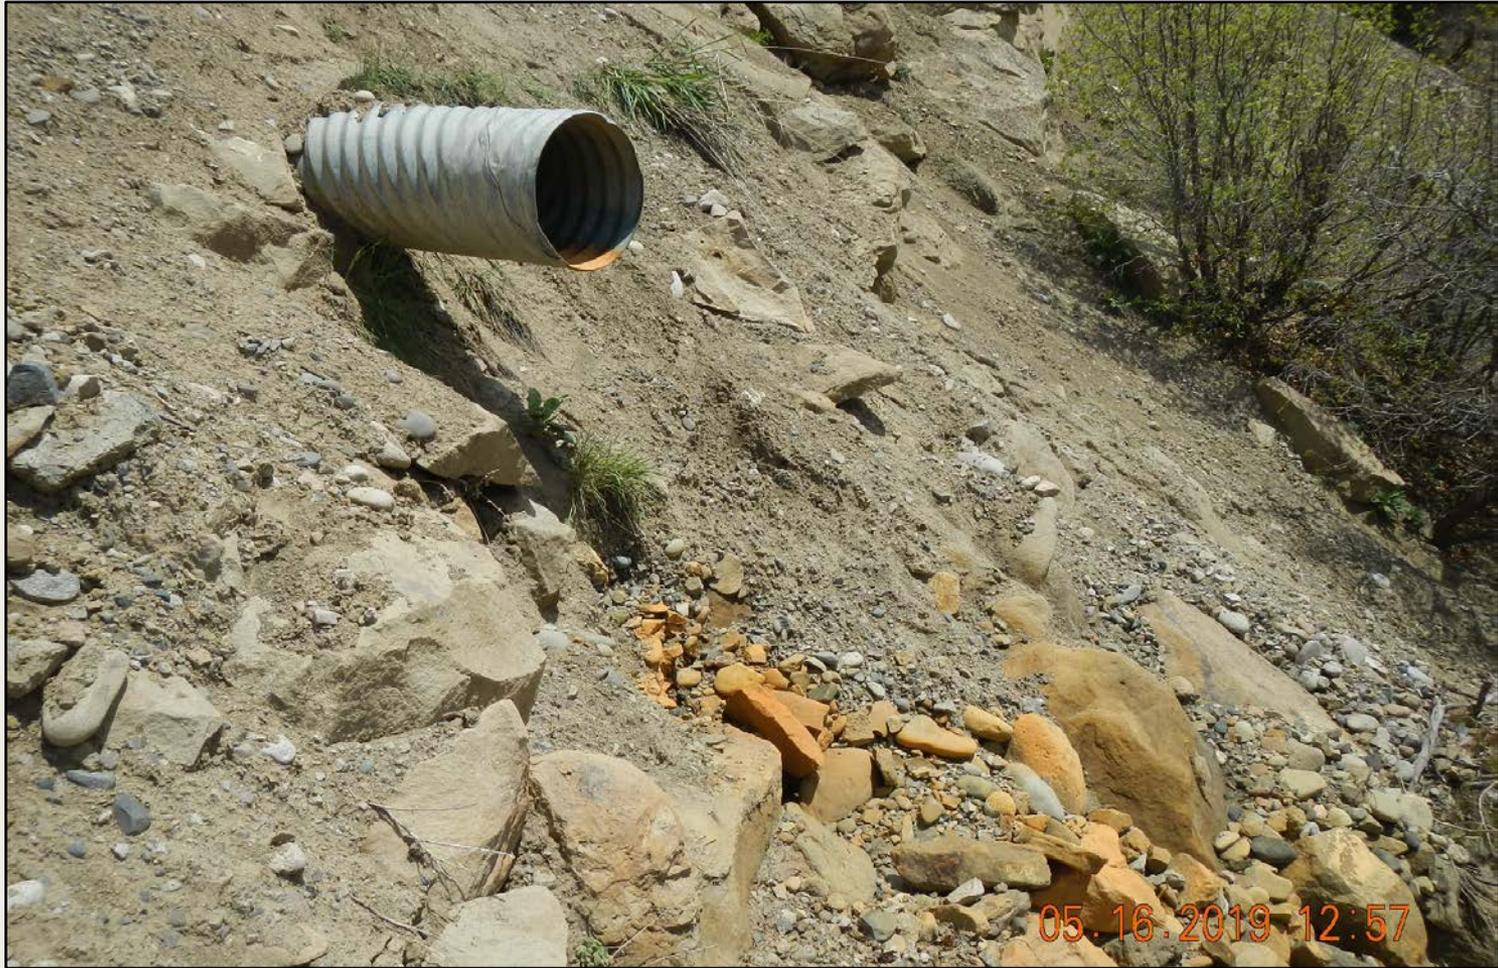
Photo 12. View of culvert outlet down-slope from release that shows discolored rock and soil indicating impacted material is flowing off and down from the release area.

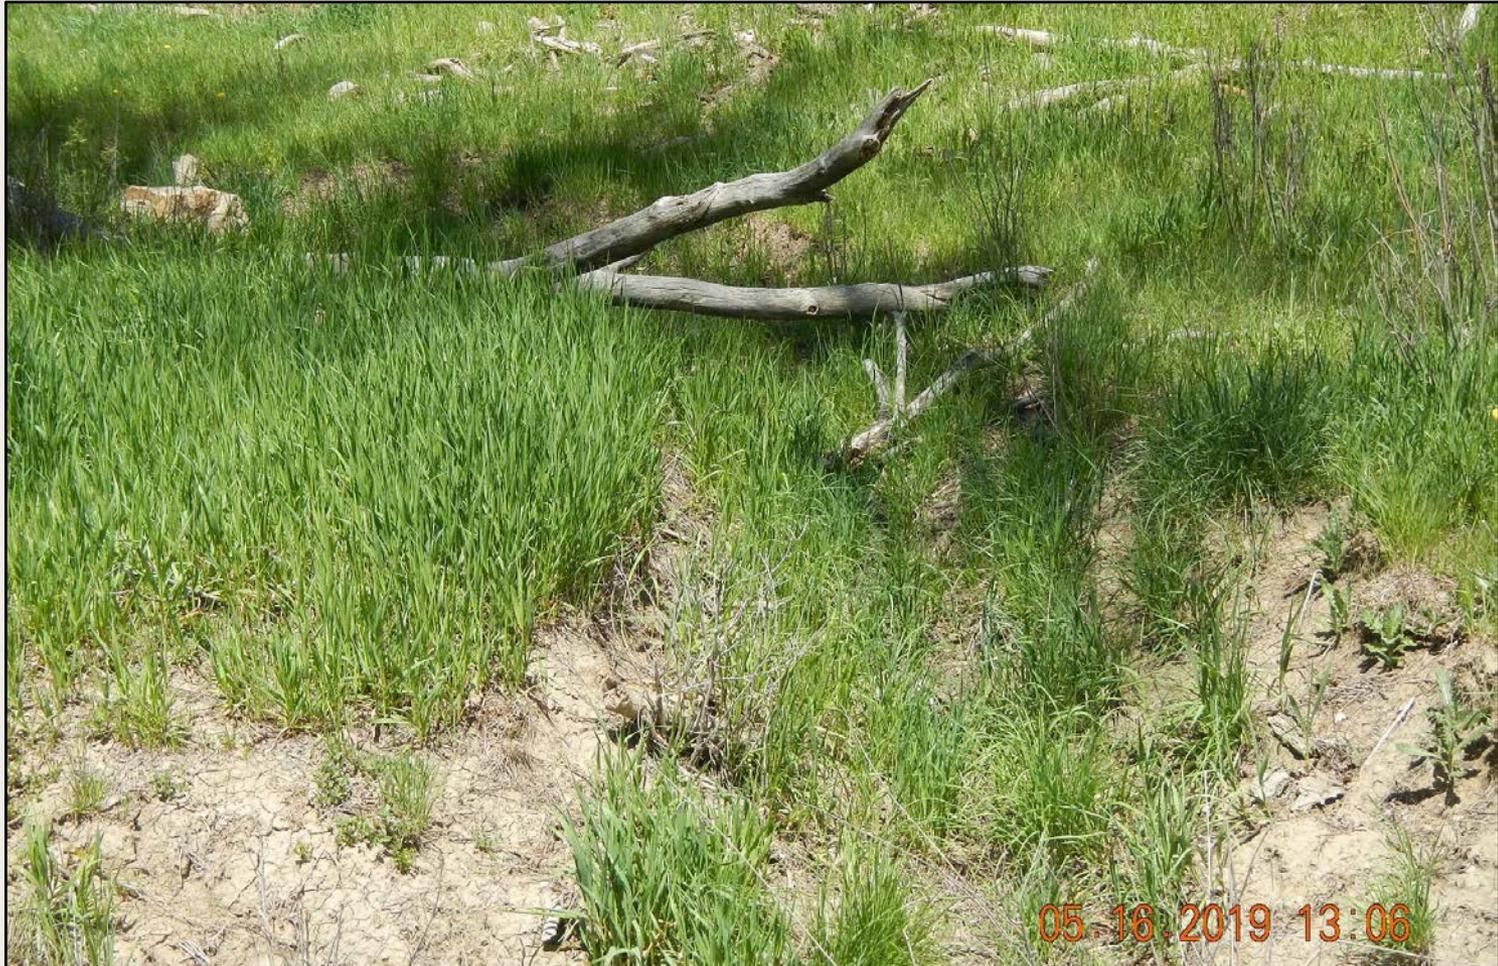
Photo 13. View of area downstream from Photo 12 where water flows through a culvert into Muddy Creek. At the time the photo was taken it does not appear that impacted materials have entered the creek. Stormwater controls are immediately needed to prevent sediment or impacted material from reaching the Creek.
