Inspection Photos
Operator: SG Interests
Location/API #: 051-06106
Date: 6-19-2019

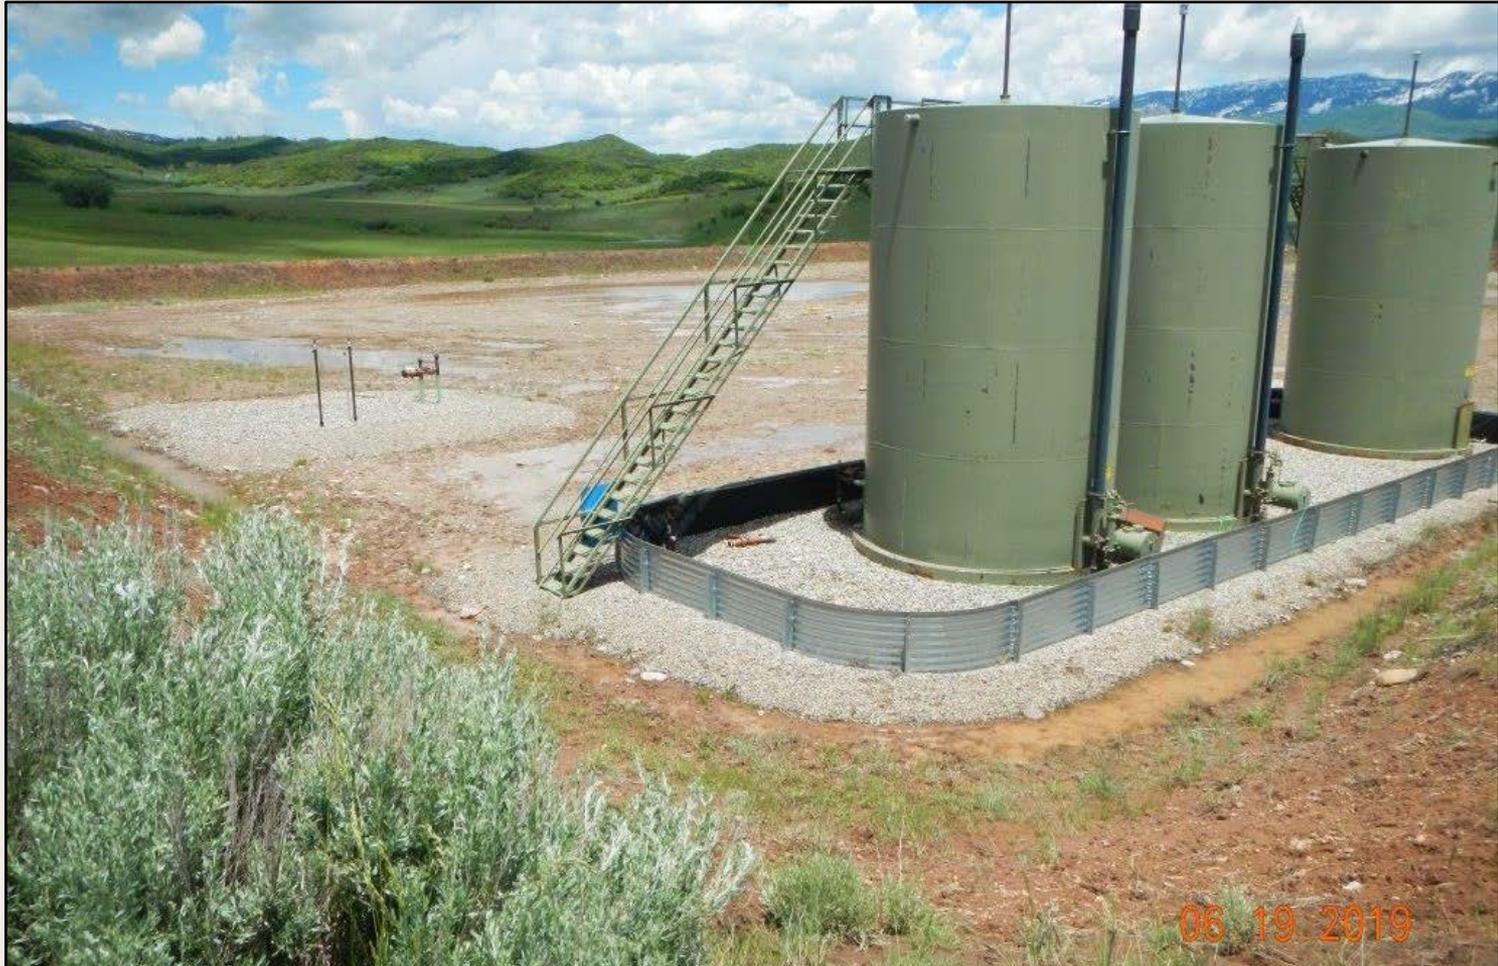
Photo 1. View of the project area from the southern corner facing center.

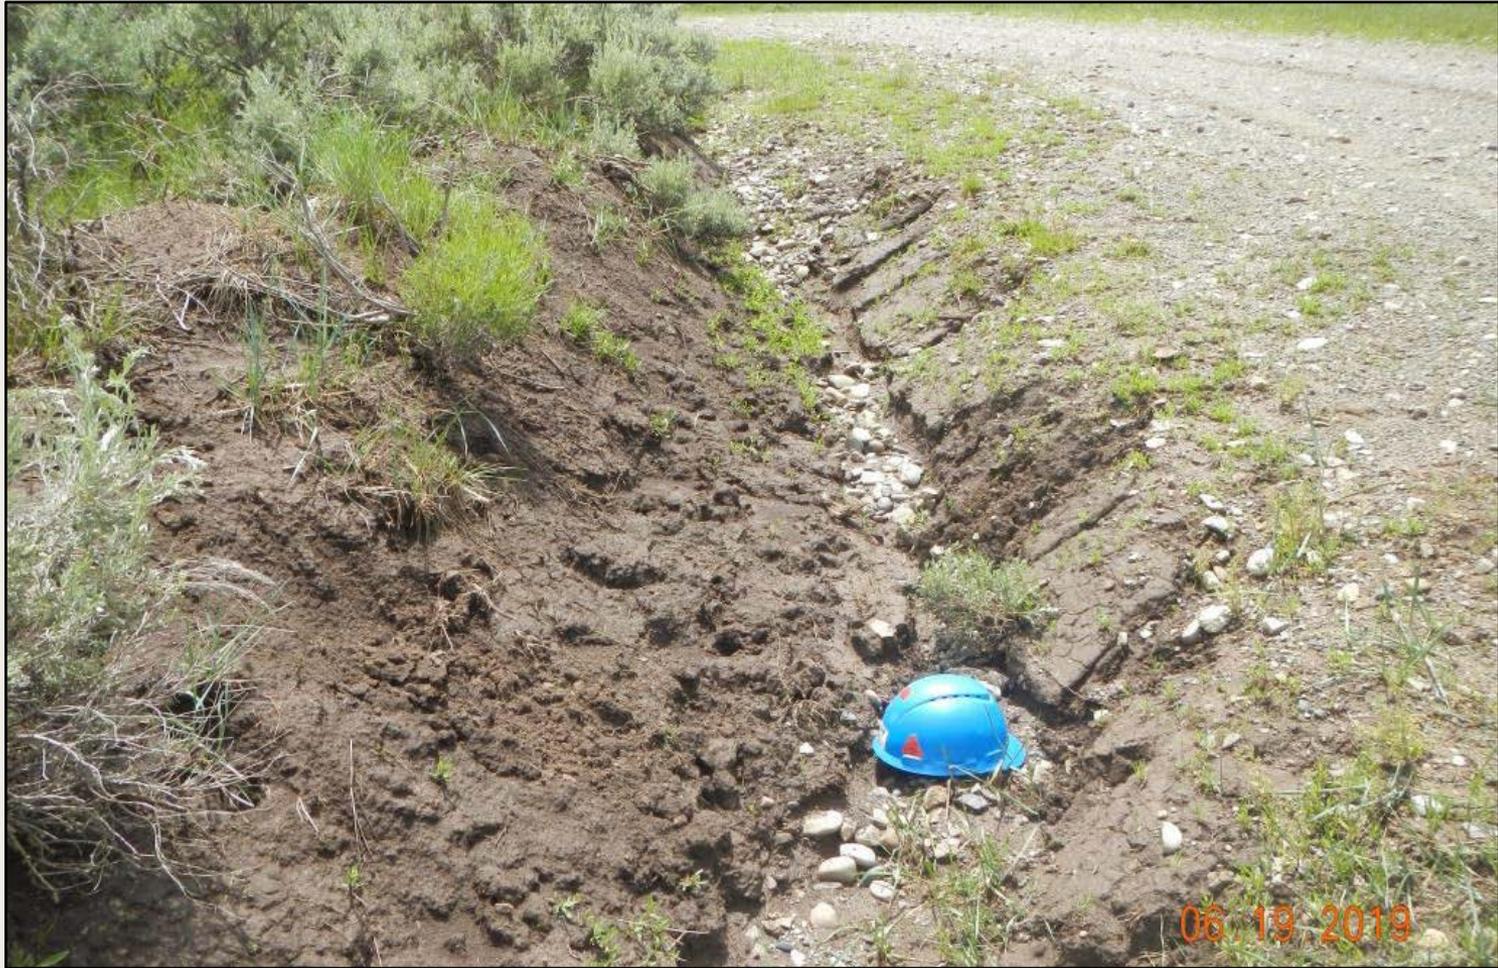
Photo 2. View of erosional channeling and rilling along the access road near the well pad entrance. Ditch banks are not stabilized.

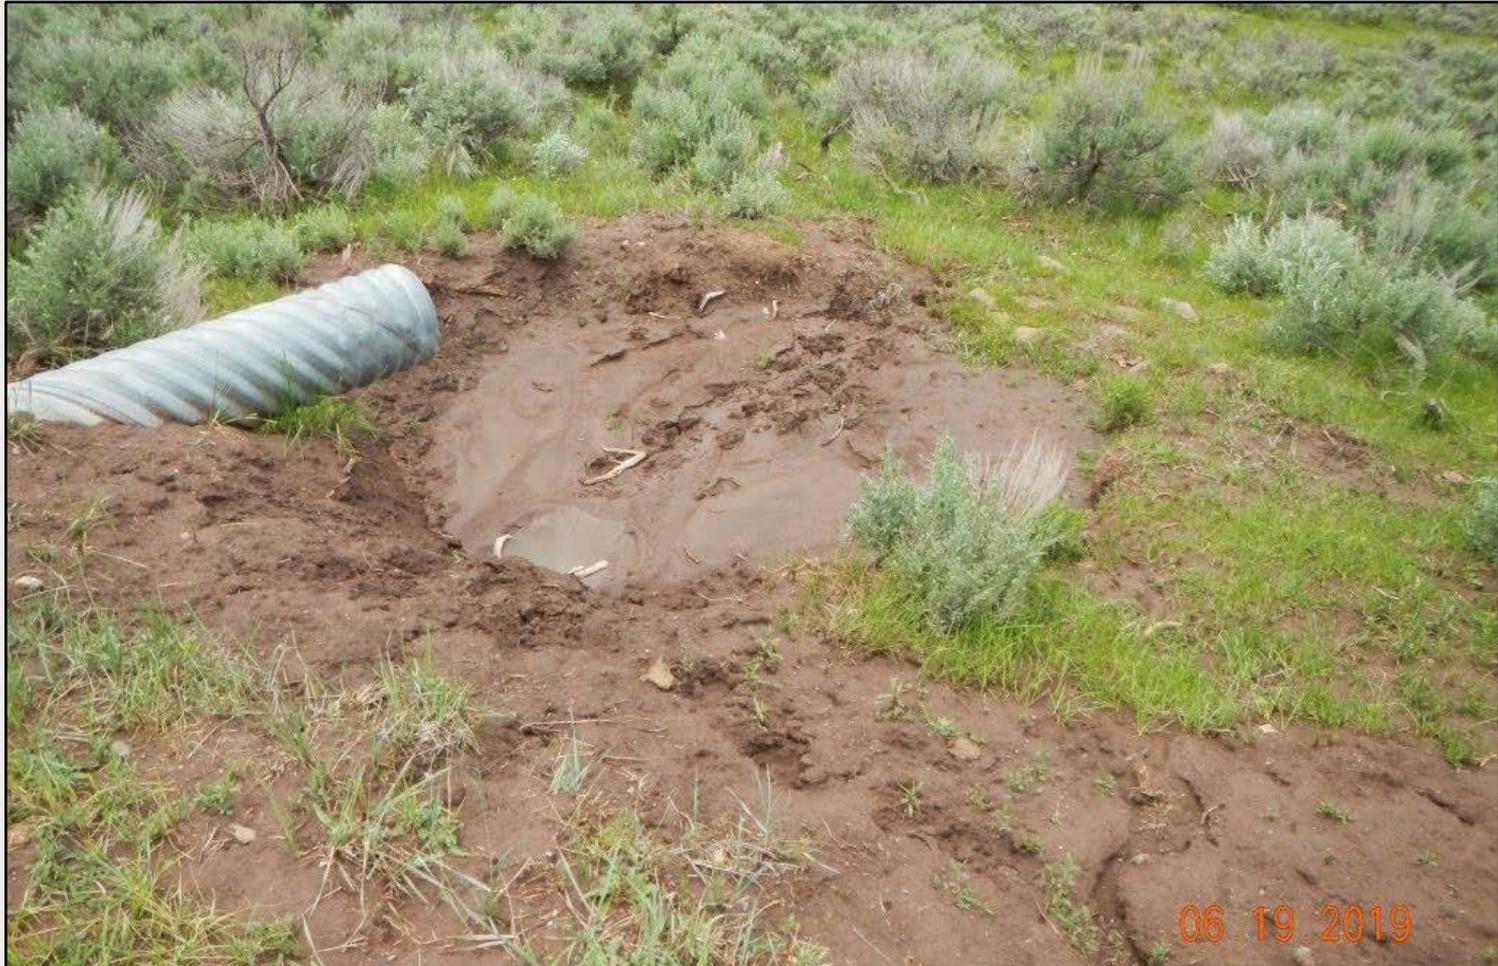
Photo 3. View of silt trap at culvert outlet along access road. Silt trap is full of sediment, overflow outlet not observable, rilling from roadside evident. Culvert installed above grade will accelerate erosion and needs outlet protection.

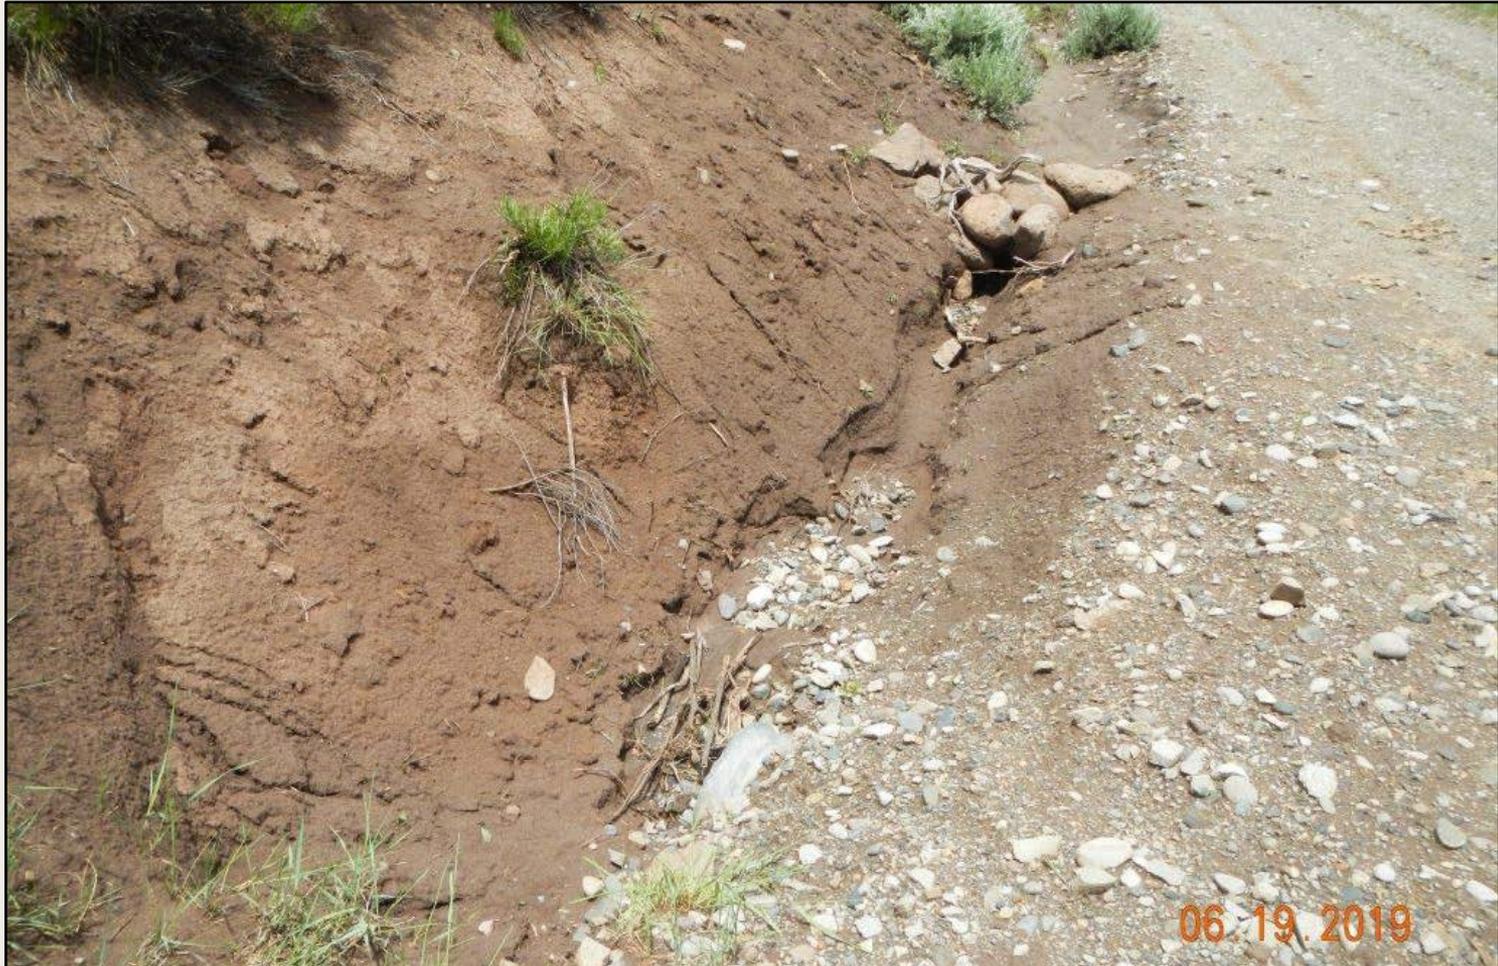
Photo 4. View of erosional channeling, rock check that is inadequate and not properly installed, along the access road. Bare soil on cut-slope are not stable.

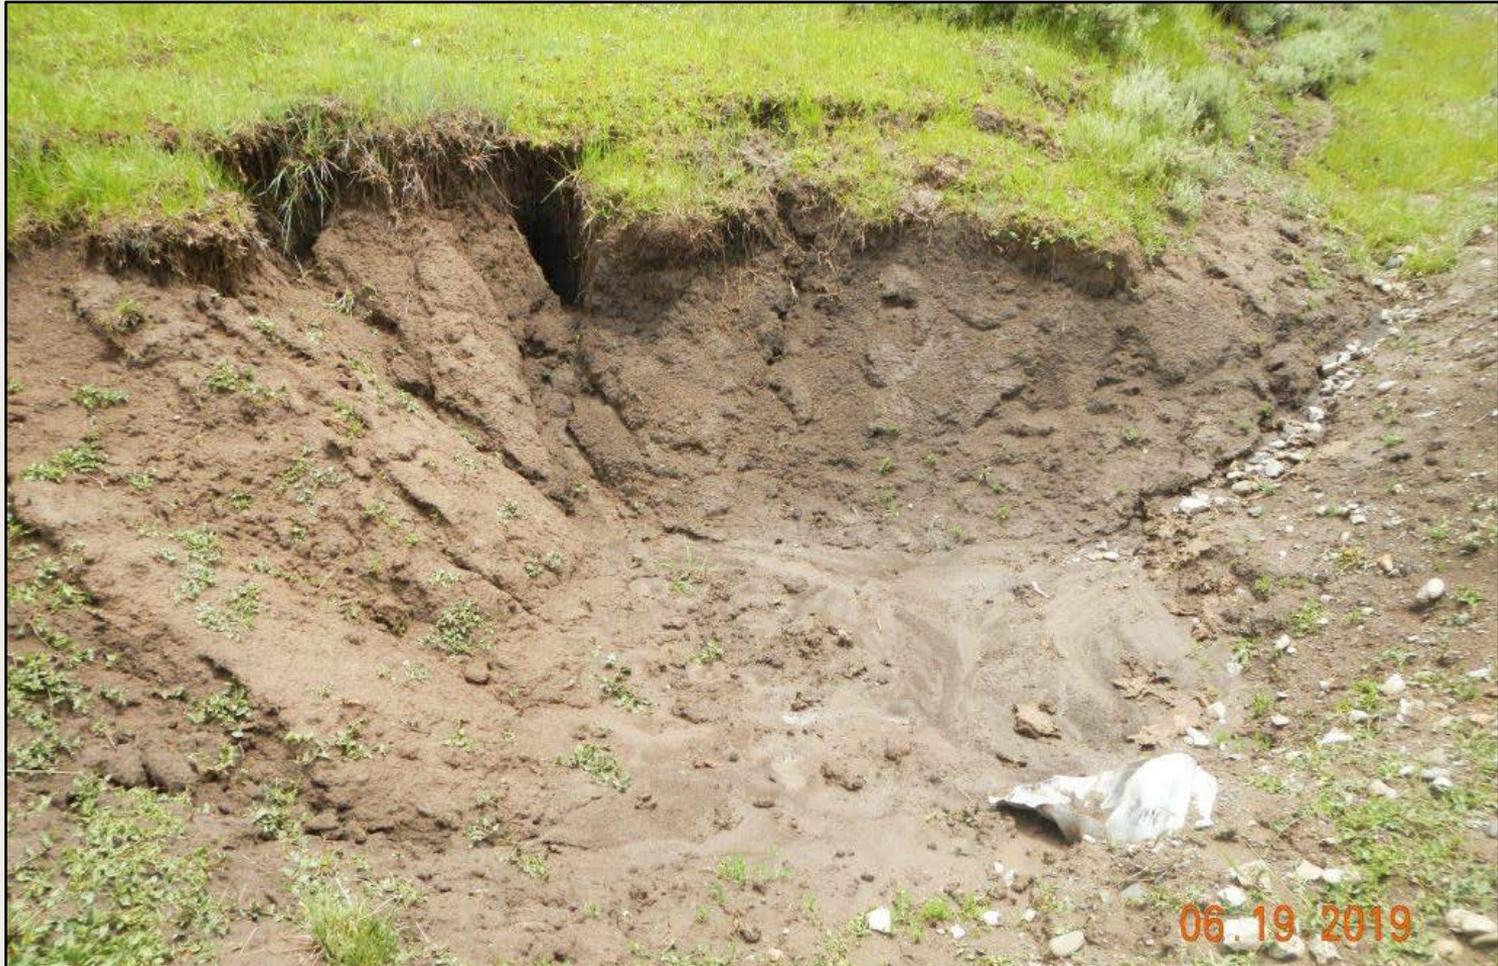
Photo 5. View of bare, eroding soils at culvert inlet, erosional channeling and sedimentation at silt trap at culvert inlet along the access road. Culvert is full of sediment.

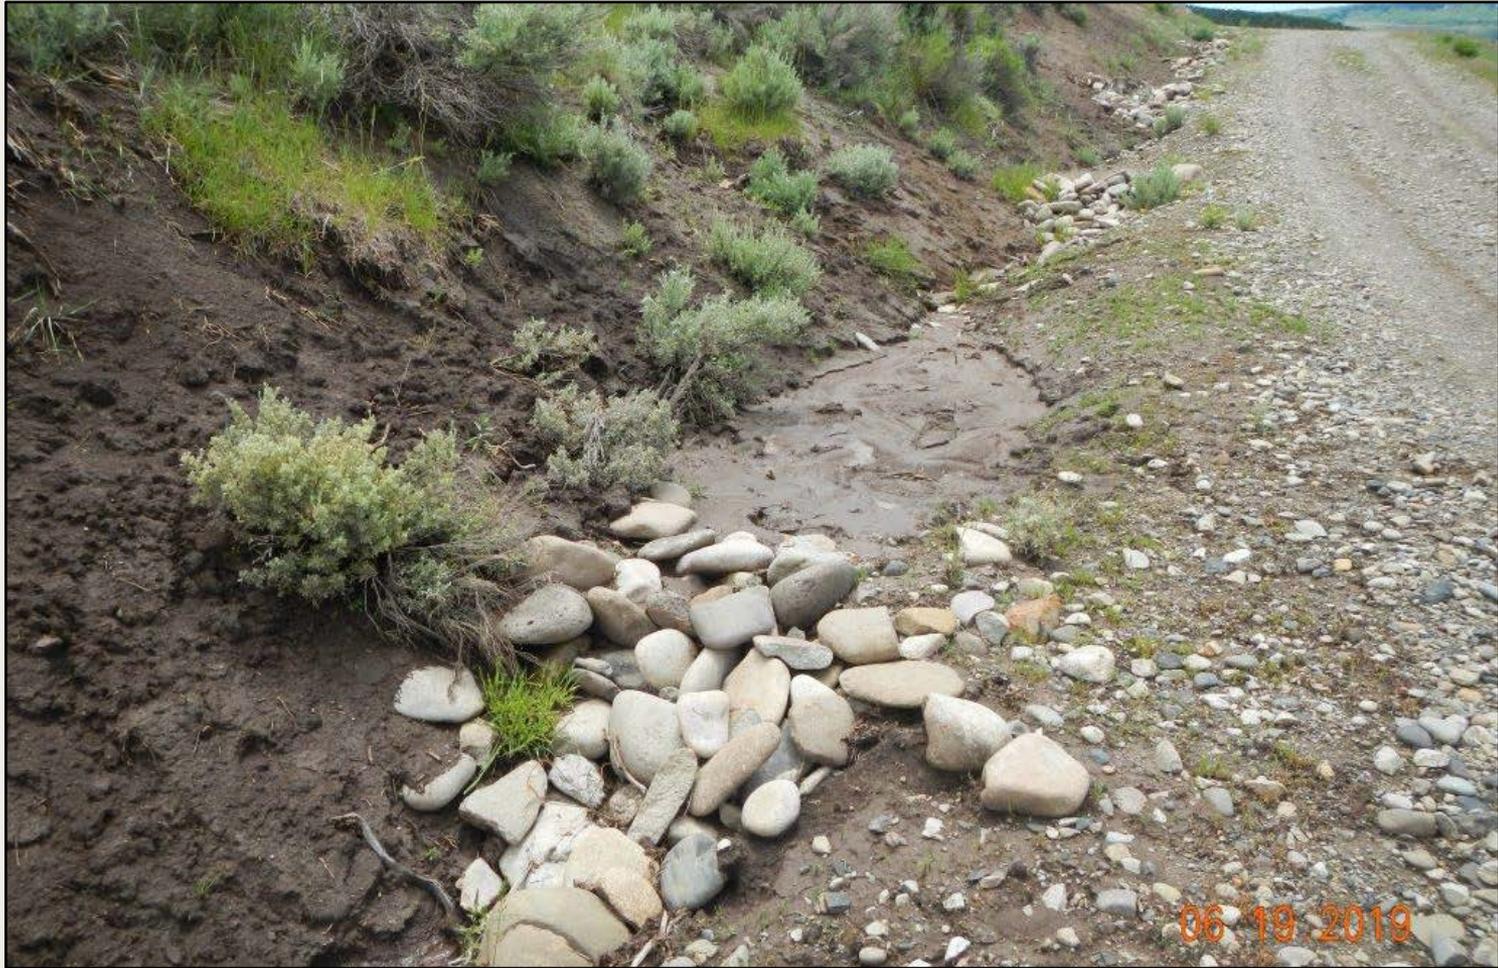
Photo 6. View of cobble check dams along the access road, not installed using good engineering practices. Sediment is accumulating above the rock and erosional channeling is occurring downstream.
