Inspection Photos

Loc#458790

Operator: Sandridge

Inspection Number: 692401155

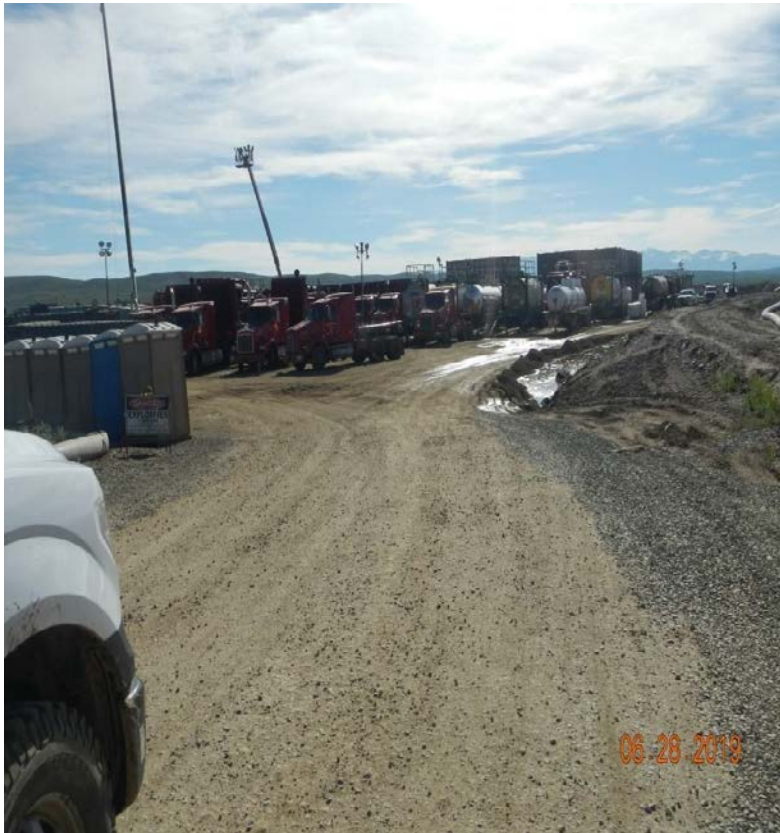
Photo#1:
View of Location from entry to East.

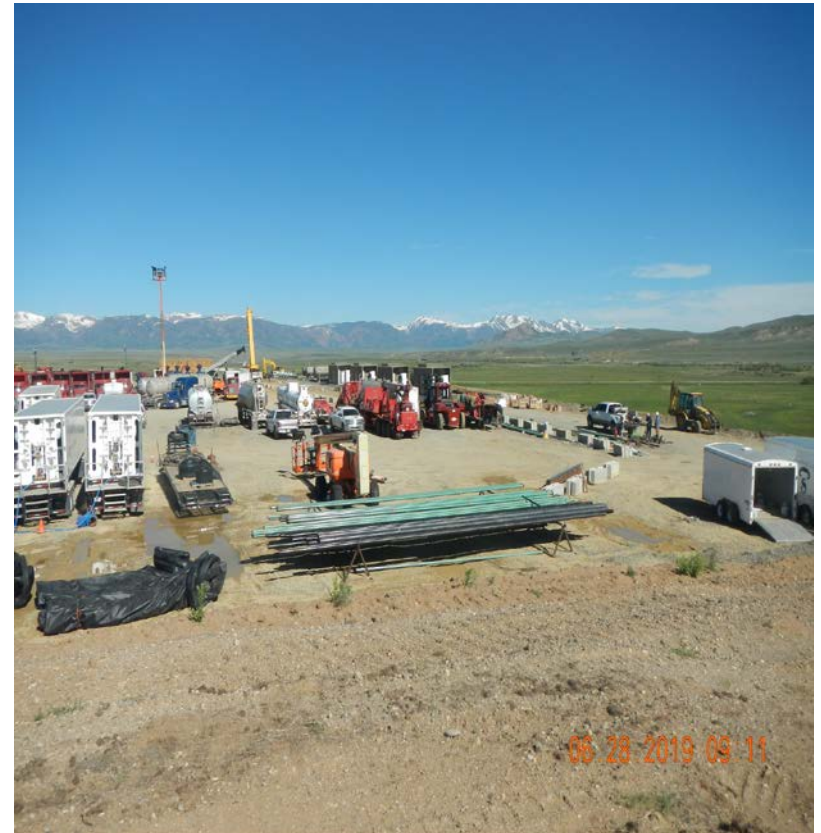
Photo#2:
Overview of Location from soil stockpile to West.

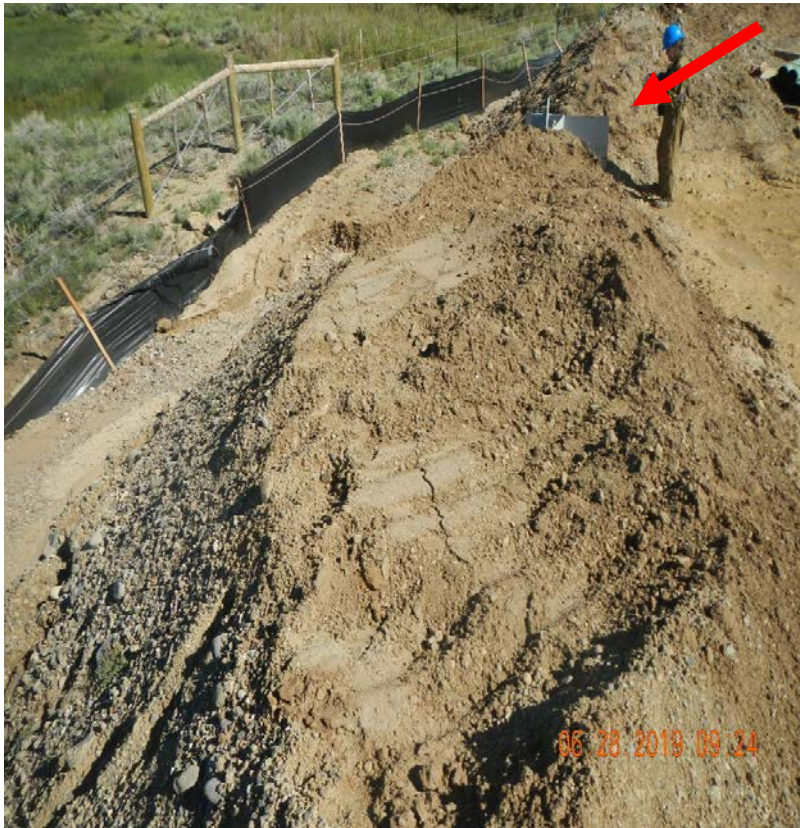
Photo#3:
Area where washout occurred at Northwest corner. Arrow indicating Weir in Photo#4

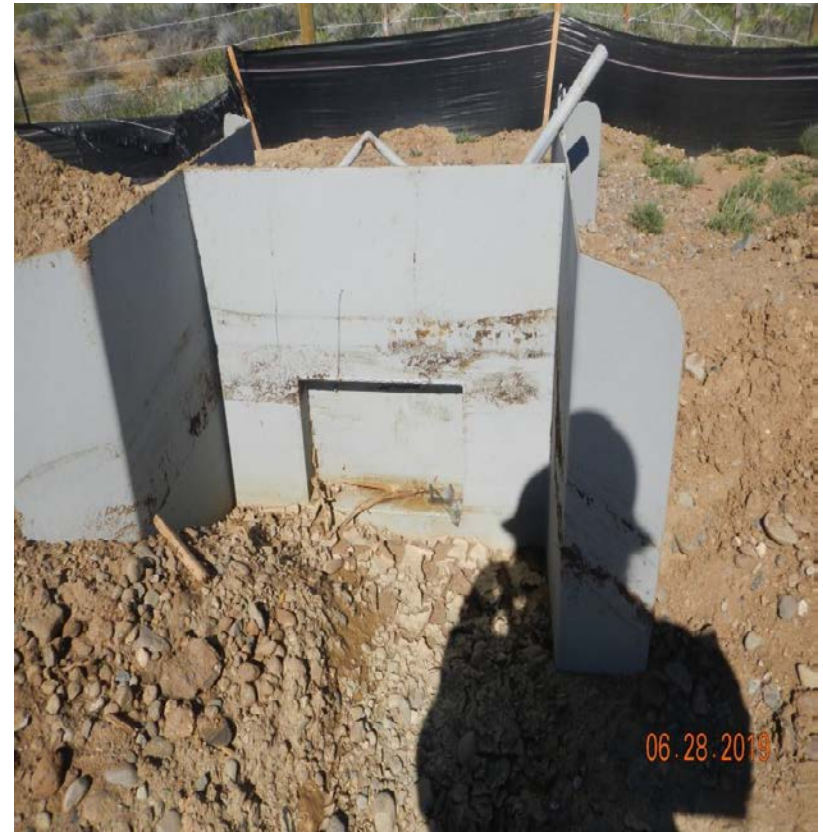
Photo#4:
Weir installation, at area where washout occurred at Northwest corner.

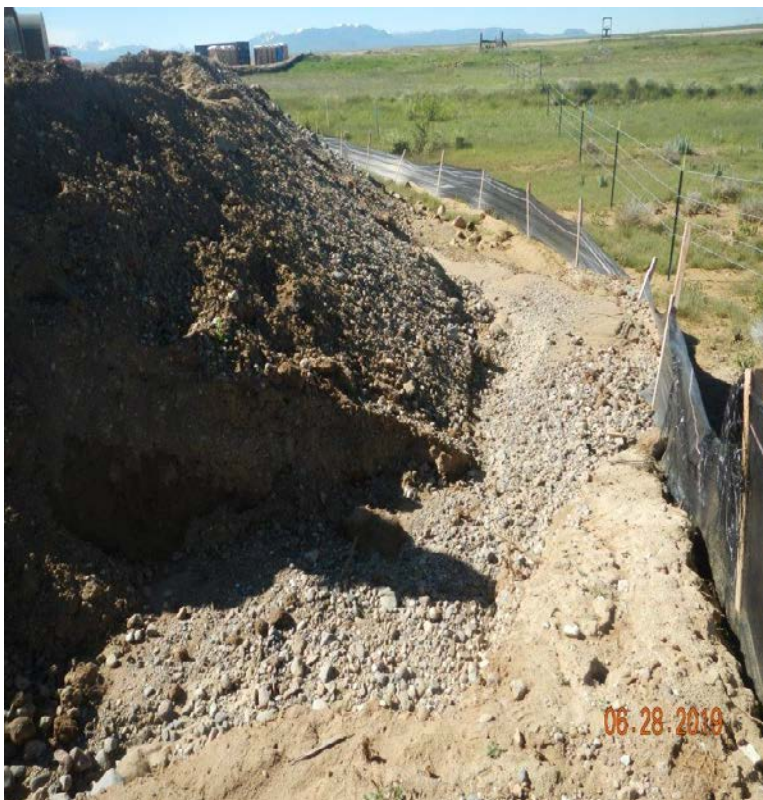
Photo#5:
View of NW washout from bottom of slope and
overwhelmed silt fence.

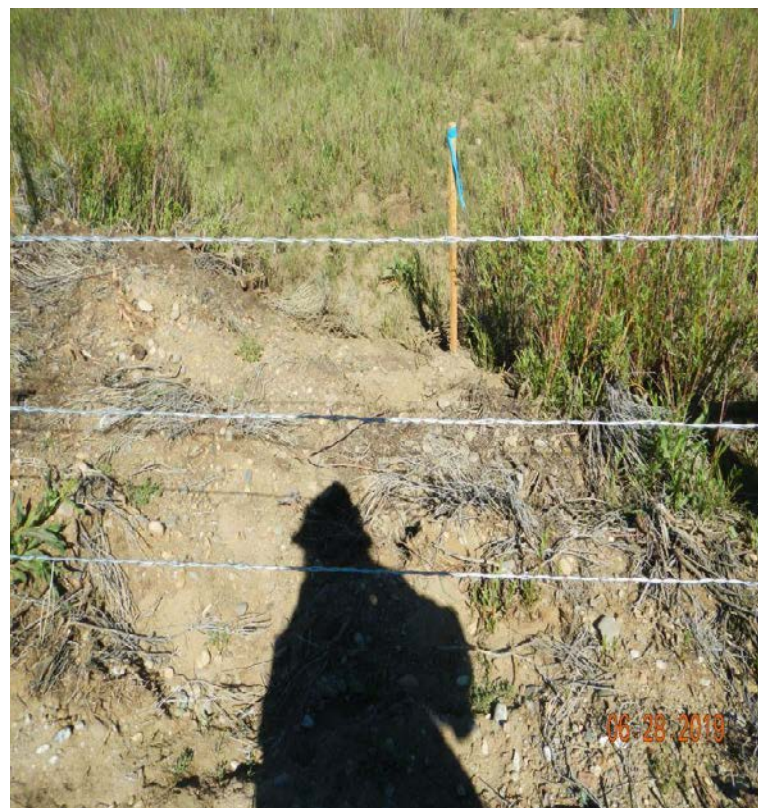
Photo#6:
Sediment migrating into wetlands; blue flagging
indicates wetlands perimeter.

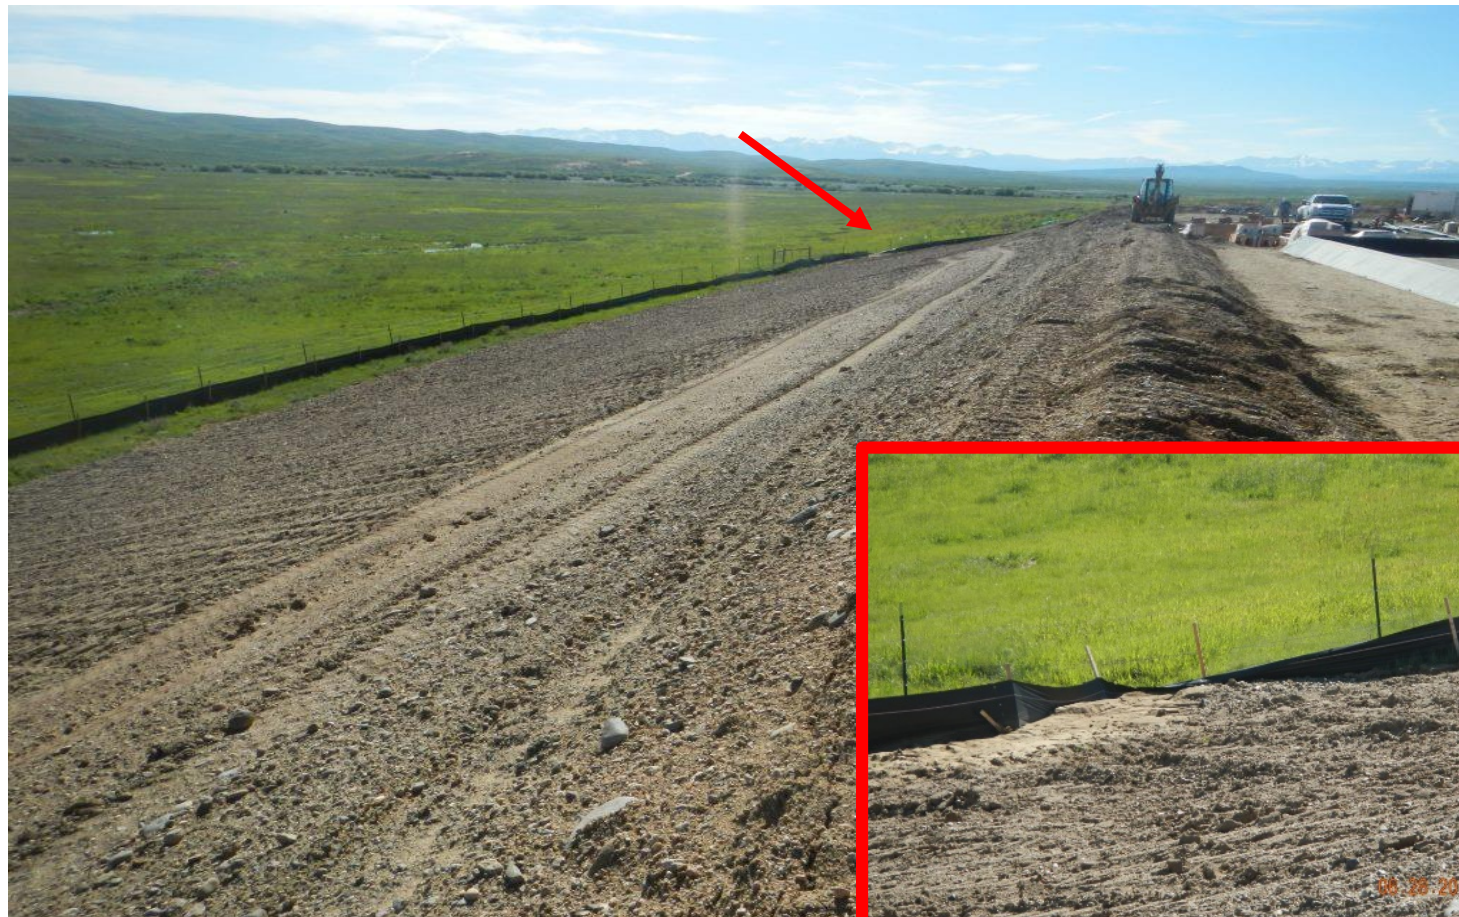
Photo#7:

View along North Fill Slope showing tracking and berm compaction. Insert is area where Silt Fence has been overwhelmed by sediment.

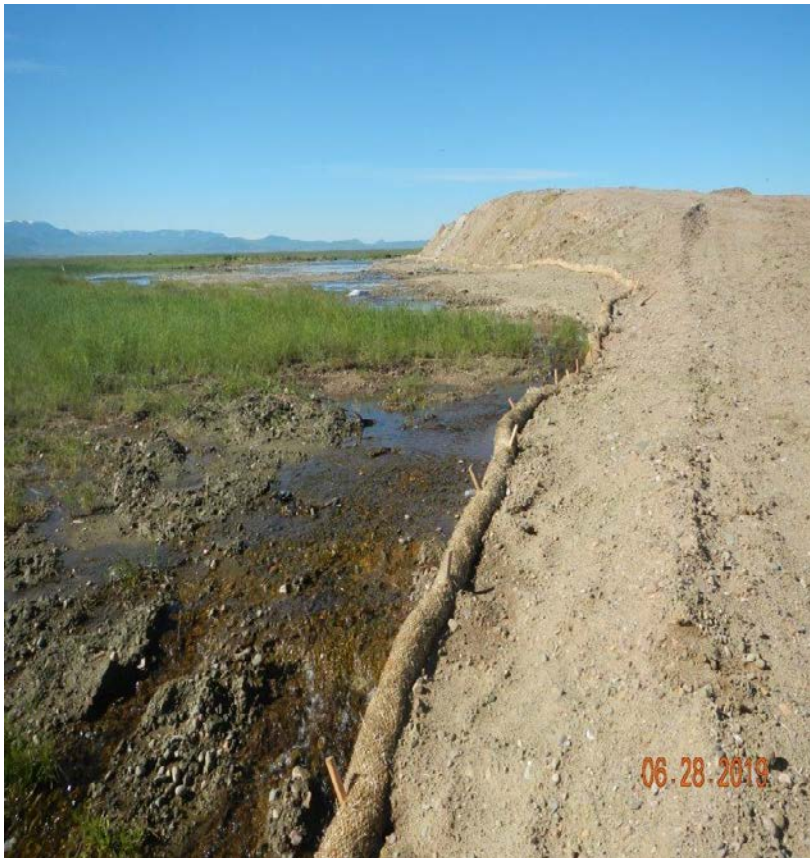
Photo#8:
View along stockpile to South.

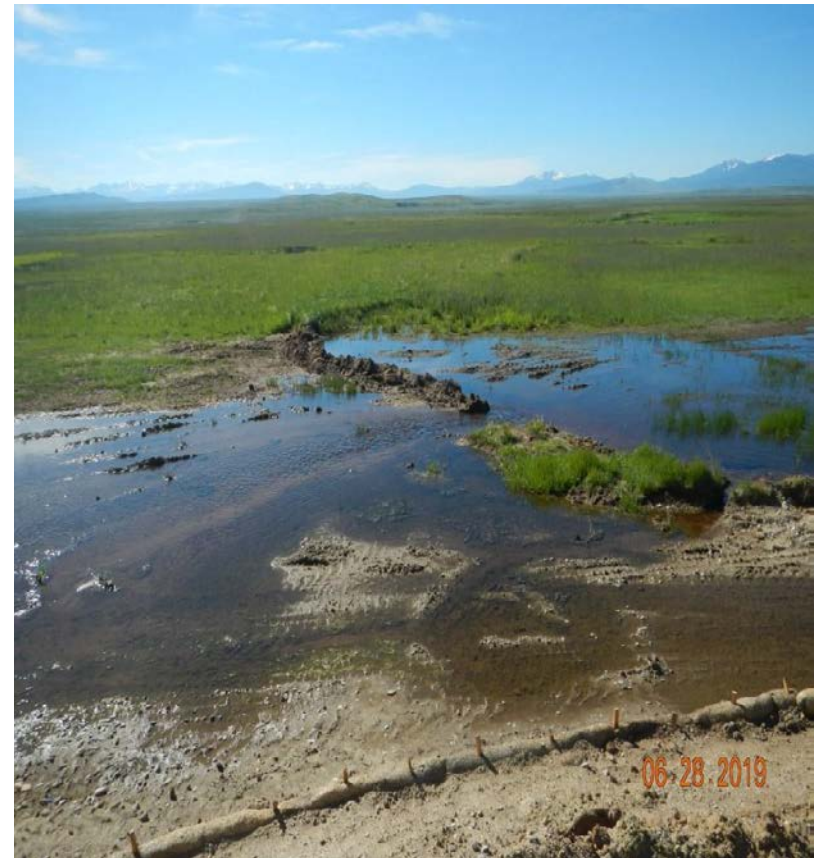
Photo#9:
View South from top of stockpile over flooded
fields; wattles at base of stockpile in fore ground.

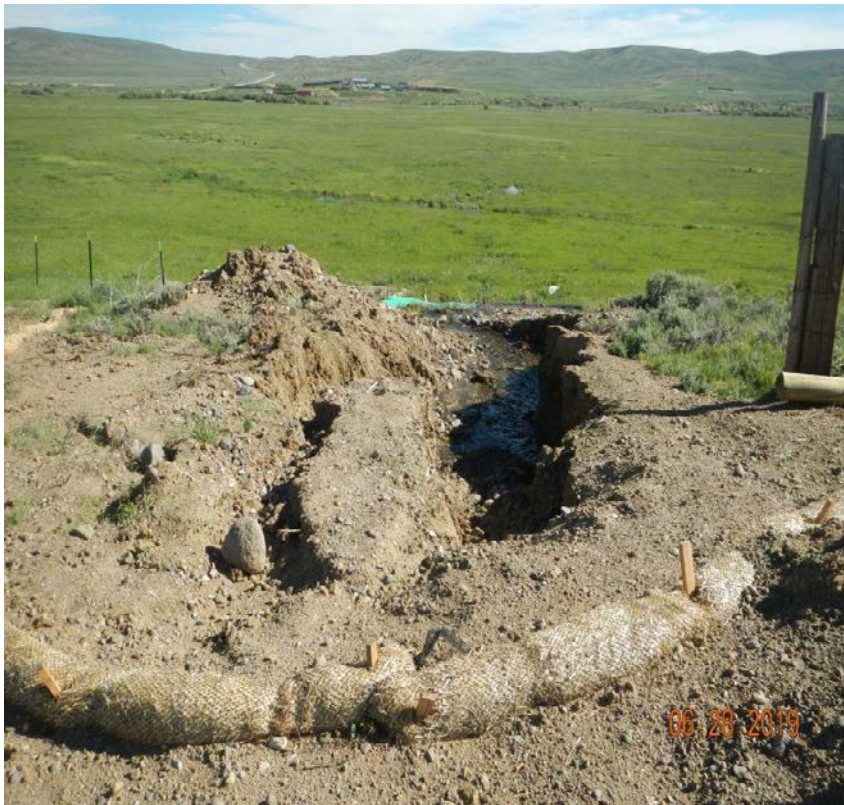
Photo#10:
View to North of washout at Northeast corner.

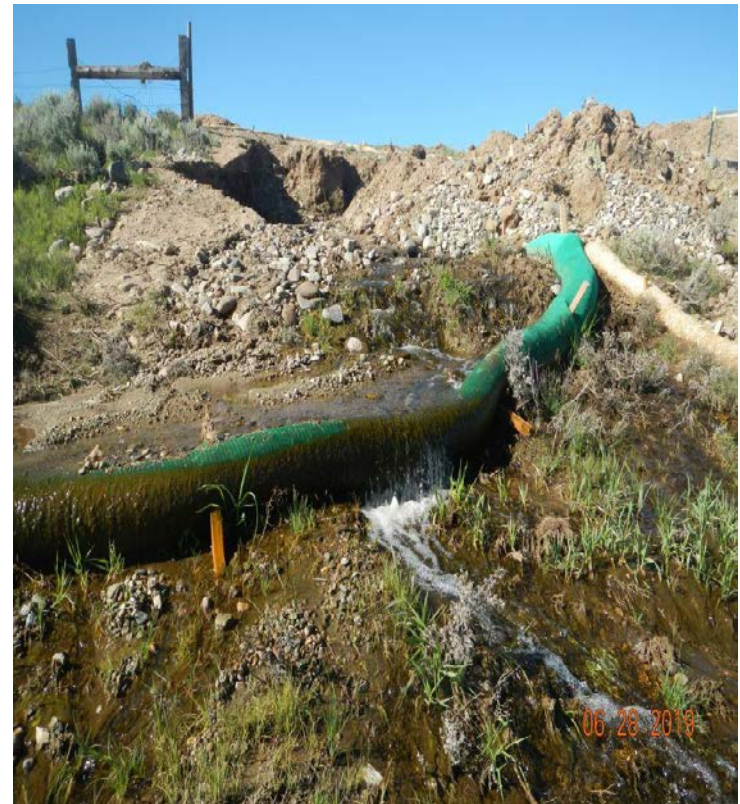
Photo#11:
View from below washout.

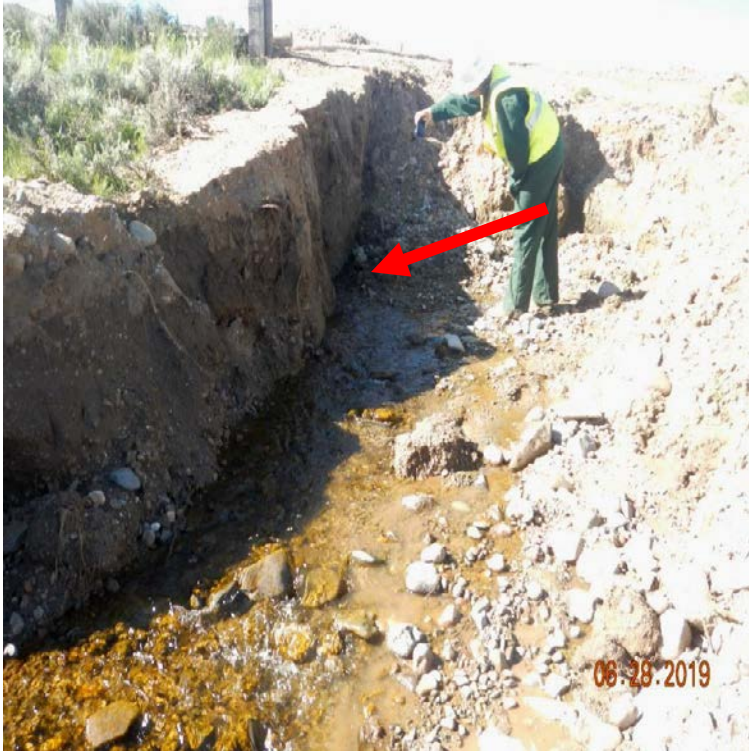
Photo#12:
Close view of NE washout. Arrow indicates point where water is discharging in Photo#13.

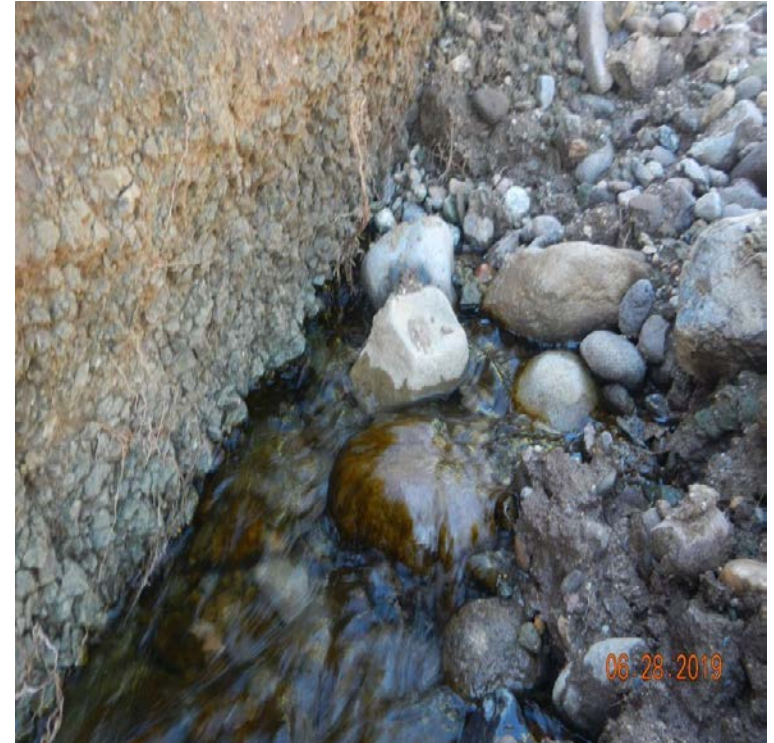
Photo#13:
Point where water from flooded fields is now discharging; channeled according to Operator from French Drain.

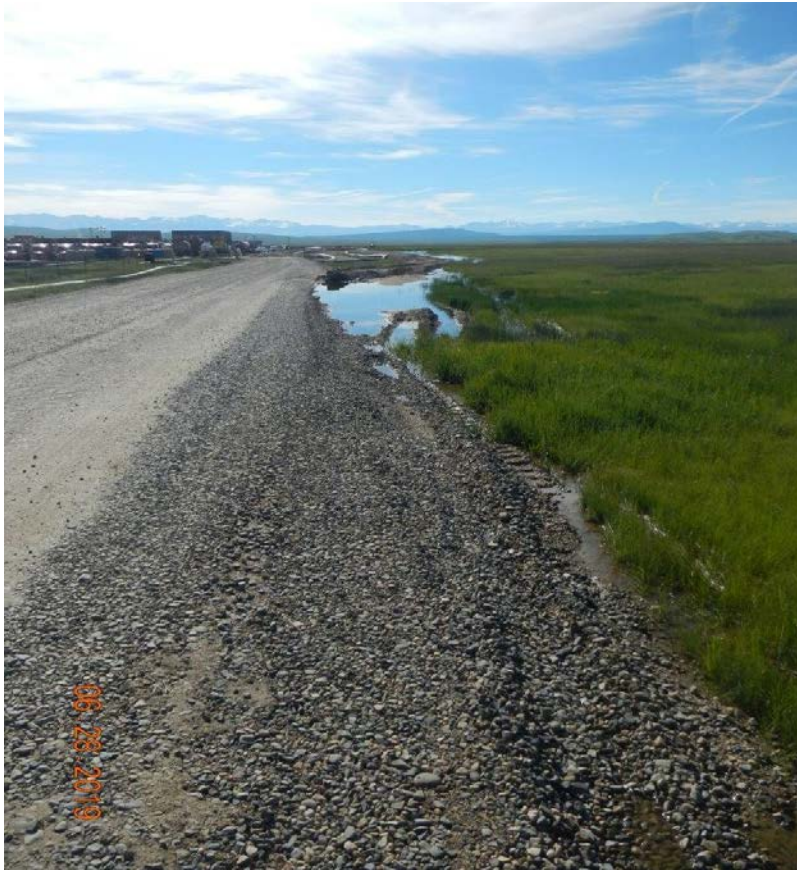
Photo#14:
Points on access road & berms need installation
of BMPs.

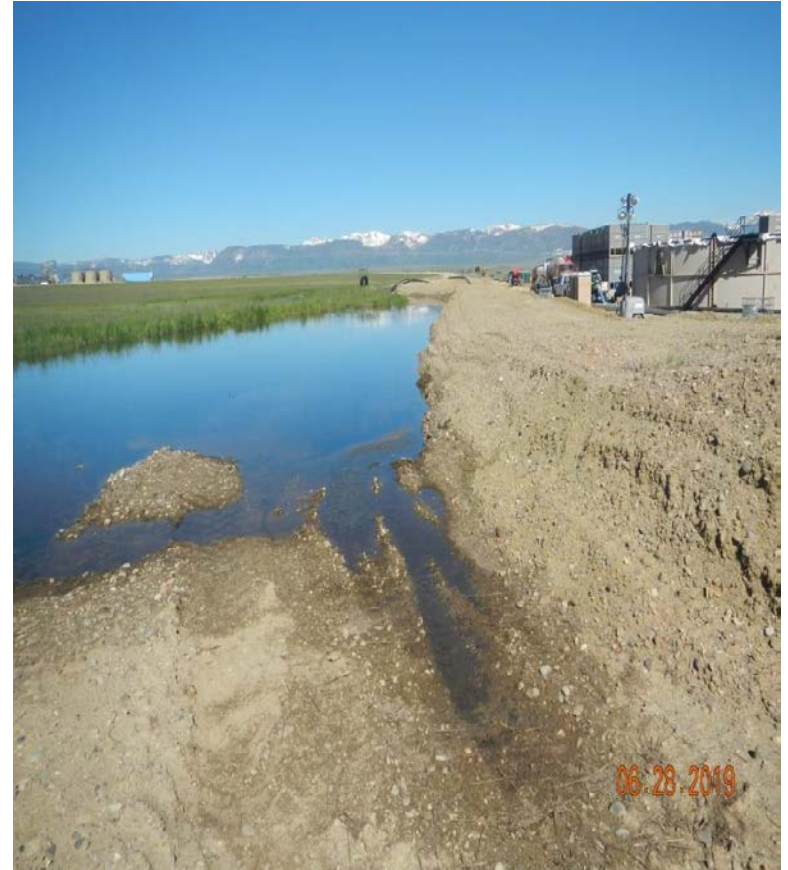
Photo#15:
Points on access road & berms need installation
of BMPs.
