# Construction and Stormwater Inspection

Operator: BAYSWATER EXPLORATION AND PRODUCTION LLC - #10261

Location ID: 455456

Inspection Document #: 697500289

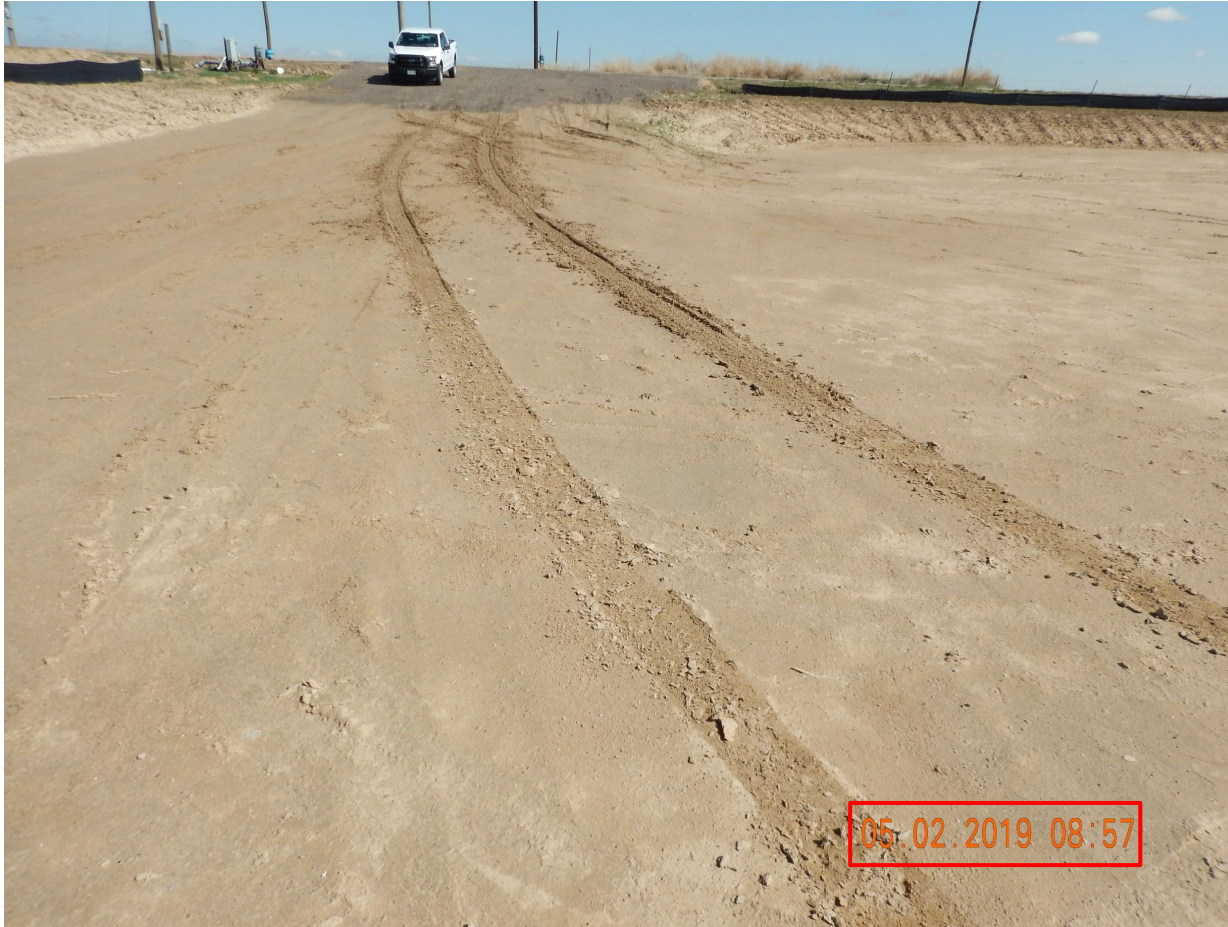
**Photo 1.** Photo taken from the northwestern well pad on May 2, 2019, facing North. Operator has not properly stabilized the well pad area to control for dust and erosion per Rule 1002.e.

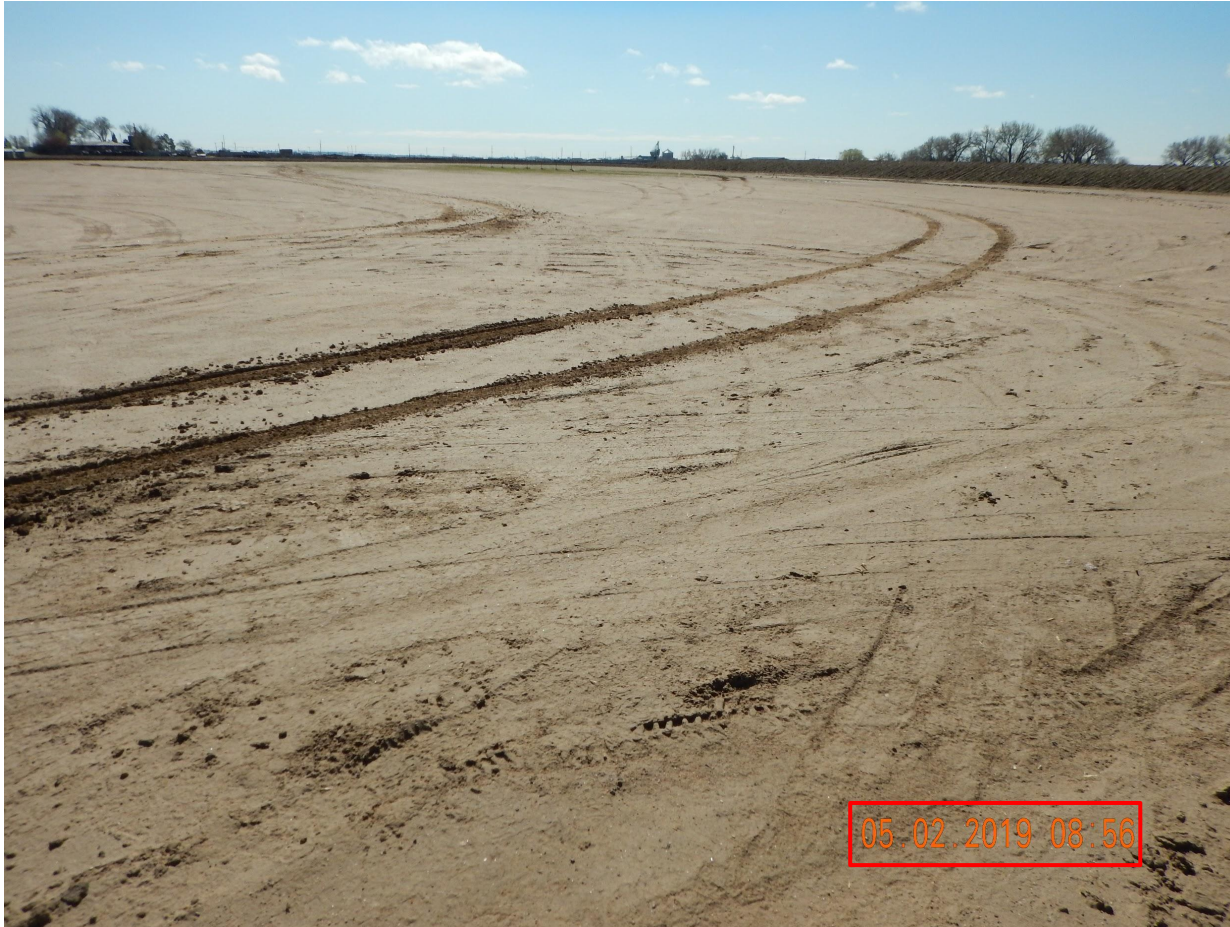
**Photo 2.** Photo taken from the northwestern well pad on May 2, 2019, facing East.  
See comments under Photo 1.

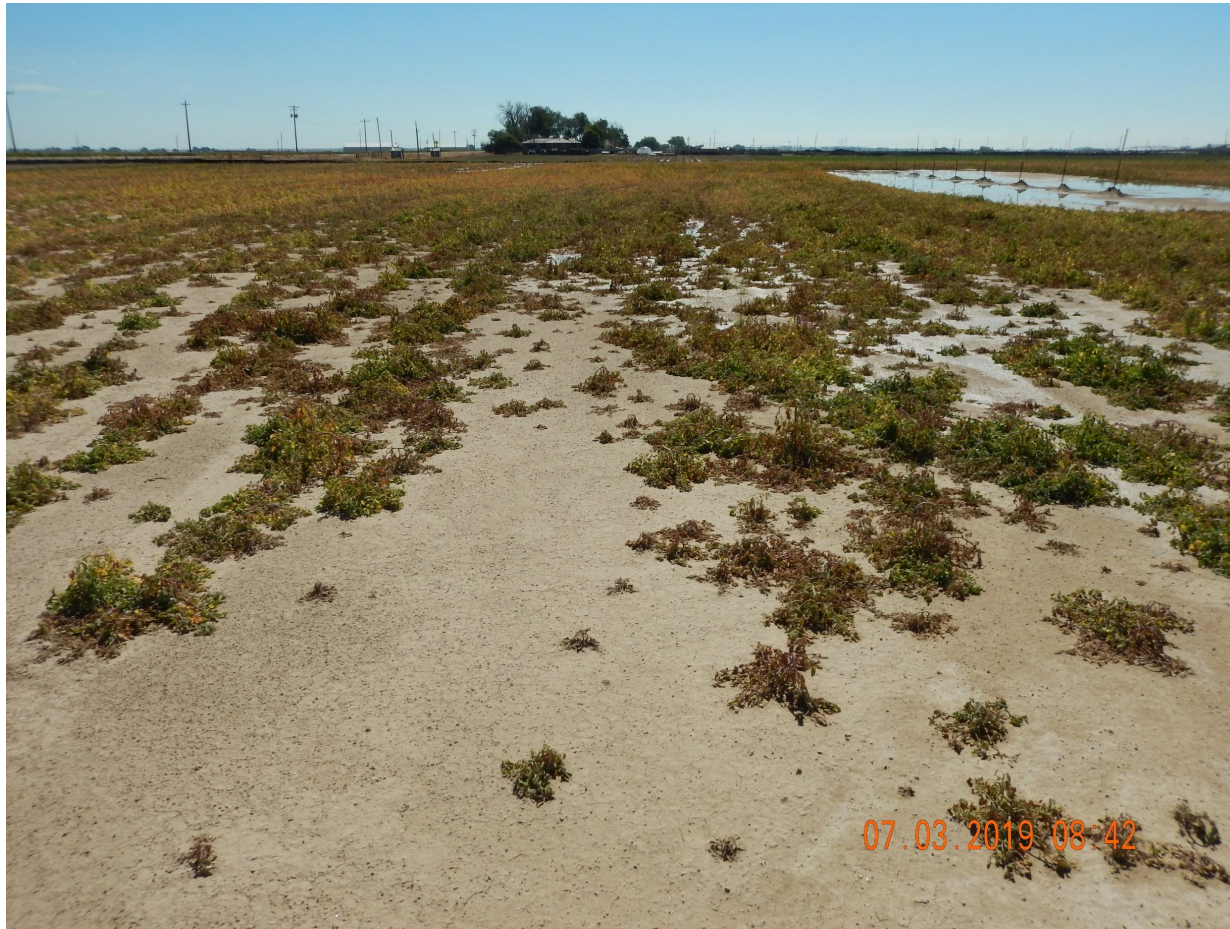
**Photo 3.** Photo taken from the western well pad on July 3, 2019, facing East. Operator has failed to properly stabilize the well pad per the previous corrective action inspection. Photo also illustrates the Operator has failed to control and manage weeds throughout the entire well pad.

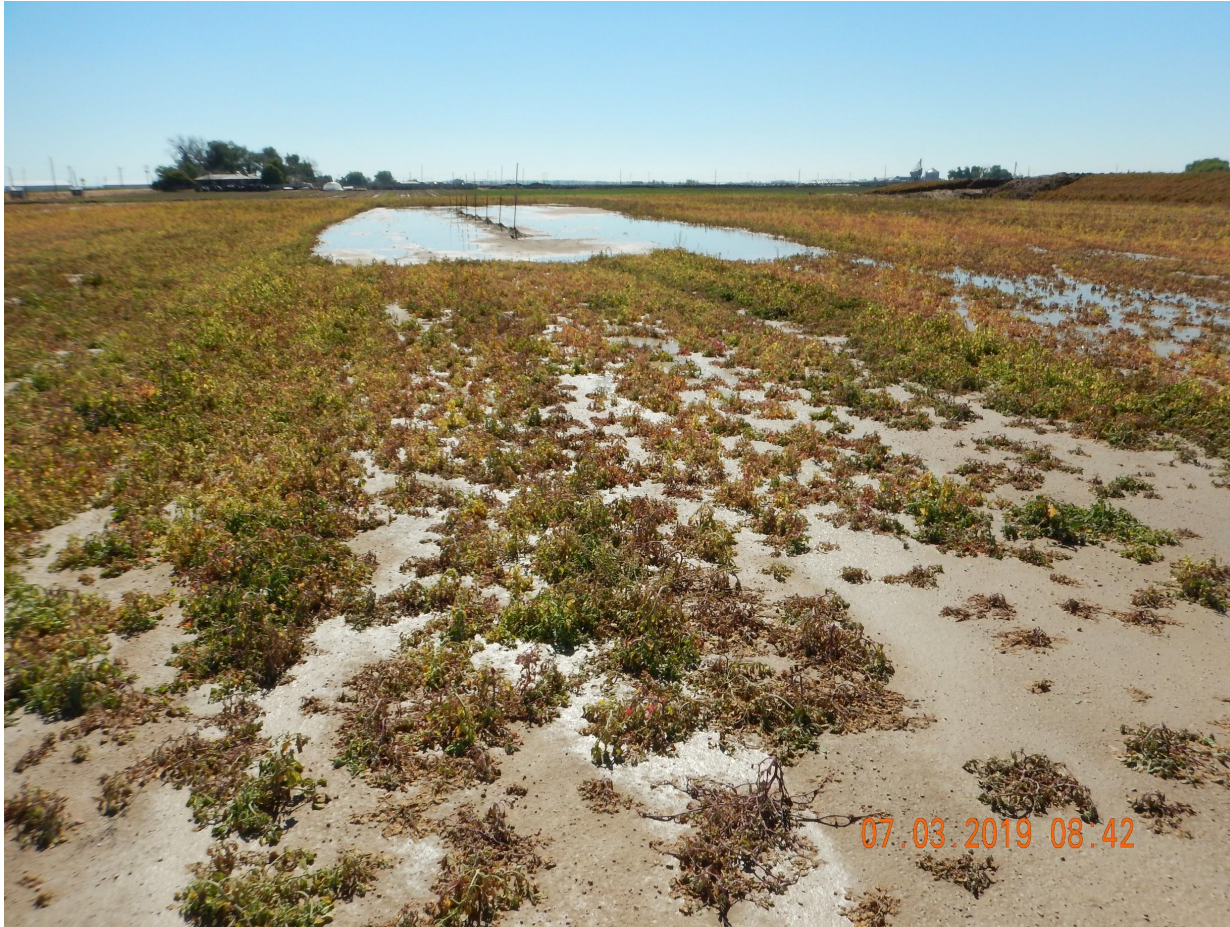
**Photo 4.** Photo taken from the central well pad on July 3, 2019, facing East. The eastern half of the well pad is saturated from irrigation water.

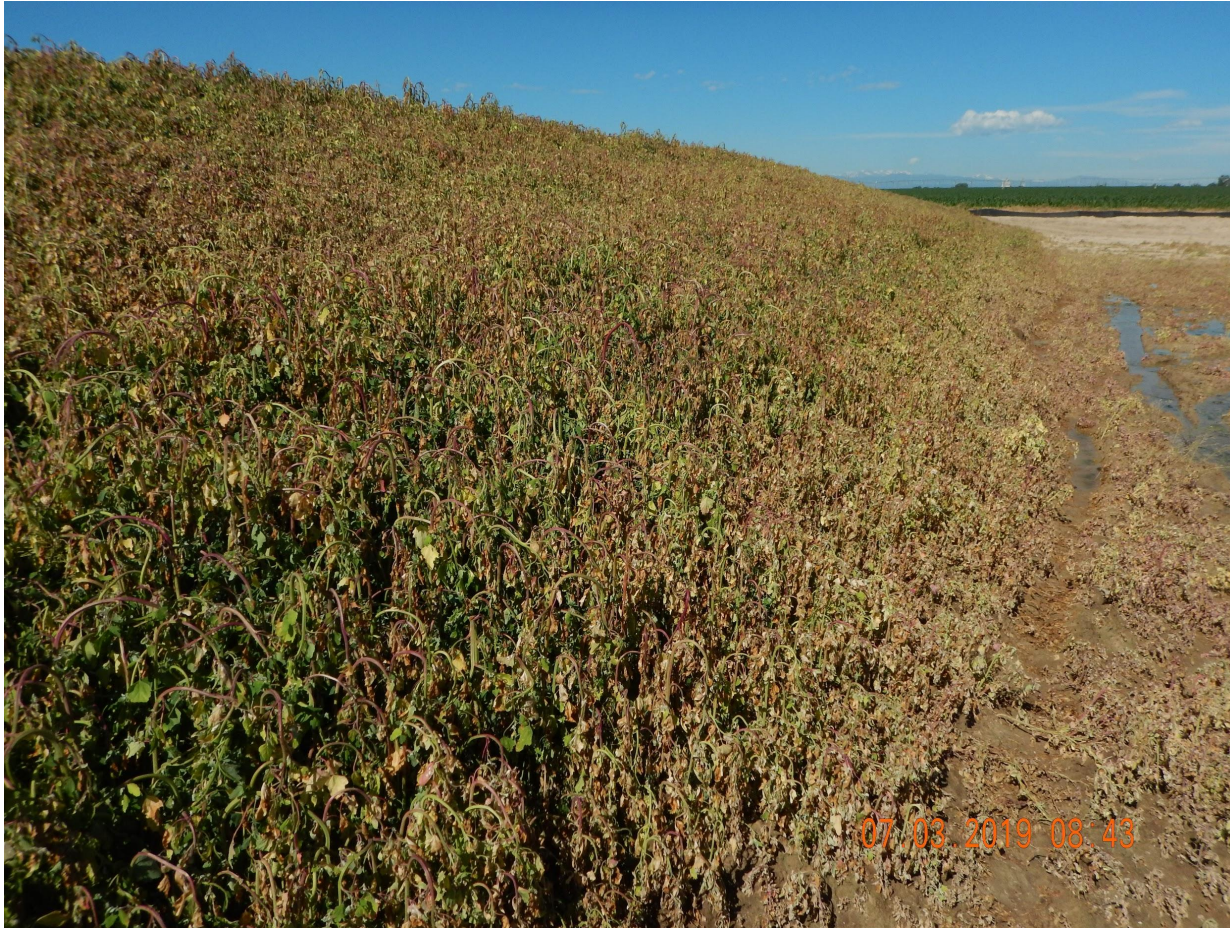
**Photo 5.** Photo taken from the north-facing topsoil stockpile on July 3, 2019, facing West. Photo illustrates the Operator has failed to control and manage weeds throughout the entire topsoil stockpile.

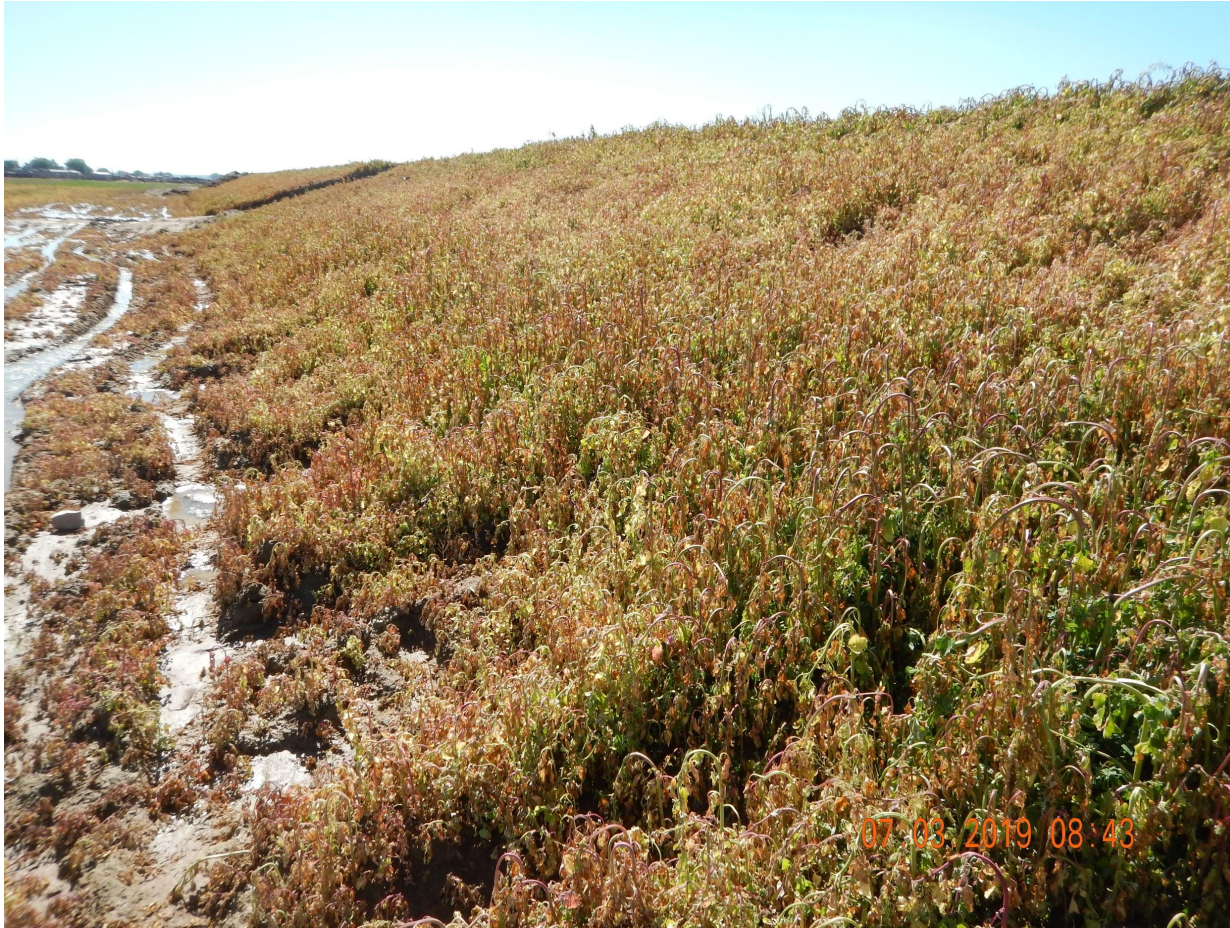
**Photo 6.** Photo taken from the north-facing topsoil stockpile on July 3, 2019, facing East. See comments under Photo 5.

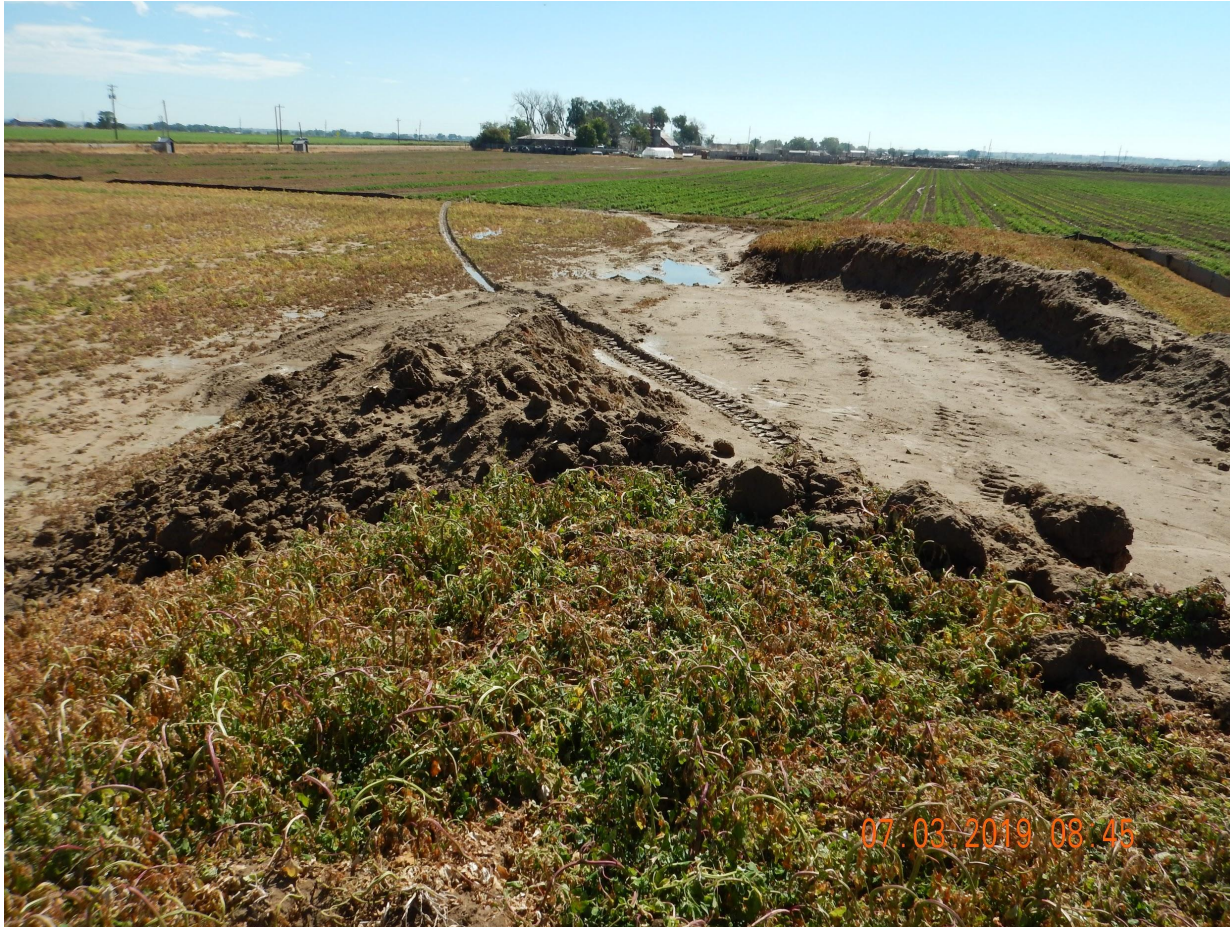
**Photo 7.** Photo taken from the eastern topsoil stockpile on July 3, 2019, facing East. Photo illustrates the Operator has failed to protect the topsoil per Rule 1002.c. Topsoil has been moved to allow the pivot irrigation system to travel through the well pad area.

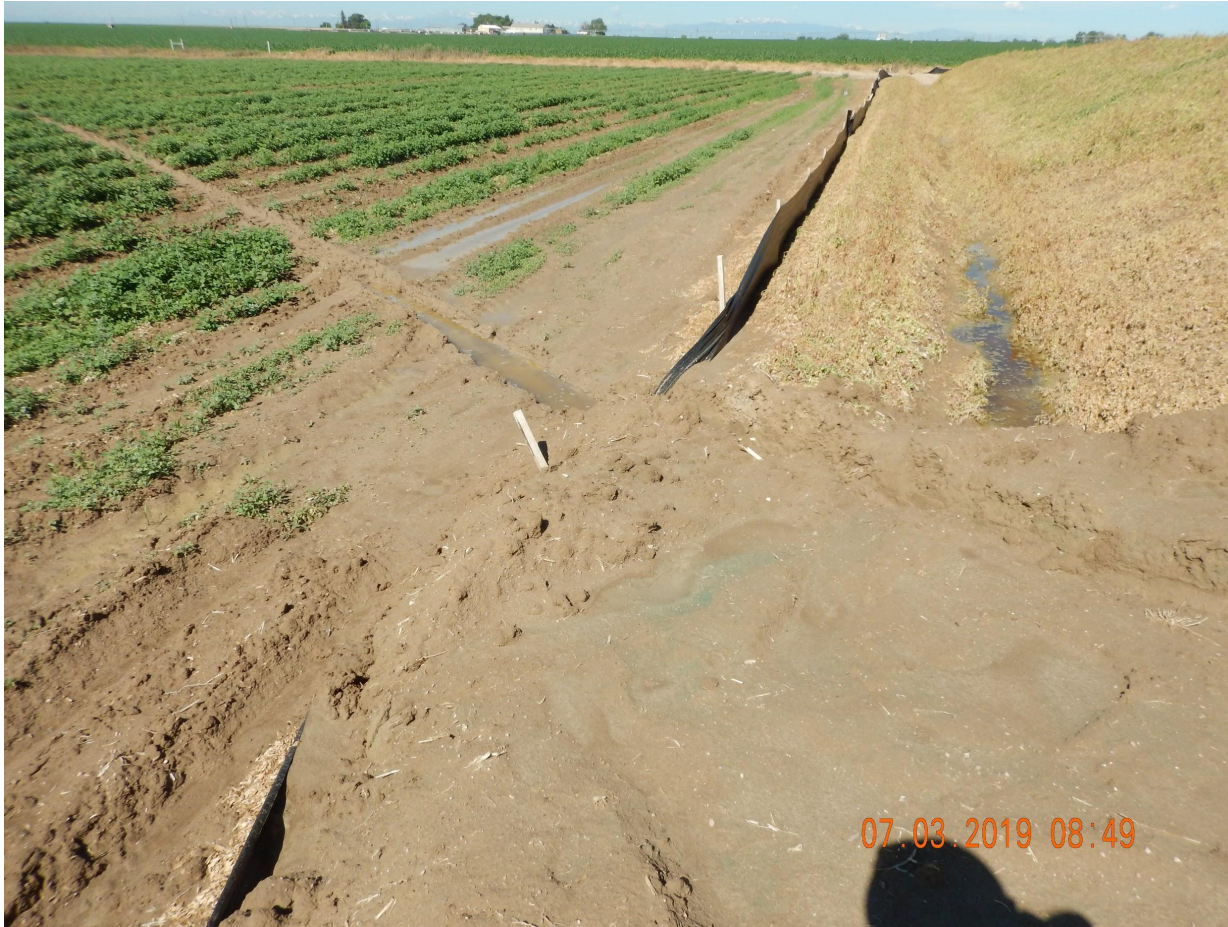
**Photo 8.** Photo taken from the eastern topsoil stockpile on July 3, 2019, facing West. Photo illustrates the Operator has failed to protect the topsoil per Rule 1002.c. and failed to maintain the perimeter stormwater BMPs.

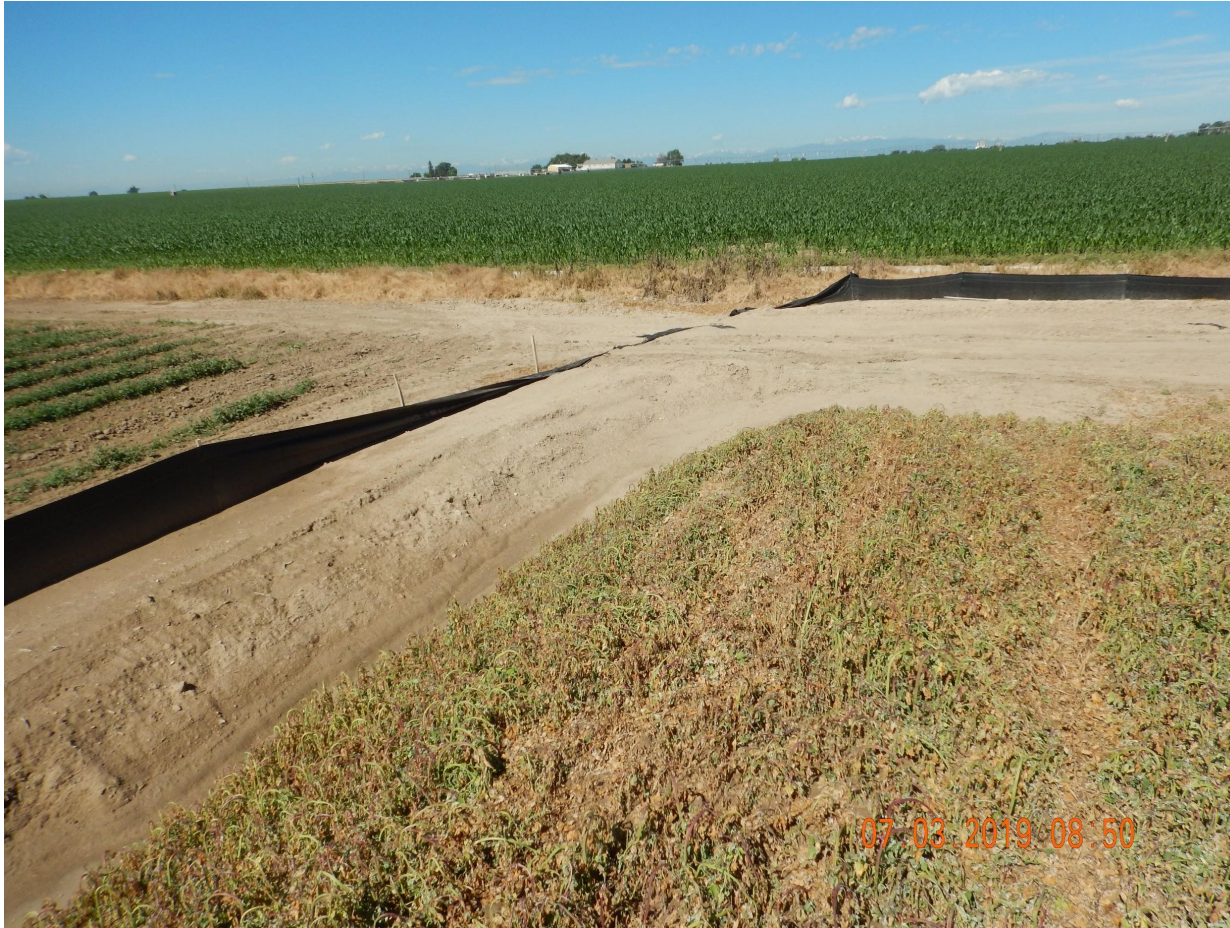
**Photo 9.** Photo taken from the western topsoil stockpile on July 3, 2019, facing West. Photo illustrates the Operator has failed to maintain the perimeter stormwater BMPs.
