Caerus Piceance LLC
API # 05-077-08680
Inspection # 696600264

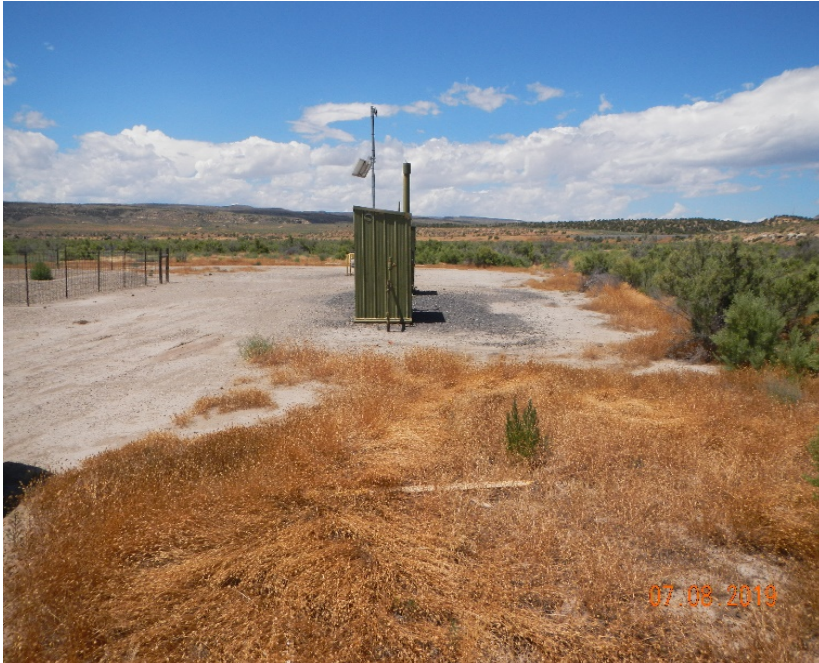
Photo #1 Photo at entrance to location.
Unused equipment on location.
No Battery Sign at entrance or tank battery.

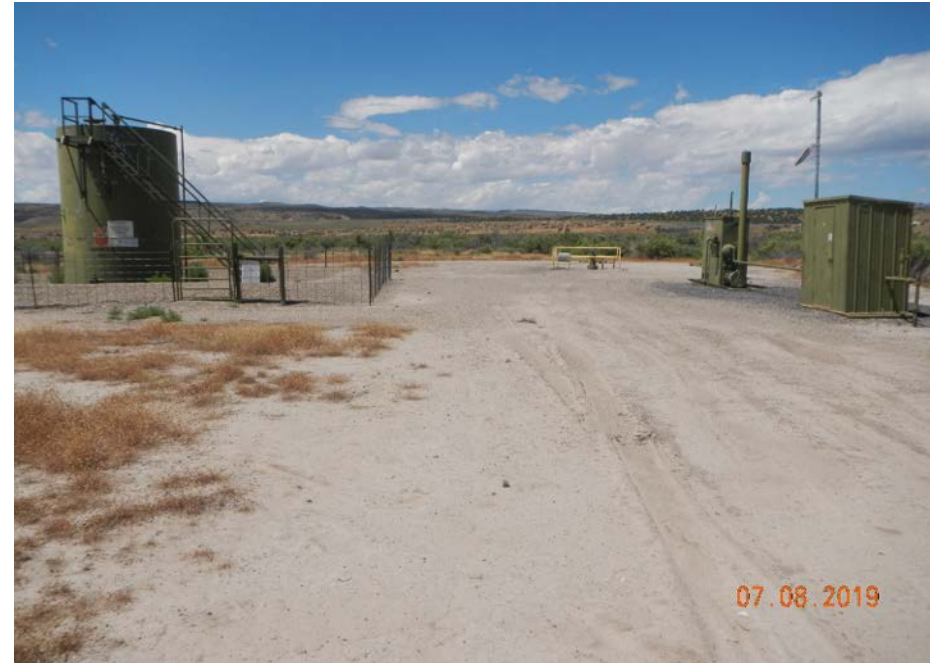
Photo #2 Photo from entrance of location.
No tank battery sign on location.
No Battery Sign at entrance or tank battery.

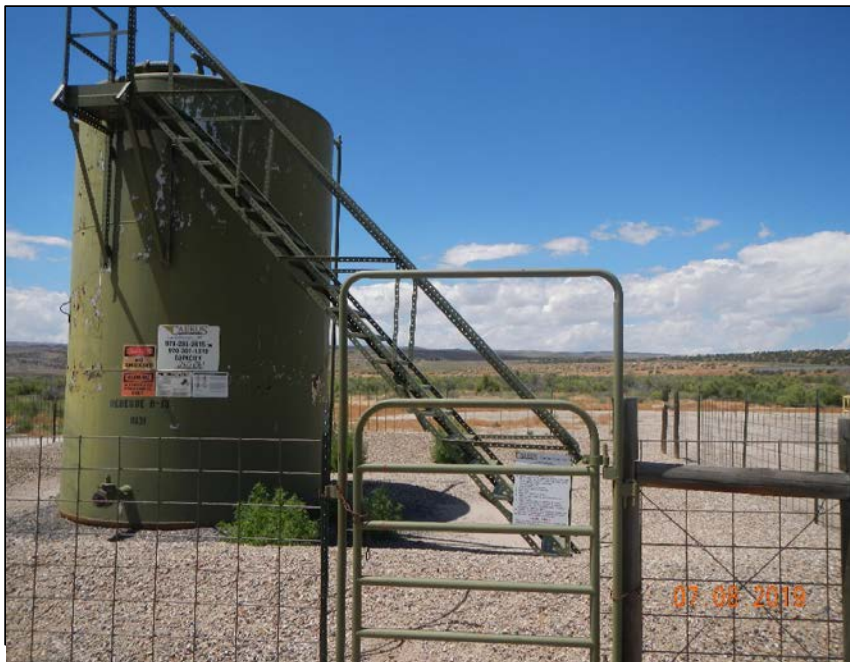
Photo #3 photo of Tank Battery.
No Tank Battery sign on location

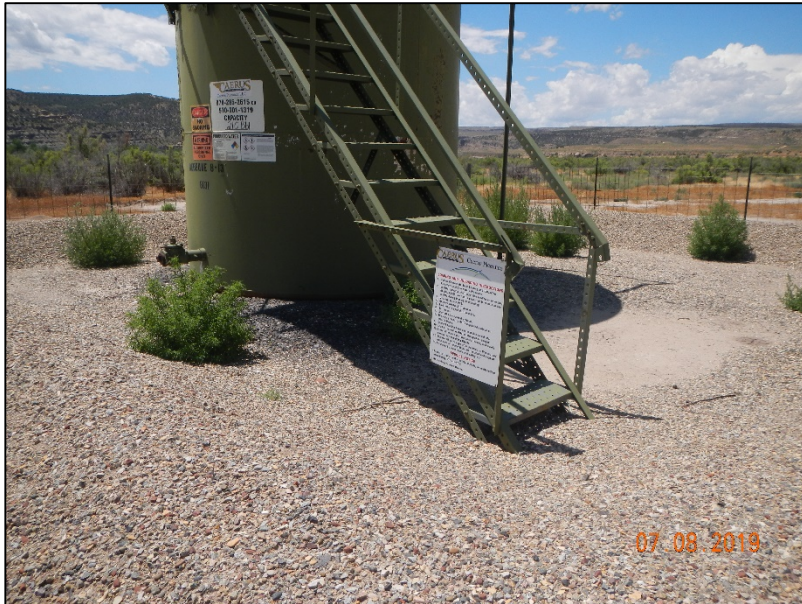
Photo #5 Weeds inside tank containment

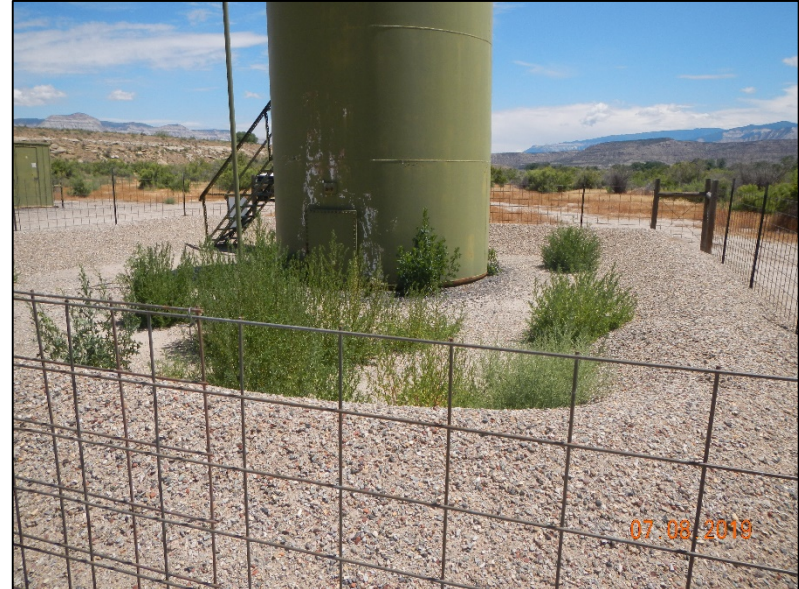
Photo #6 Weeds inside tank containment

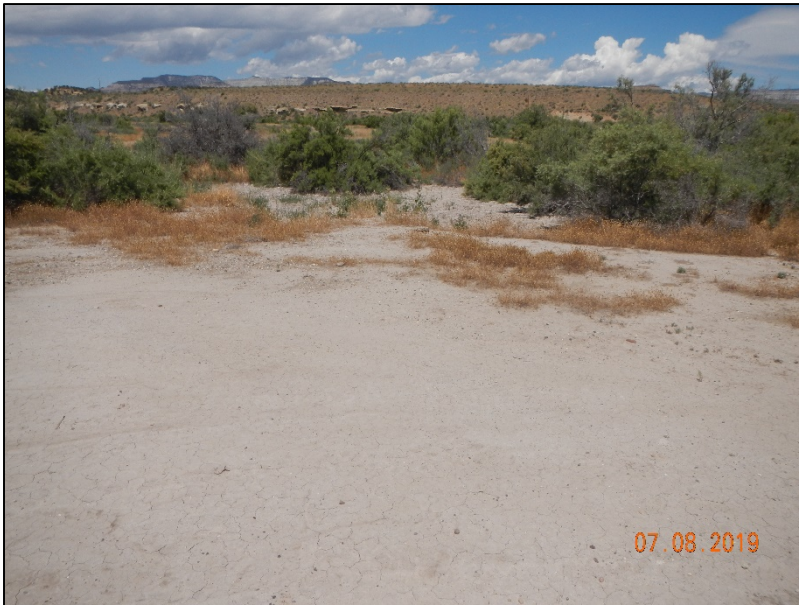
Photo #7 Storm water erosion moving sediment off NW corner of location. No BMP or berm needs maintenance

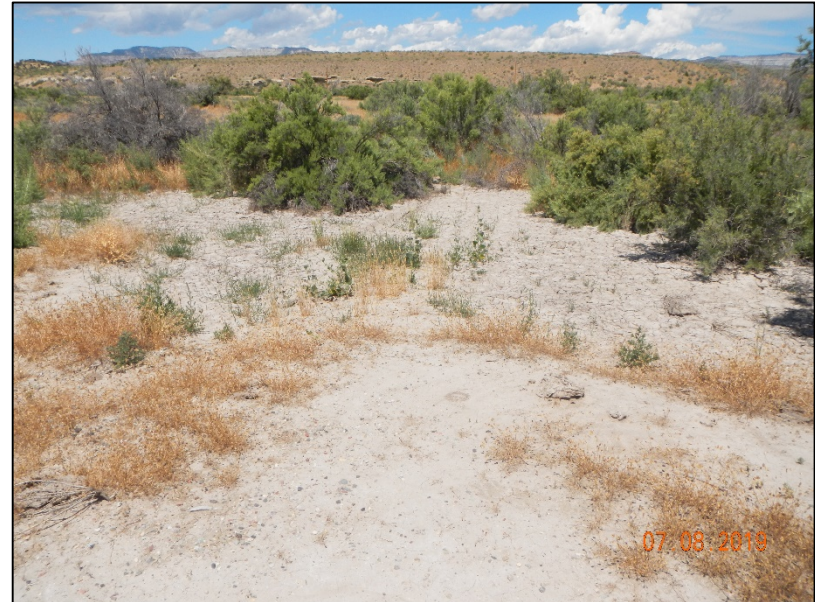
Photo #8 Storm water erosion moving sediment off NW corner of location. No BMP or berm needs maintenance.

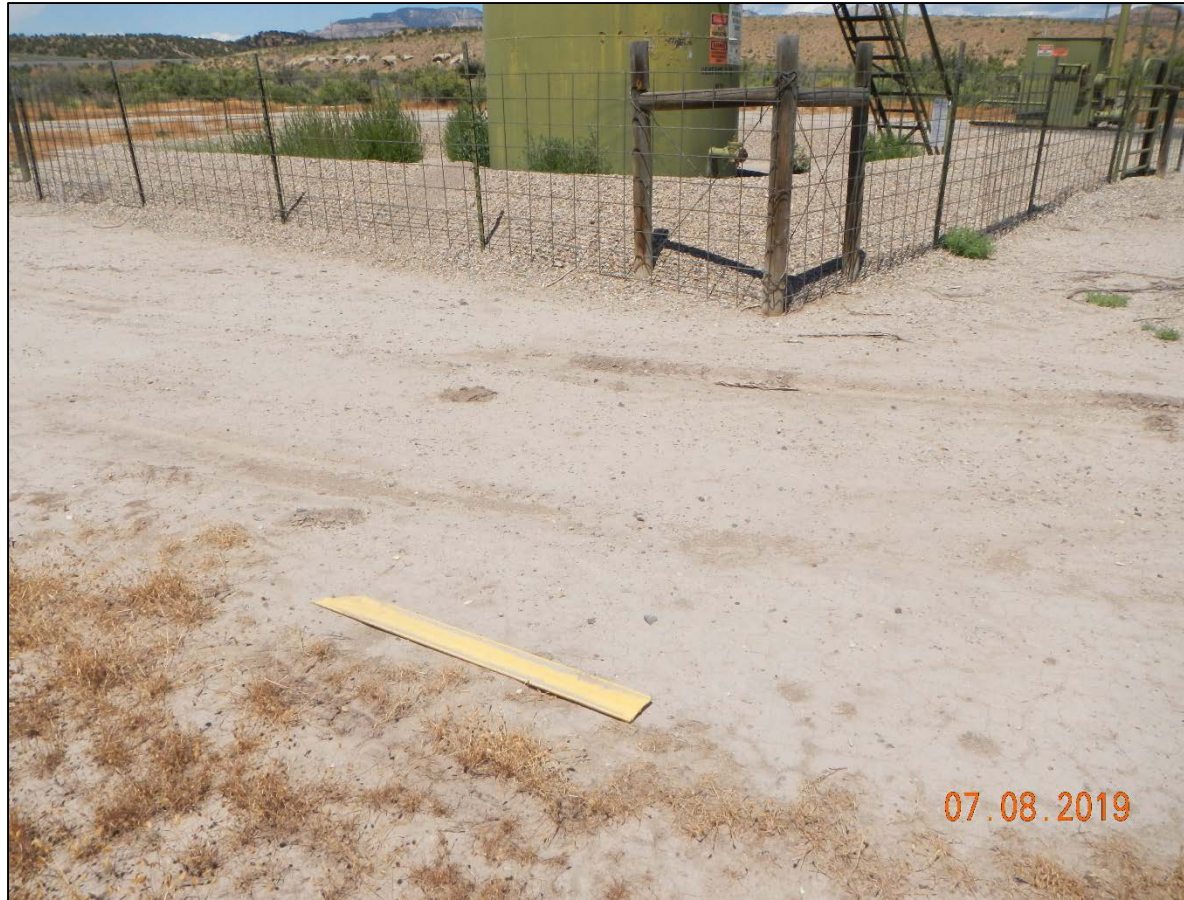
Photo #9 Un-used equipment on location.
