Inspection Photos
Operator: SG Interests
Location/API #: 051-06069
Date: 6-19-2019

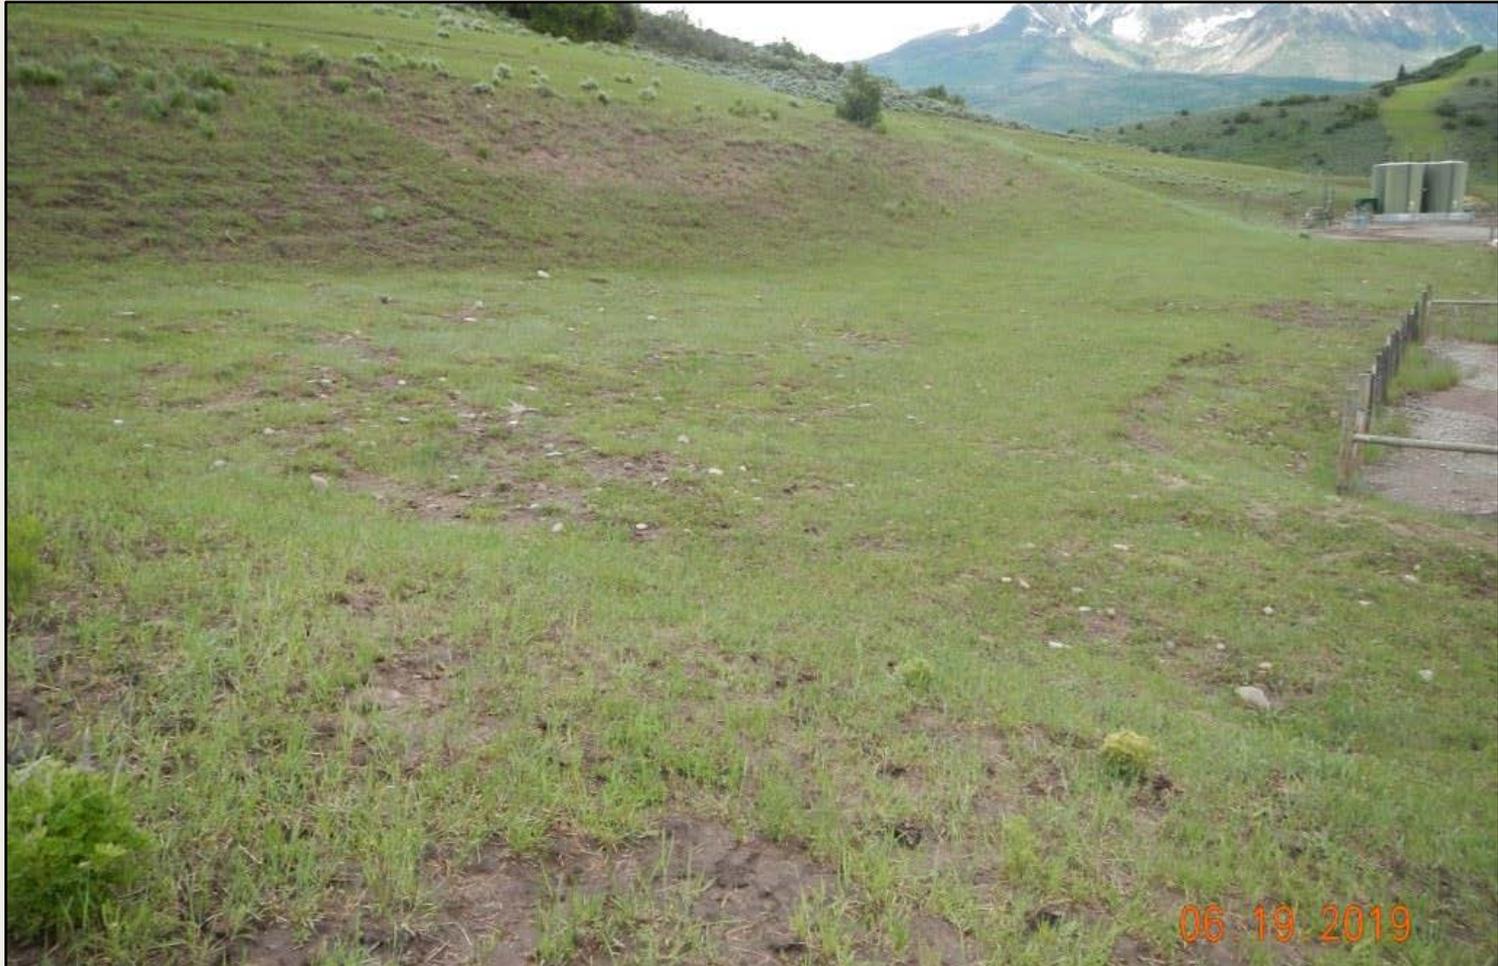
Photo 1. View of the northern project area from the northwestern edge facing eastward.

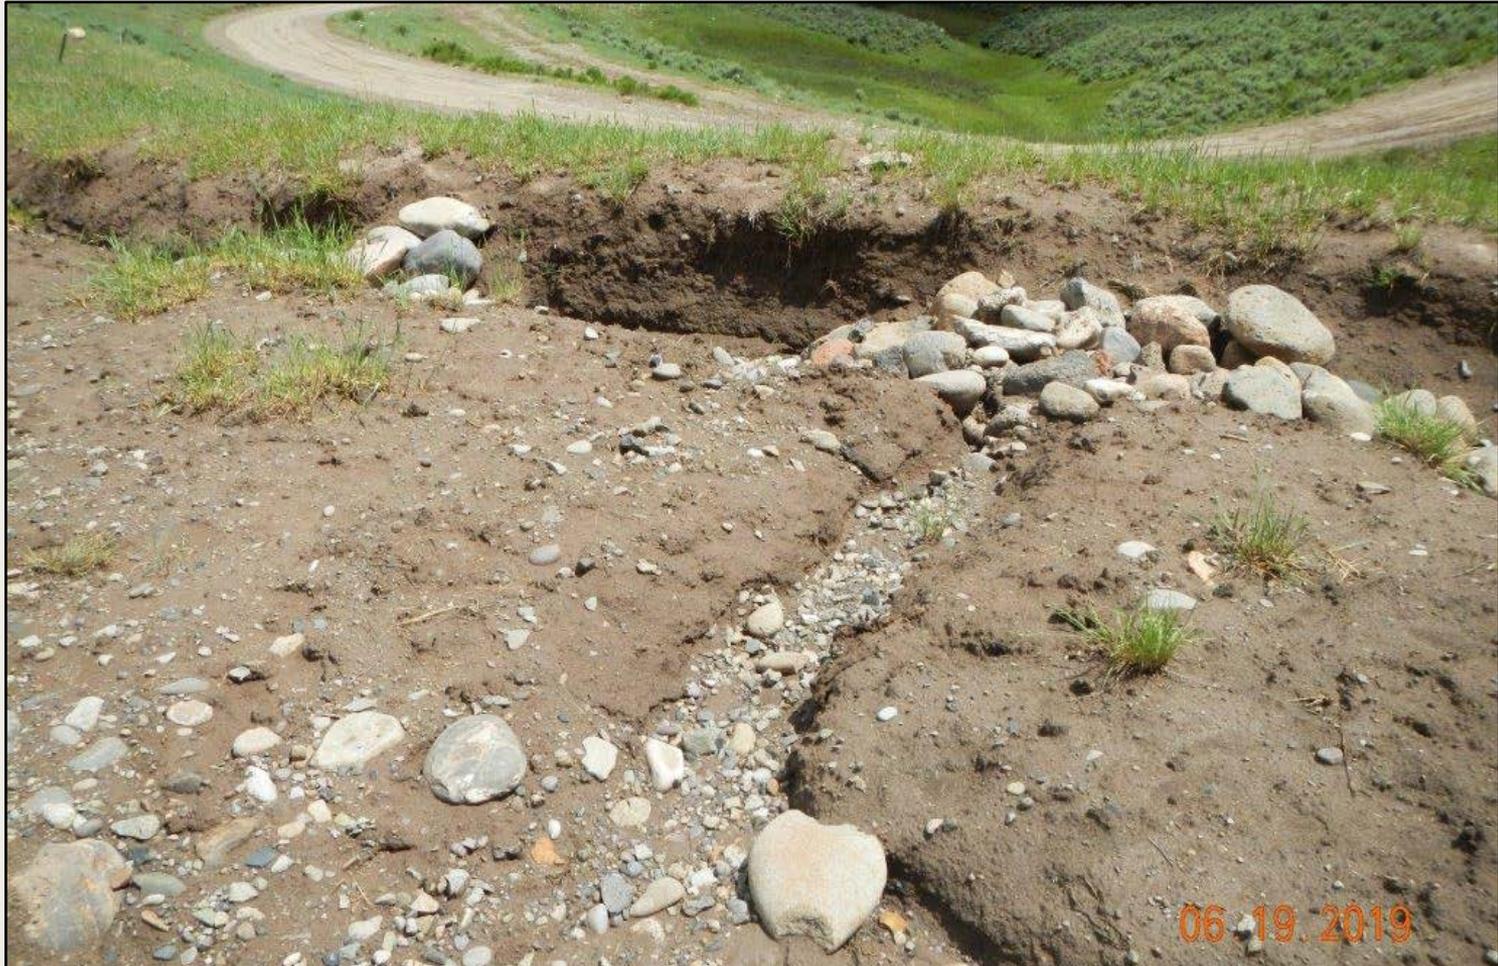
Photo 2. View of erosional channeling and downcutting along the southern edge of the project area. Rock checks do not appear to be functioning.
