Inspection Photos

Loc#445005

Operator: Sandridge

Inspection Number: 692401138

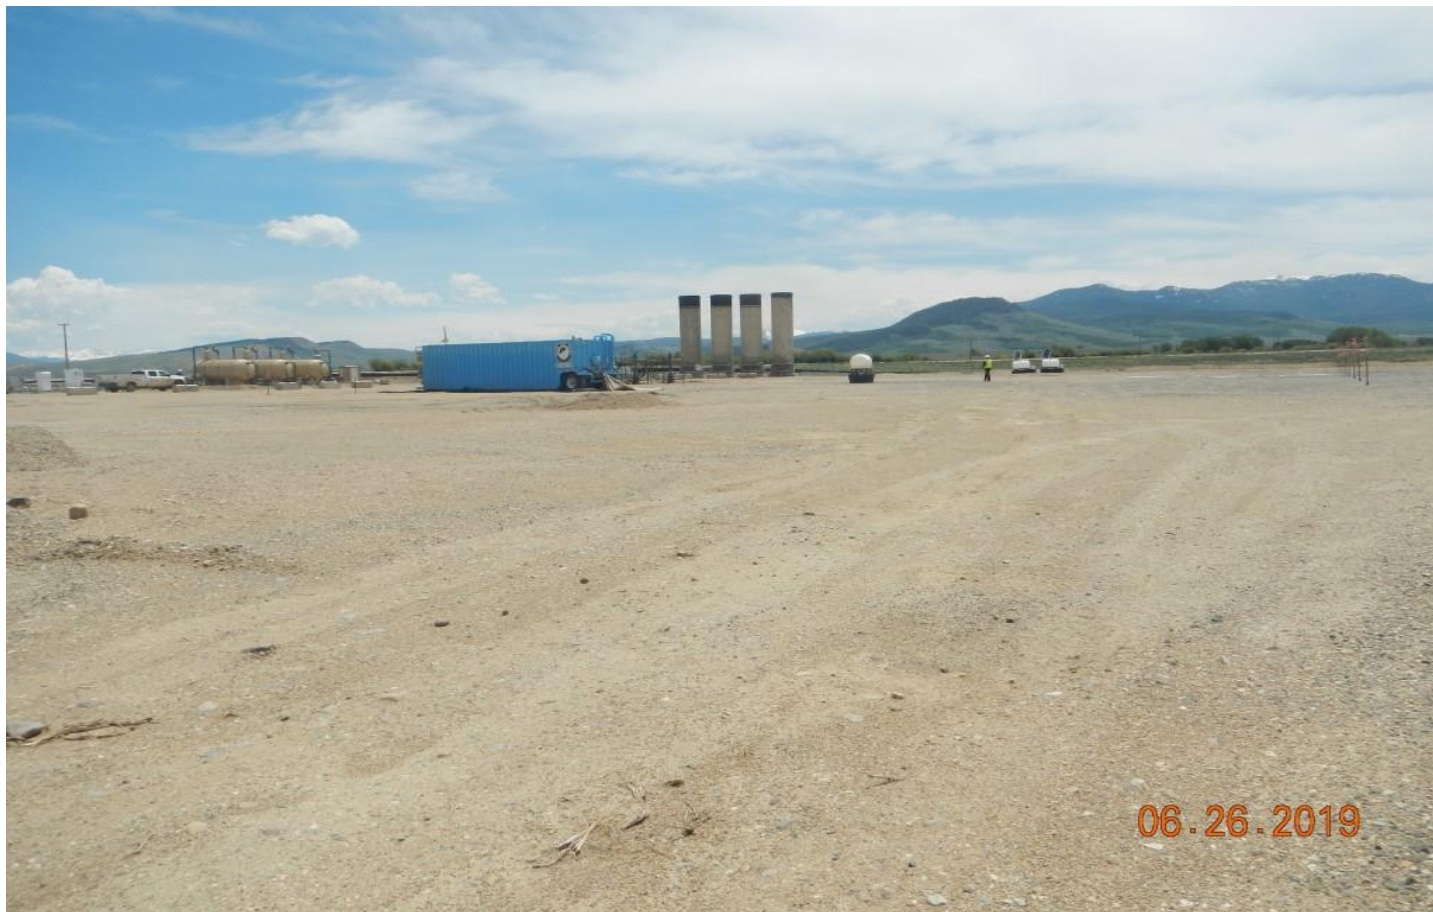
Photo#1:
Overview of Location from entry.

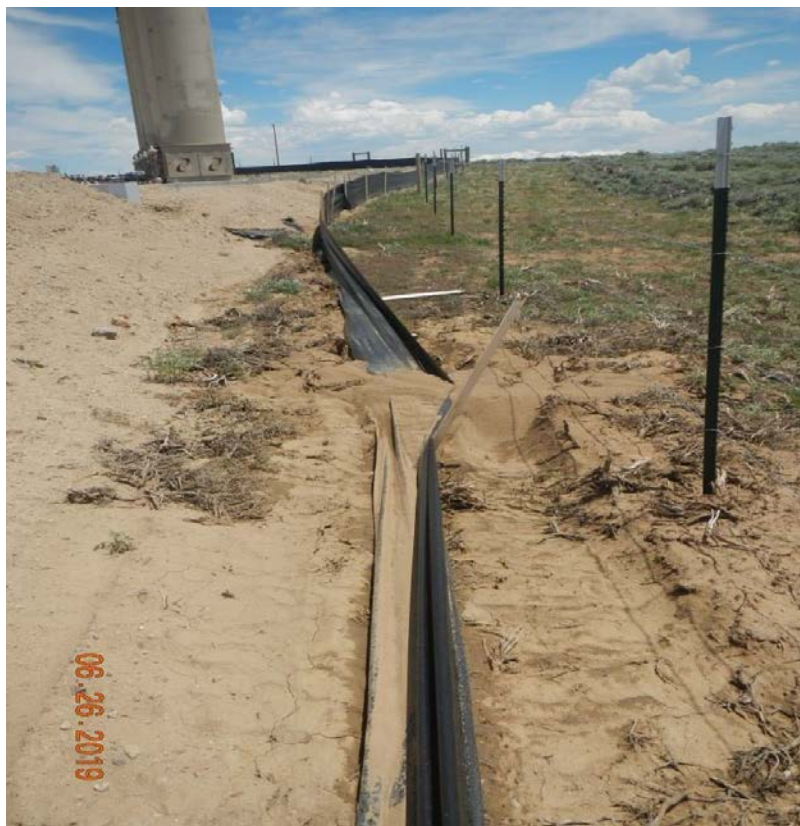
Photo#2:
Silt fence overwhelmed.

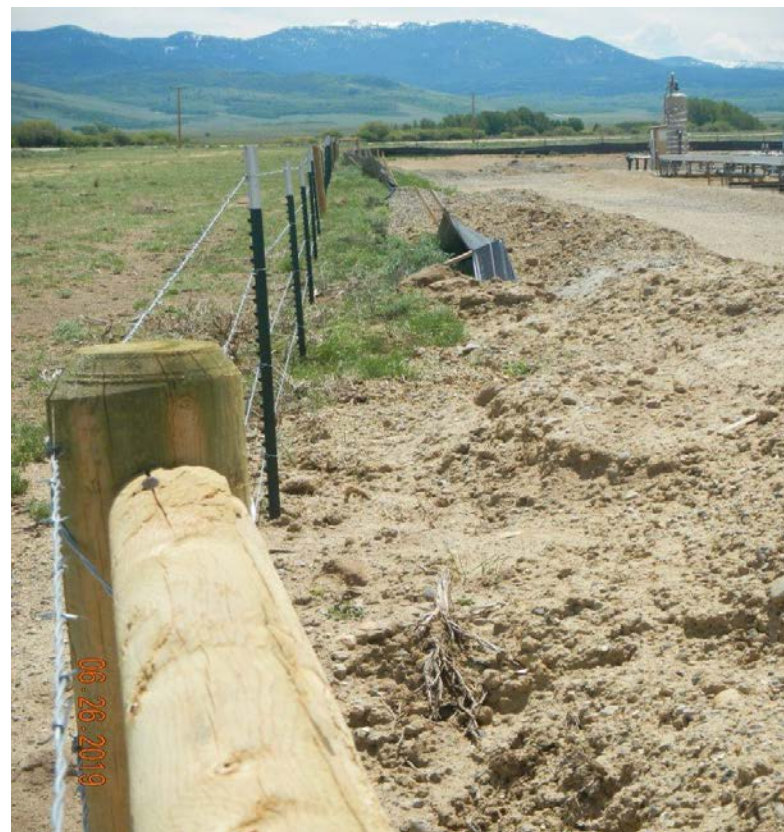
Photo#3:
Silt fence buried.

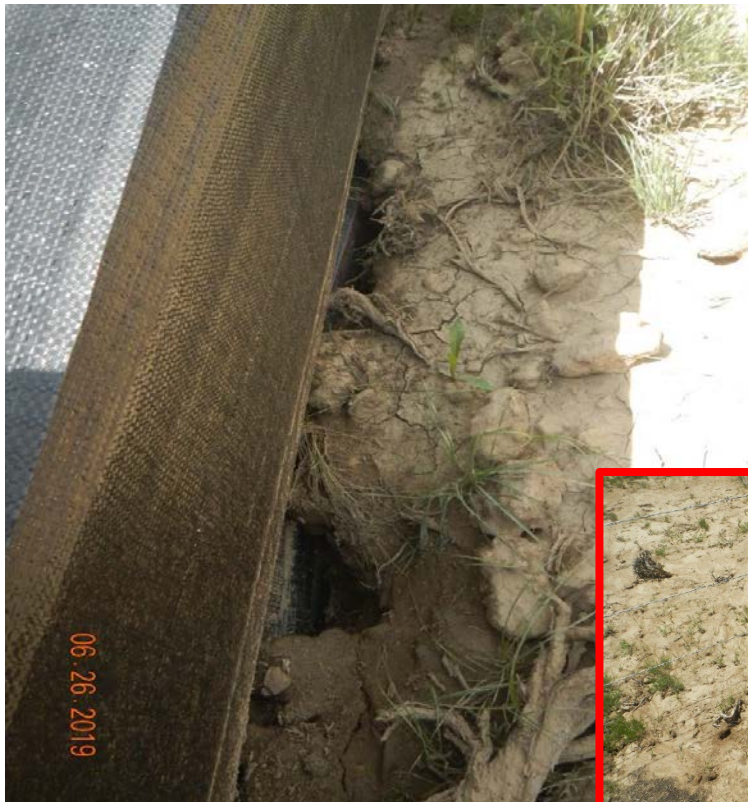
Photo#4:

Points where silt fence is being undercut by stormwater.

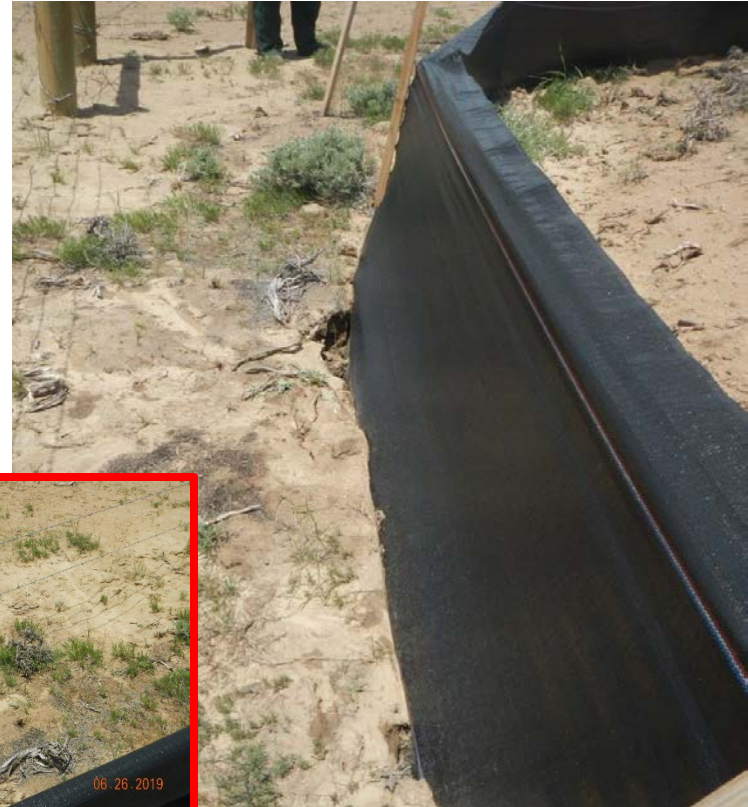
Photo#5:

Outside of silt fence where stormwater is daylighting & sediment transporting off site.

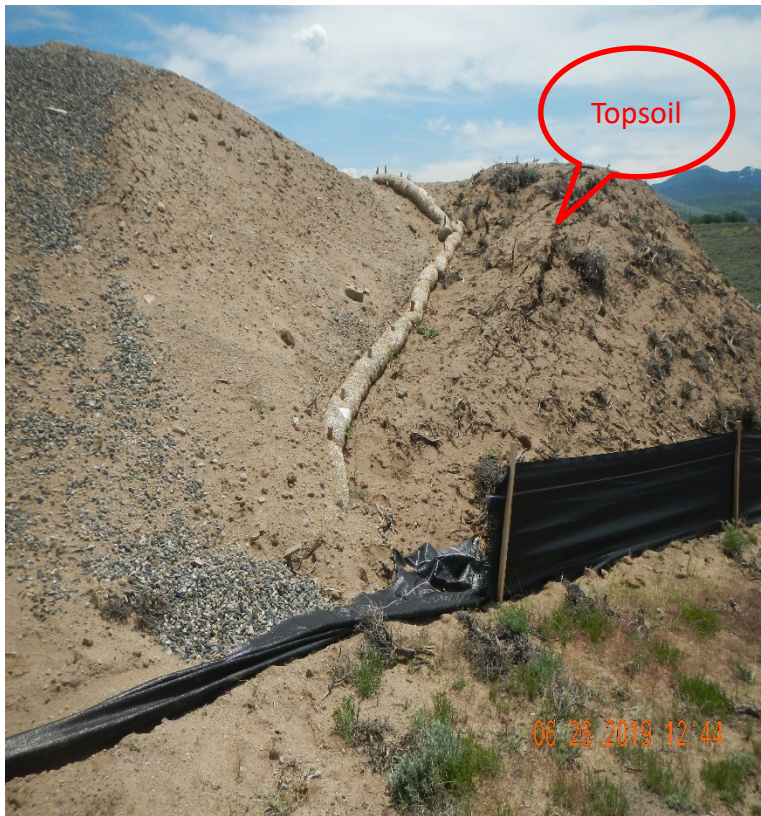
Photo#6:
Slopes/ topsoil stockpile are not stabilized, resulting in erosion, sediment migration and degradation.

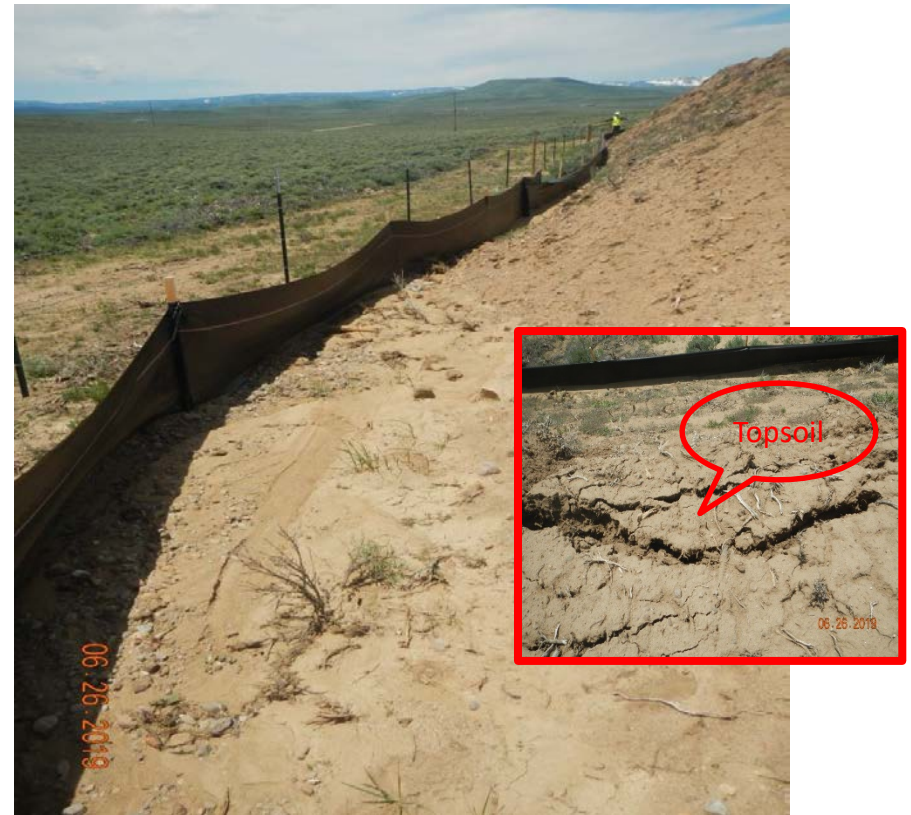
Photo#7:
Slopes/topsoil stockpile are not stabilized, resulting in erosion, sediment migration and degradation.

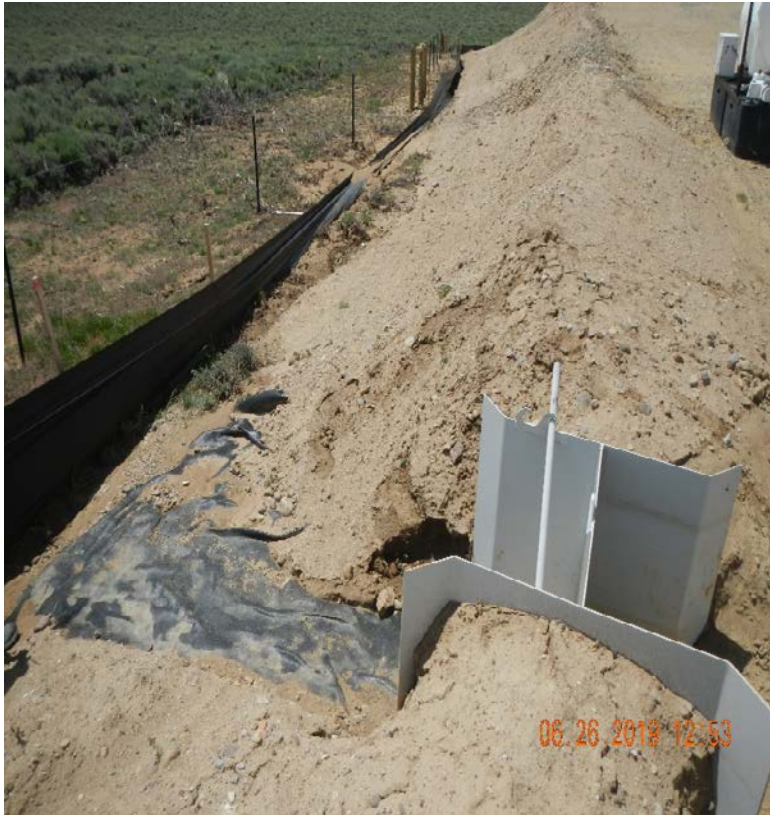
Photo#8:

Weir is not installed in position to function properly.

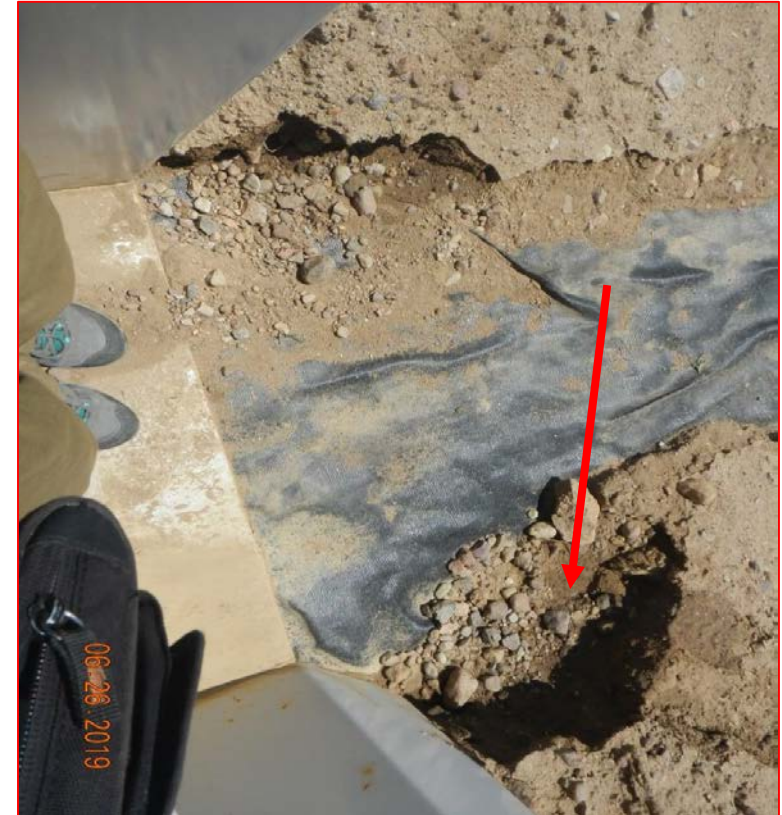
Photo#9:

Weir is not installed in position to function properly. Arrow indicates where SW is undercutting.

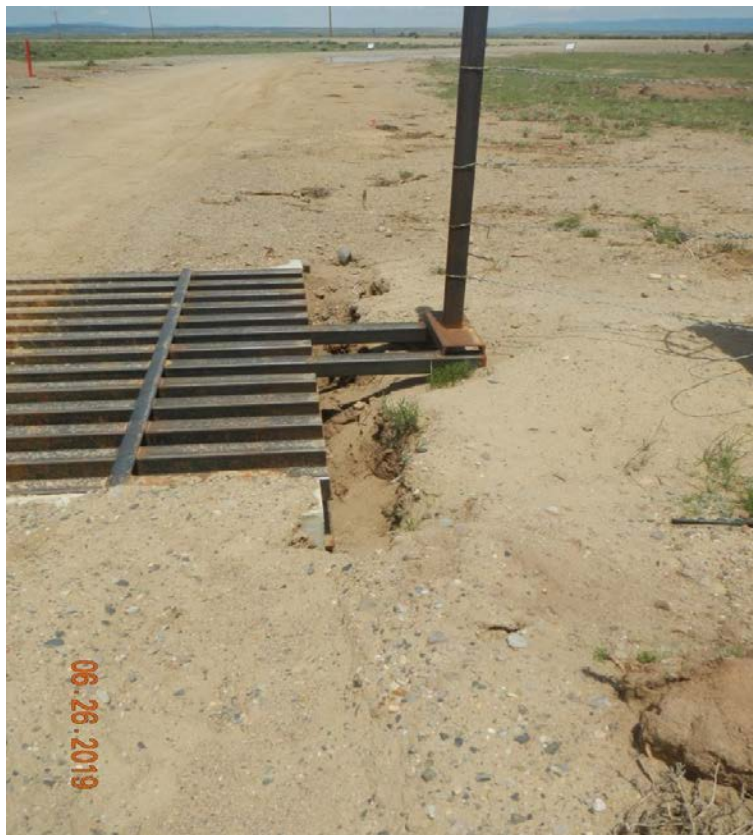
Photo#10:
Absence of BMPs at entries and along access road.

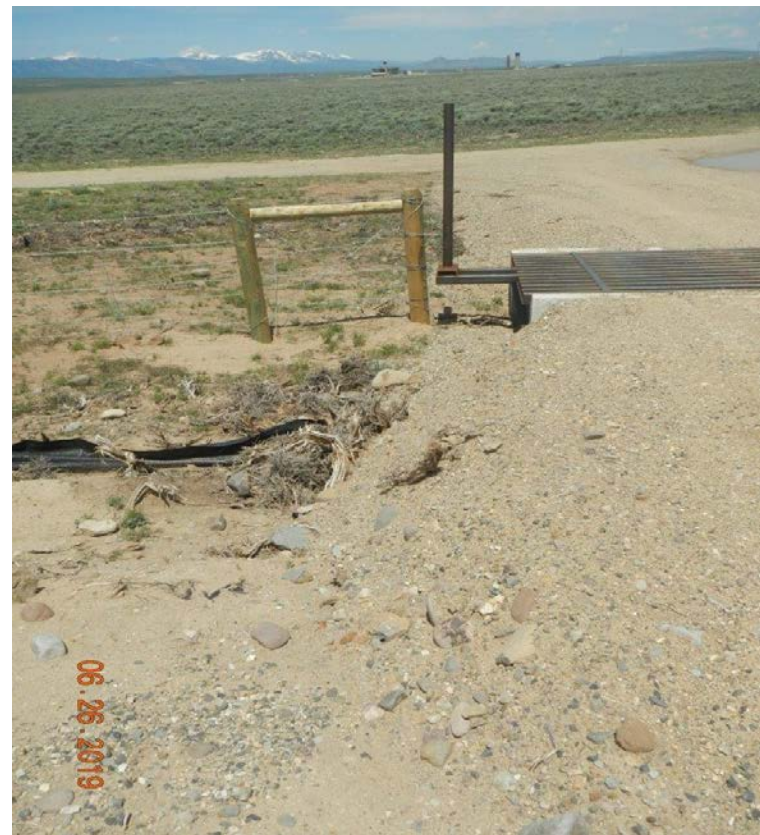
Photo#11:
Absence of BMPs at entries and along access road.
