KP Kauffman - COGCC Inspection Photos
Location: Facility #4 North Consolidation Flowline Release
Spill ID # 463820

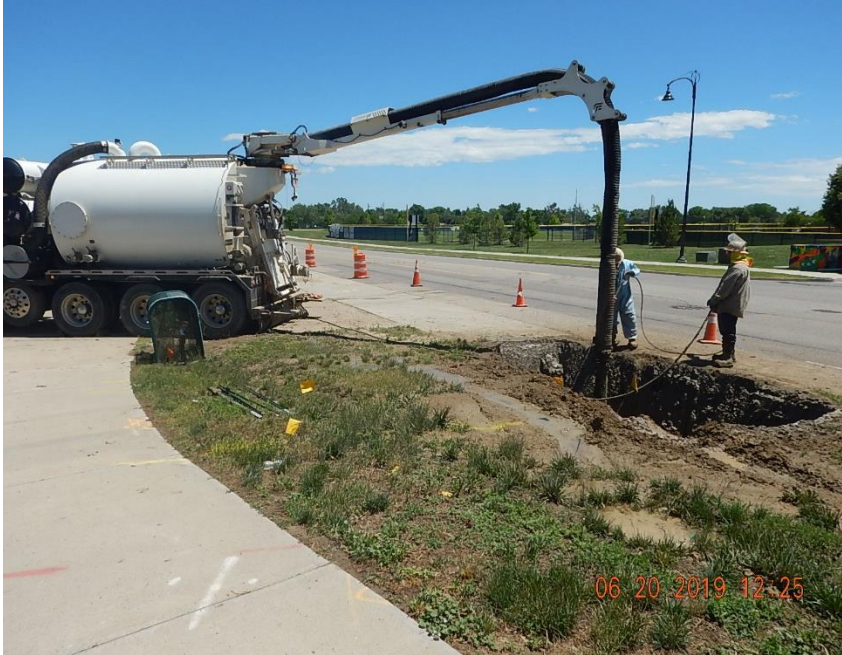
Hydro-excavation work being completed by KPK contractors on 6/20/2019. View looking east on Tipple Parkway.

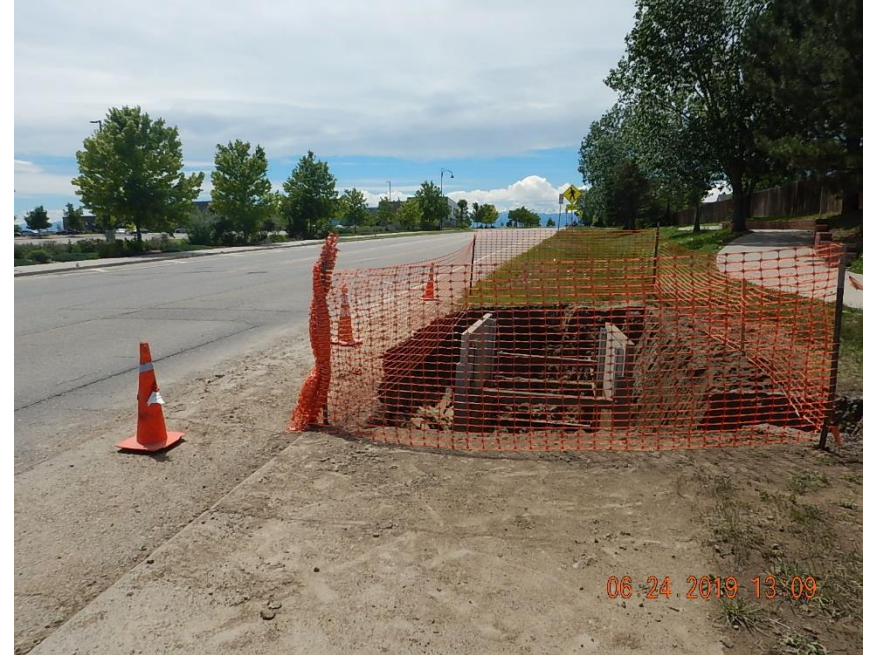
Excavation (fenced) with trench box installed on 6/24/2019. View looking west on Tipple Pkwy.

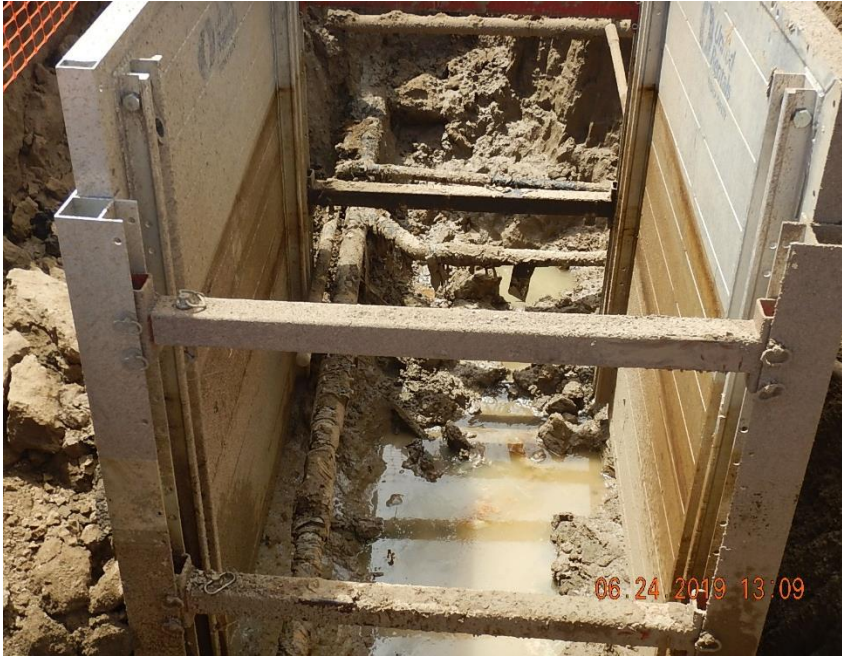
View of flowlines exposed in excavation; bolted clamp can be seen on 3" consolidation flowline. Photo date 6/24/19.

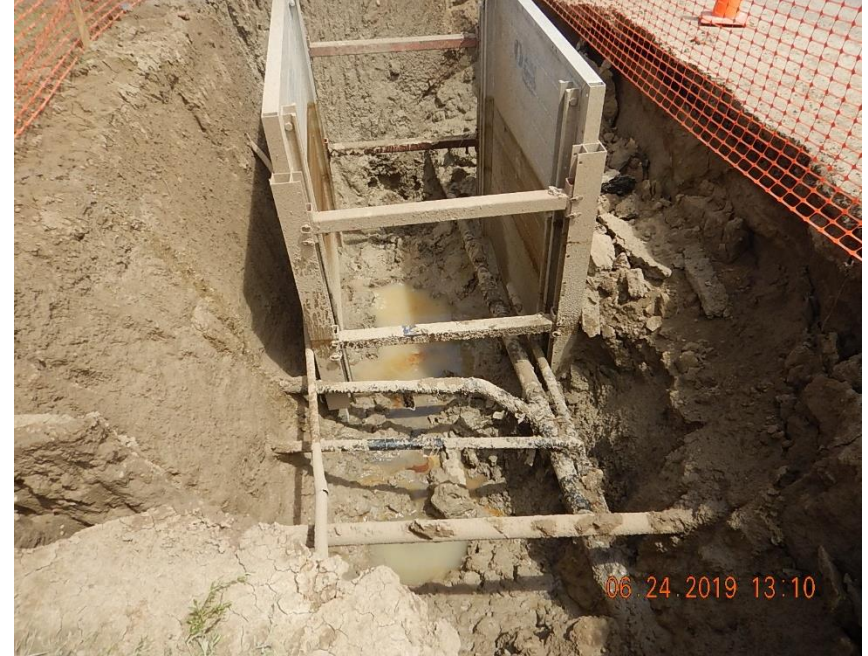
**View of flowlines exposed (at spill Id #463820) in excavation. Flowlines tie in to crude oil and gas consolidation lines.
Note: Marked utilities (non KPK/ via 811 call) are also present in the excavation.**

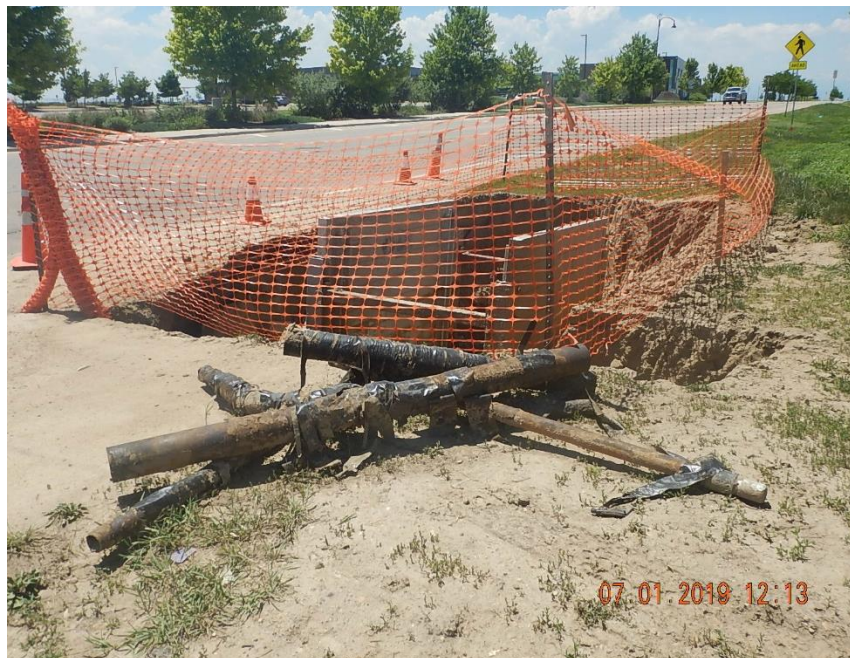
Photo of excavation and pipe removed during repair work by KPK personnel. View looking west/ photo date 7/1/19.

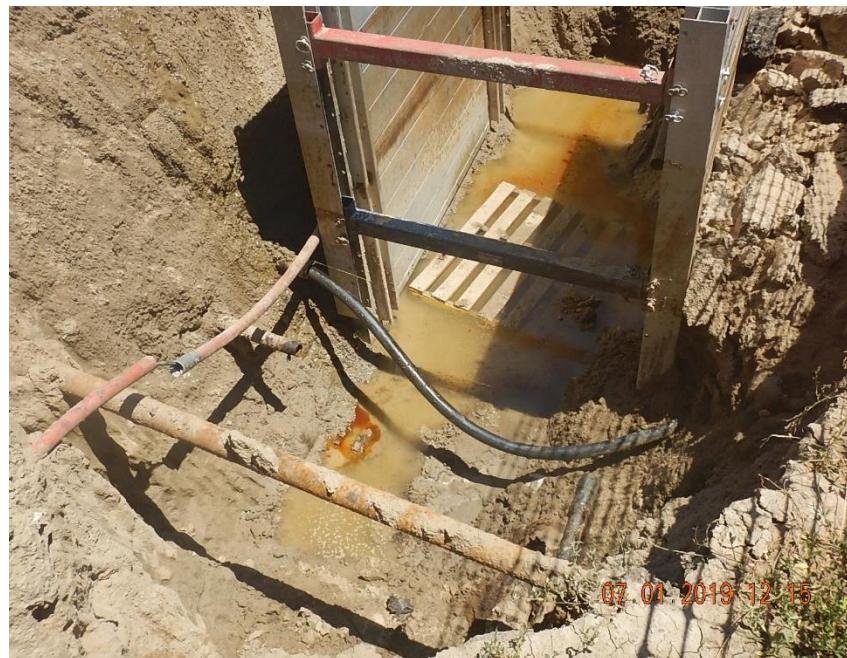
View of excavation and flowline repair/ replacement work in progress. Note: free product (crude oil) is present at trench bottom (on water). Photo taken 7/1/2019

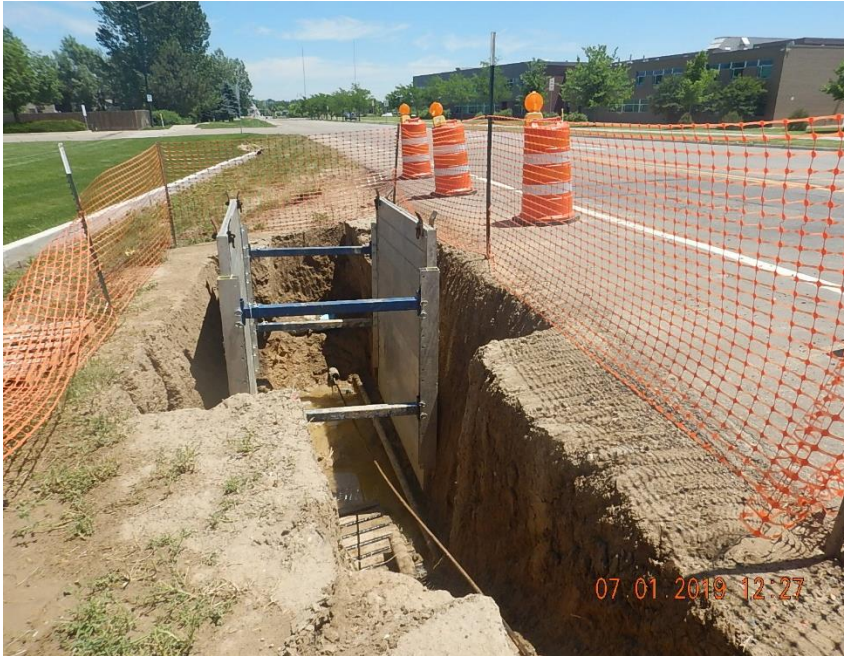
View of second excavation approximately 1250' west of spill ID #463820. An attempt to install a 2" HDPE pipe via slip line was unsuccessful. View east/ photo date 7/1/19

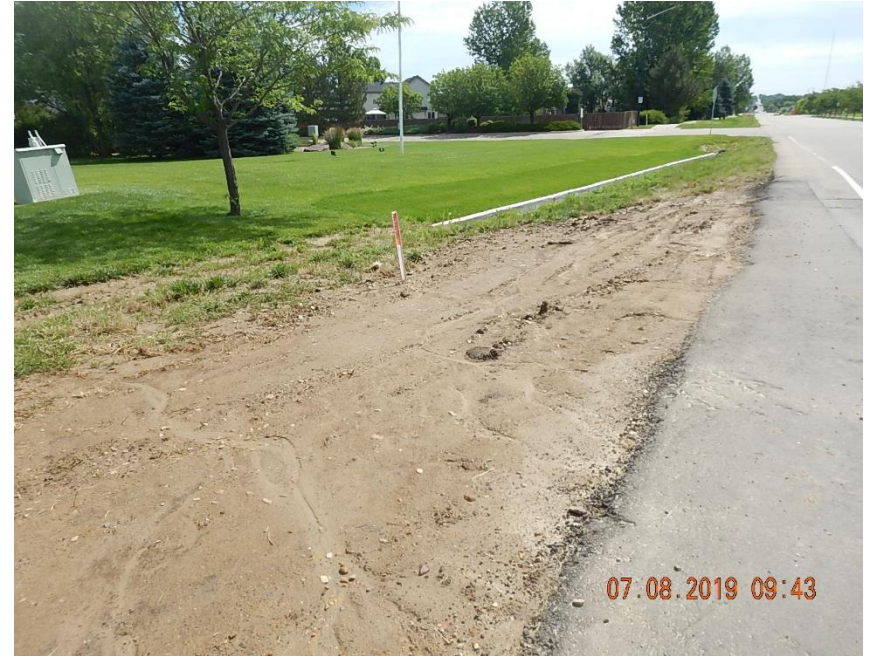
**Second excavation backfilled as observed on 7/8/19.
View looking east along Tipple Parkway.**

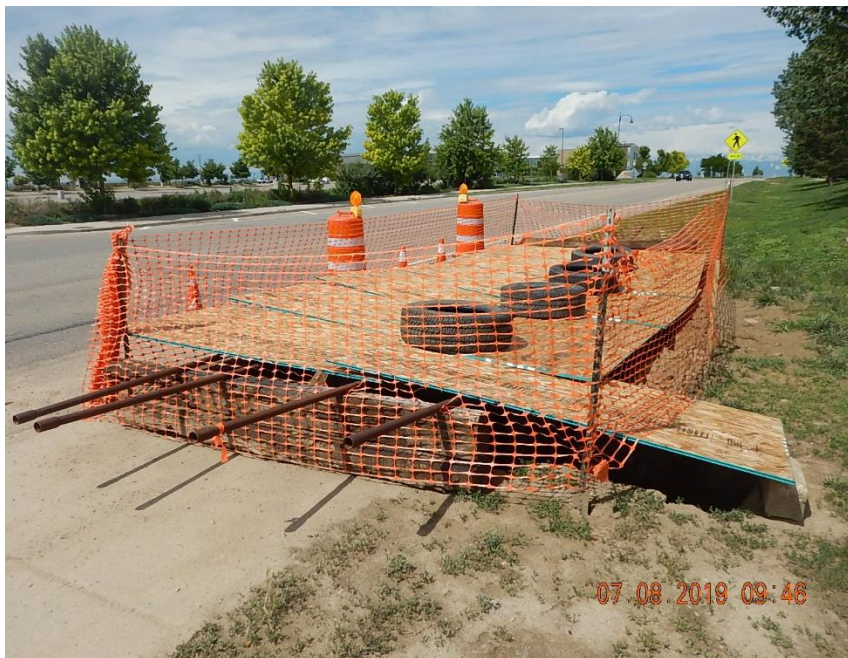
Excavation fenced and covered on 7/8/2019. View to west.

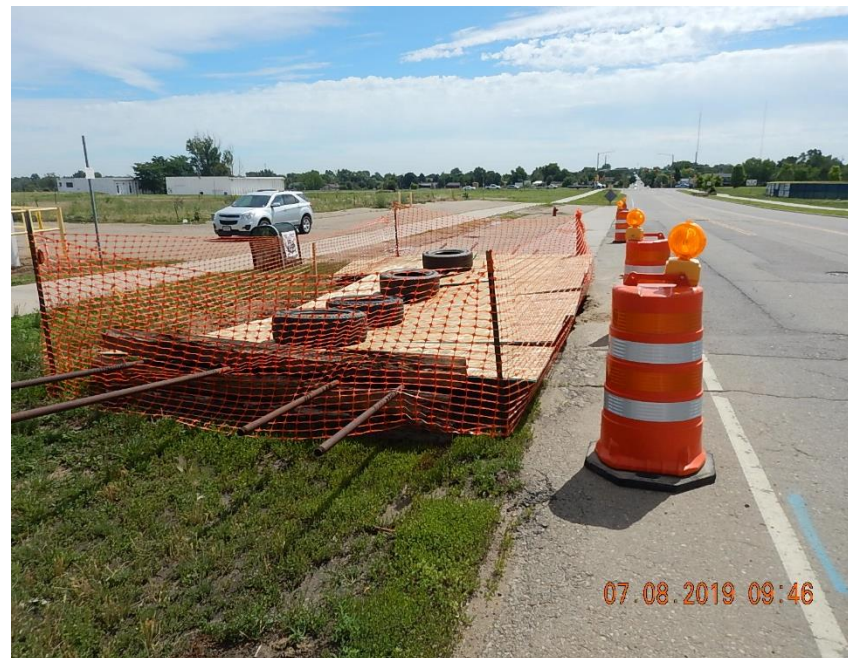
Excavation fenced and covered on 7/8/2019. View to east.
