Inspection Photos
Location Name: LORENCITO 12-9-34-66
API#: 05-071-06654
INSP. #: 695100988

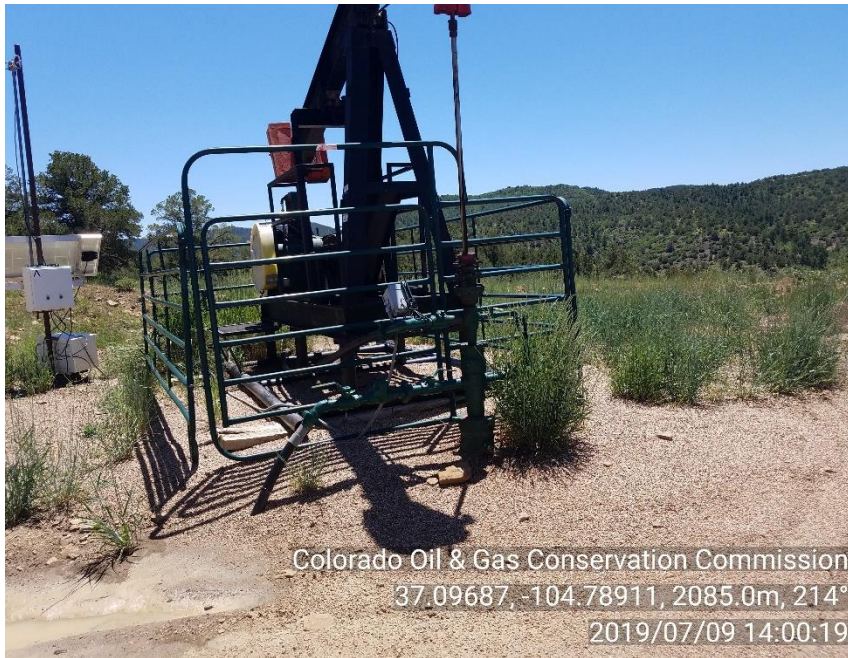
PHOTO 1: WELLHEAD

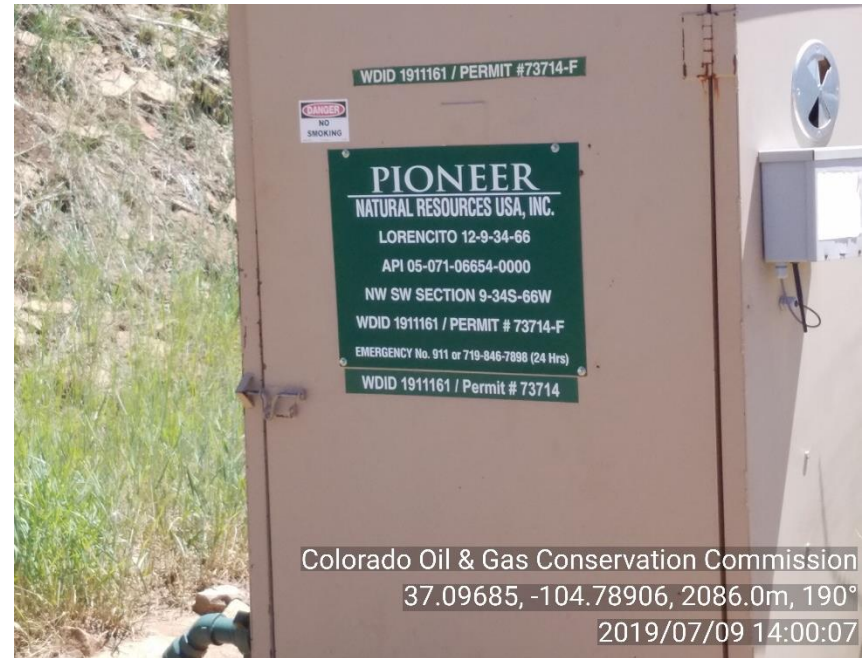
PHOTO 2: WELL SIGN

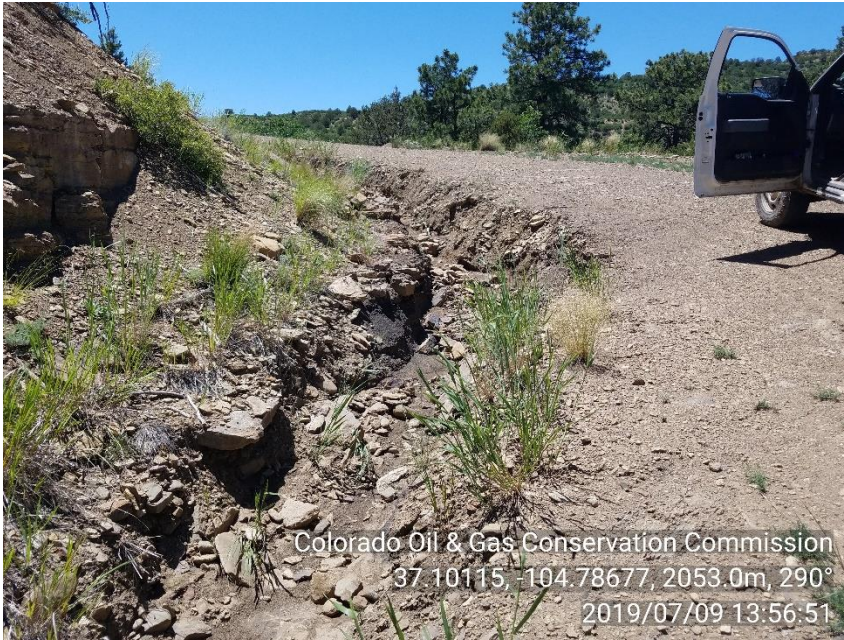
PHOTO 3: EROSION IN DITCH ALONG ACCESS ROAD NORTH OF LOCATION. REPAIR EROSION, INSTALL BMP'S AND MAINTAIN IN ACCORDANCE WITH 1002.f. CA DATE 8/9/19.

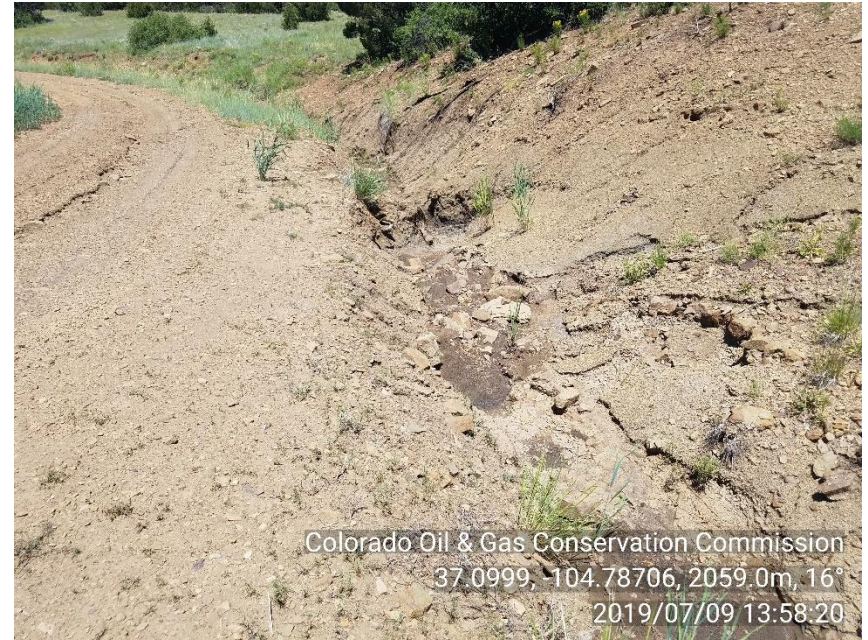
PHOTO 4: EROSION IN DITCH ALONG ACCESS ROAD NORTH OF LOCATION. REPAIR EROSION, INSTALL BMP'S AND MAINTAIN IN ACCORDANCE WITH 1002.f. CA DATE 8/9/19.

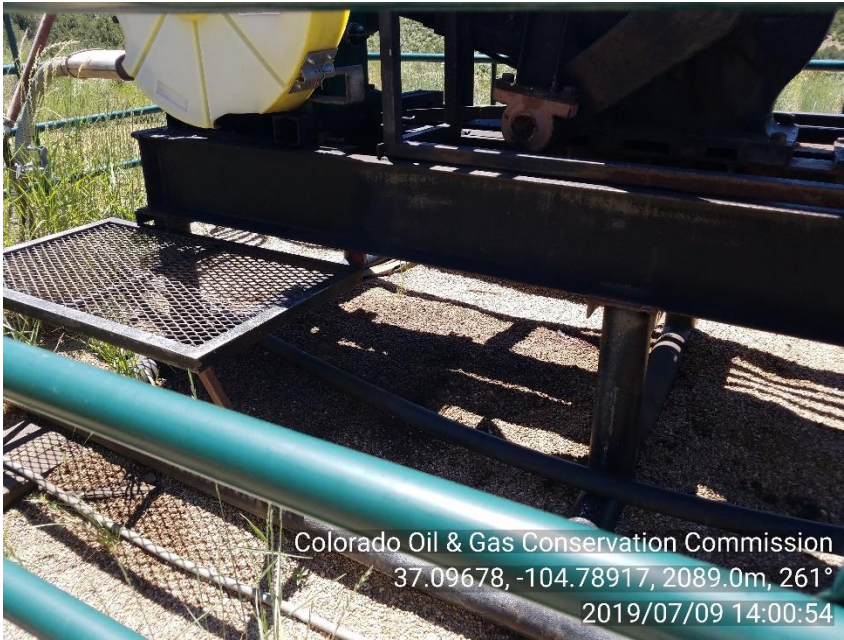
PHOTO 5: IMPACTED SOIL UNDER PUMPJACK PRIME MOVER AND GEAR BOX. Remove and dispose impacted material in approved manner, service and maintain equipment and self inspect to prevent recurrence of conditions per 1002.f(2) and 907. CA DATE 8/9/19
