Inspection Photos

API: 05-009-06555

Operator: LORENTZ OIL & GAS

Inspection Date: 7/9/2019

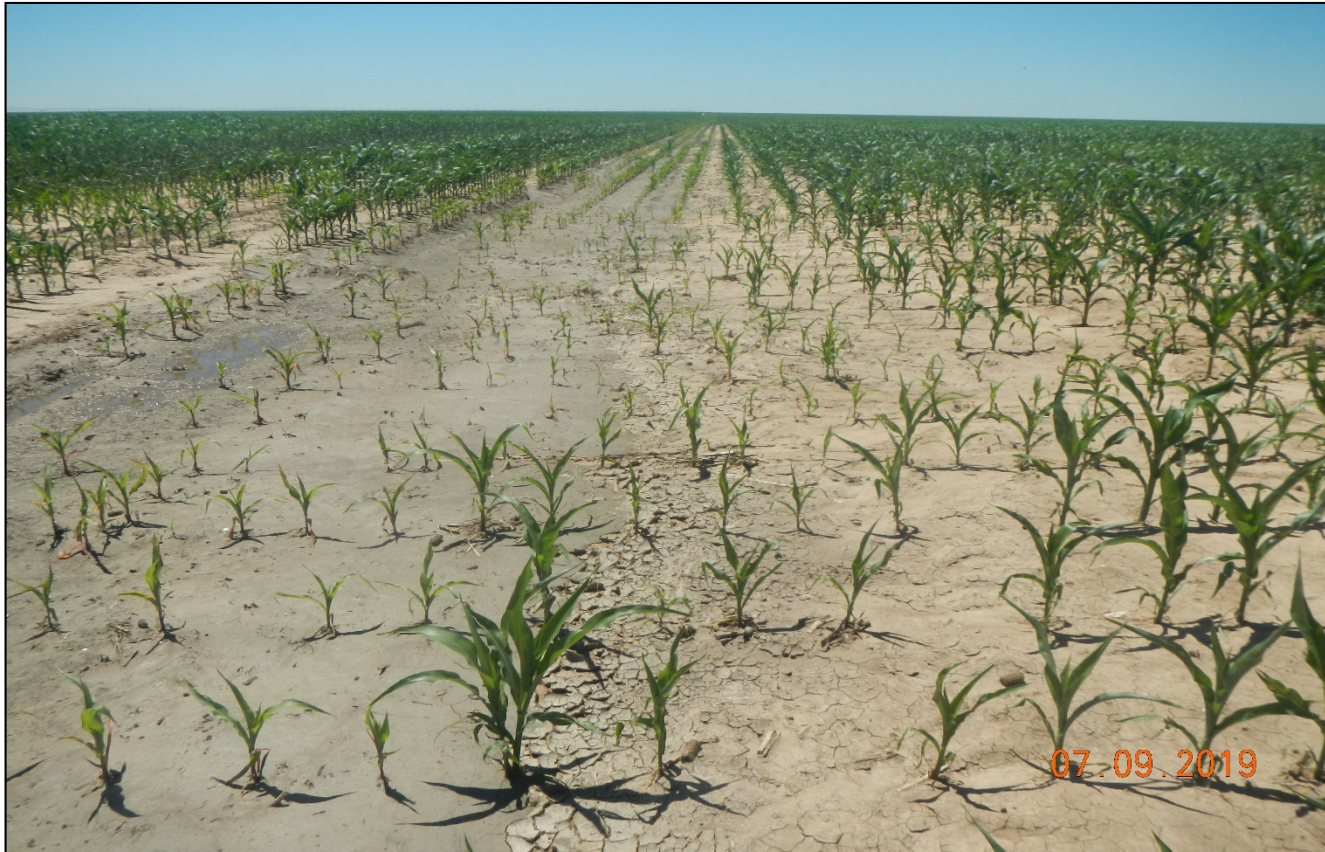
Photo 1. Facing south along the former access road. Crop is stunted and has not reestablished.

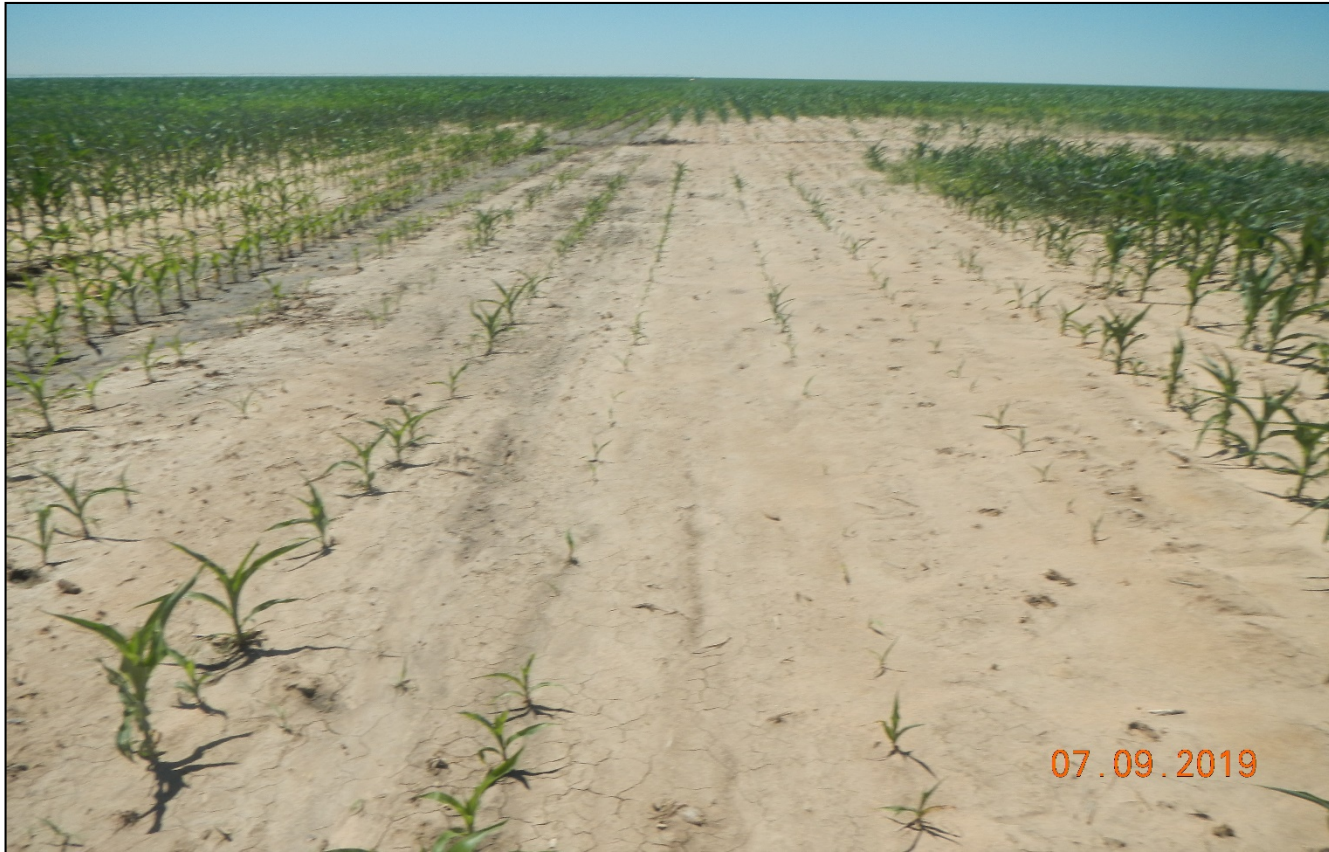
Photo 2. Facing south toward the location. Crop has not reestablished.

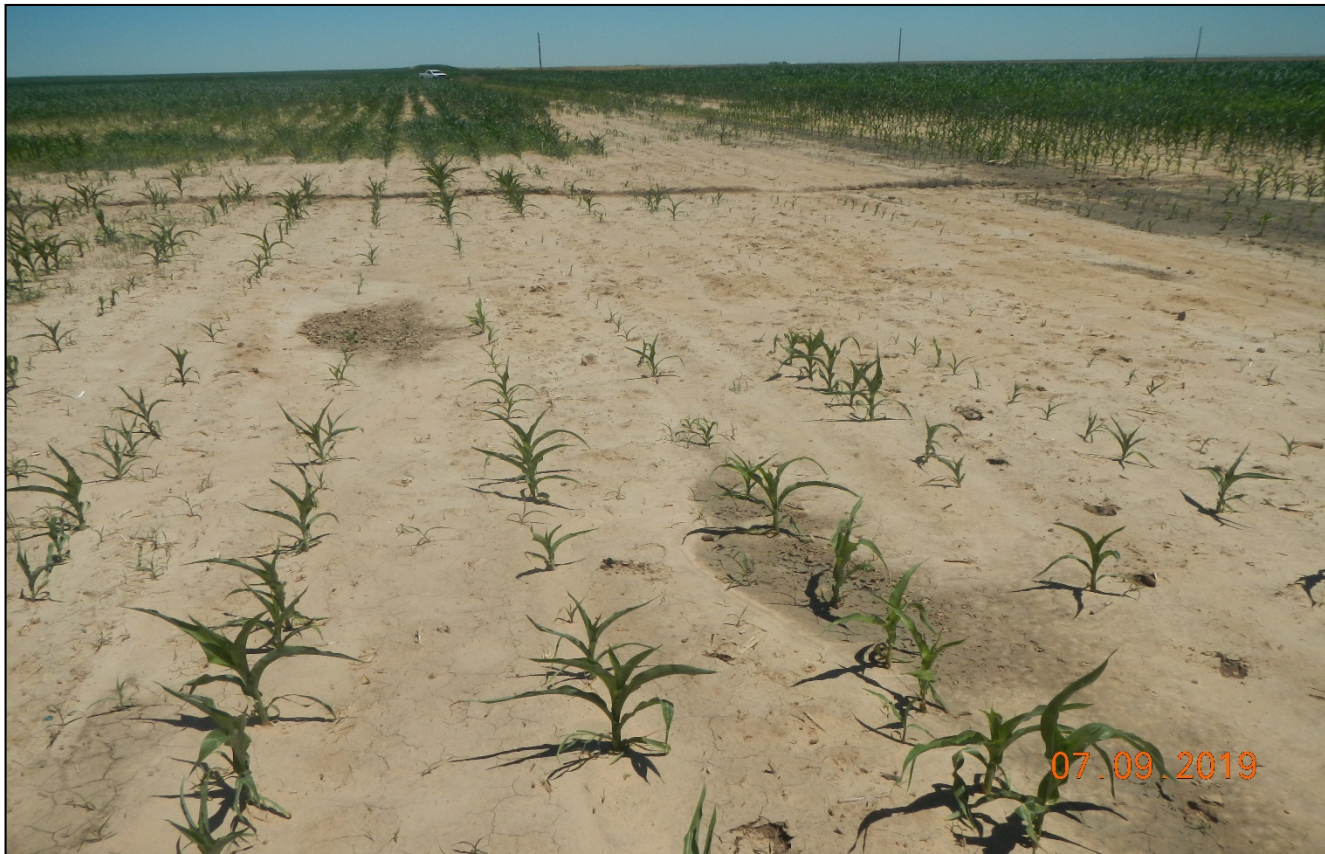
Photo 3. Facing north toward the location. Crop has not reestablished.

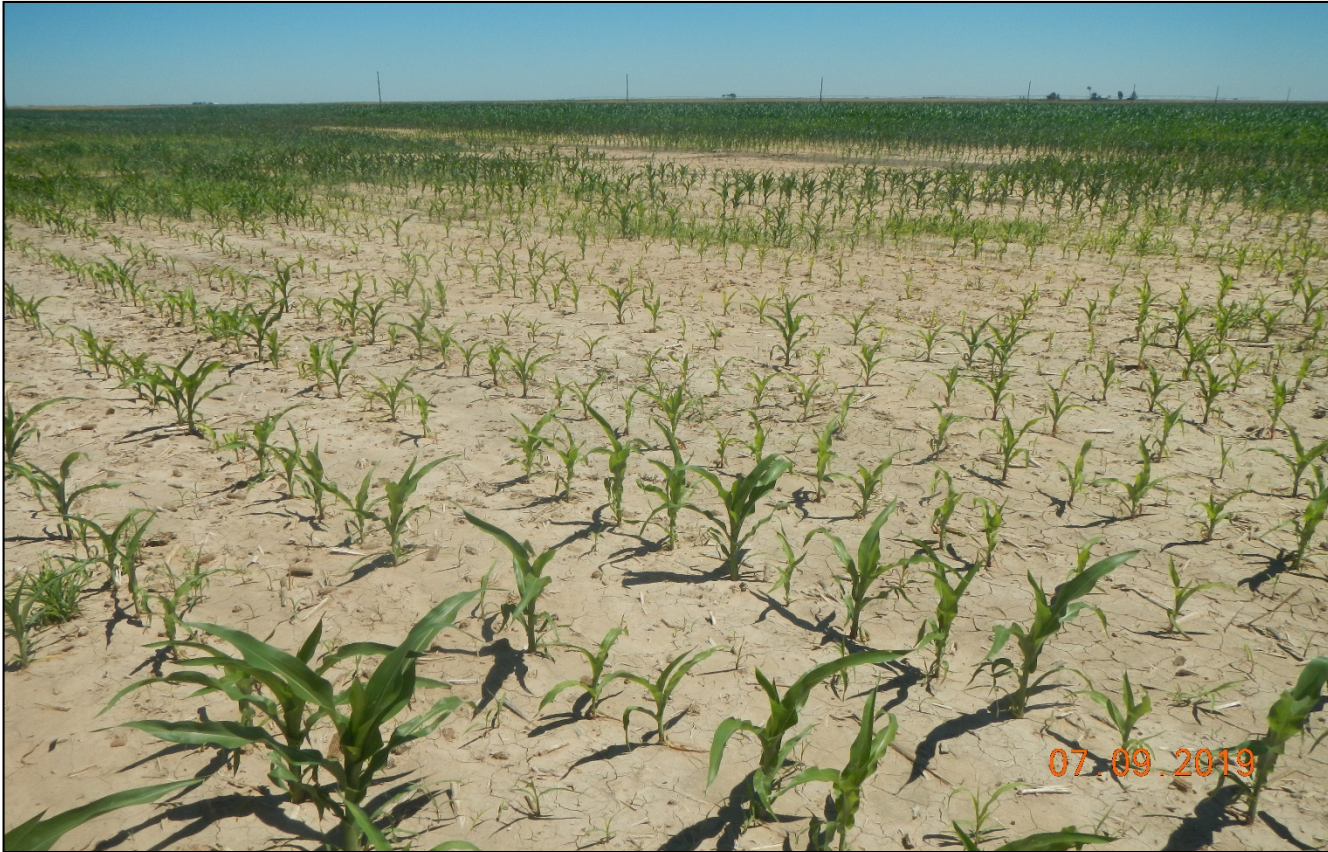
Photo 4. Facing northeast toward the location. Crop is stunted and has not reestablished.

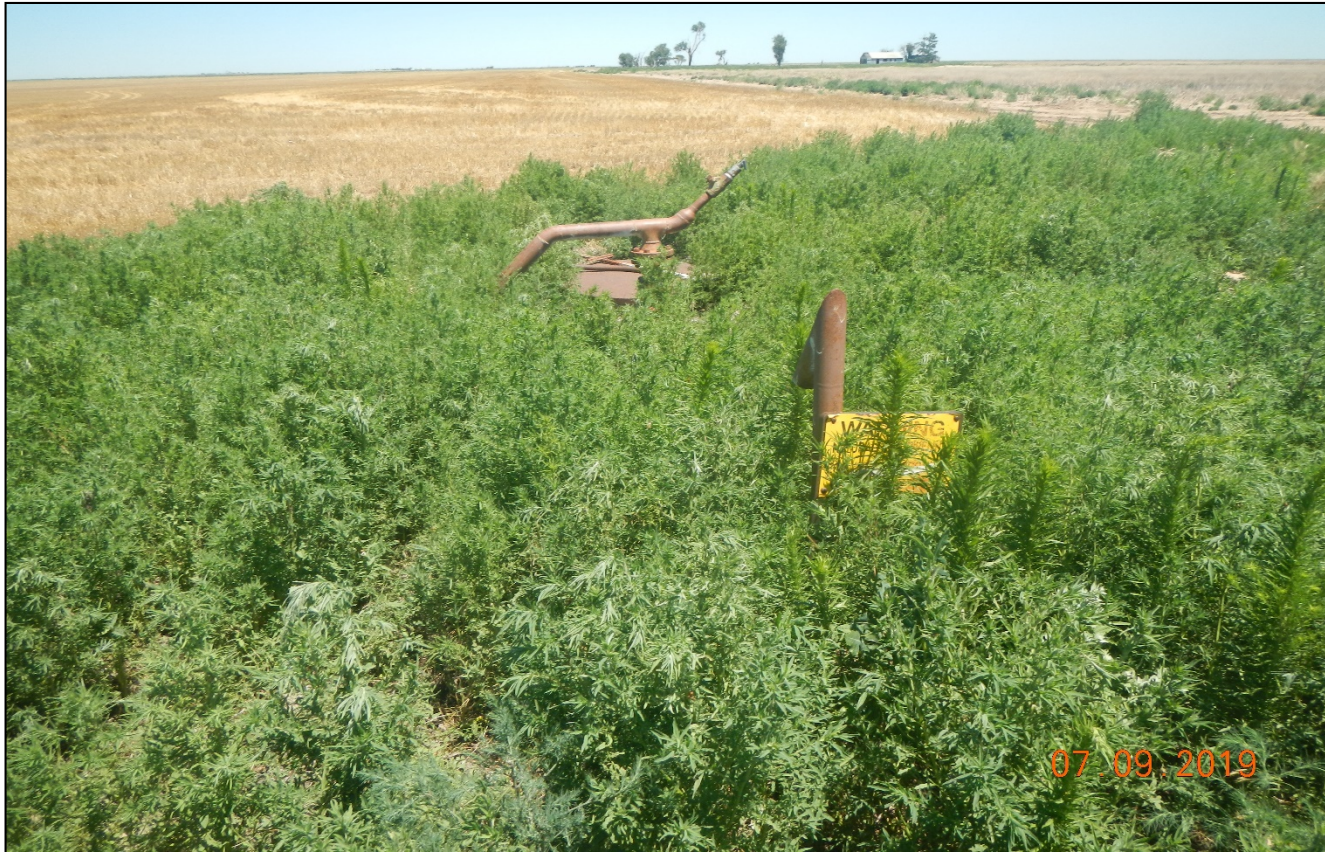
Photo 5. There is a pipe riser that remains on the north side of the county road approximately 2700' to the northeast of the well site.

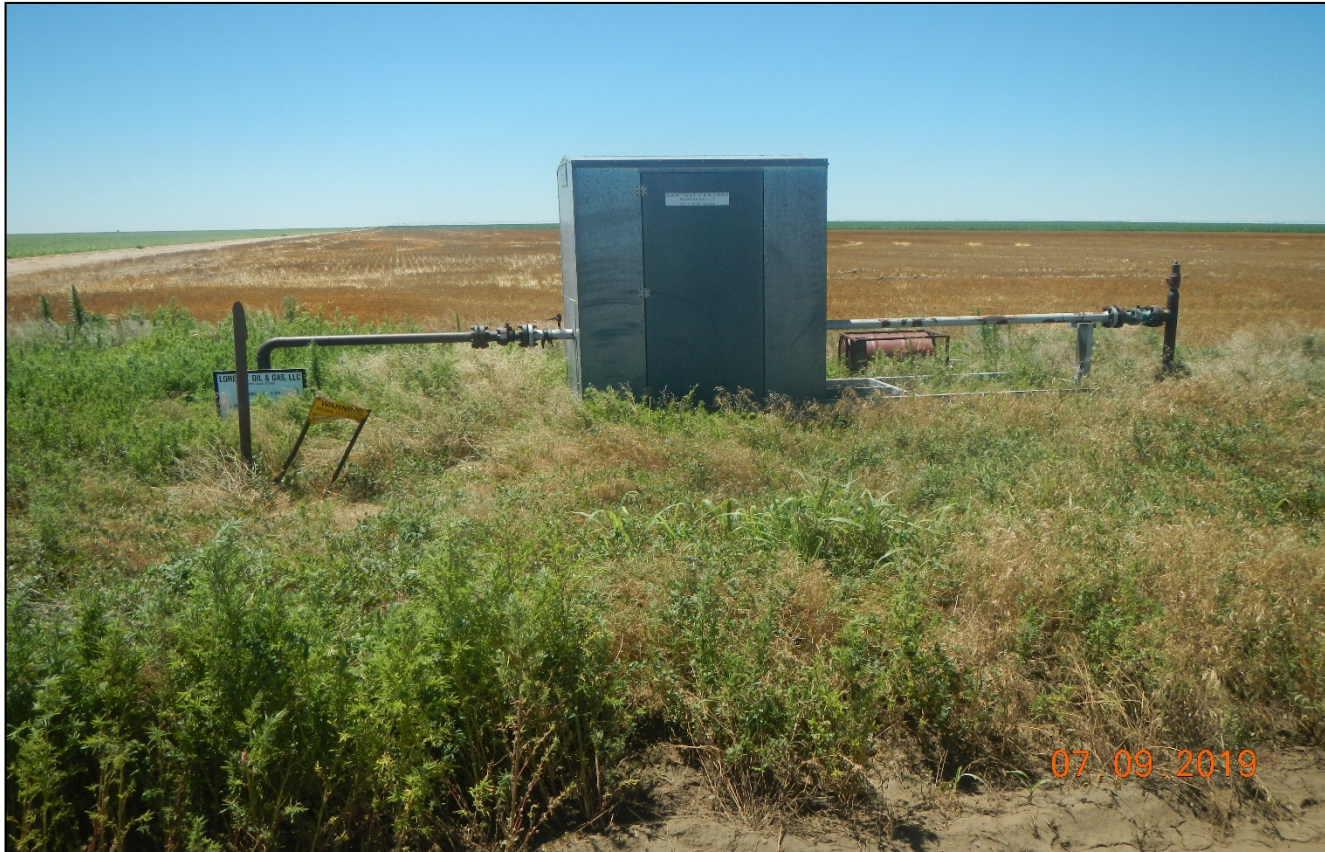
Photo 6. There is a pipe riser and meter shed that remains on the south side of the county road approximately 2700' to the northeast of the well site.

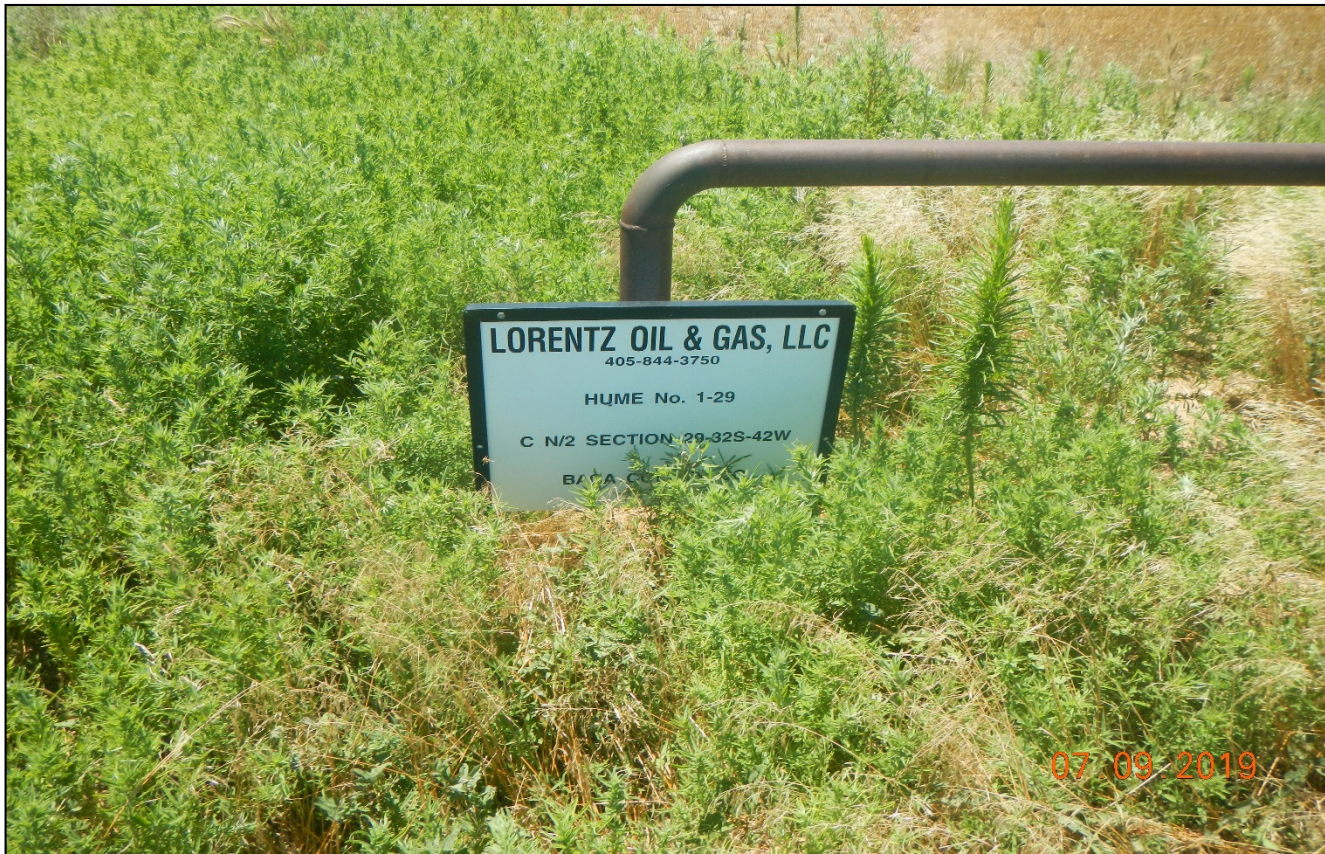
Photo 7. Sign that remains at the meter shed shown in previous picture.
