Inspection Photos

API: 05-009-06643

Operator: CHOLLA PRODUCTION

Inspection Date: 7/9/2019

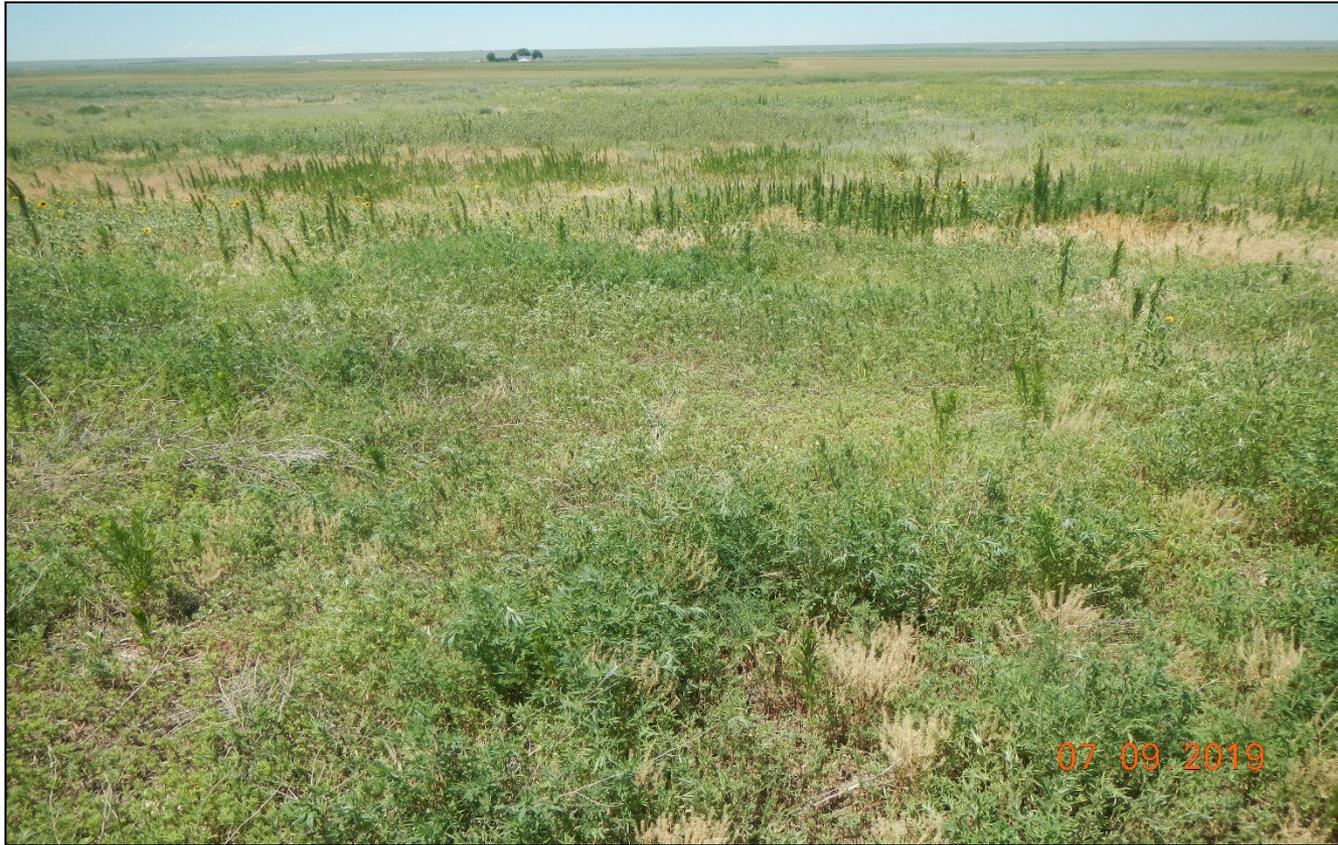
Photo 1. Facing north at the location.

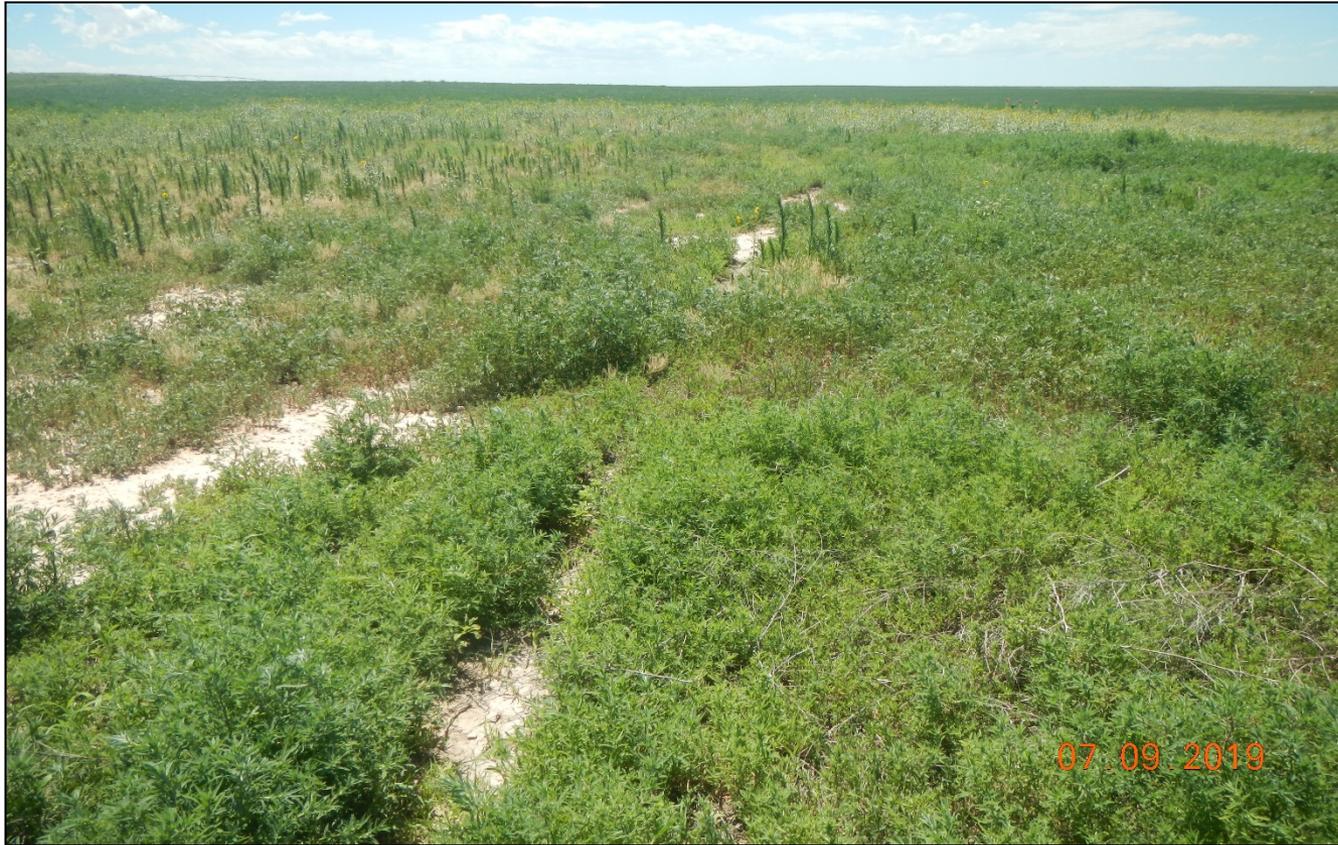
Photo 2. Facing west at the location.

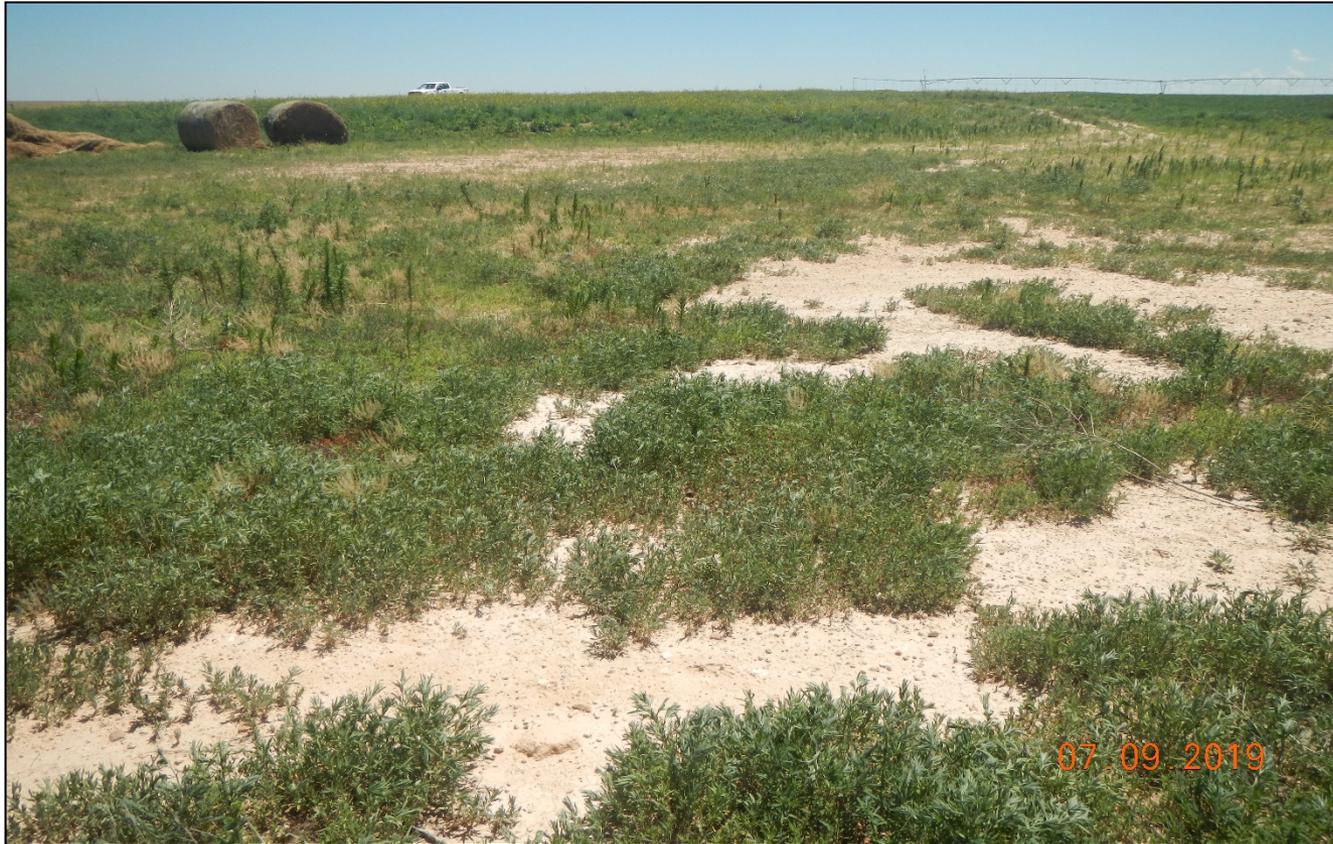
Photo 3. Facing south at the location.

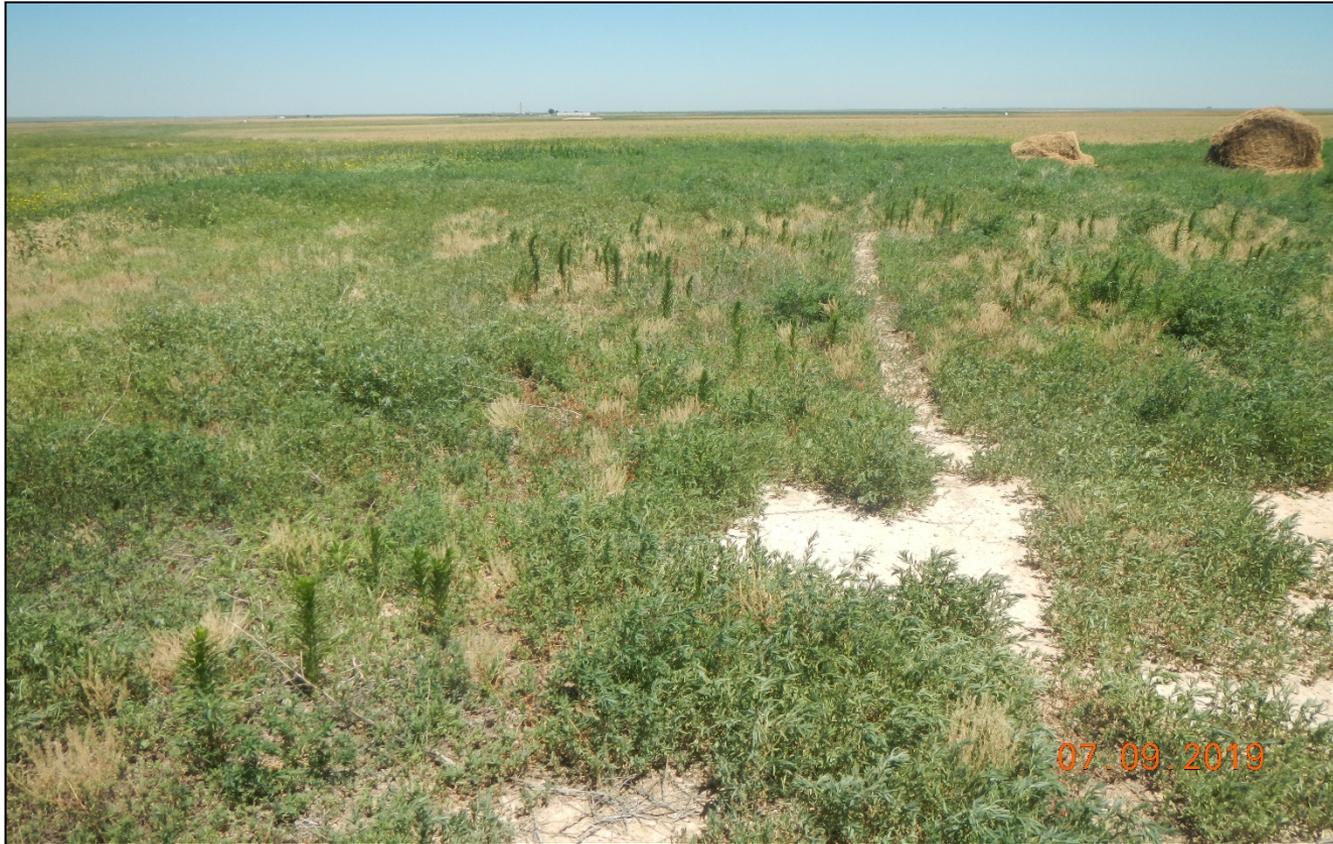
Photo 4. Facing east at the location.

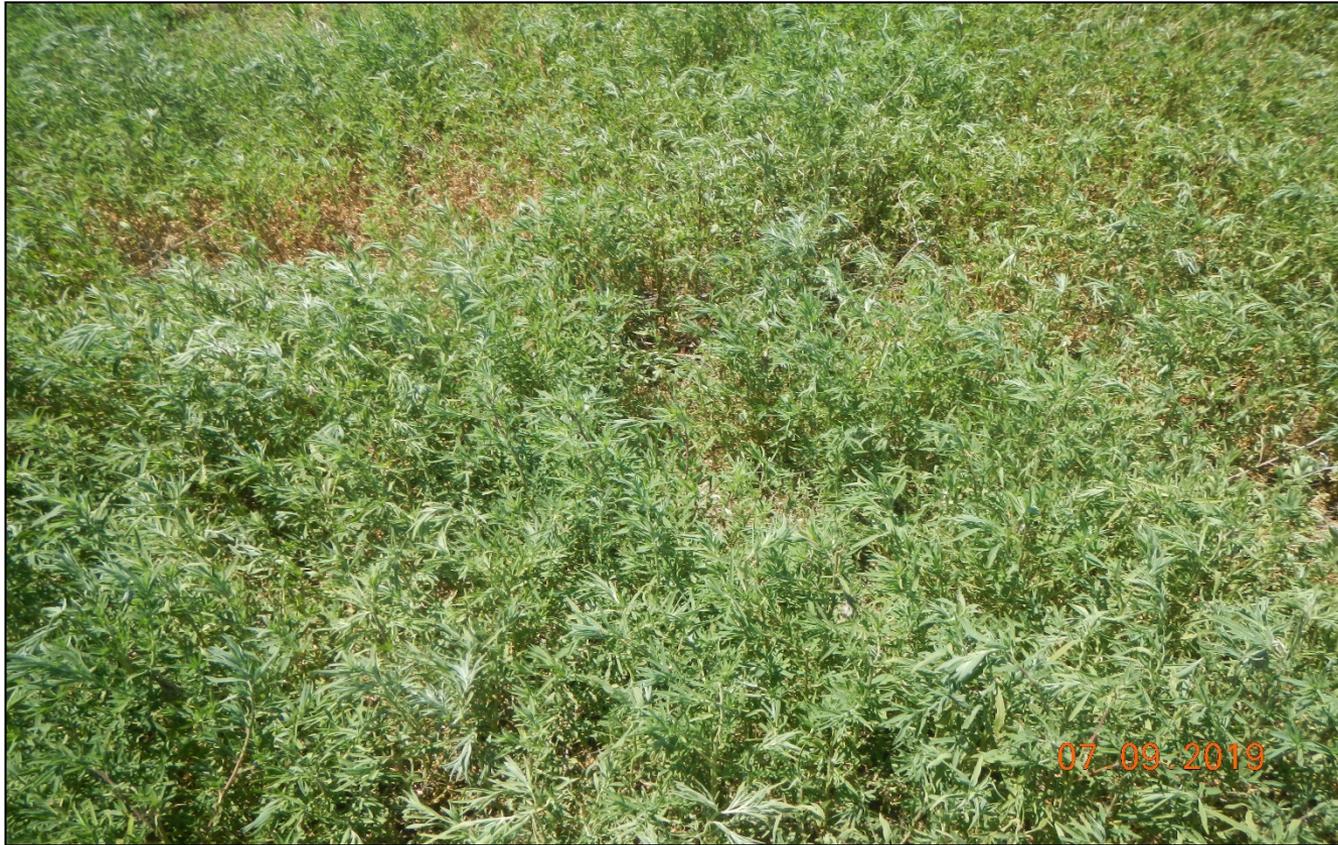
Photo 5. View of vegetation cover at the location consists of weedy species.

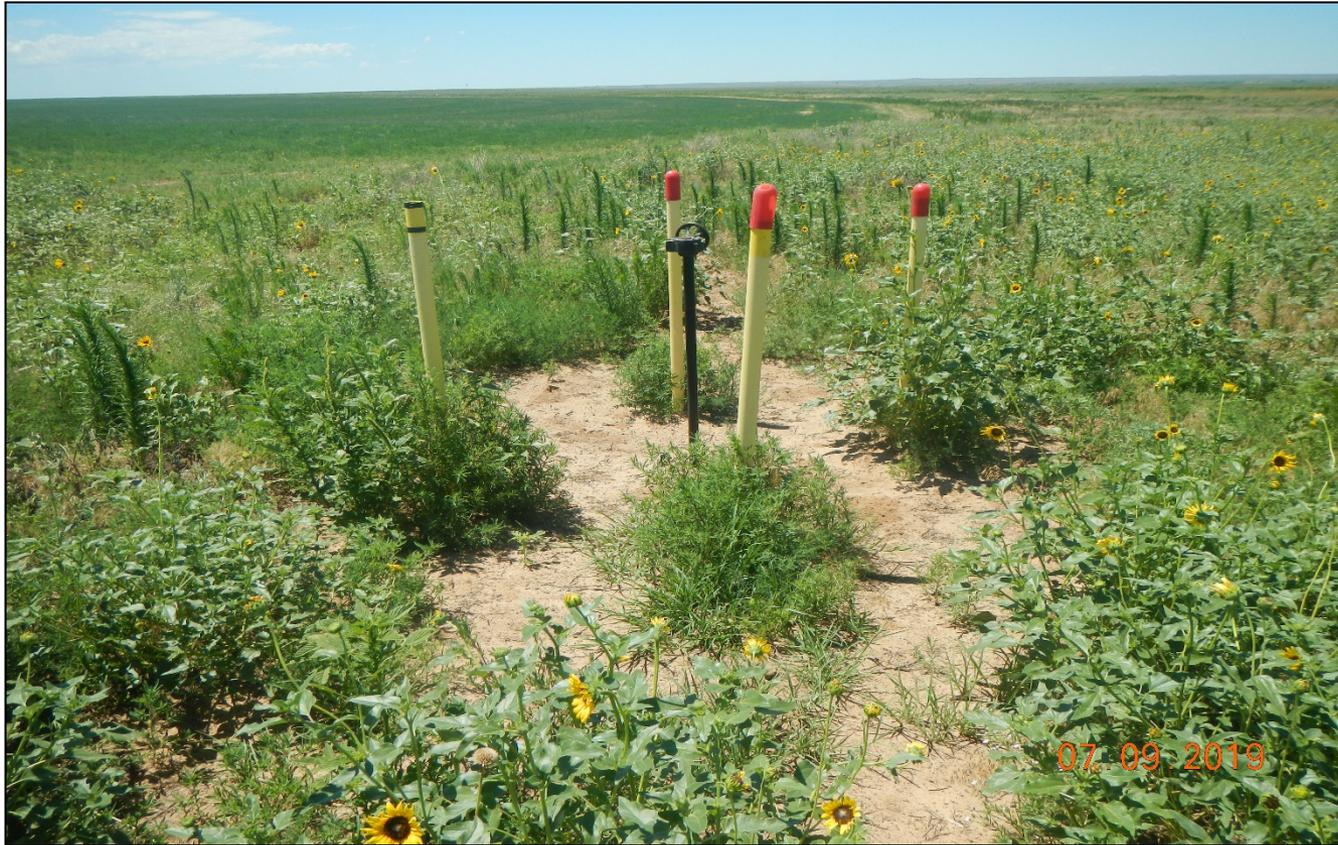
Photo 6. There is a pipe riser 150' west of the well site.

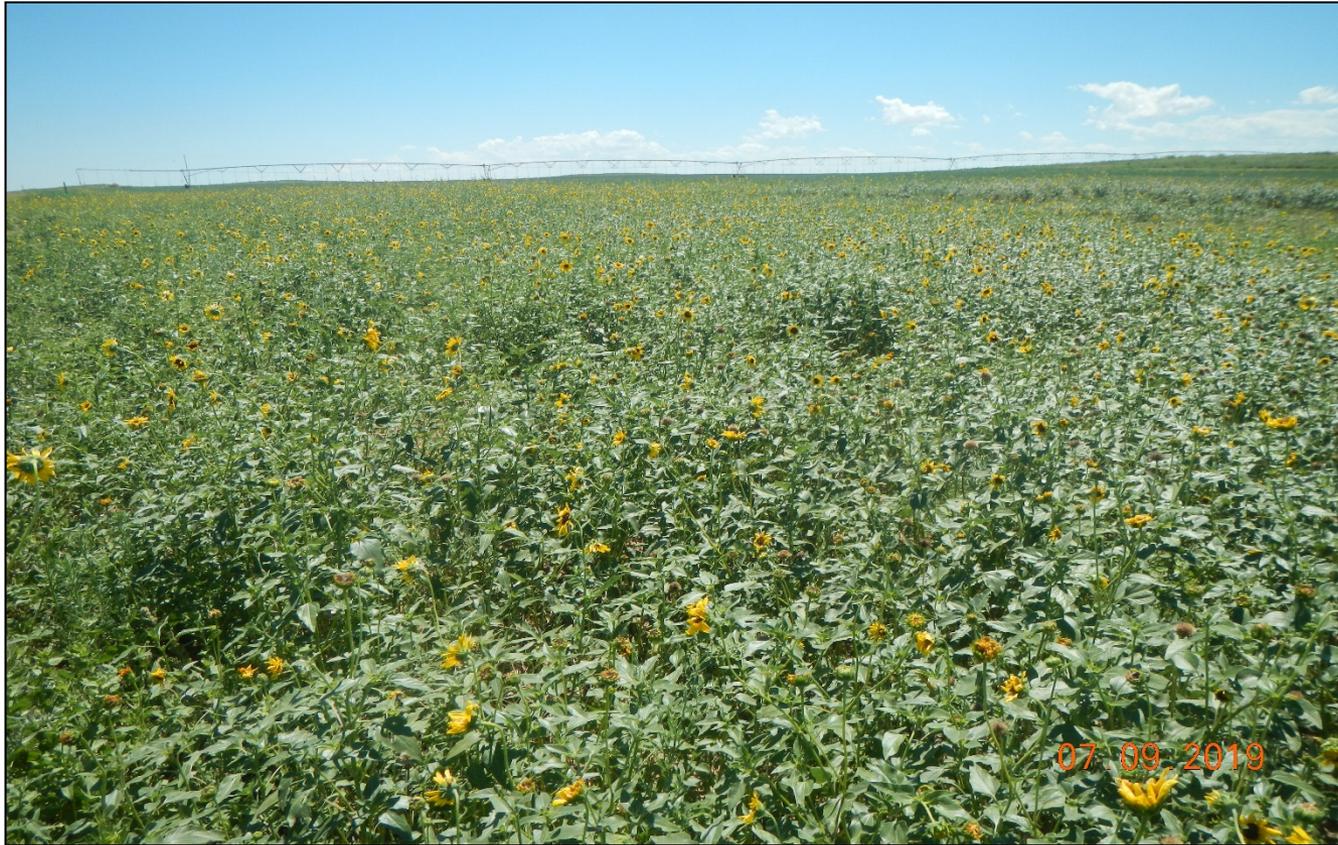
Photo7. Surrounding reference area consists of Common sunflowers.
