Inspection Photos  
Operator: Kinder Morgan  
Location/API #: 033-06081  
Date: 7-1-2019

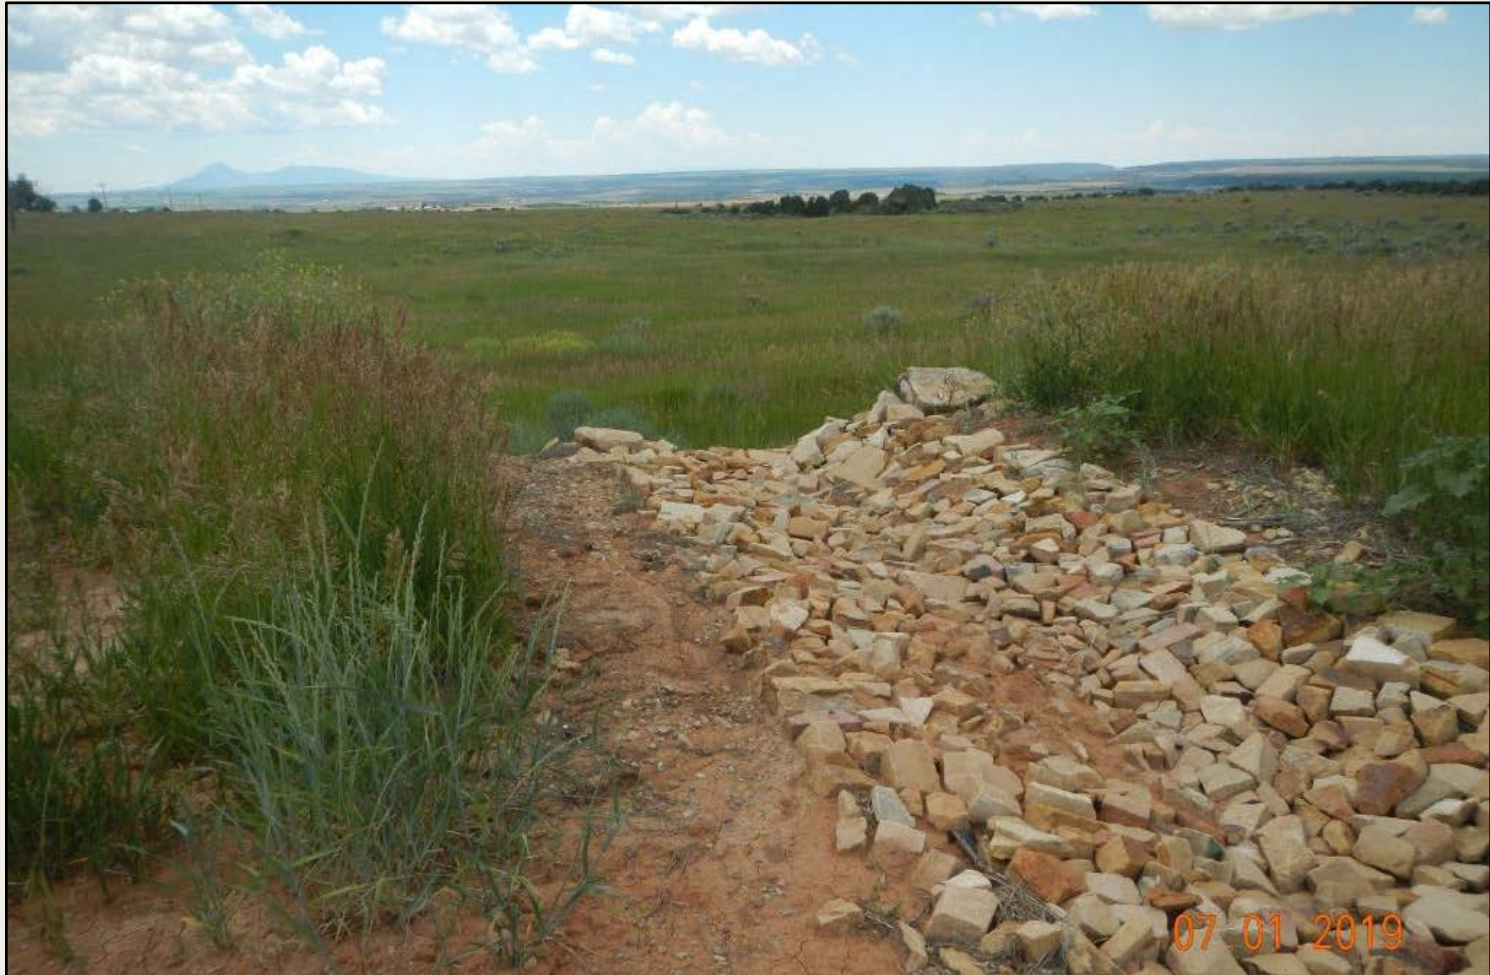
Photo 1. View of course rock run-down within the southern project area, appears newly installed.

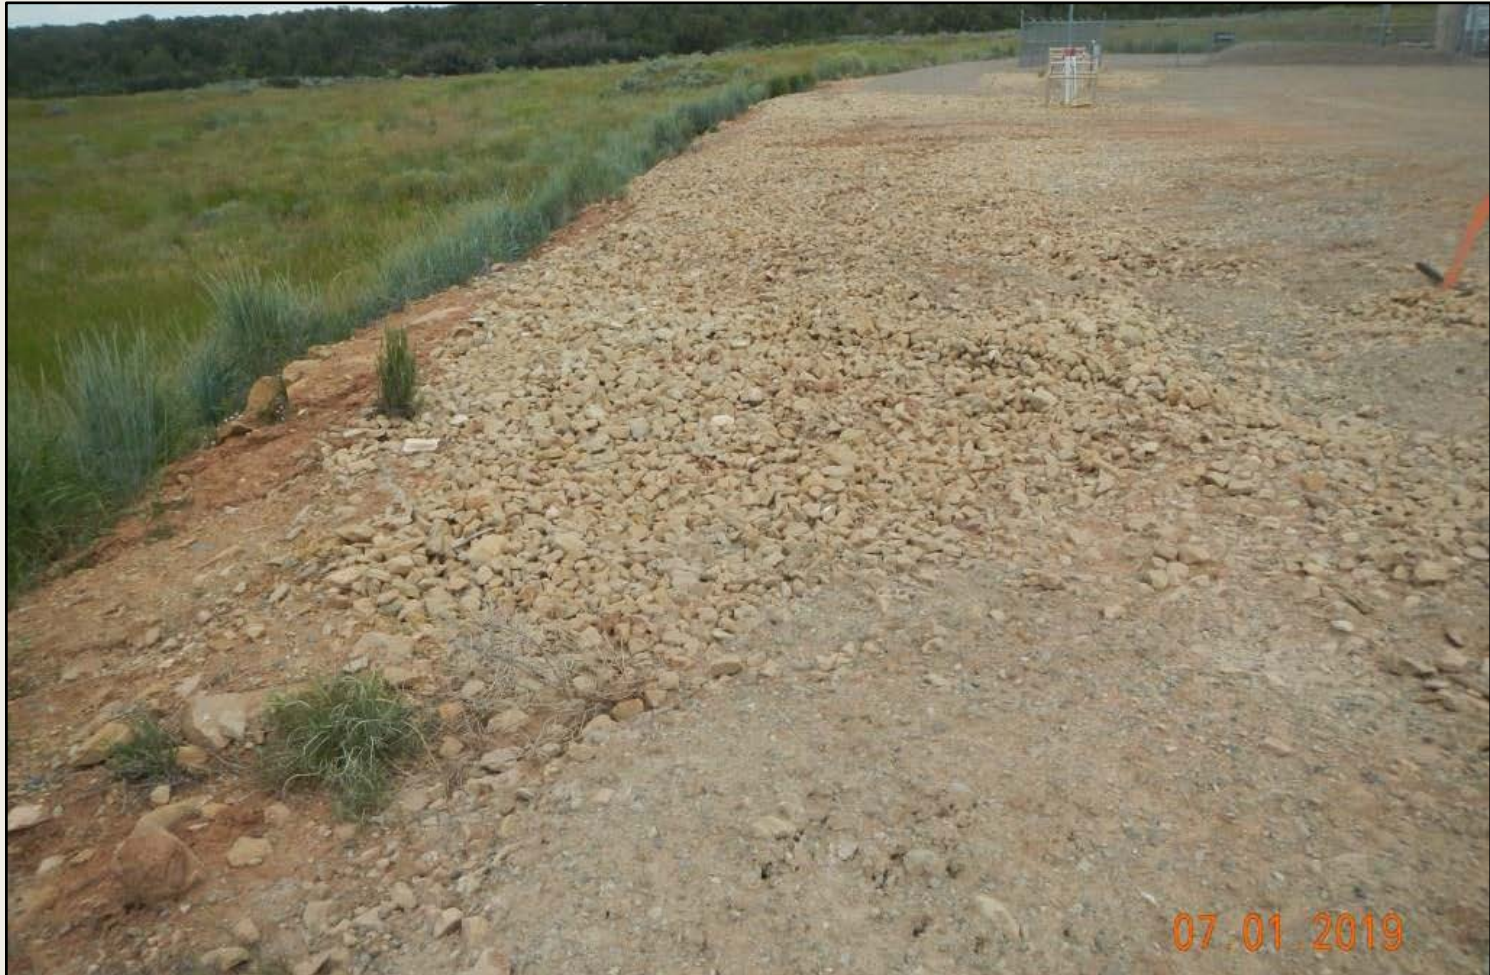
Photo 2. View of rock placement along the western edge of the well pad above eroding slopes. This appears newly installed and will require monitoring as well pad slopes southwestward.

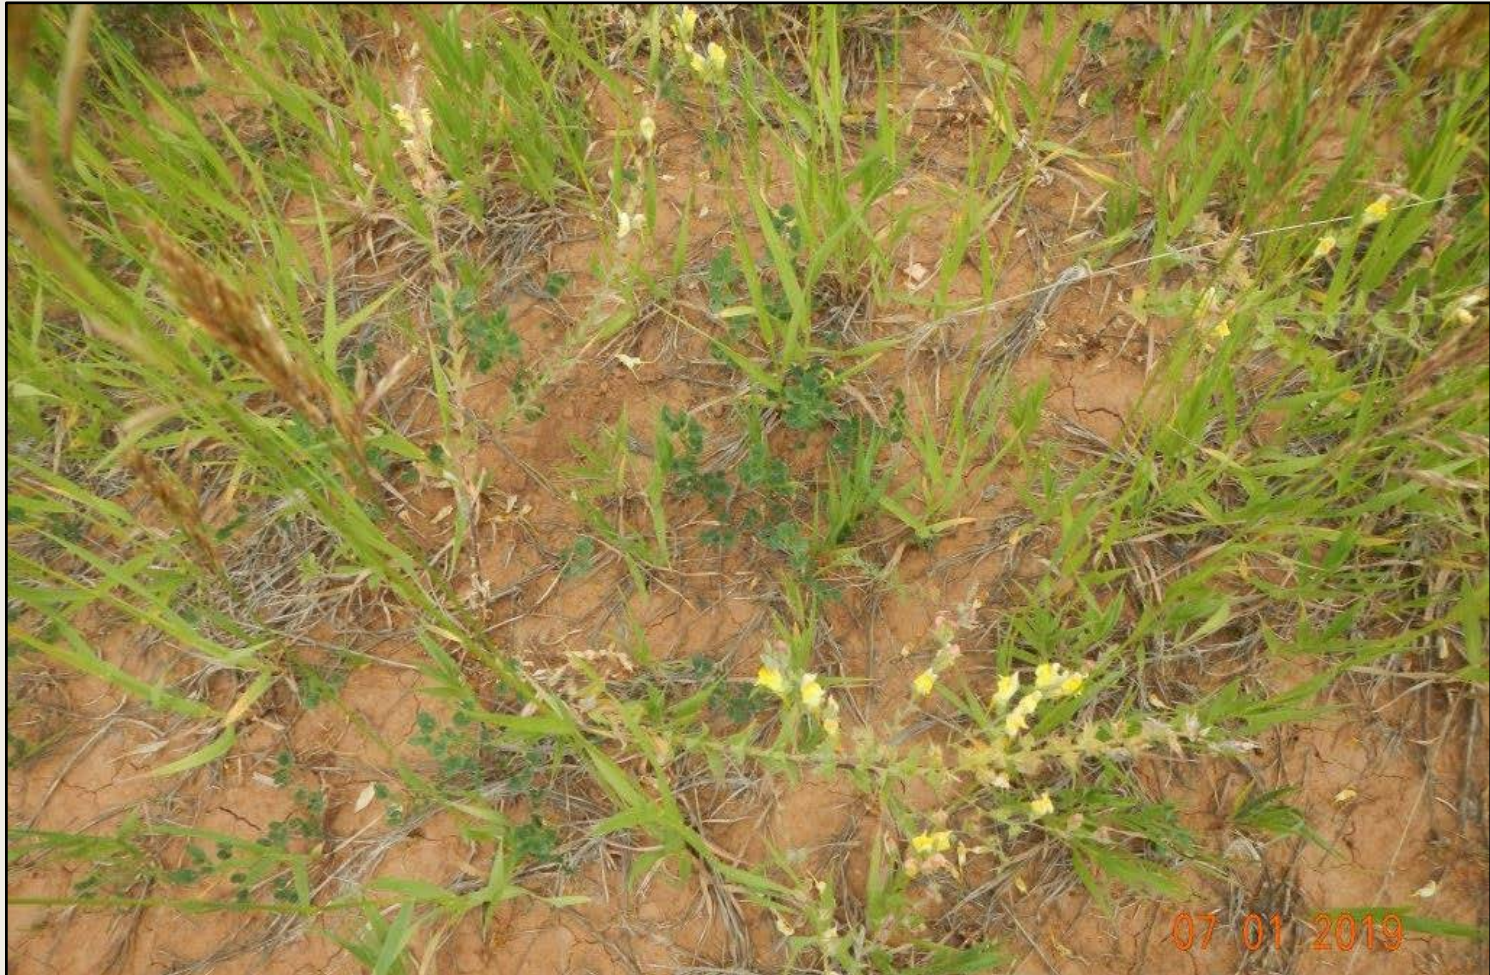
Photo 3. View of dalmatian toadflax (yellow flowers; *Linaria dalmatica*) within the western project area.
