Caerus Piceance LLC
API # 05-077-09079
Inspection # 696600286

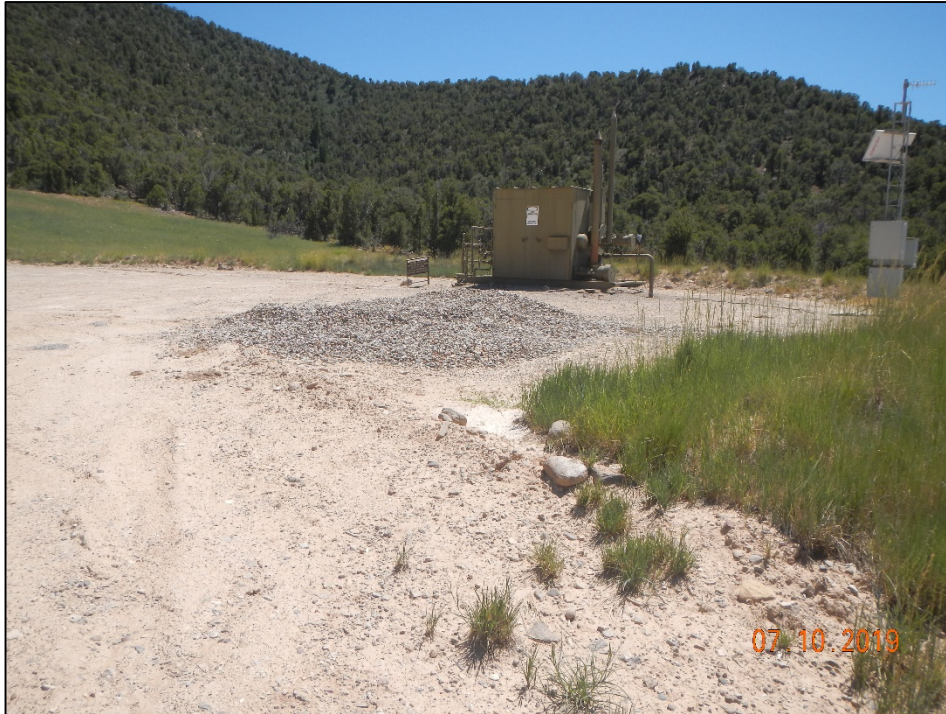
Photo #1. Photo at entrance of location.

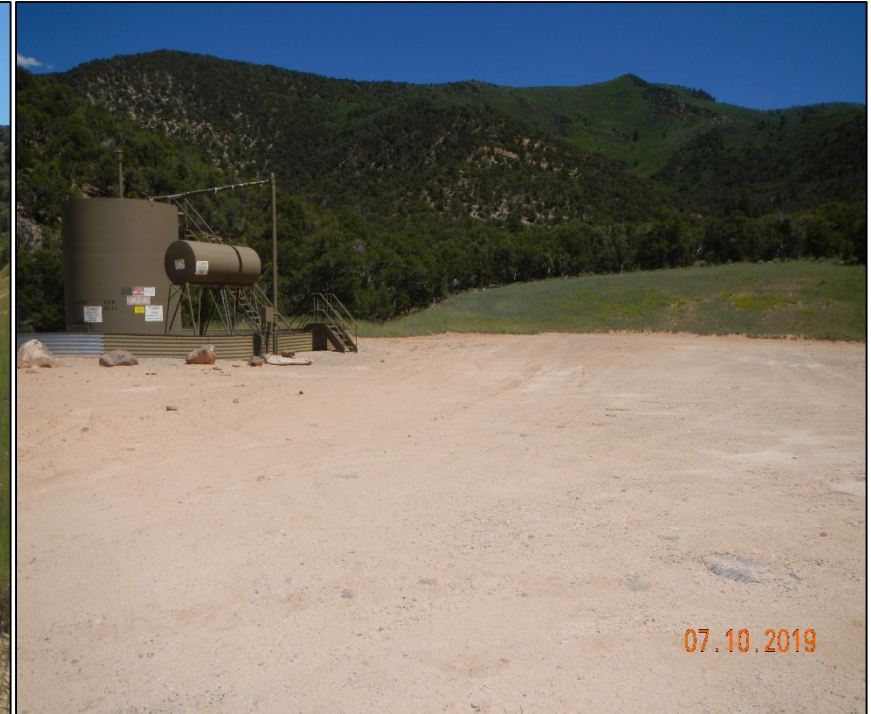
Photo #2 Photo at entrance of location.

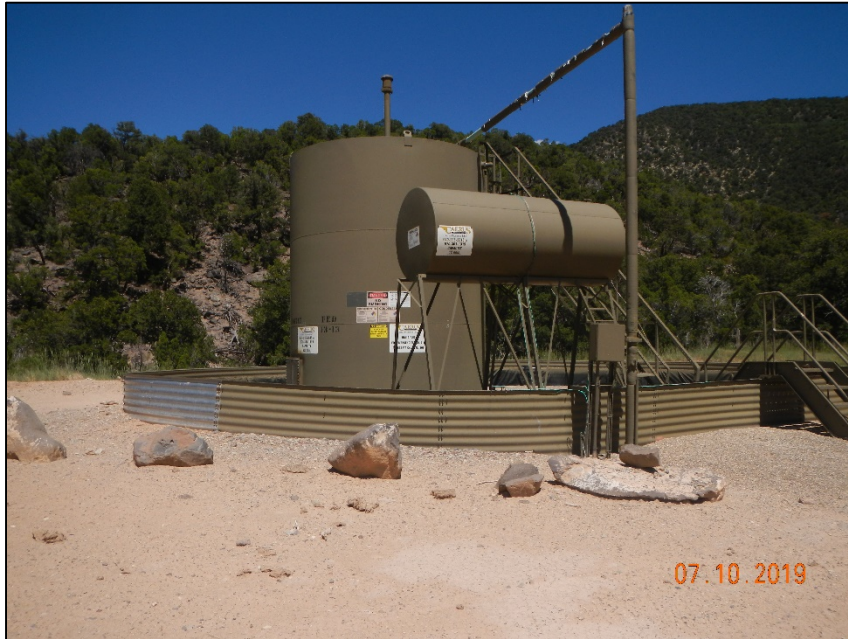
Photo #3. Photo of tank battery

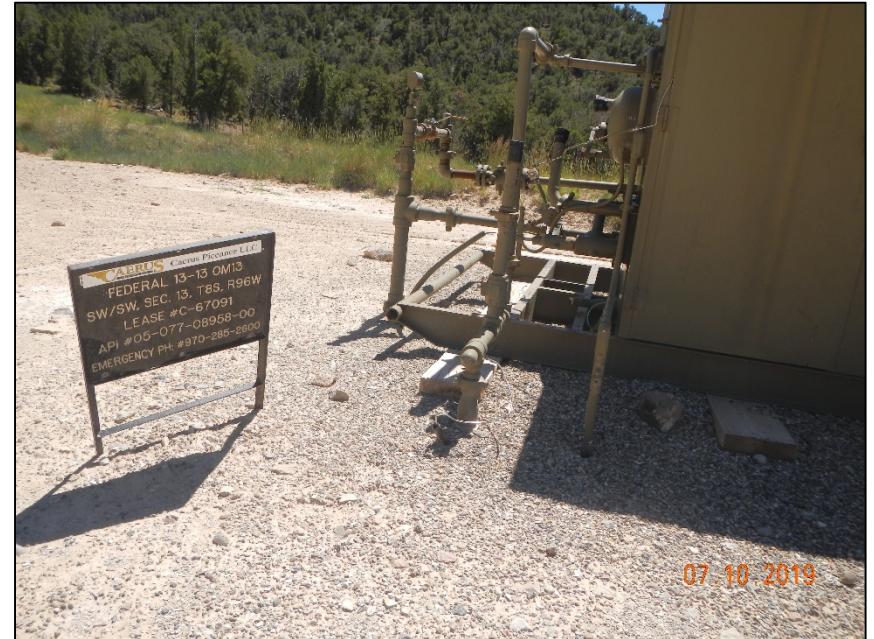
Photo #4 photo Separator

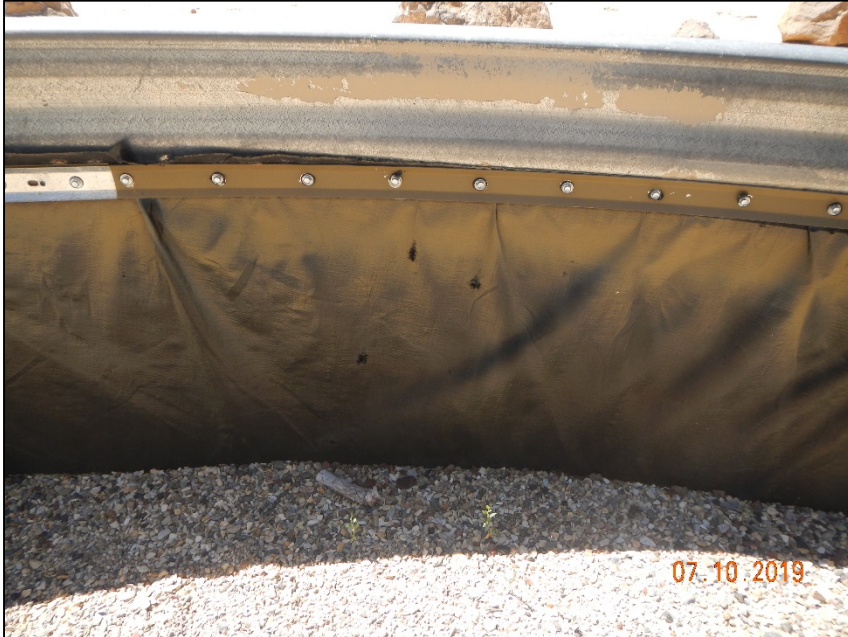
Photo #5 photo of holes in tank containment liner

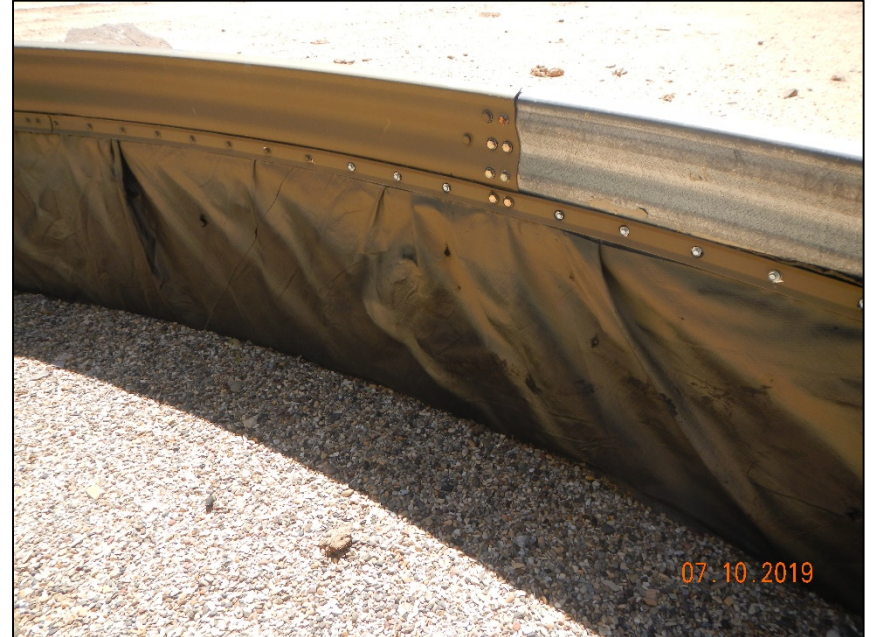
Photo #6 photo of holes in tank containment liner

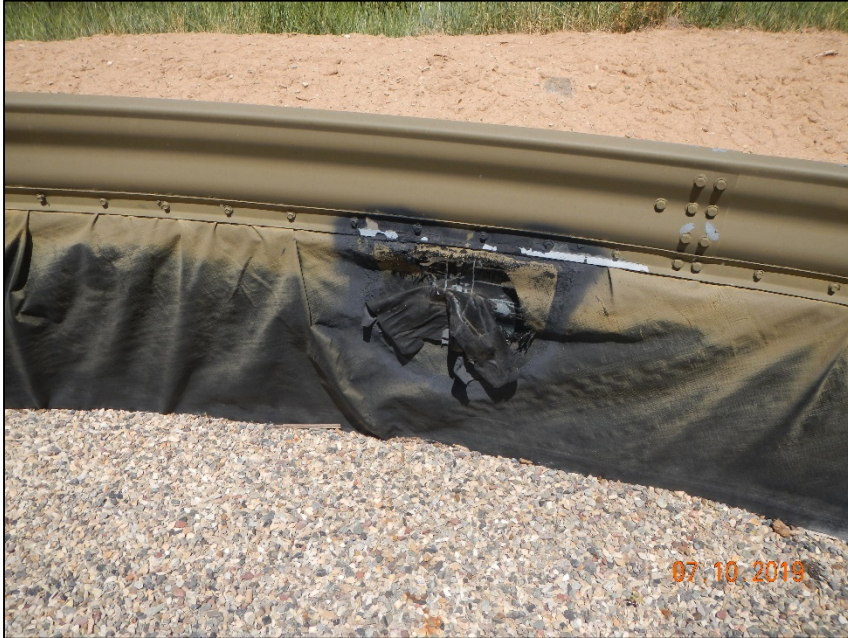
Photo #7 photo of holes in containment liner

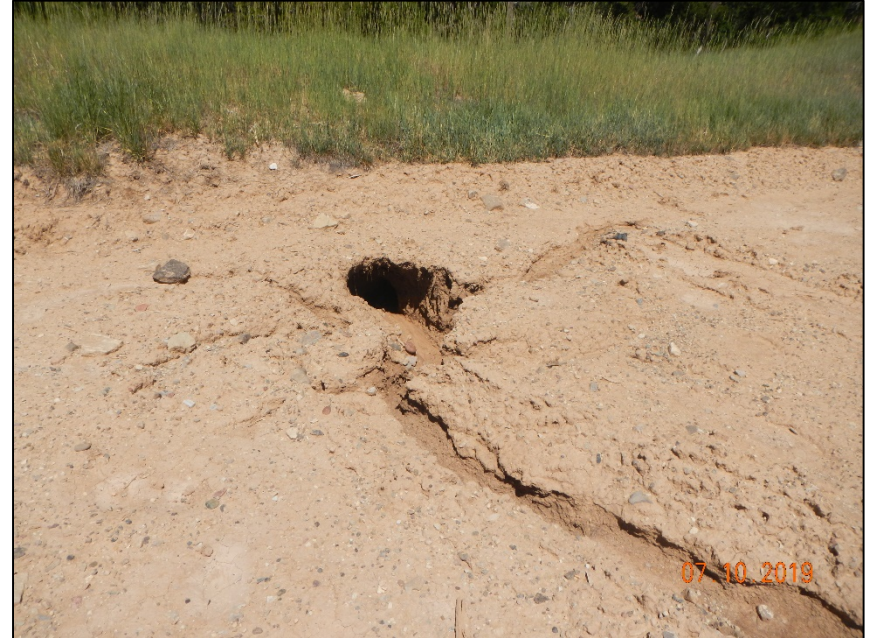
Photo #8 Erosion leading to a hole on location

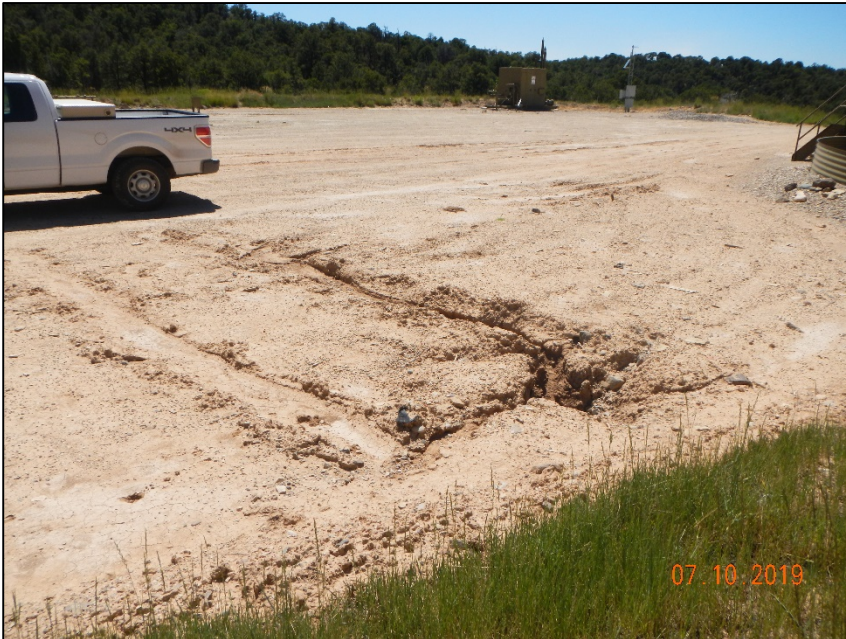
Photo #9 Erosion leading to a hole on location

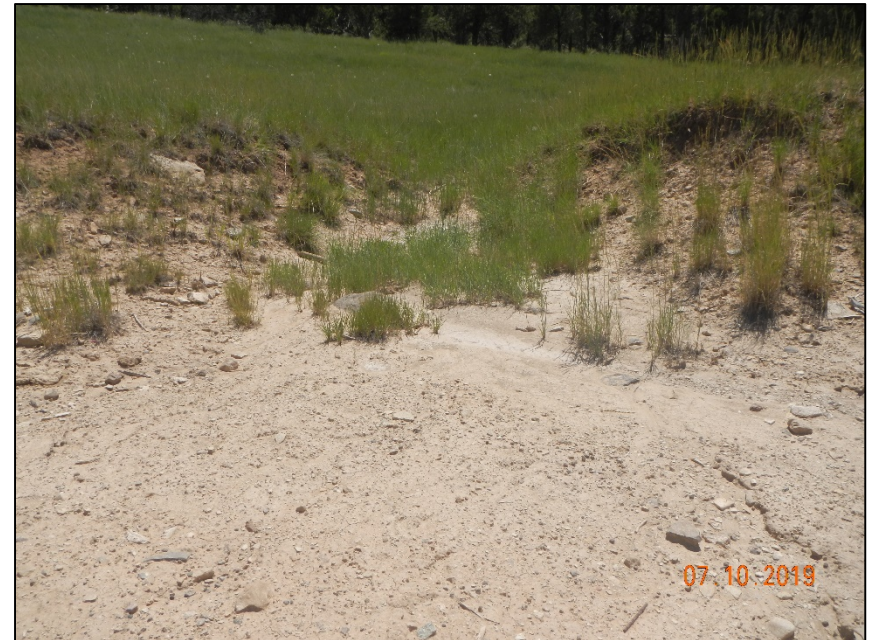
Photo #10 Storm water BMP need maintenance. Drain is full of sediment.

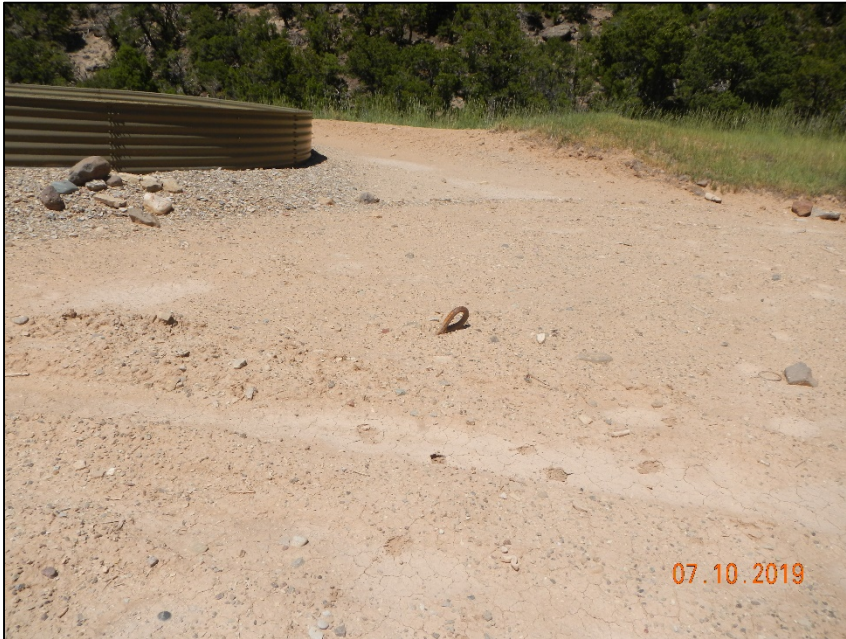
Photo #11 Deadman not marked

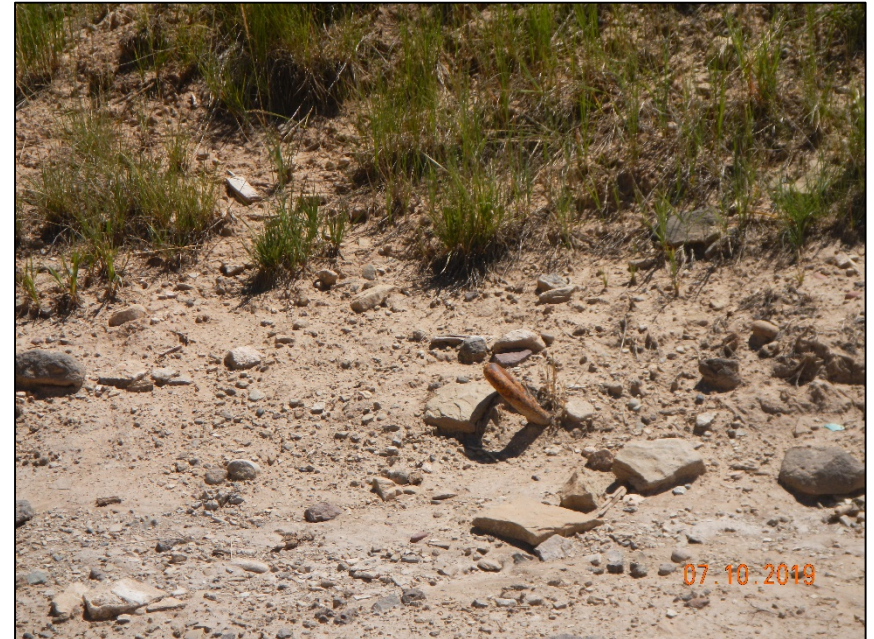
Photo #12 Deadman not marked
