Inspection Photos

API: 05-071-06598

Operator: EVERGREEN NATURAL RESOURCES

Inspection Date: 7/11/2019

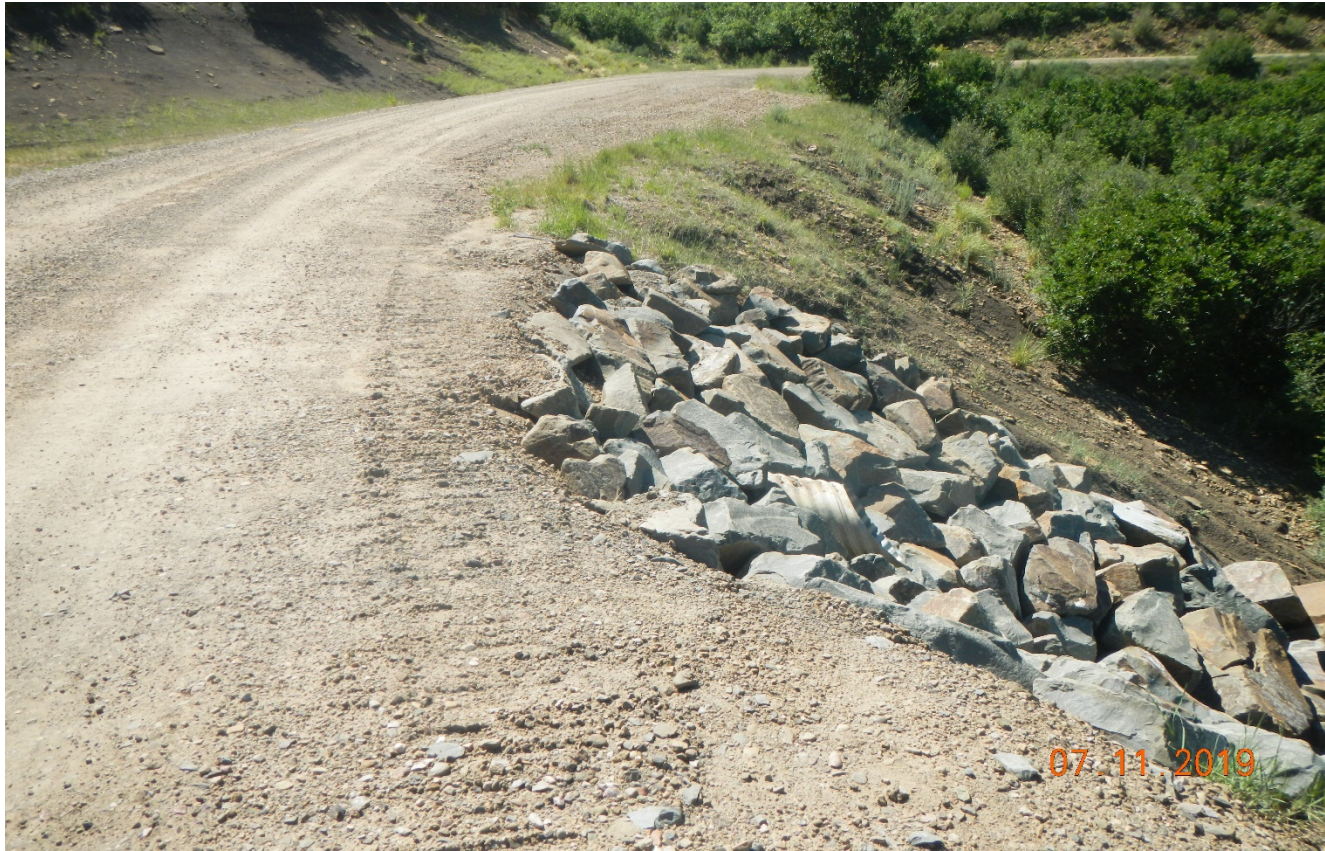
Photo 1. Facing along the main road. Rock rip/rap has been installed as outlet protection at numerous culvert outlets.

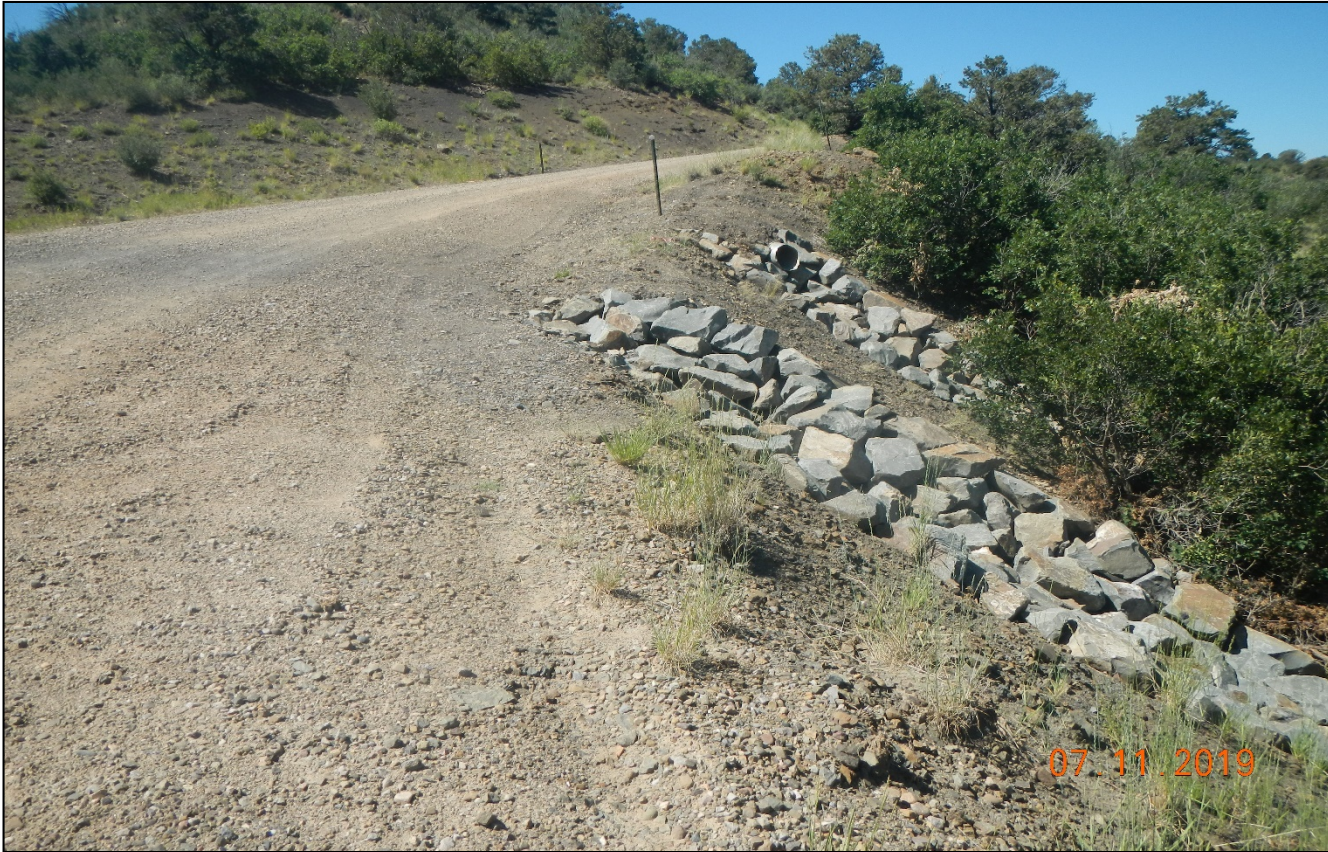
Photo 2. Facing along the main road. Rock rip/rap has been installed as outlet protection at numerous culvert outlets.

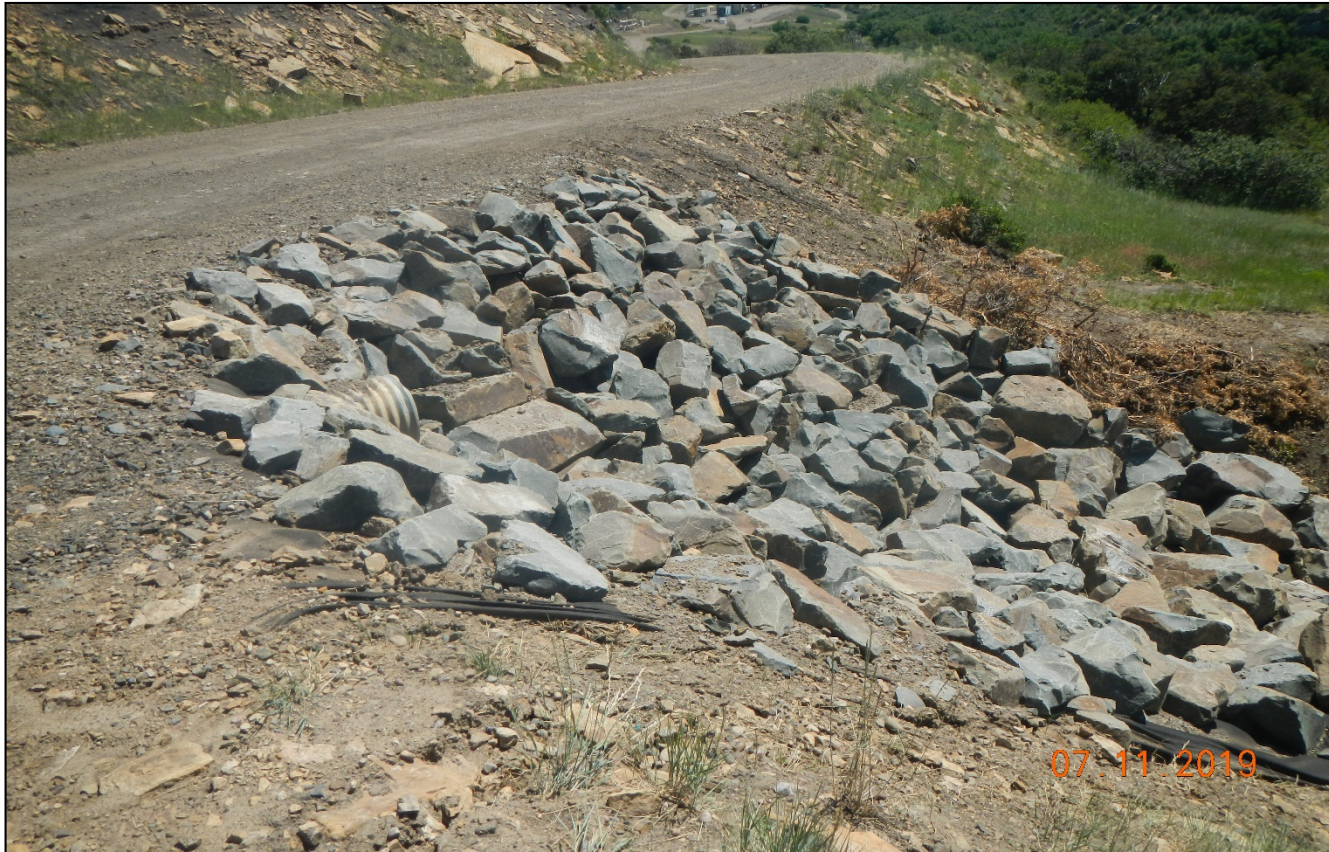
Photo 3. Outlet protection has been installed on the culvert with geotextile.

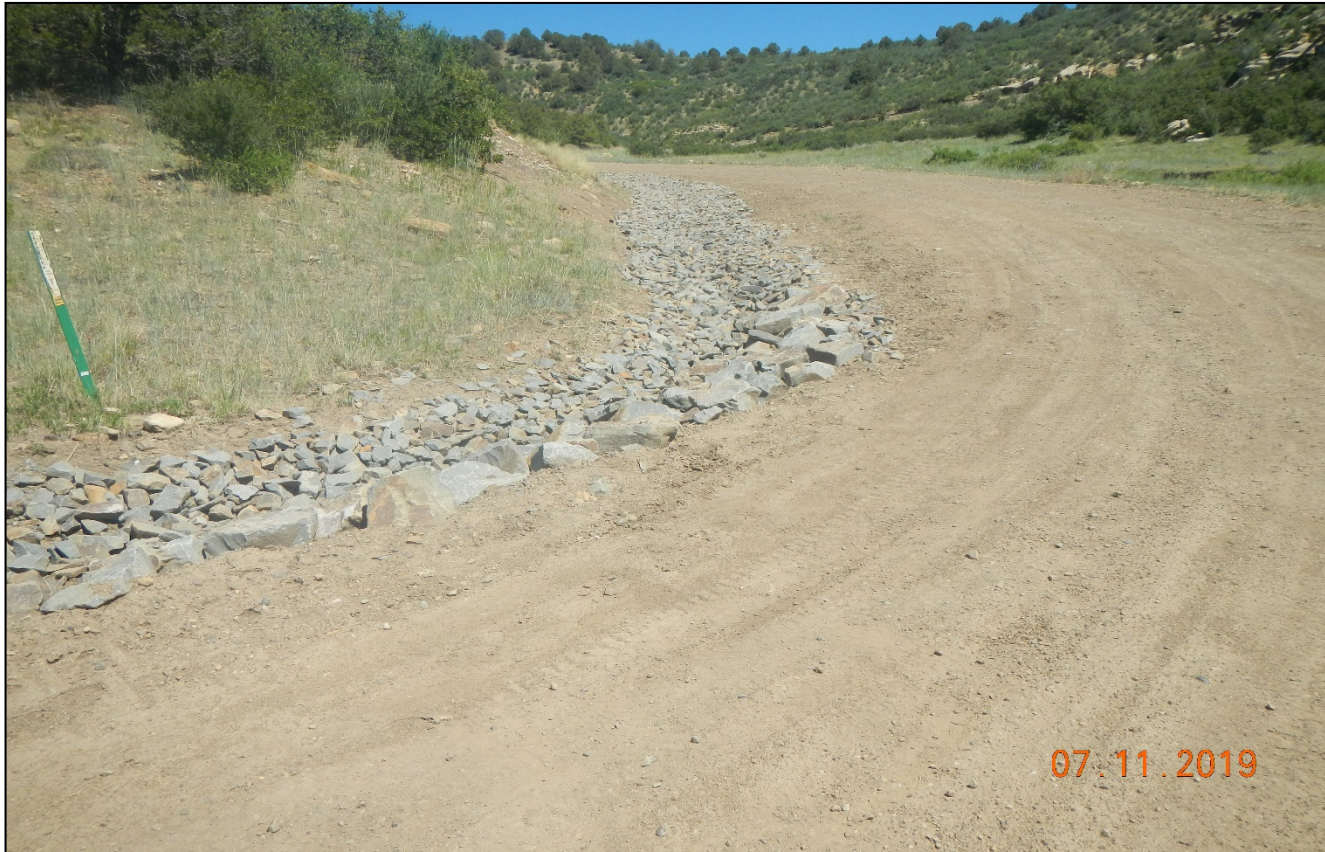
Photo 4. Rip/rap has been installed along the side of the road where erosion was occurring.

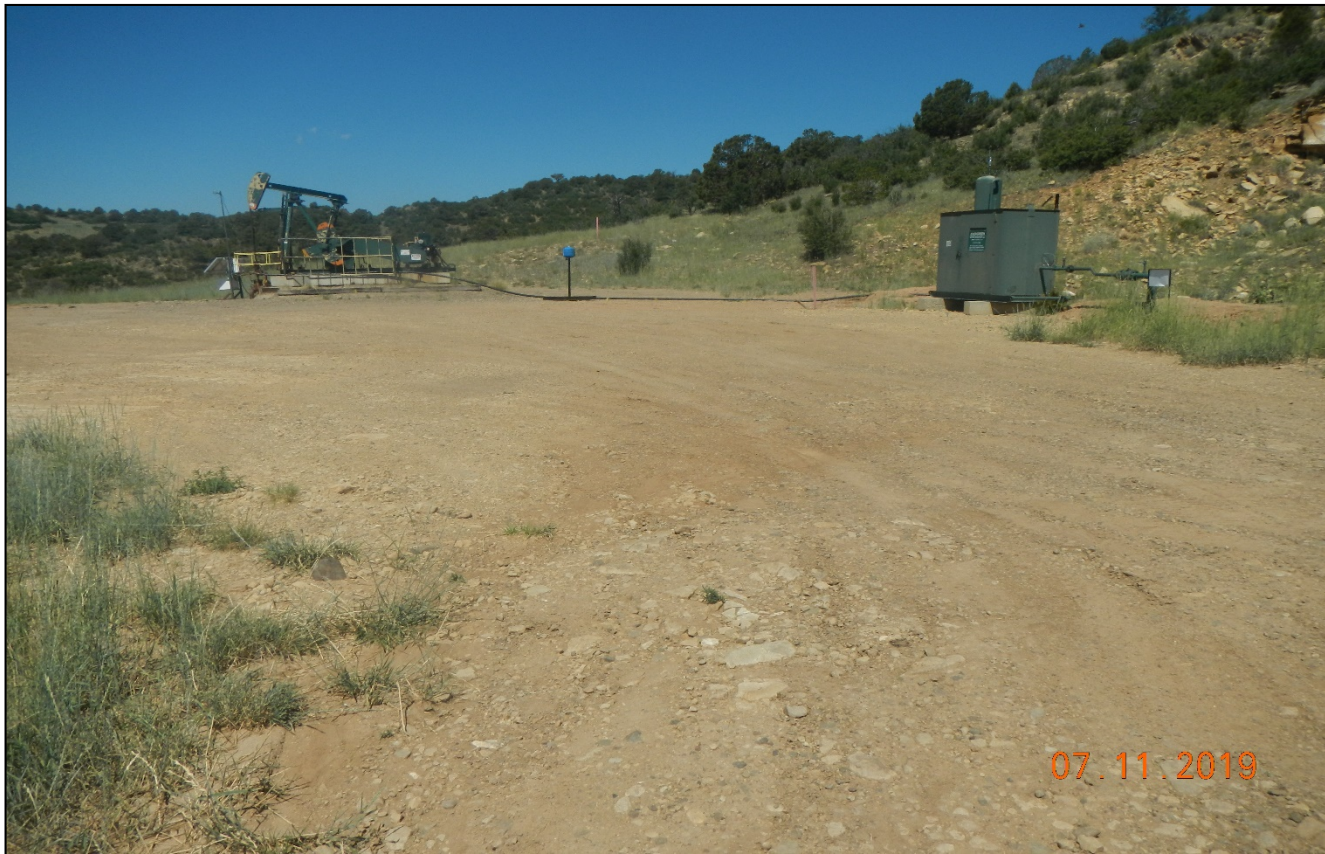
Photo 5. Facing toward the location.
