**Inspection Photos**  
**Location Name: STATE-68N60W /36SESE**  
**Location #: 331563**

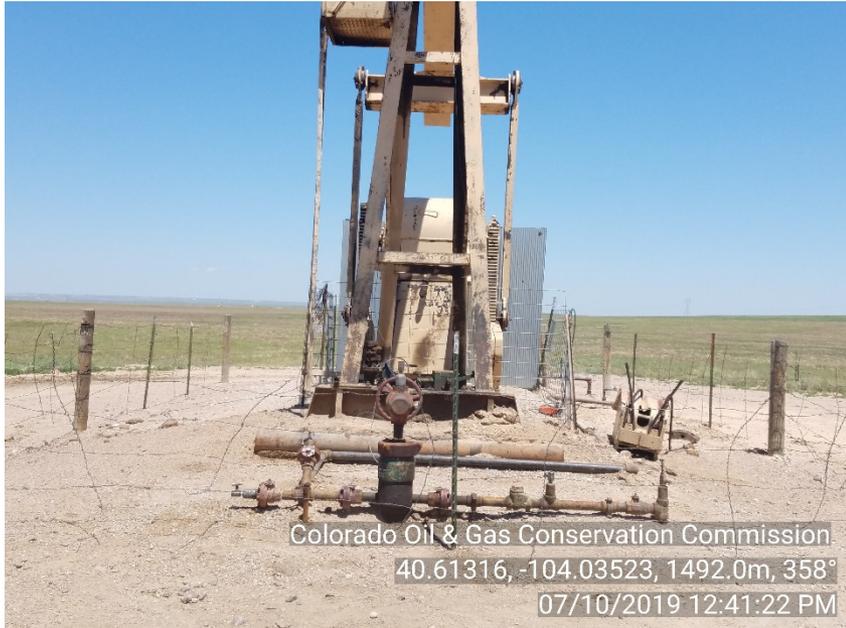
**Photo #1**  
**State 36-16 (05-123-20908) Wellsite**  
**Shut-In | SI**  
*Day tanks, drum removed*  
*Stained soil appears mitigated*

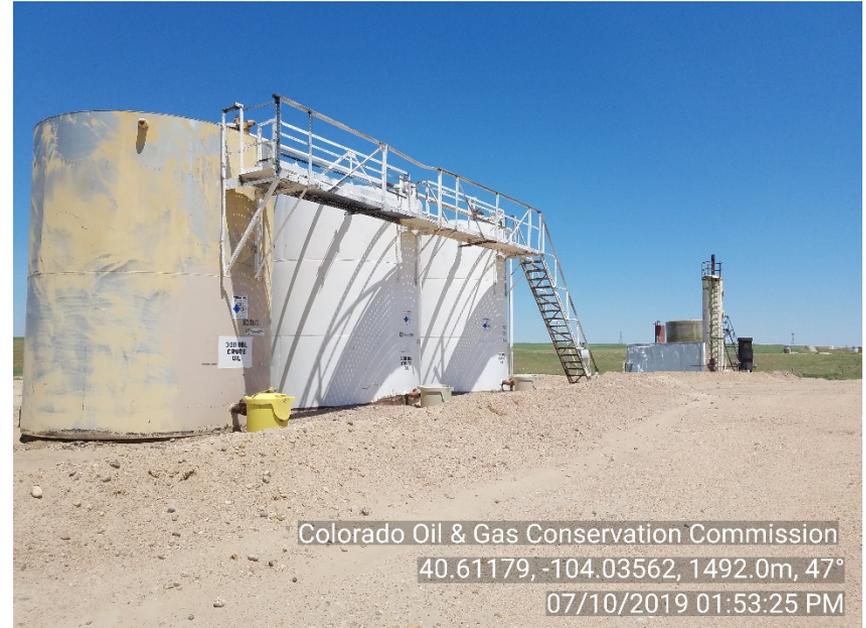
**Photo #2**  
**State 36-16 Battery**  
**Shut-down**

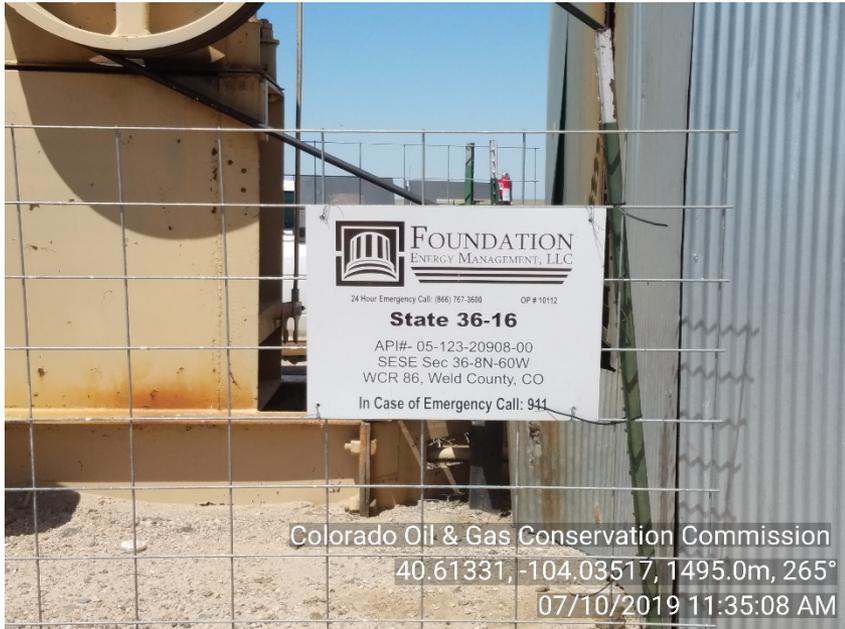
**Photo #3**  
**State 36-16** Wellsite  
*Sign posted*

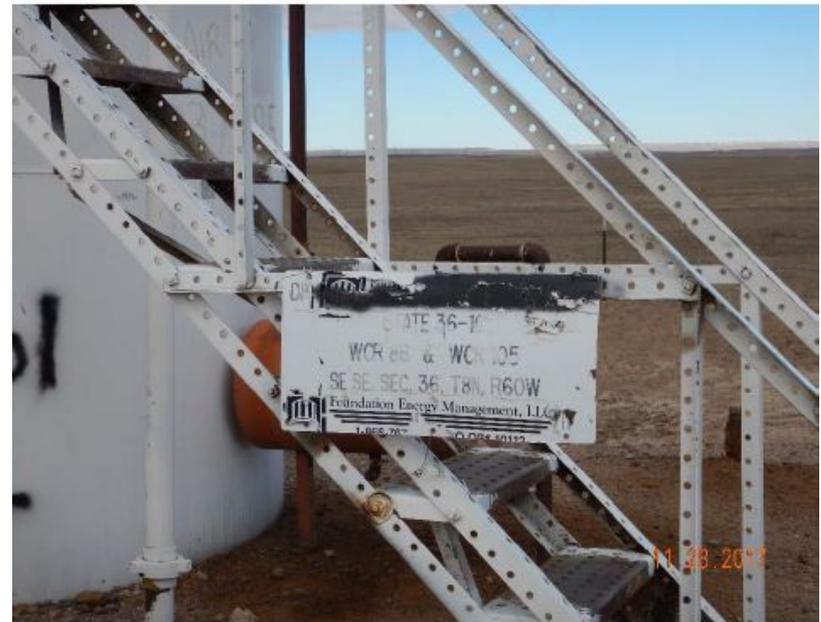
**Photo #4**  
**State 36-16** Battery sign  
*Phone number illegible – prior insp.*

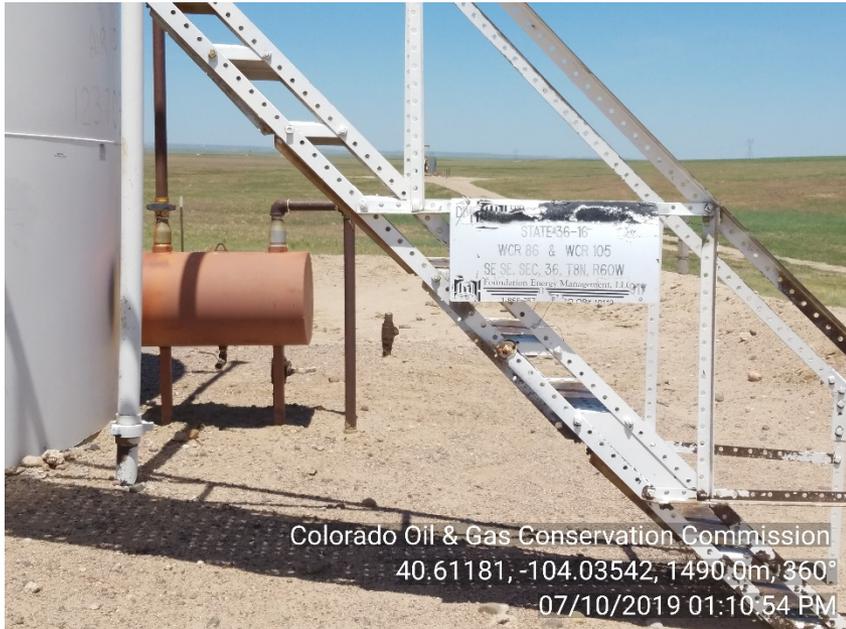
**Photo #5**  
**State 36-16 Battery sign**  
**Phone number is Legible**  
**See Photo #6**

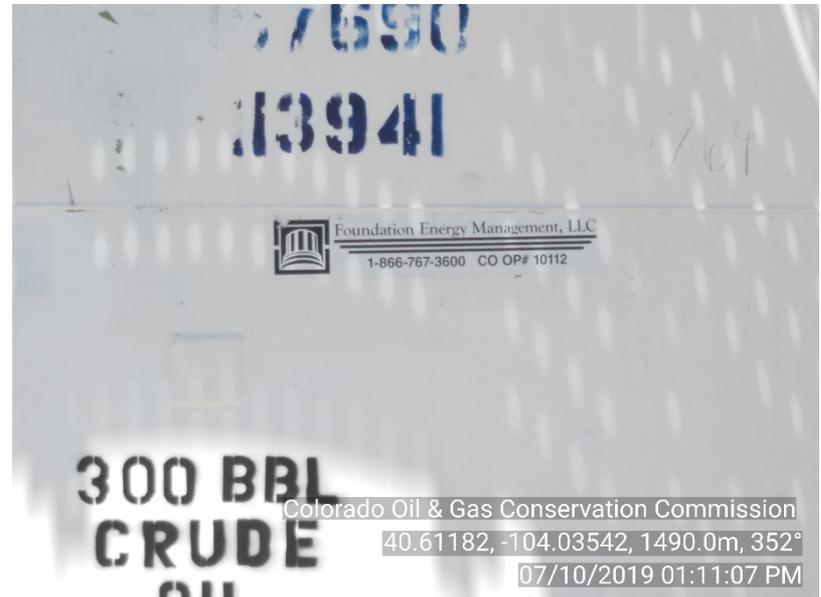
**Photo #6**  
**State 36-16 Battery sign**  
**Phone number is Legible**  
**Sign adjacent to walkway sign**

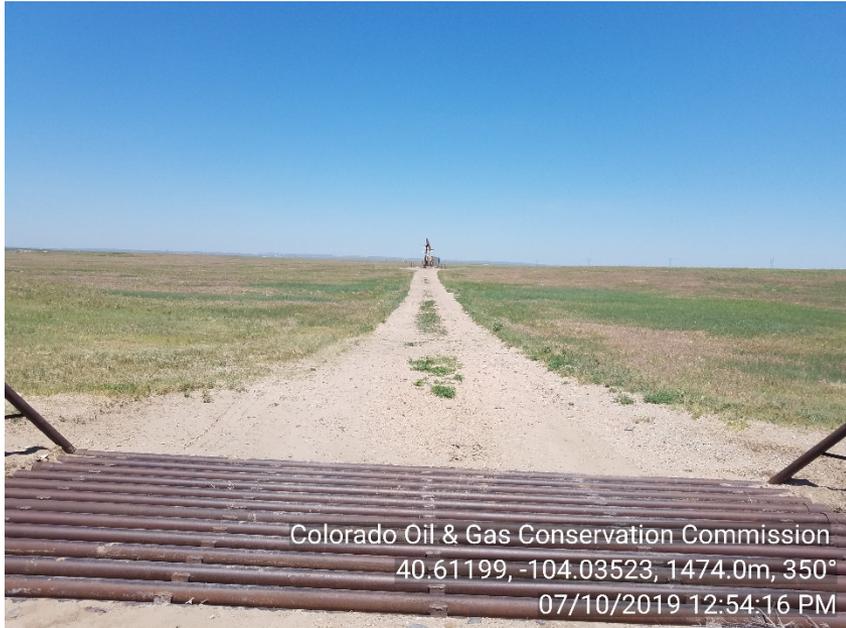
**Photo #7**  
**State 36-16** Wellsite  
*Access road ruts - Appears mitigated*

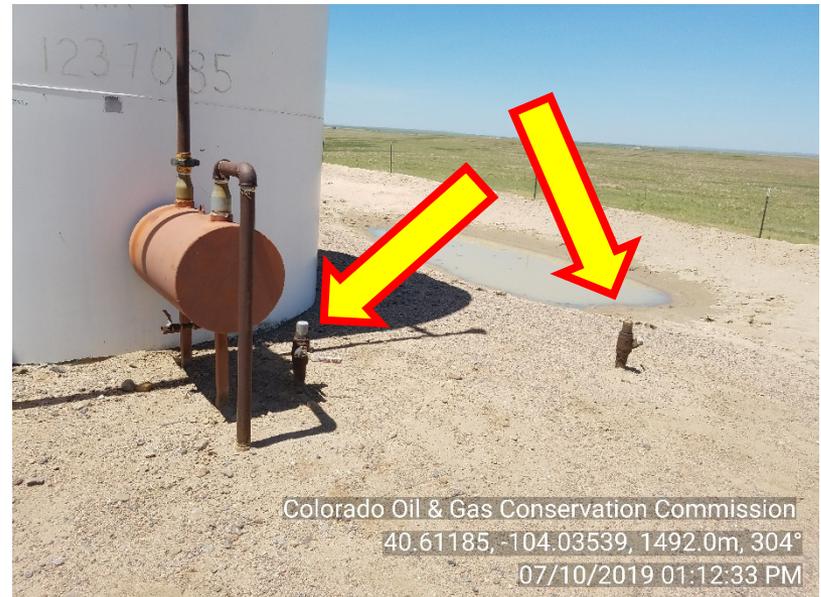
**Photo #8**  
**State 36-16** Battery – Oil Tanks  
**2 – Unmarked, Unused risers**

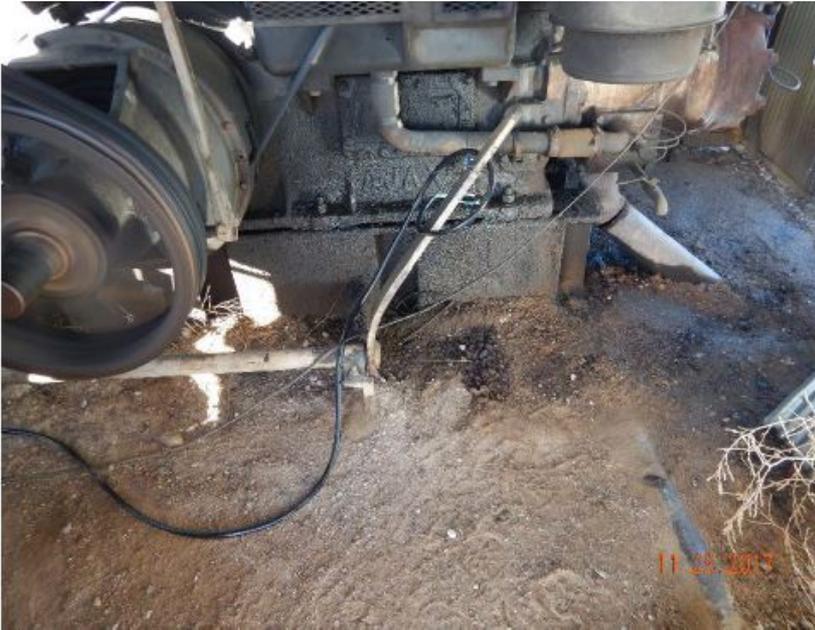
**Photo #9**  
**State 36-16 Prime Mover – Gas Engine**  
**Stained soil beneath gas engine**  
*prior insp.*

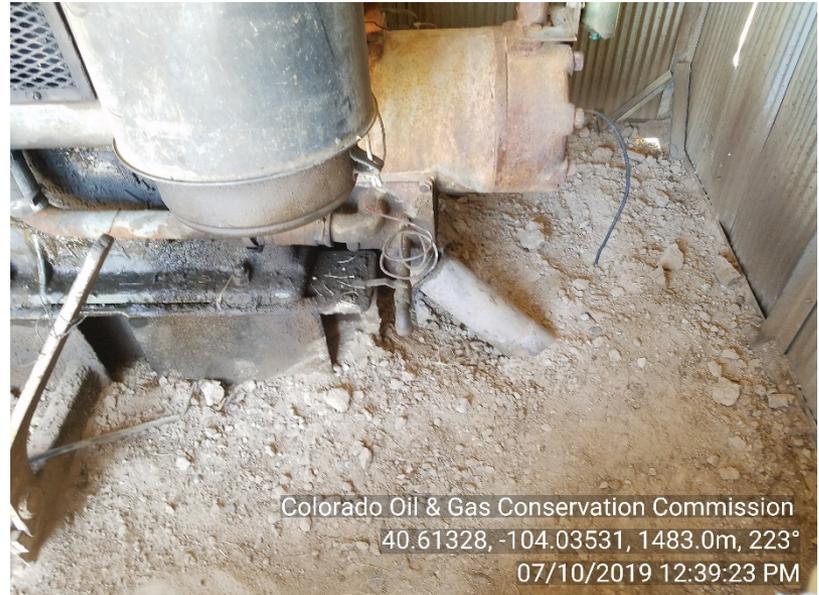
**Photo #10**  
**State 36-16 Prime Mover – Gas Engine**  
**Stained soil beneath gas engine**  
*Appears mitigated*

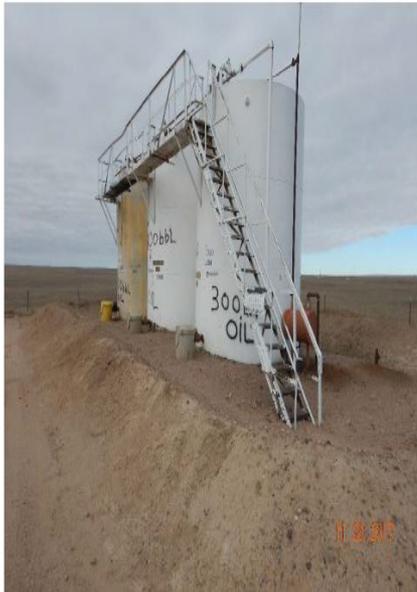
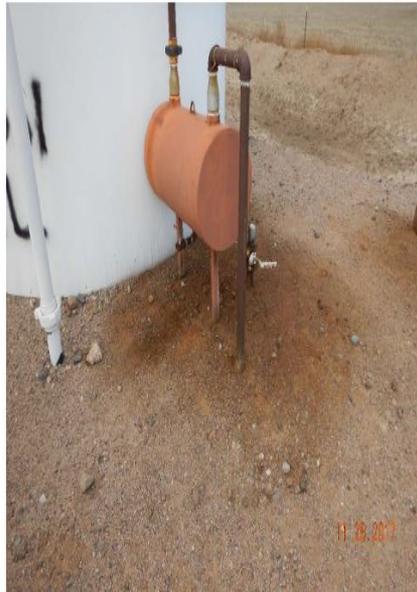
**Photo #11**  
**State 36-16** Crude Oil Tanks – East side  
**Stained soil**  
*prior insp.*

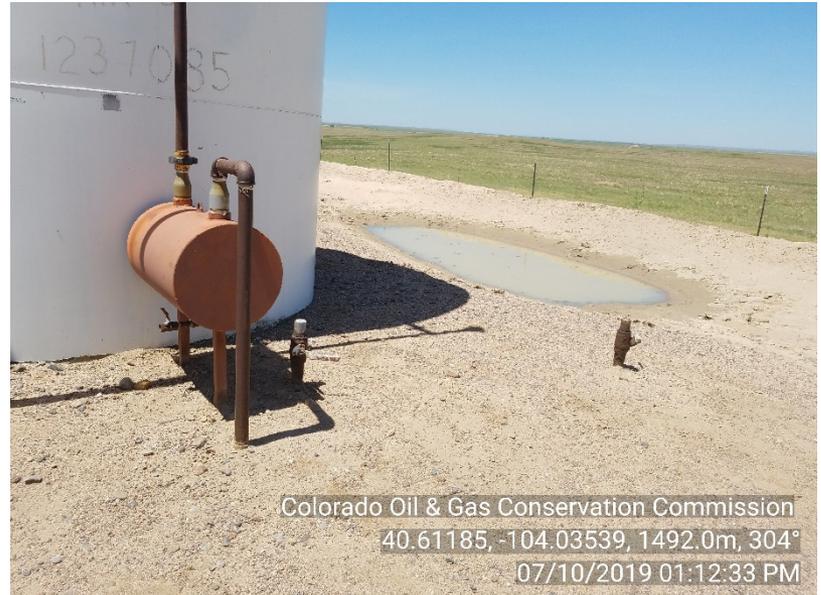
**Photo #12**  
**State 36-16** Crude Oil Tanks – East side  
**Stained soil - *Appears mitigated***

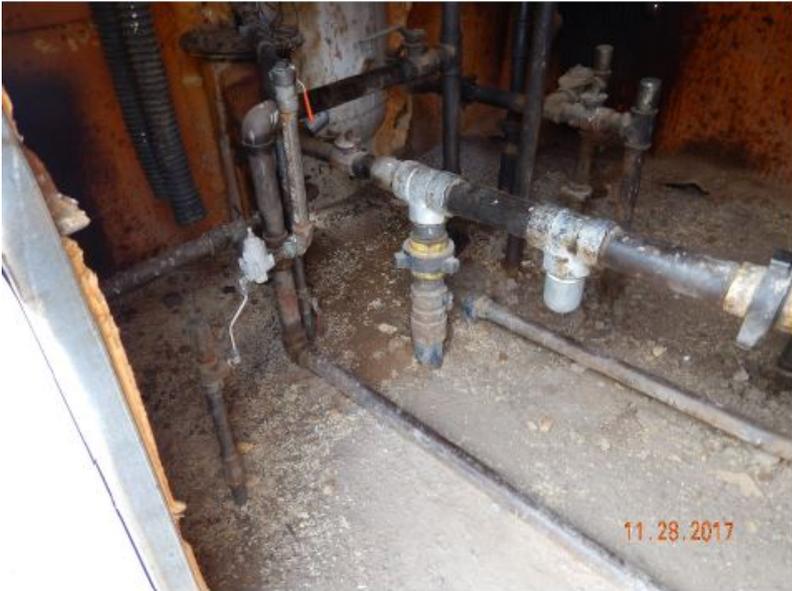
**Photo #13**  
**State 36-16** Treater – Separator shed  
**Stained soil**  
*prior insp.*

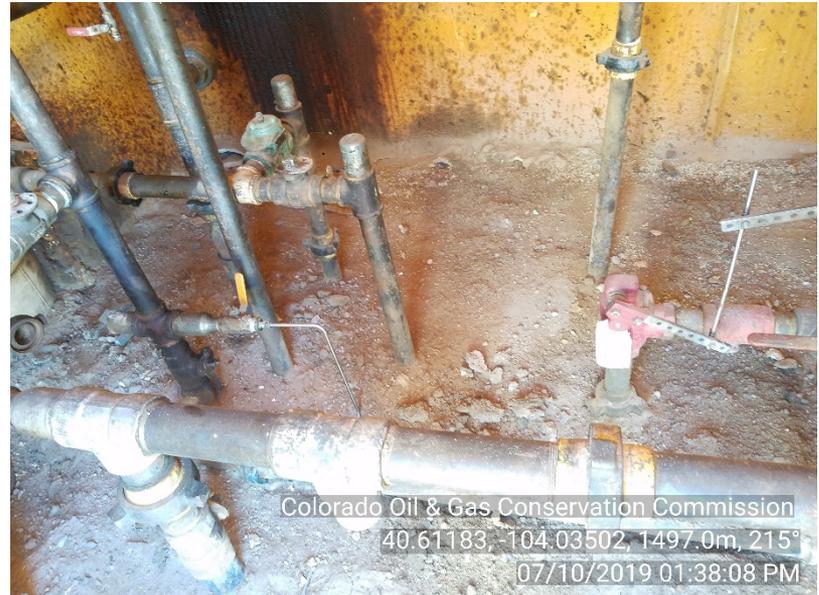
**Photo #14**  
**State 36-16** Treater – Separator shed  
**Stained soil - *Appears mitigated***

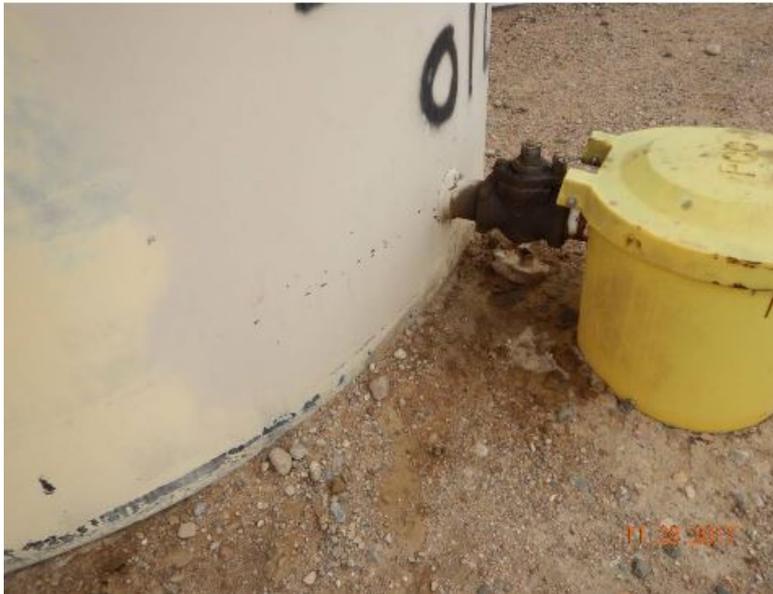
**Photo #15**  
**State 36-16** Crude Oil Tanks – Front Load outs  
**Stained soil**  
*prior insp.*

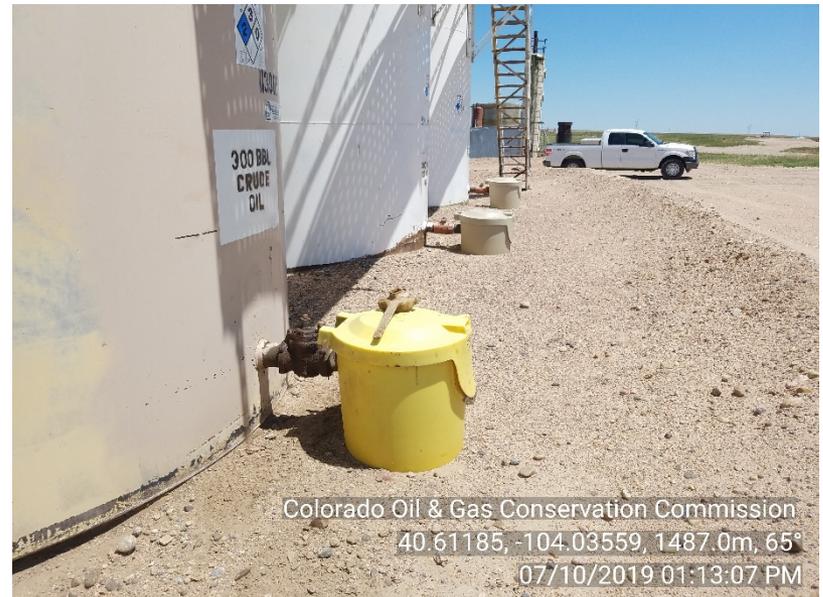
**Photo #16**  
**State 36-16** Crude Oil Tanks – Front Load outs  
**Stained soil - *Appears mitigated***

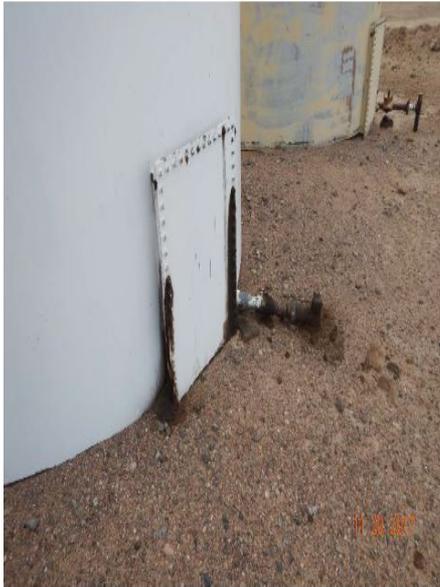
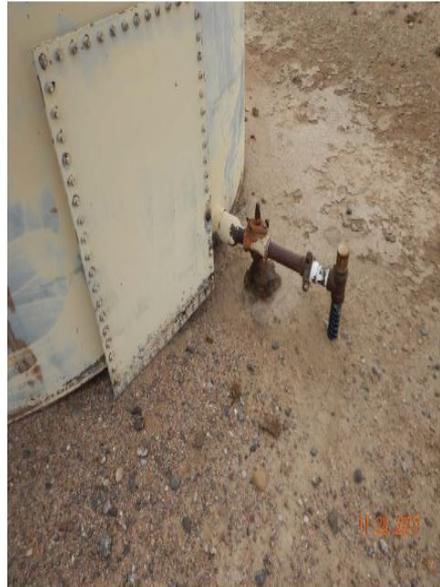
**Photo #17**

**State 36-16** Crude Oil Tanks – Rear drain valves  
**Stained soil**  
*prior insp.*

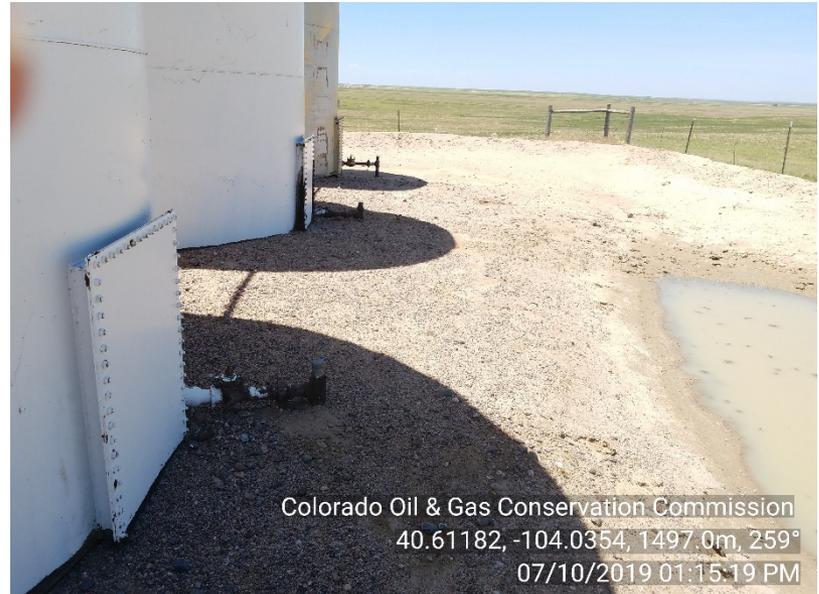
**Photo #18**

**State 36-16** Crude Oil Tanks – Rear drain valves  
**Stained soil - *Appears mitigated***

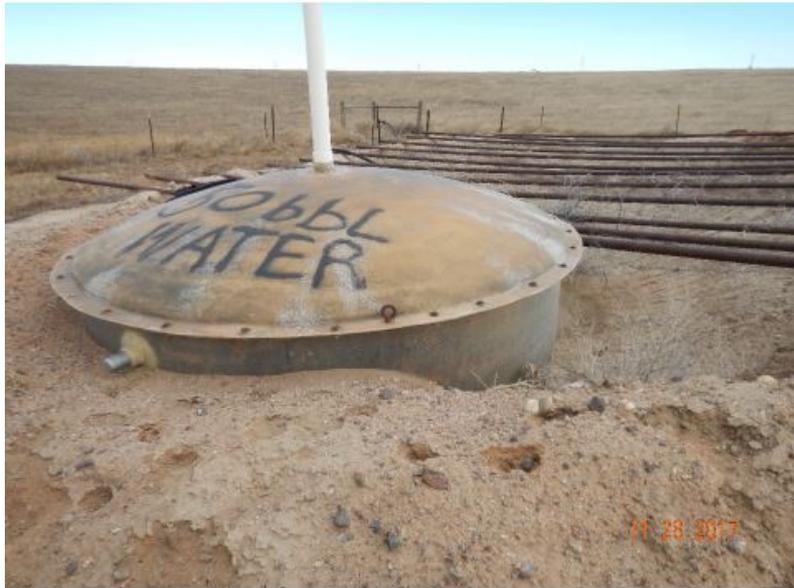
**Photo #19**  
**State 36-16** Pit Area – Skim tank  
**No NFPA placard**  
*prior insp.*

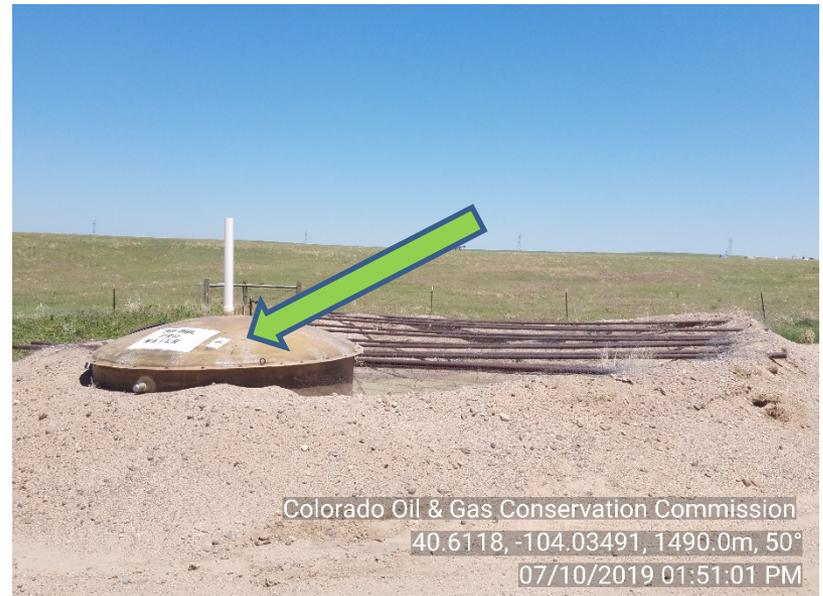
**Photo #20**  
**State 36-16** Pit Area – Skim tank  
**NFPA placard - Posted**

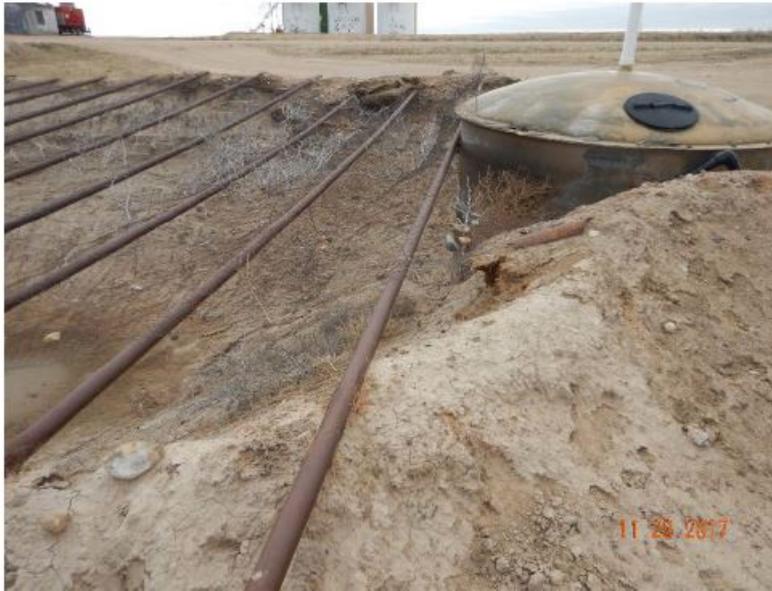
**Photo #21**  
**State 36-16 Pit Area**  
**Damaged berms, stain soil, netting gaps**  
*prior insp.*

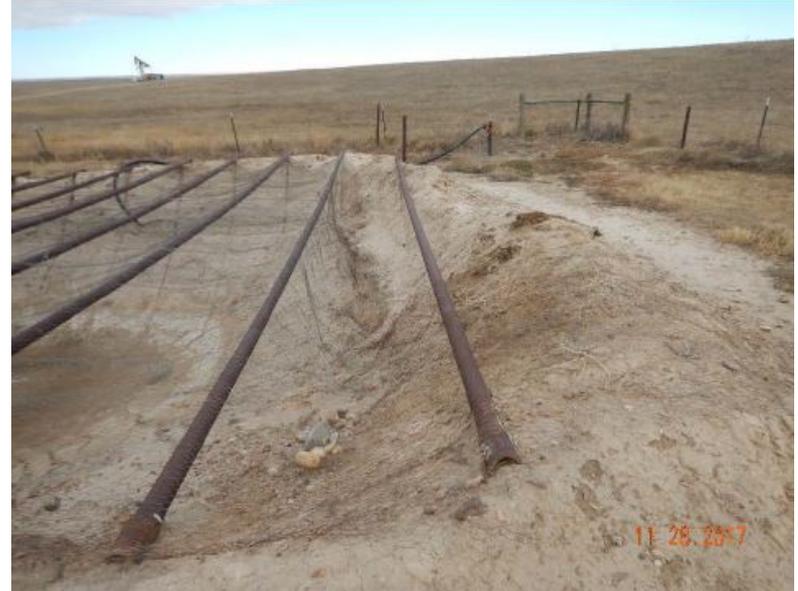
**Photo #22**  
**State 36-16 Pit Area**  
**Damaged berms, stain soil, netting gaps**  
*prior insp.*

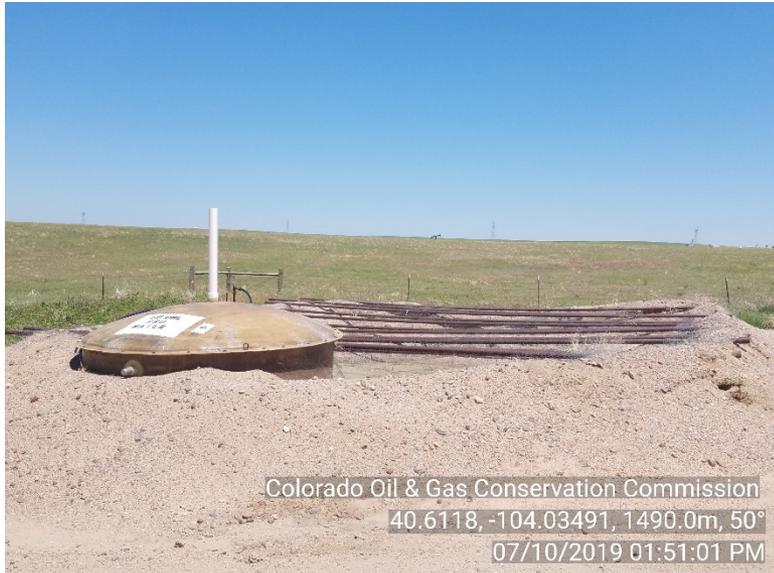
**Photo #23**  
**State 36-16 Pit Area**  
**Damaged berms, stain soil, netting gaps**  
*Appears mitigated.*

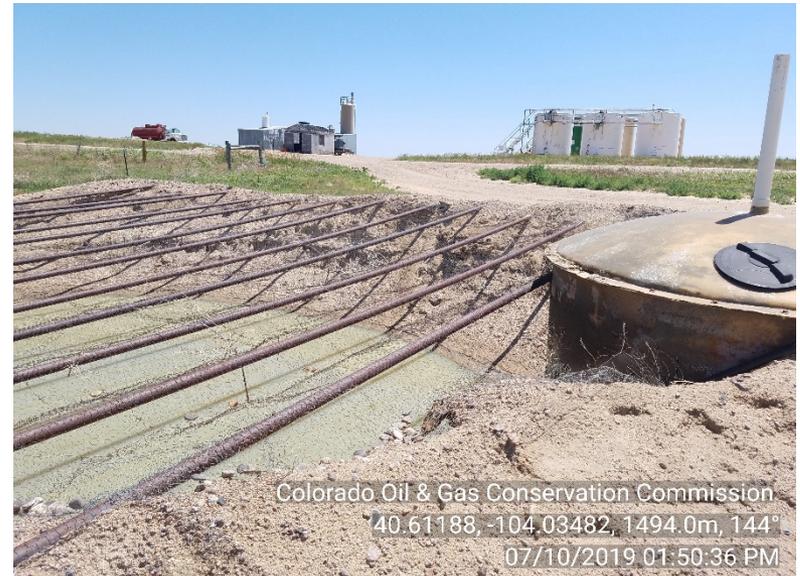
**Photo #24**  
**State 36-16 Pit Area**  
**Damaged berms, stain soil, netting gaps**  
*Appears mitigated*

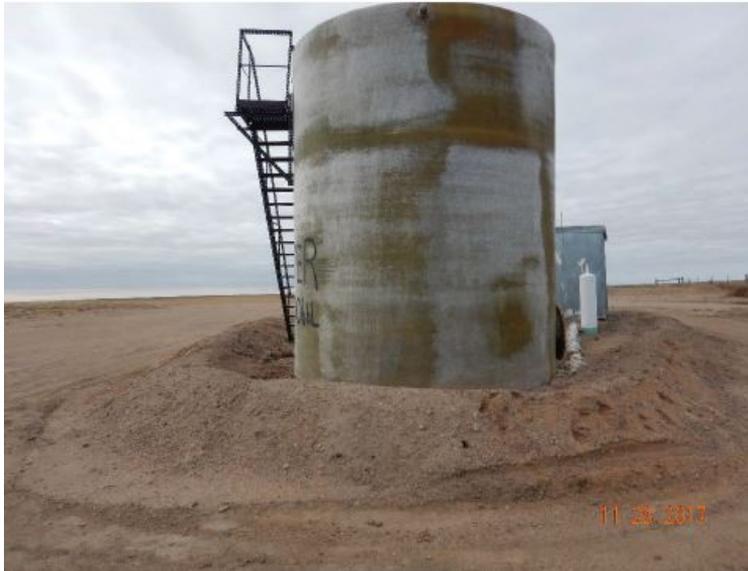
**Photo #25**  
**State 36-16** Produced H2O tanks  
**Inadequate berms**  
*prior insp.*

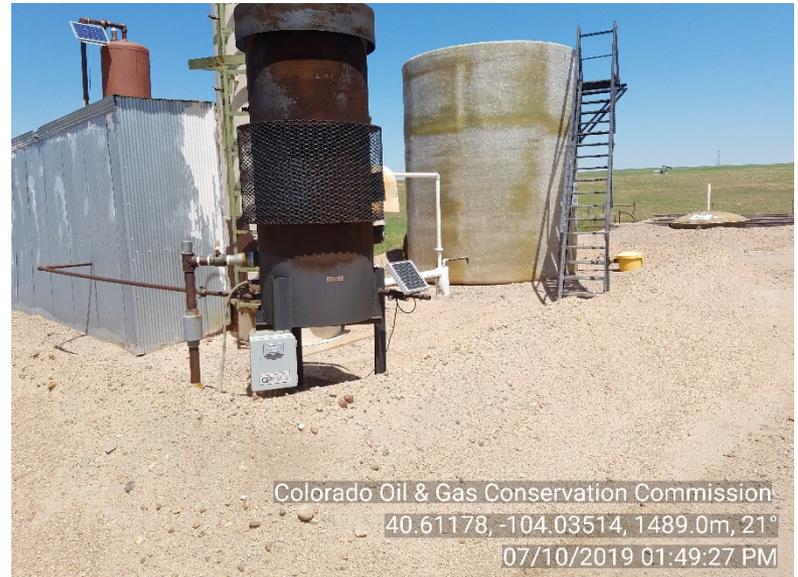
**Photo #26**  
**State 36-16** Produced H2O tanks  
**Enlarged berms**  
*Appears mitigated*

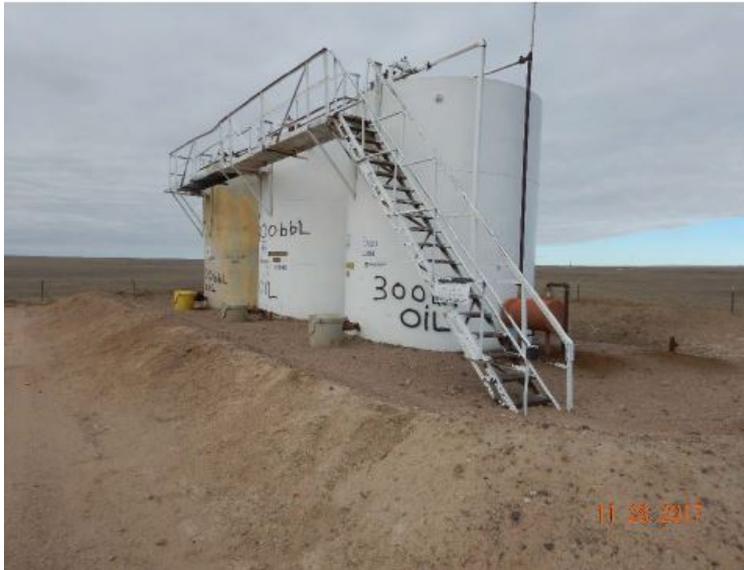
**Photo #27**  
**State 36-16** Produced Oil tanks  
**Inadequate berms**  
*prior insp.*

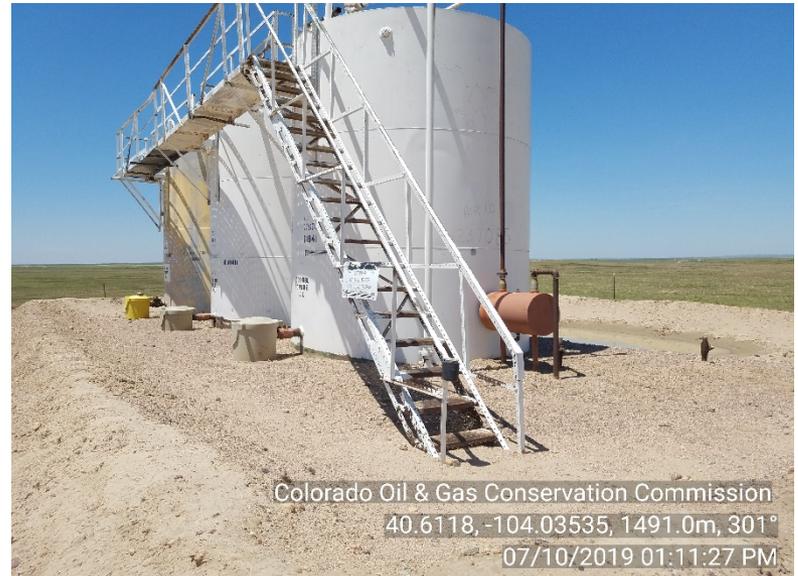
**Photo #28**  
**State 36-16** Produced Oil tanks  
**Enlarged berms**  
*Appears mitigated*
