Inspection Photos
Operator: BP America
Location/API #: 067-07114
Date: 7-10-2019

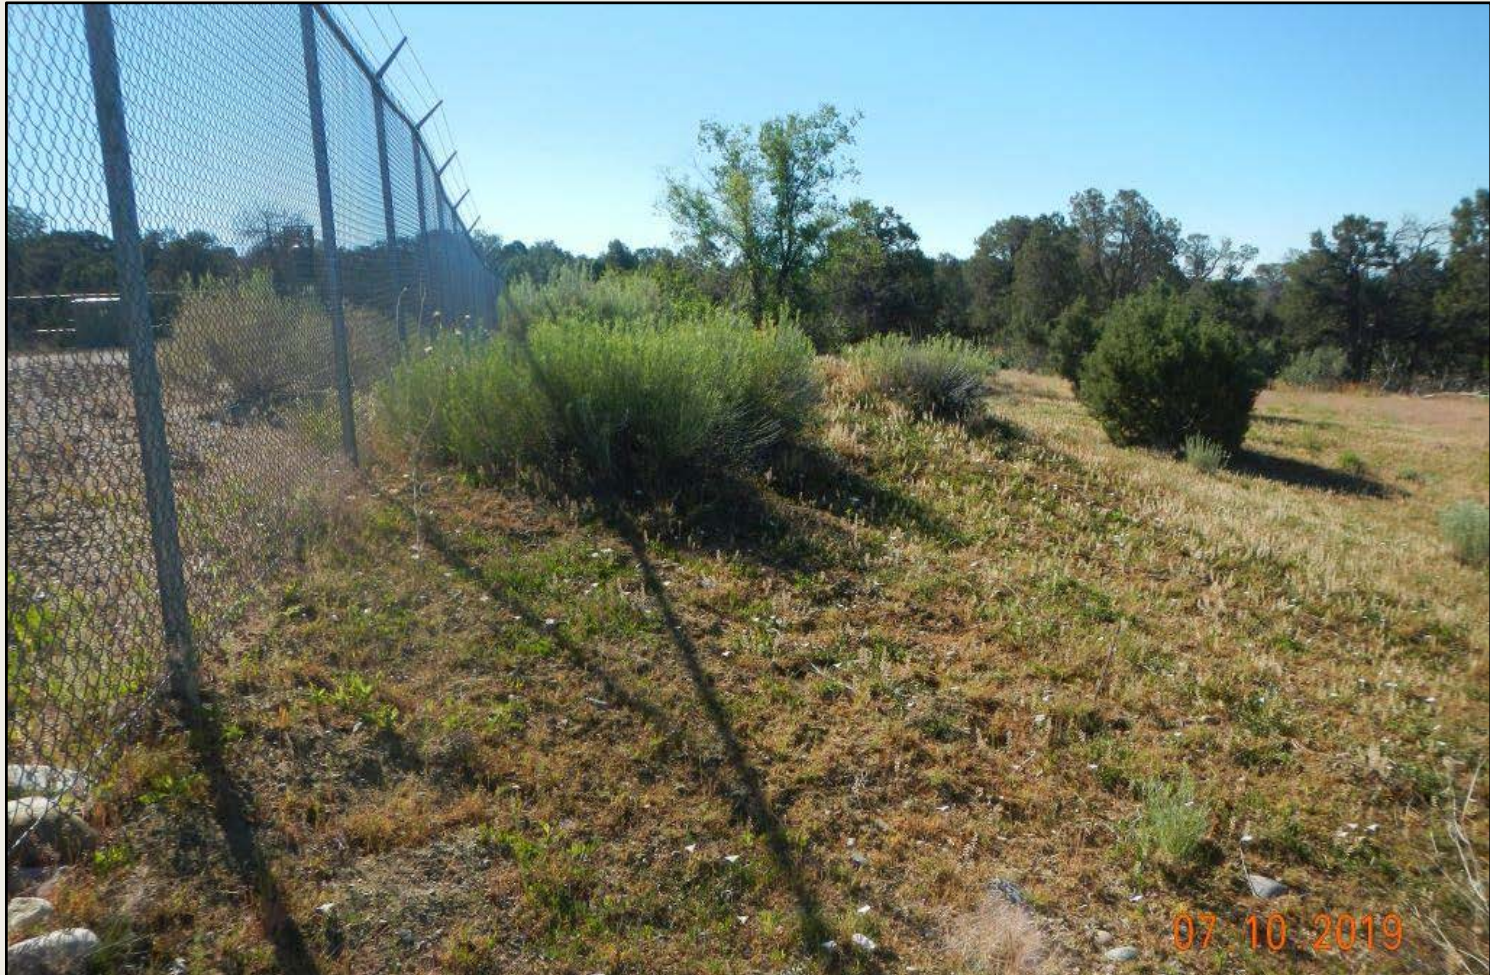
Photo 1. View of the southern project area from the southwestern corner facing eastward.

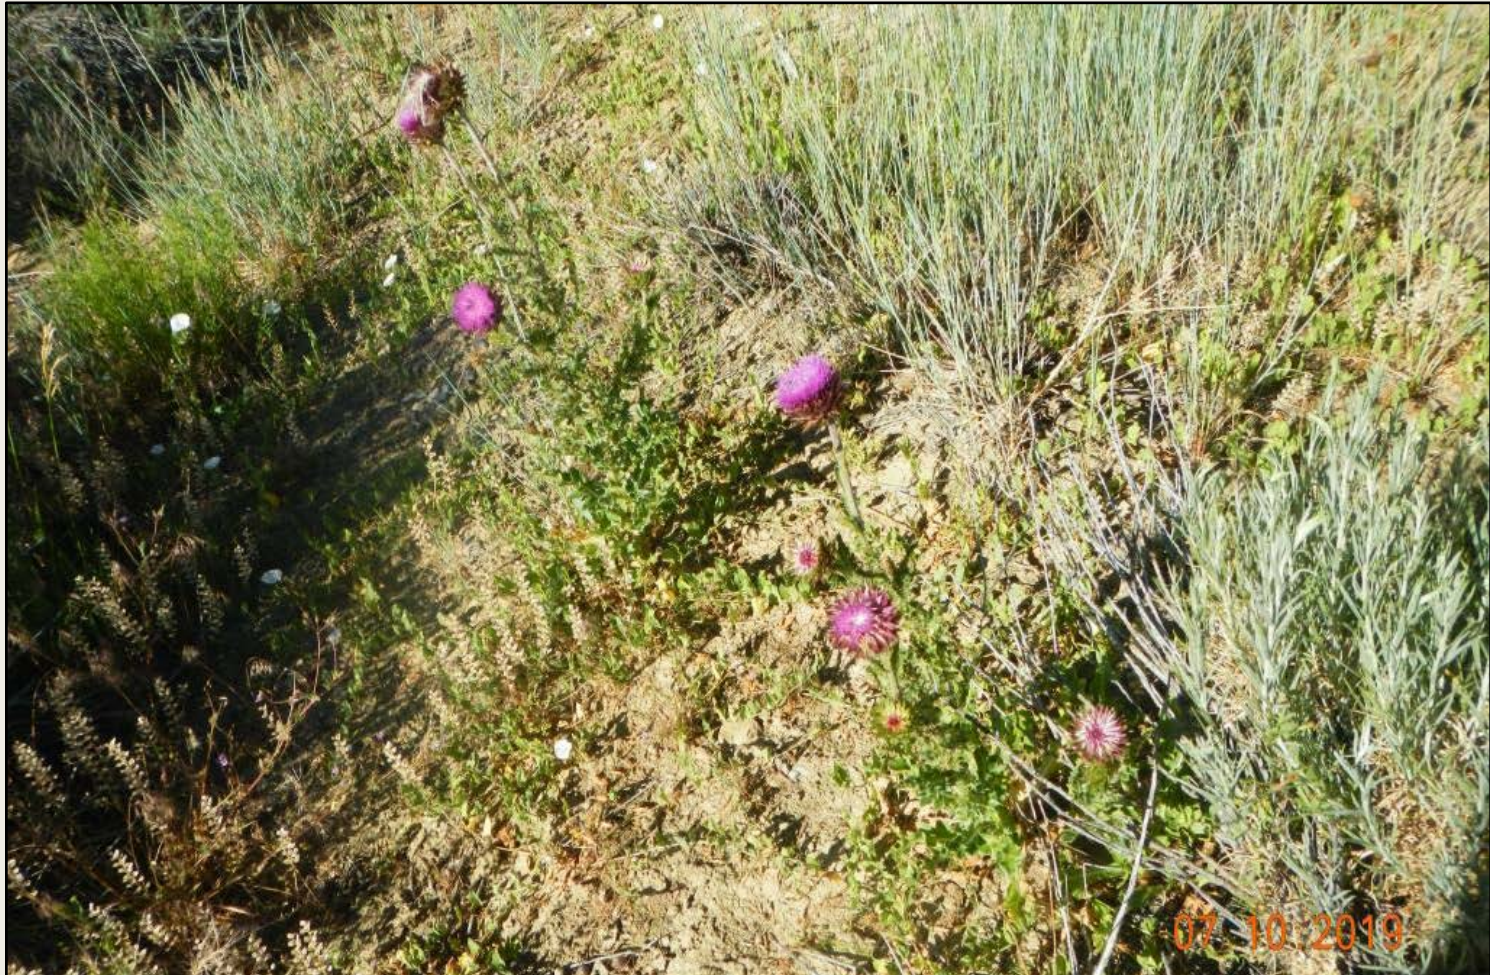
Photo 2. View of musk thistles (*Carduus nutans*) within the project area.

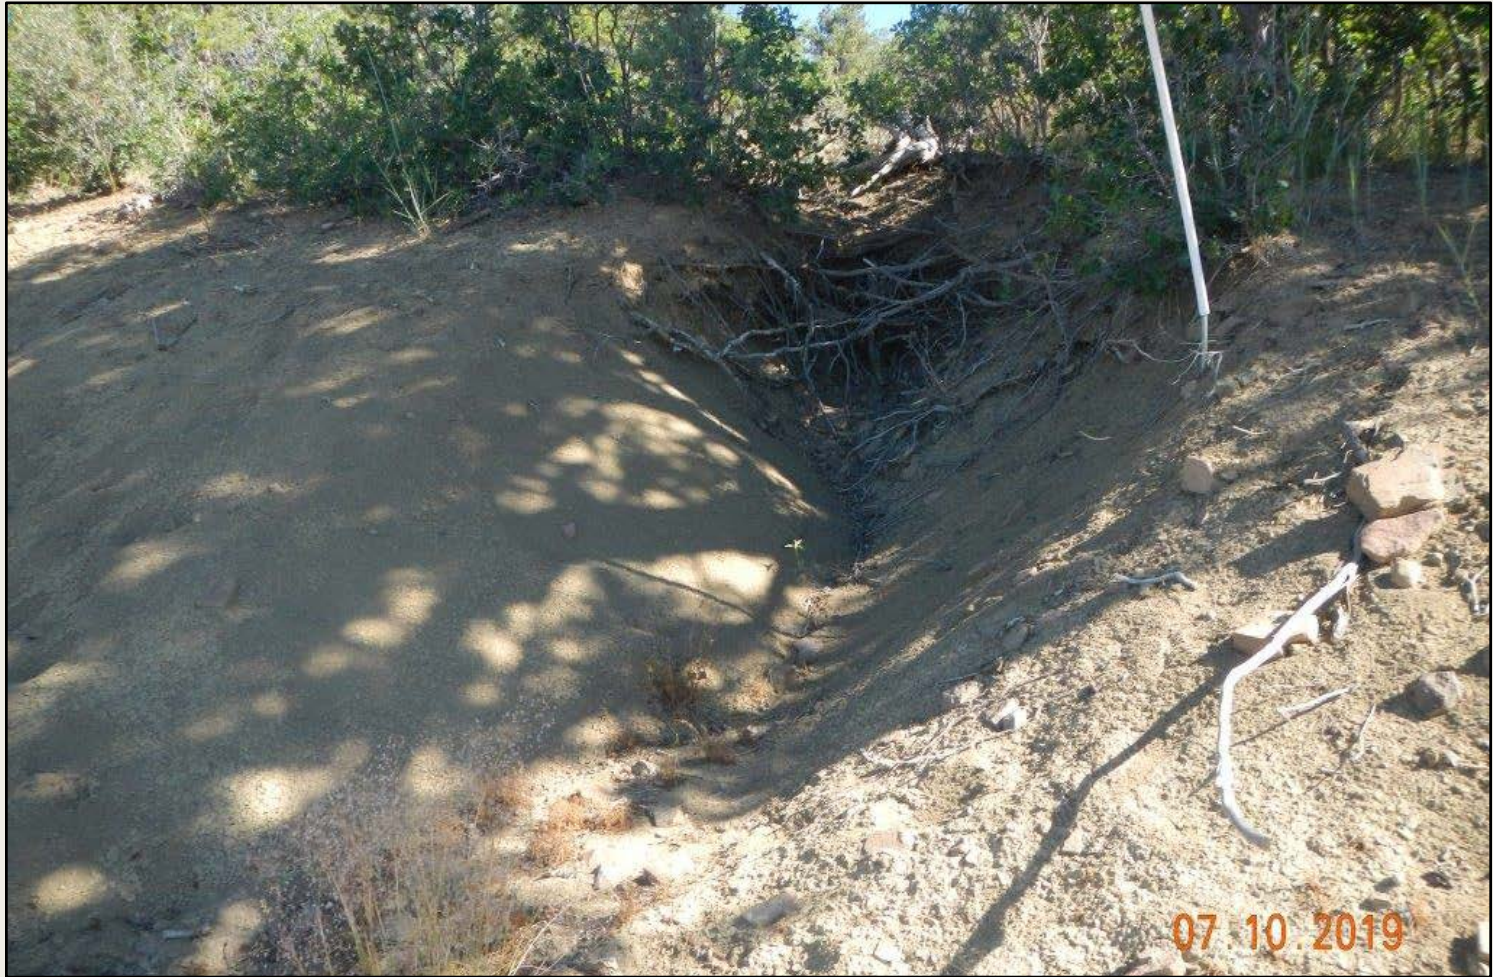
Photo 3. View of erosional channel in northern project area that is eroding the northern cut-slope.

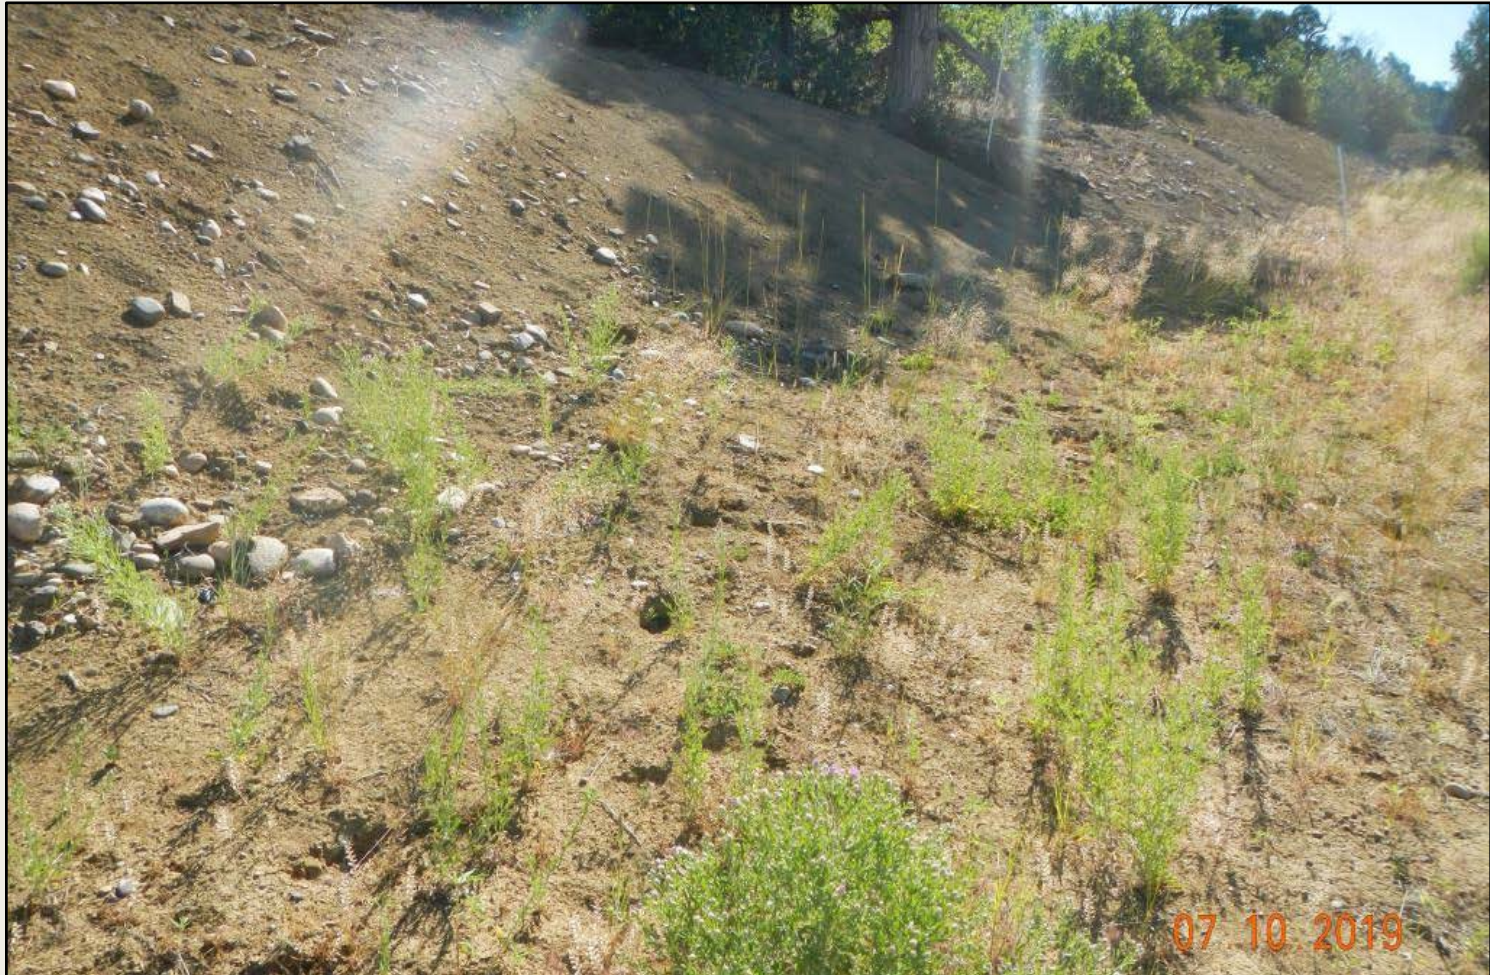
Photo 4. View of Russian knapweed (*Rhaponticum repens*) within the northern project area. Northern cut-slope is not stabilized.
