**Inspection Photos**  
**Location Name: SINJIN-66N65W /36SWSW**  
**Location #: 328688**

Location Name: SINJIN-66N65W /36SWSW

Location #: 328688

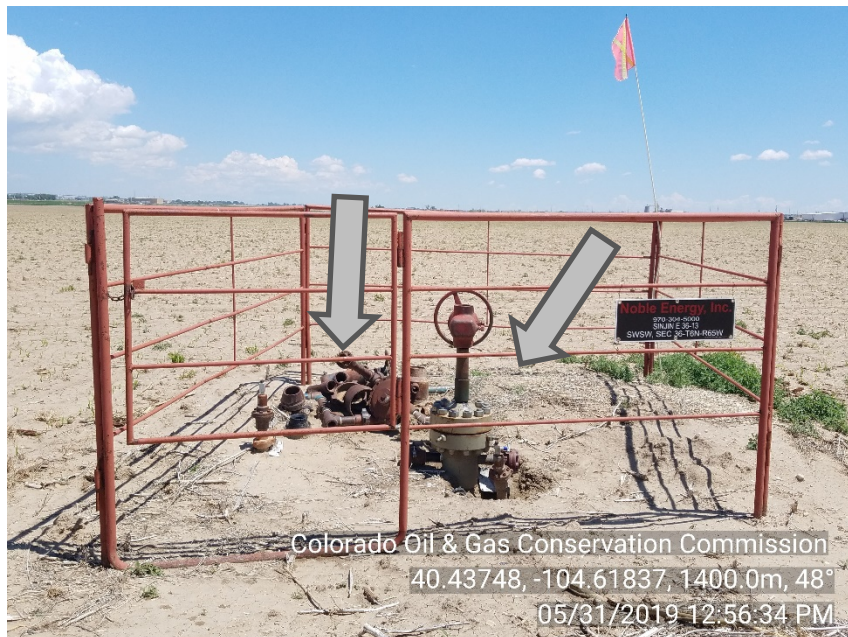
**Photo #1**

**Sinjin E 36-13 (API # 05-123-16306) Wellsite**  
**Temporarily Abandoned | TA**  
*No LOTO on Master / Casing valves*  
*No LTSI or Decommission TA/SI tags per agreement*  
*Unused Equipment – prior insp.*

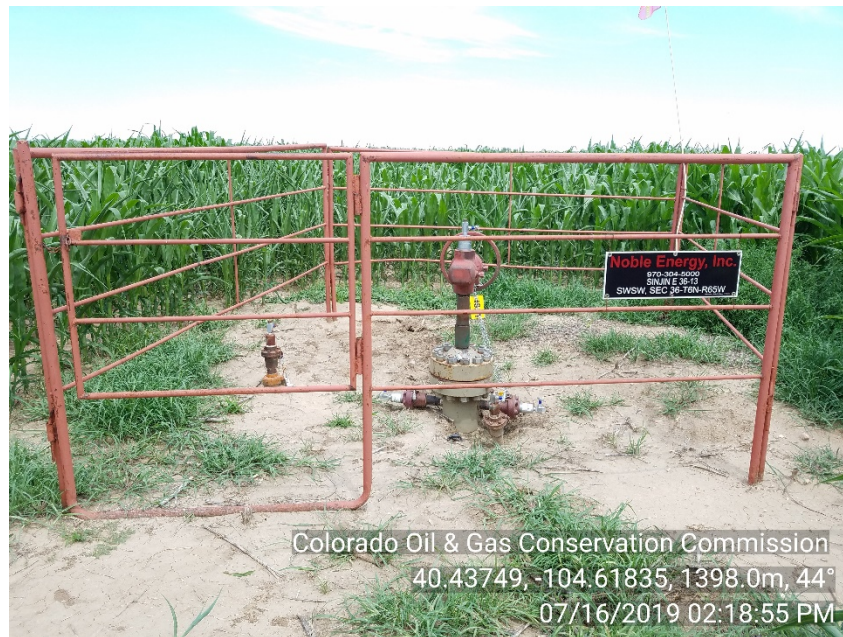
**Photo #2**

**Sinjin E 36-13 Wellsite**  
**Temporarily Abandoned | TA**  
***LOTO NOW on Master / Casing valves***  
***LTSI or Decommission TA/SI tags NOW posted***  
***Unused Equipment – Removed***

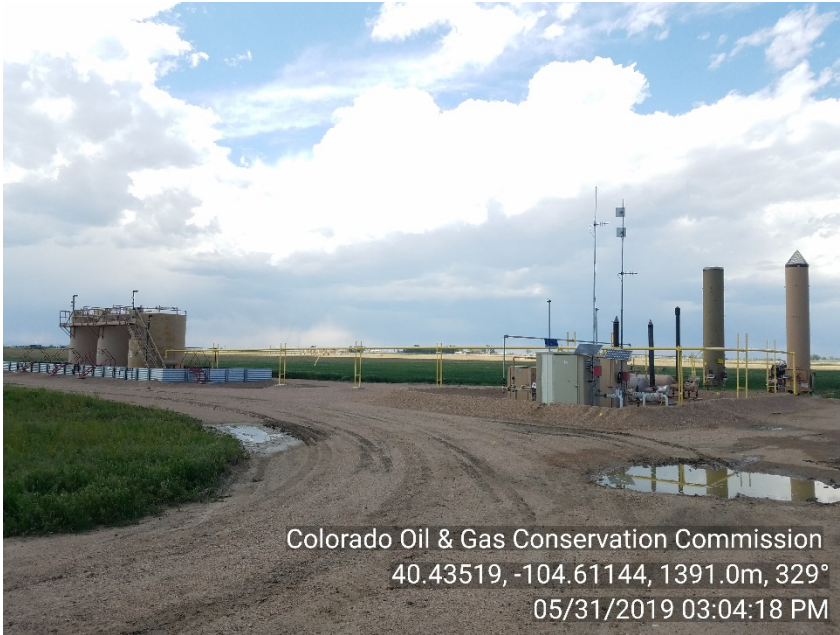
### Photo #3

Sinjin E 36-9, 11, 12, 13, 25, LDS F 1-29 Battery

Shut-down

*Mud w/ puddles from prior rain  
prior insp.*

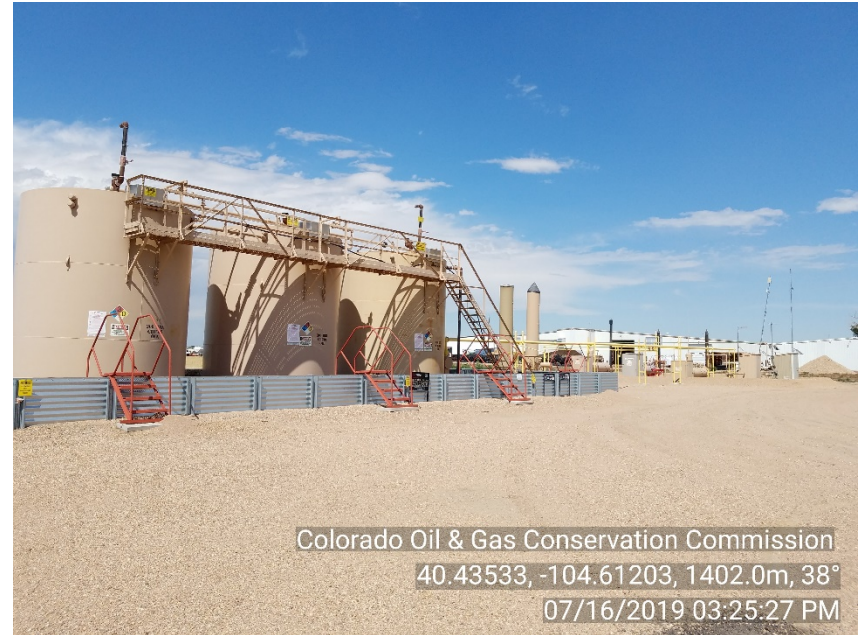
### Photo #4

Sinjin E 36-9, 11, 12, 13, 25, LDS F 1-29 Battery

Shut-down
