Inspection Photos
Location Name: A.D Jeffers A#1
Location ID: 323176

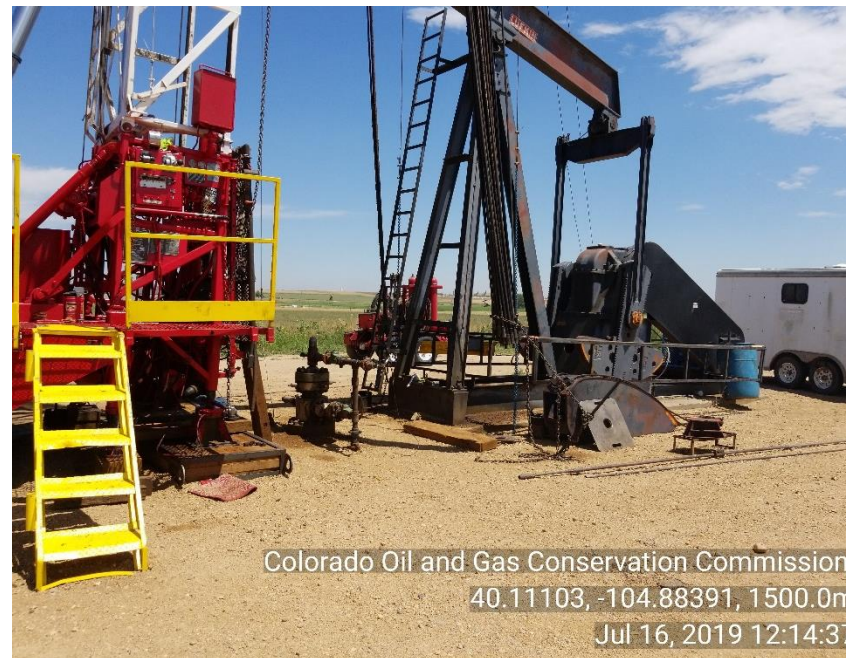
Photo 2 Rig working on well.

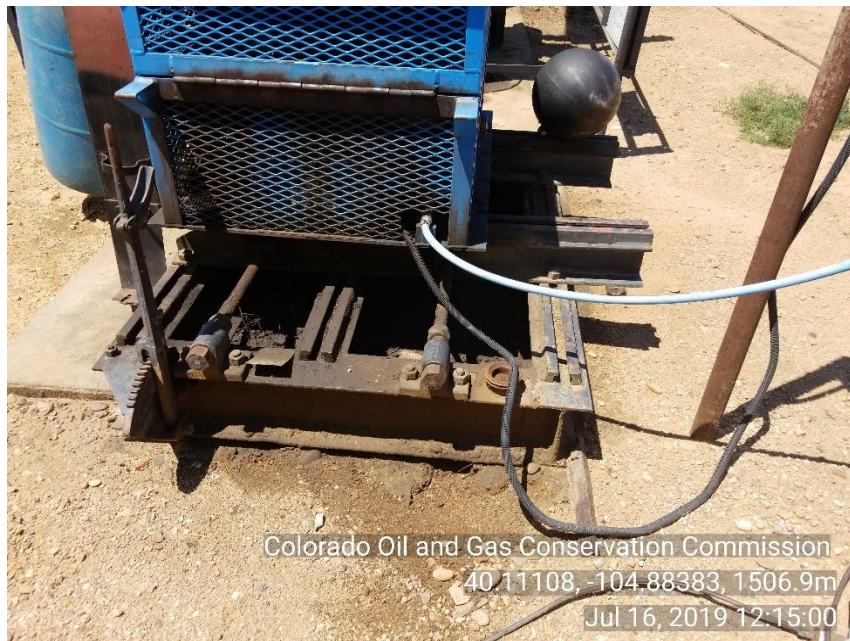
Photo 3 Stained soil in and around PU motor

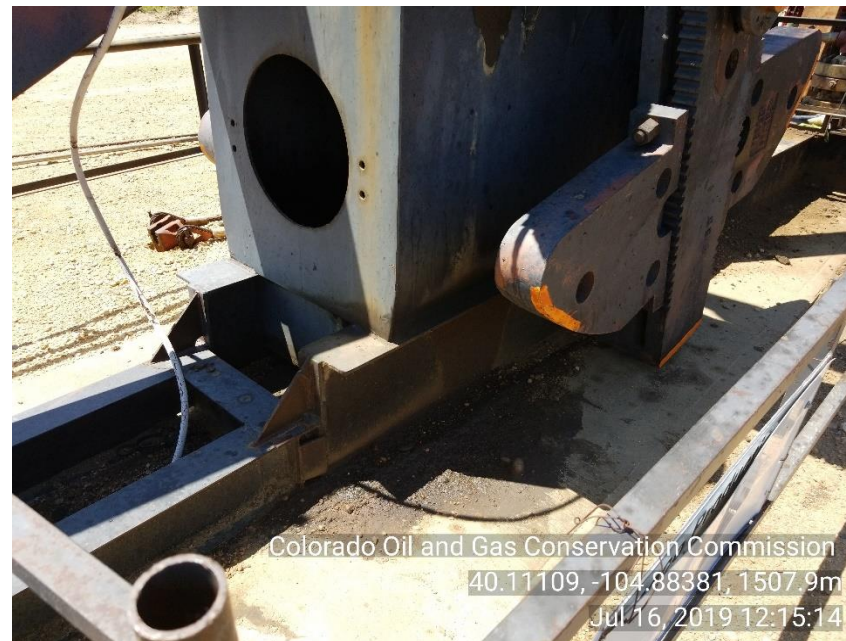
Photo 4 Stained soil on PU base from what appears to be from gear box

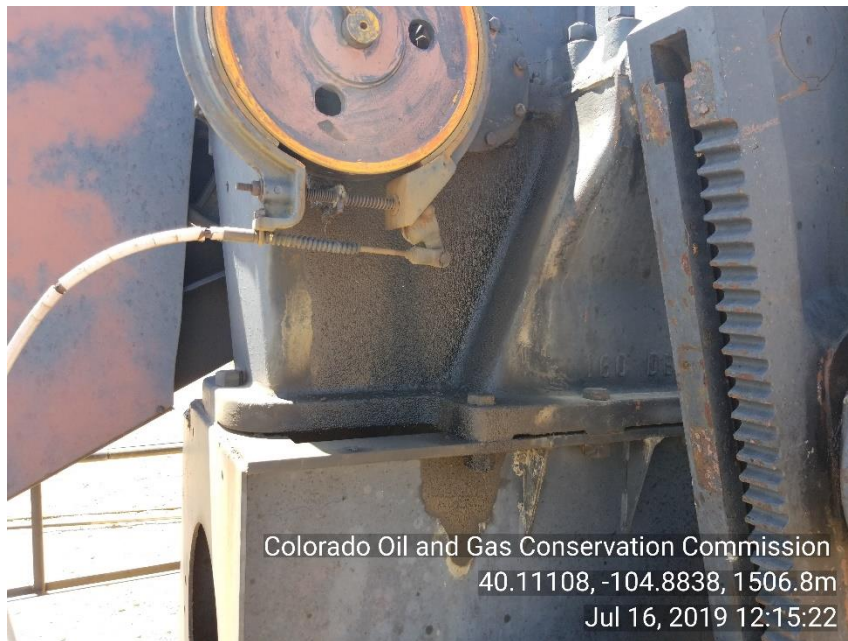
Photo 5 Mechanical issue: gear box appears to be leaking

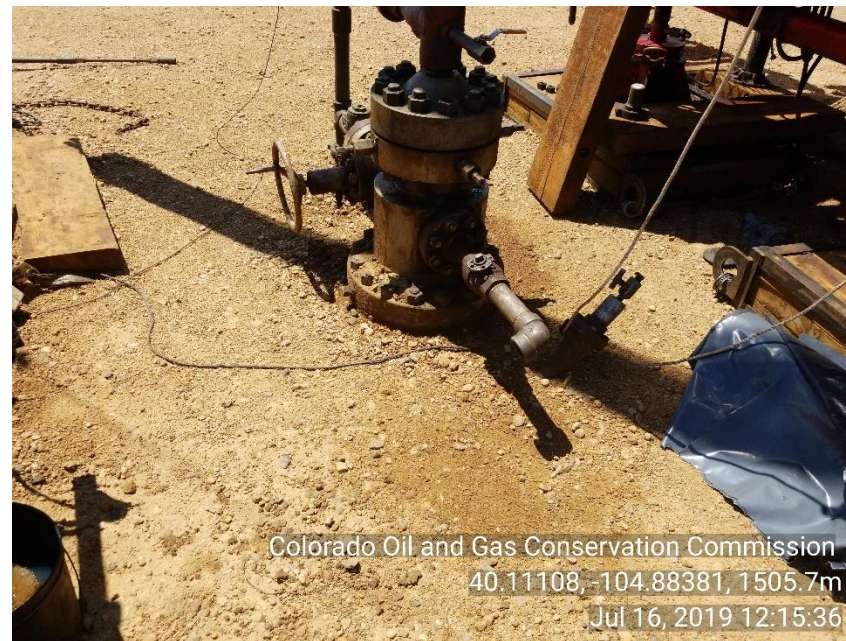
Photo 6 Stained soil around WH

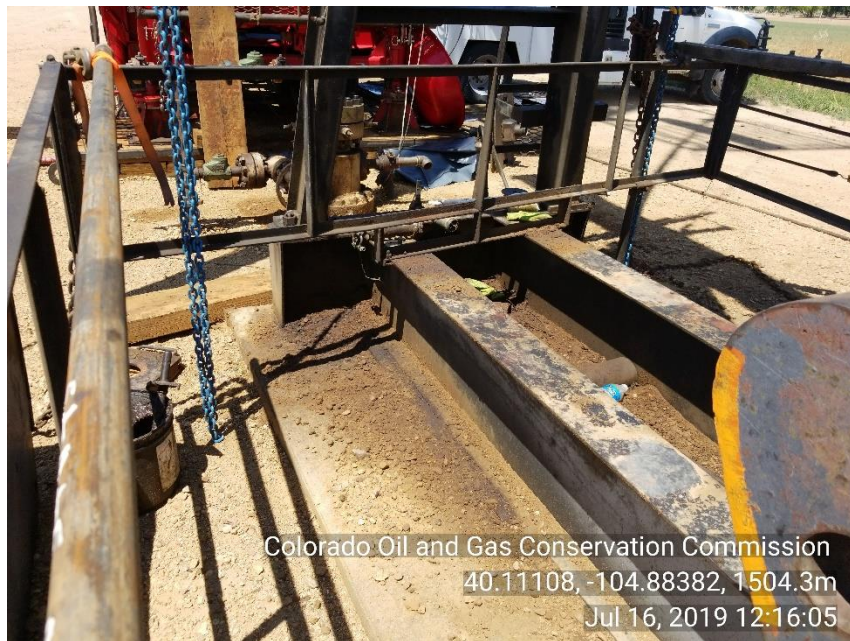
Photo 7 Stained soil in and around PU base

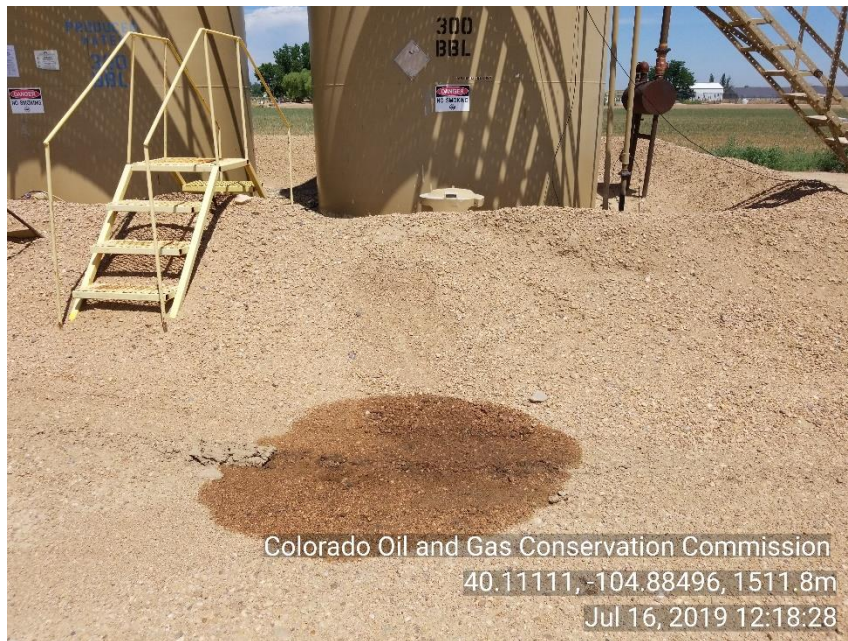
Photo 9 Stained soil from what appears to be from trucks unloading.

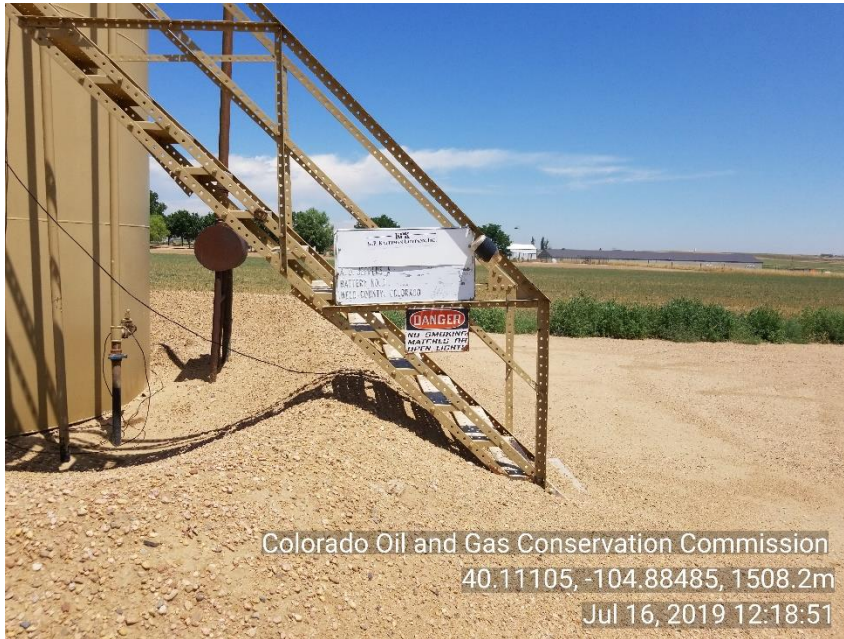
Photo 11 TNK BTRY sign faded not legible.
