Inspection Photos
Location Name: Champlin 86 Amoco F #2
Location ID: 319003

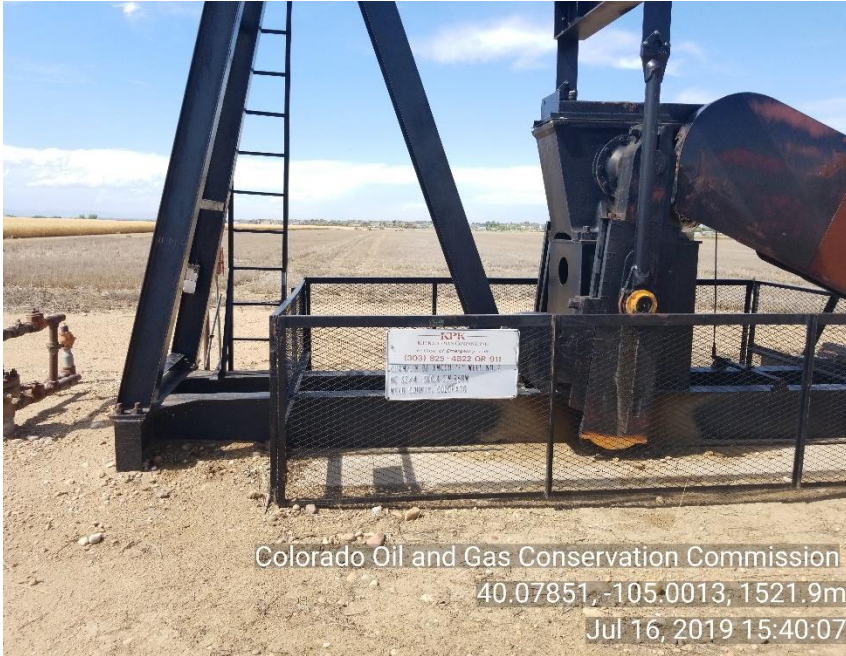
Photo 1 New well head sign has been installed.

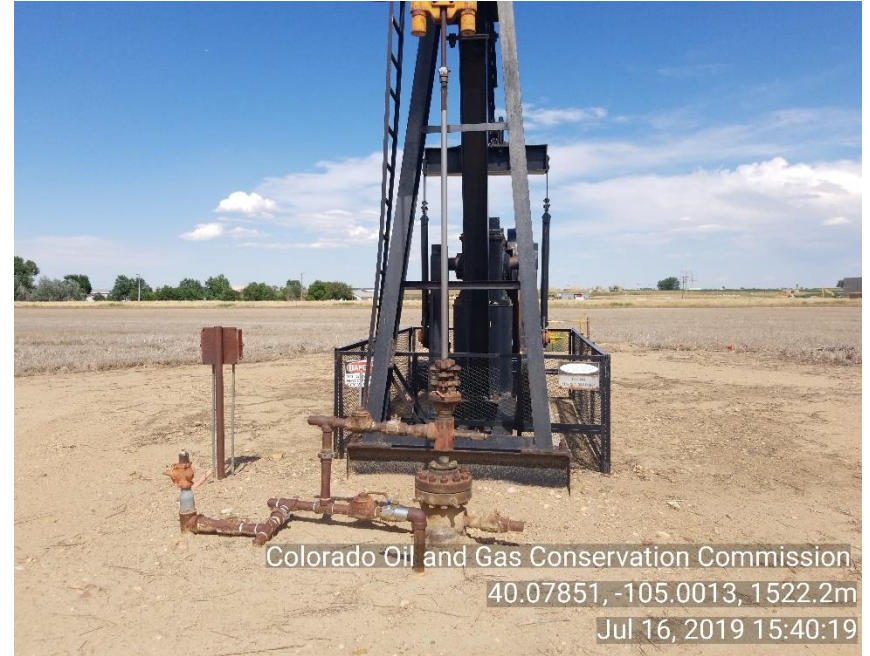
Photo 2 Weeds have been removed from around PU base
