Inspection Photos  
Location Name: EDKAM #2-23  
Location ID: 332669

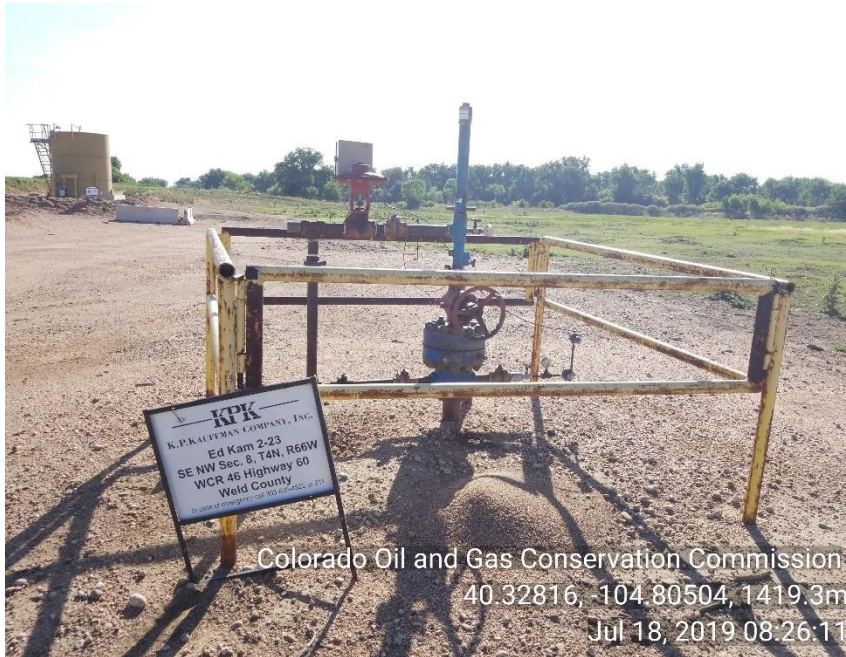
Photo 1 WH and WH sign

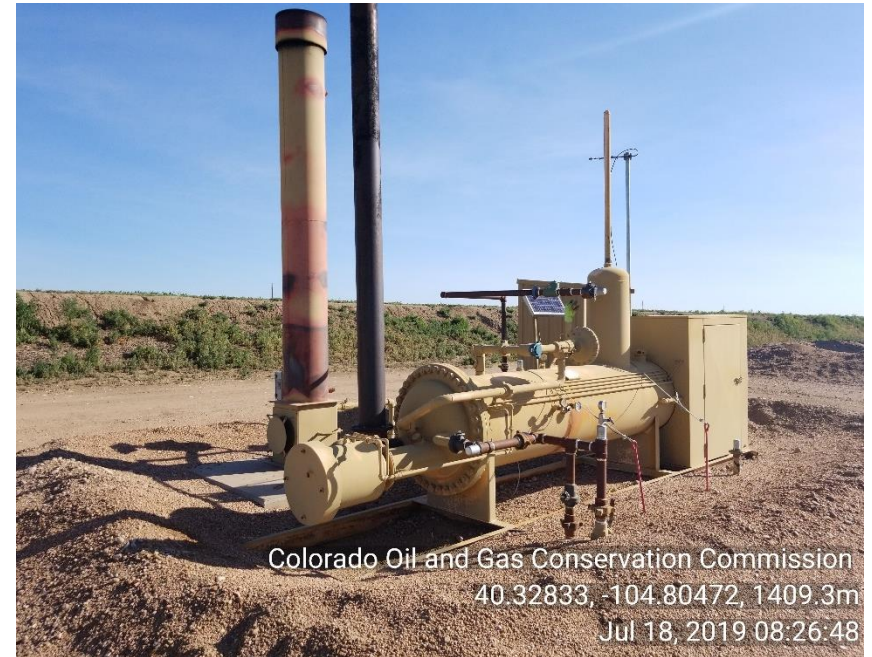
Photo 2 Sep/meter house and ECD

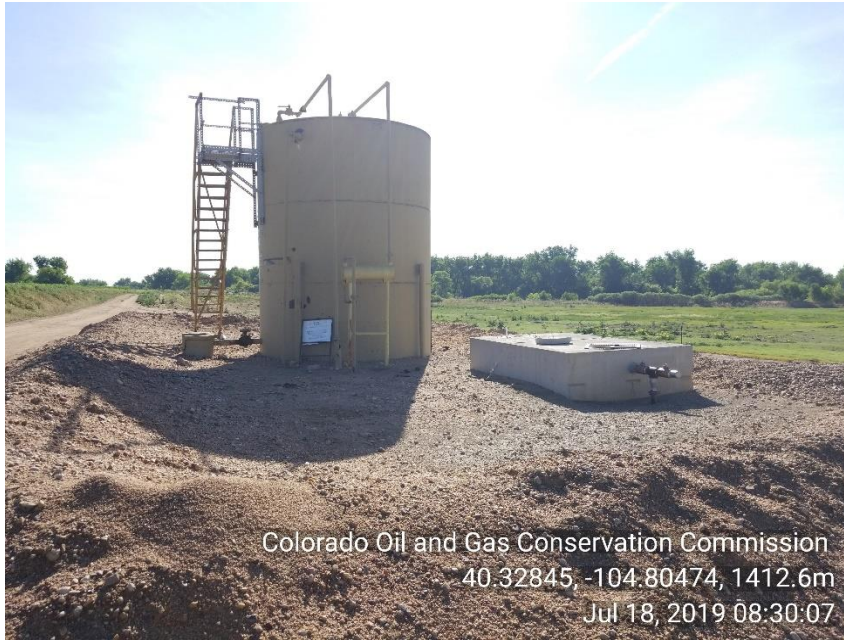
**Photo 3 TNK BTRY located in floodplain does not have steel containment.**

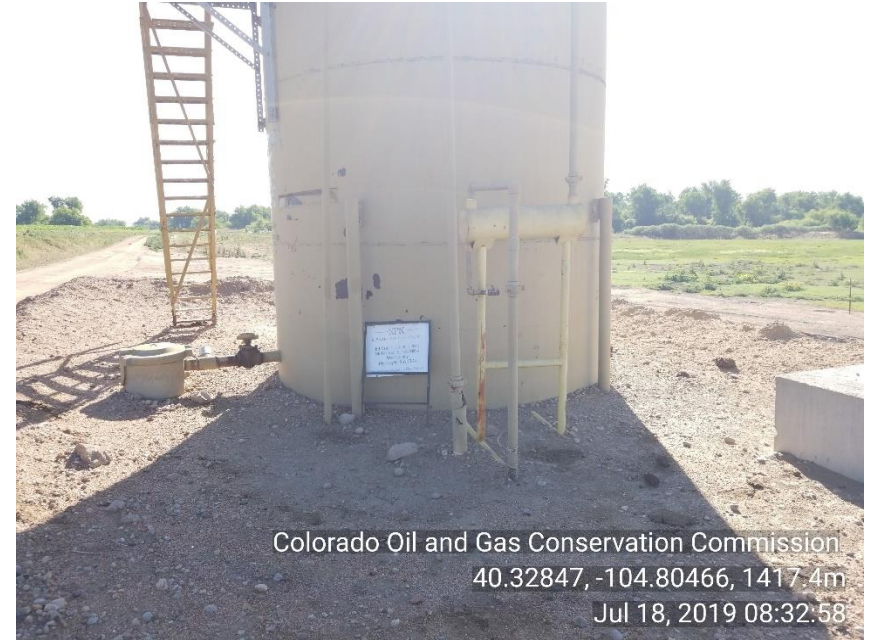
**Photo 4 TNK BTRY in floodplain and does not have proper anchoring.**

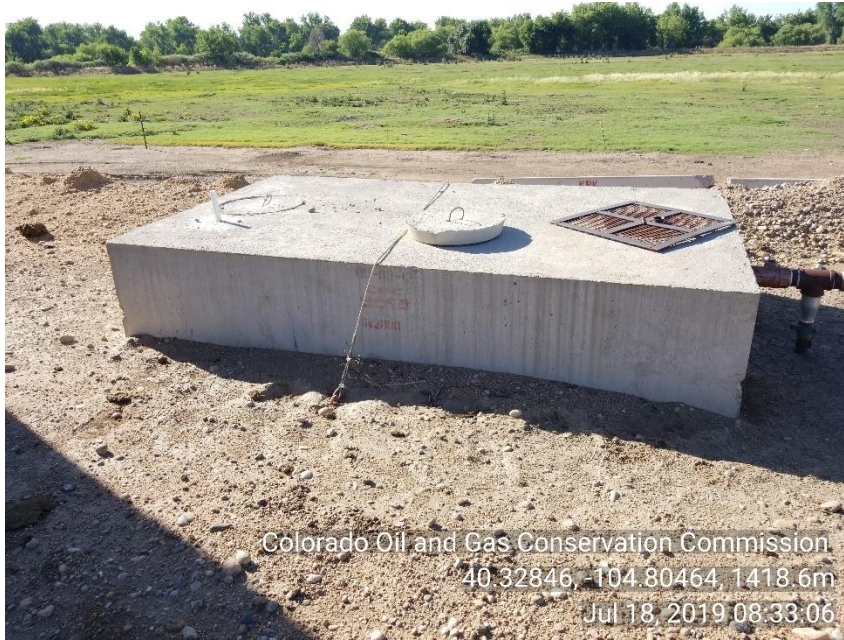
**Photo 5 Produced water tank Anchoring installed.**

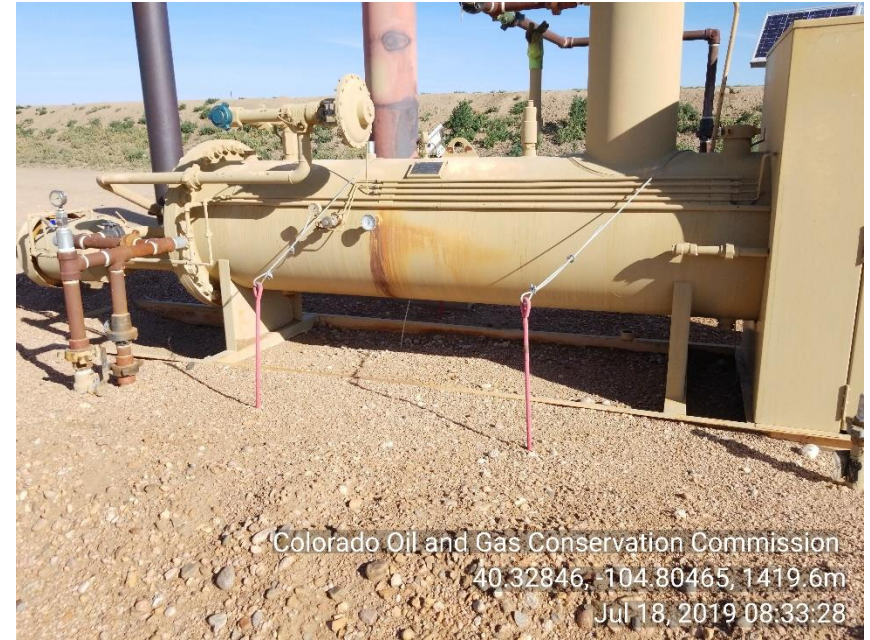
**Photo 6 HOZ Sep anchoring installed**
