Inspection Photos

Location Name: TPR Well Pad 25A & TPR 25A Land Application

Location ID: #334457 & Facility ID: #452466

Inspection Date: July 9, 2019

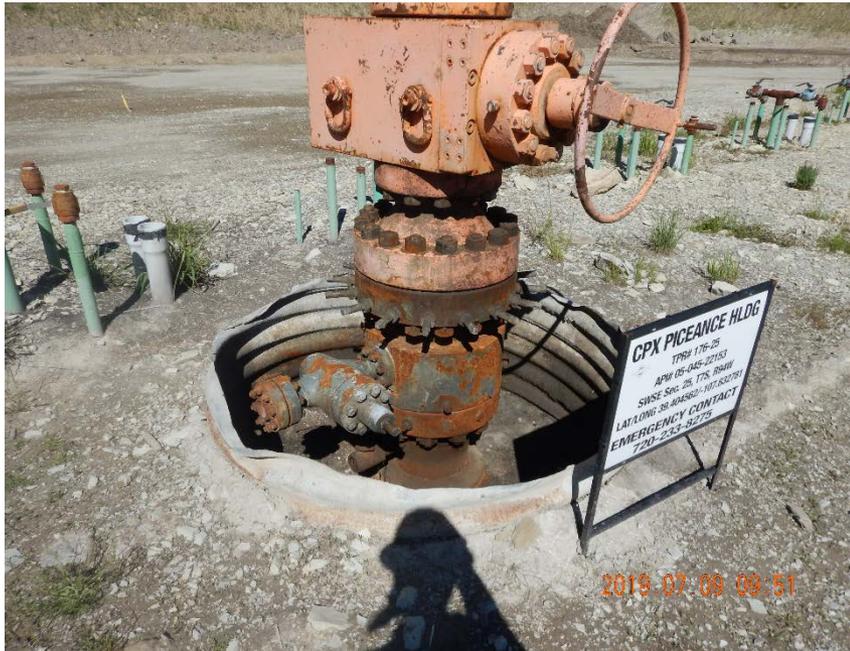
Photo #1 – TPR #176-25 wellhead. Note open well cellar contains accumulations of oil-stained soil, multiple unmarked flowline risers in background.

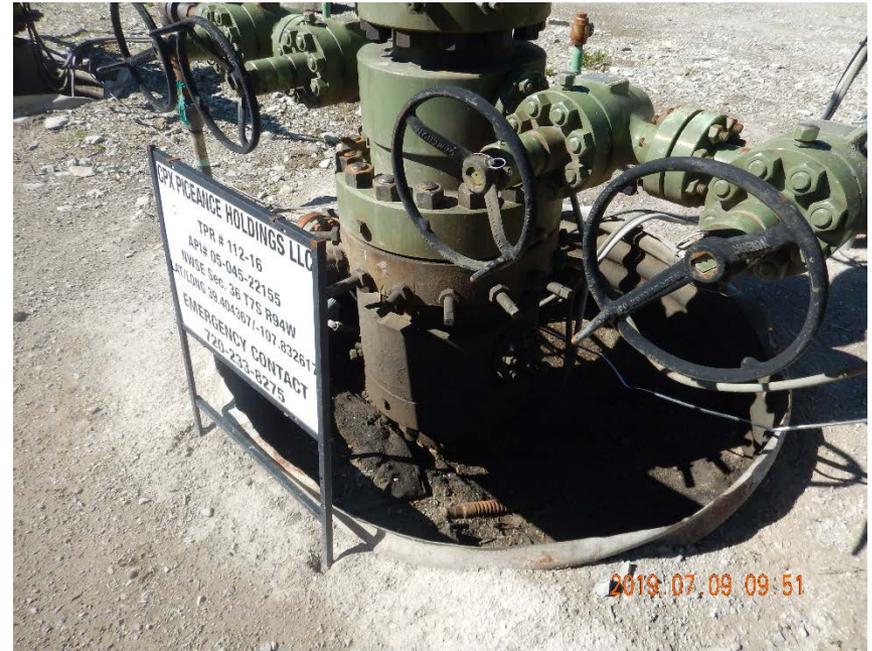
Photo #2 – TPR #112-16 wellhead, note open well cellar contains accumulations of oil-stained soil.

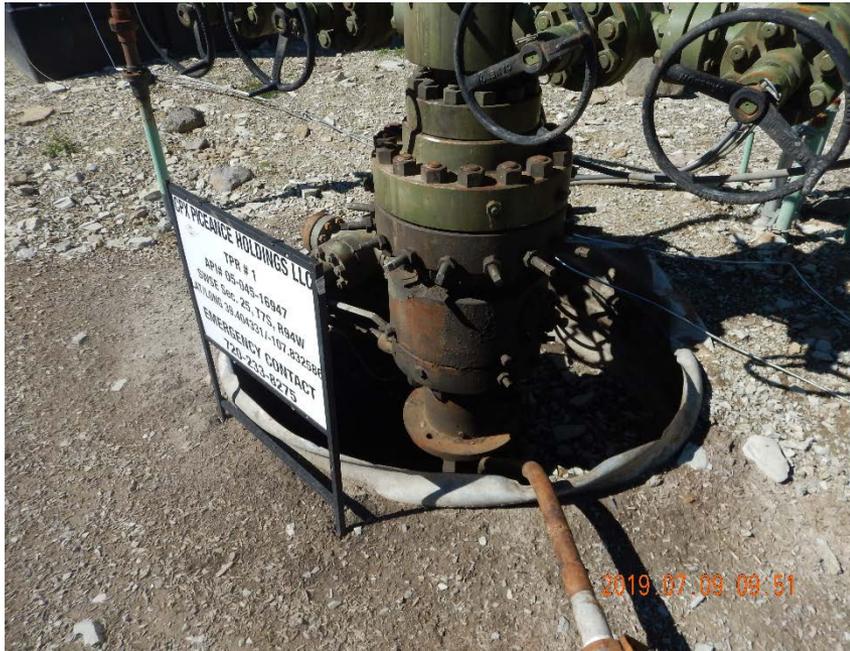
Photo #3 – TPR #1 wellhead. Accumulations of oil-stained soil observed inside open well cellar on inspection date.

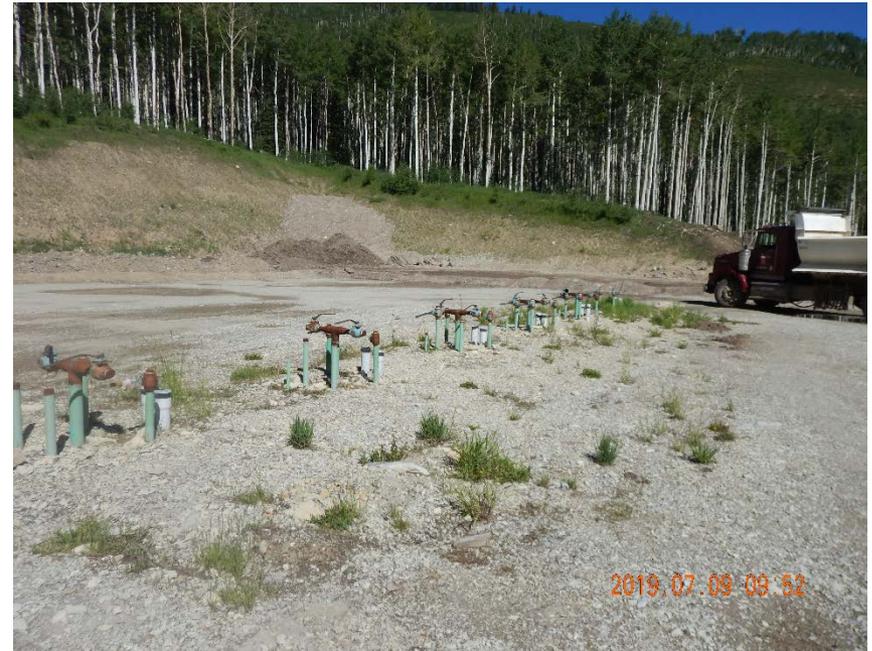
Photo #4 – Unmarked, unused flowline risers northwest of wellheads. Note uncontrolled vegetation growth in this area.

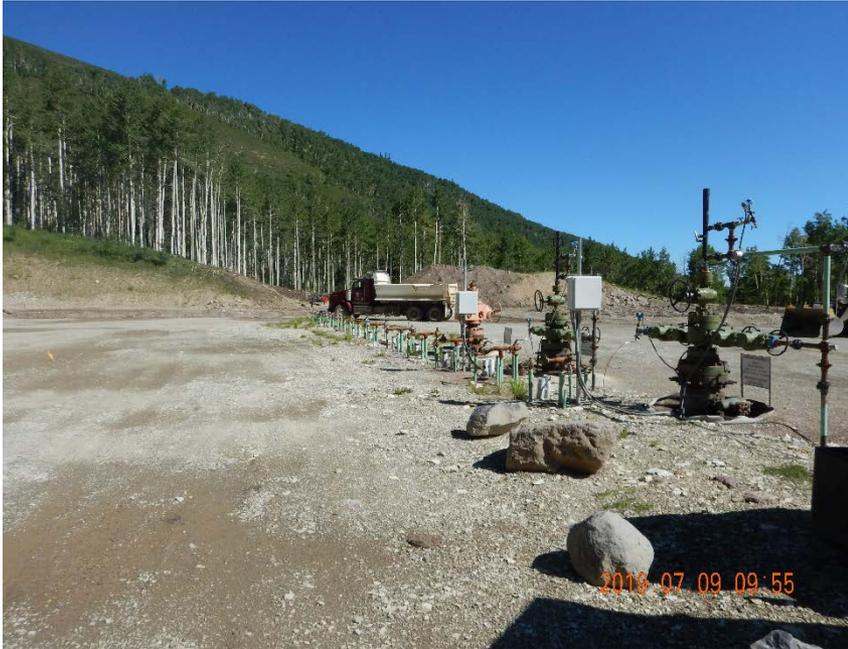
Photo #5 – Overview of wellheads and unmarked flowline risers in center of pad.

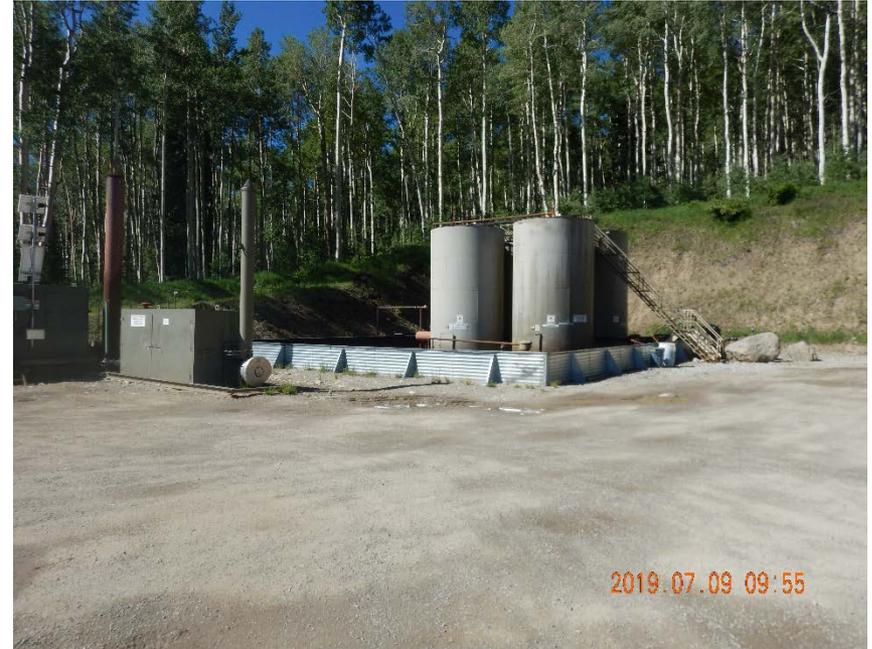
Photo #6 – Overview of tank battery and heated horizontal separators in southwest corner of location. Note vegetation growth beneath separator and along tank battery secondary containment device.

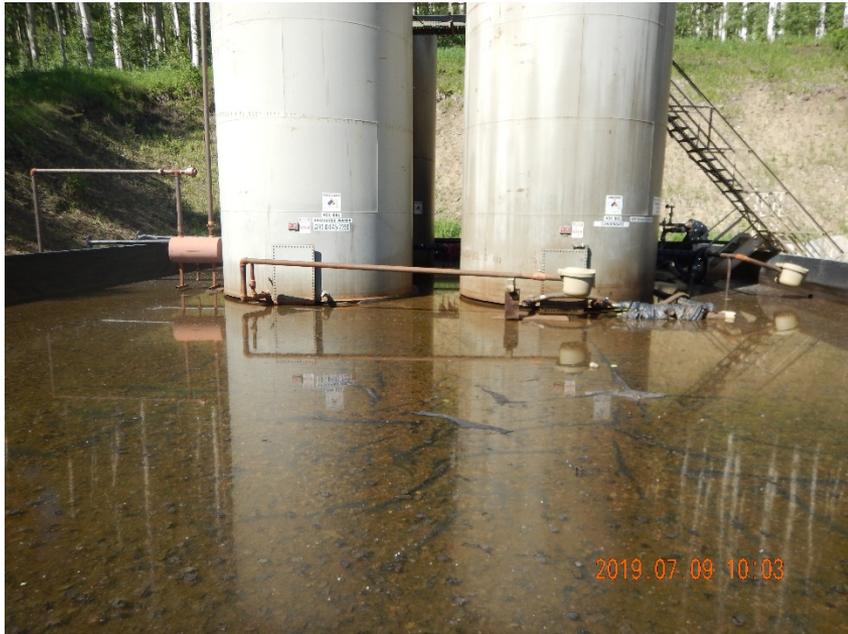
Photo #7 – Approximately 4” of fluids observed inside of tank battery containment area on inspection date. Hydrocarbon odors were noted in the area.

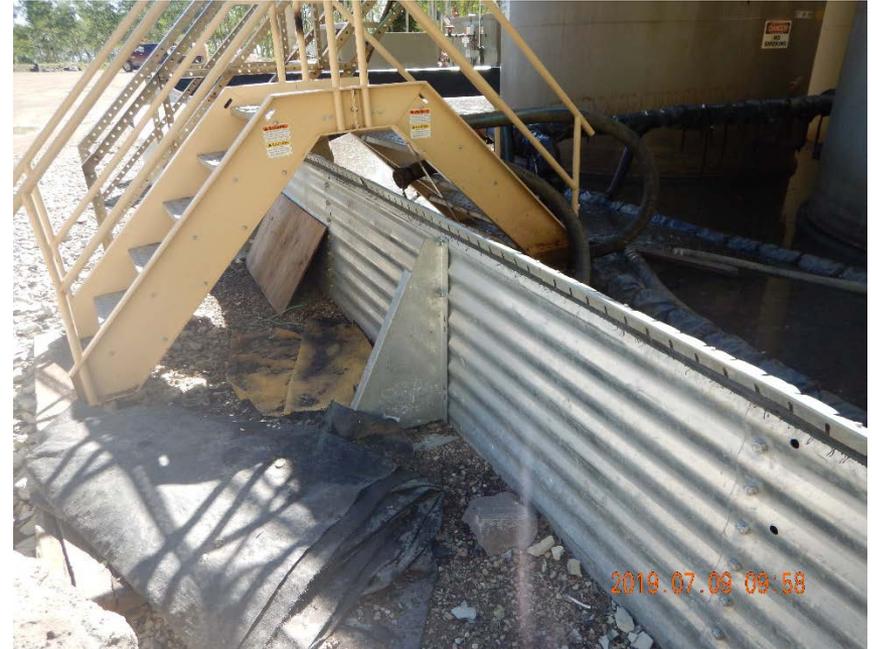
Photo #8 – Assorted supplies and debris (liner material, felt, wood debris) stored outside of tank battery secondary containment on north side.

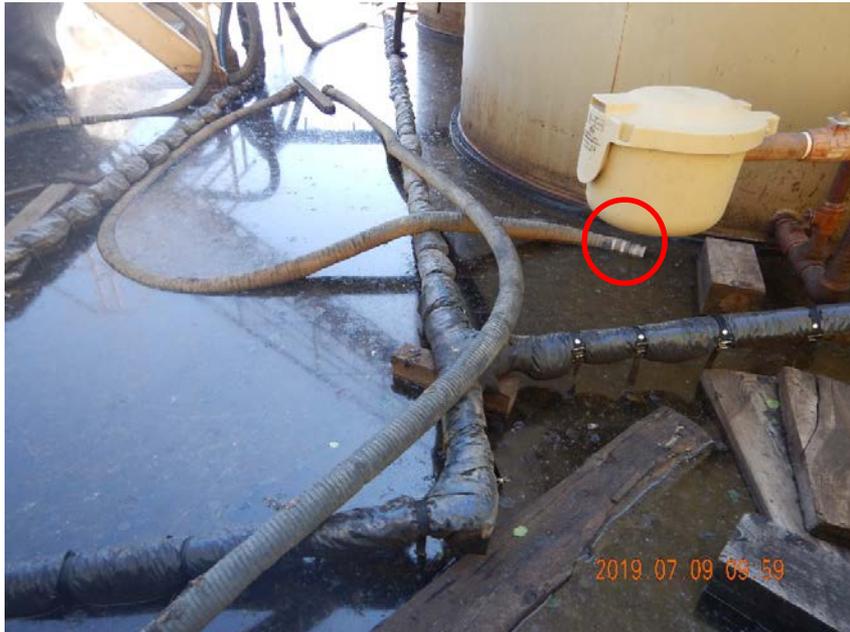
Photo #9 – Hoses and wood debris stored inside of tank battery secondary containment area. Note metal fittings on hoses.

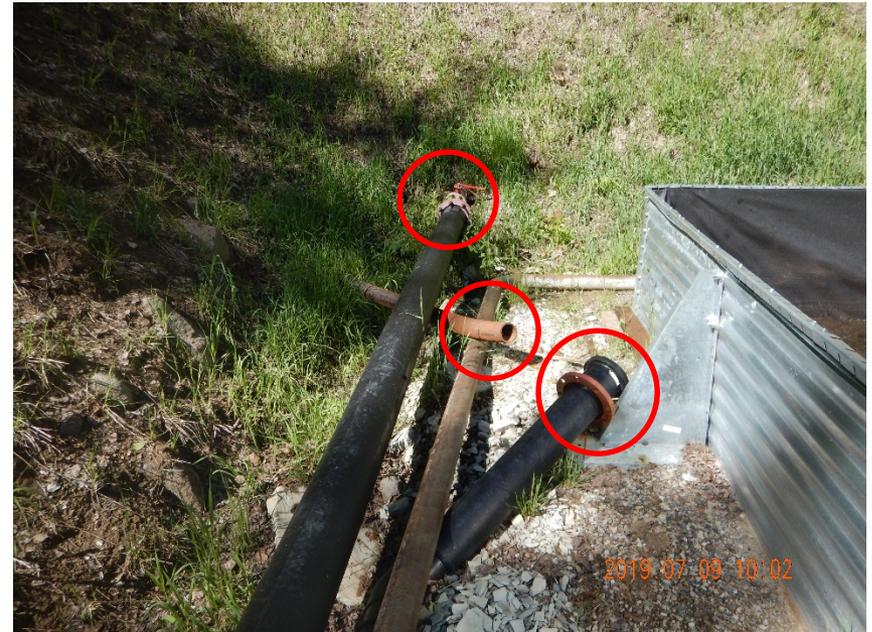
Photo #10 – Assorted flowlines located southwest of tank battery. Note unmarked HDPE and steel flowlines, two of which were uncapped on inspection date (circled in red).

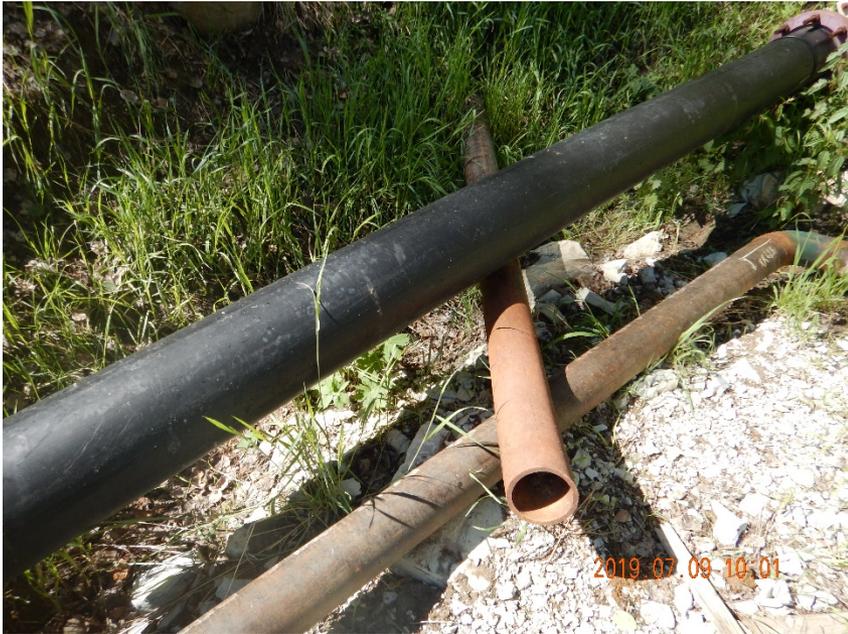
Photo #11 – Uncapped, unmarked 4” steel flowline from previous photo leads off-location to the south.

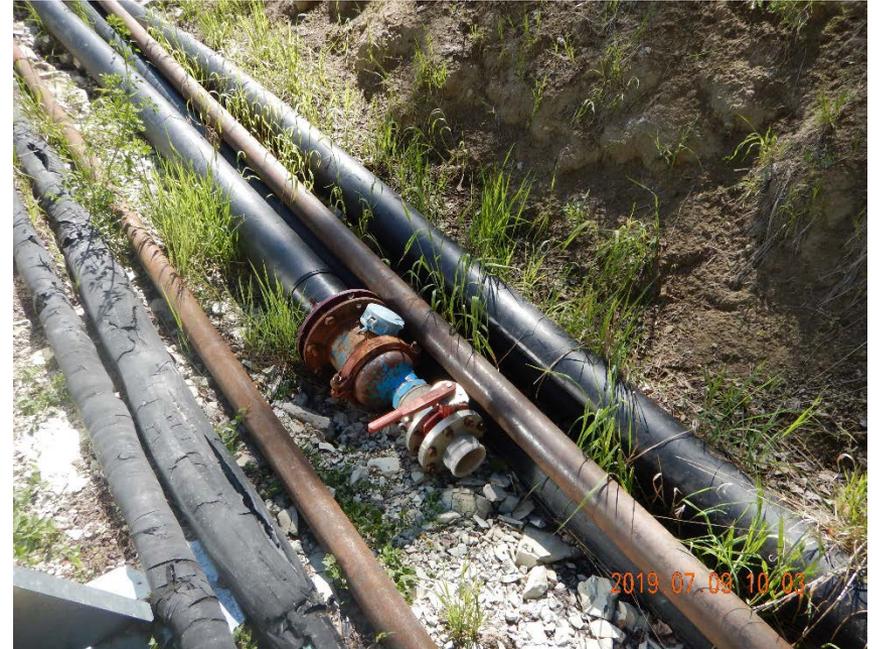
Photo #12 – Additional unmarked flowline south of tank battery.

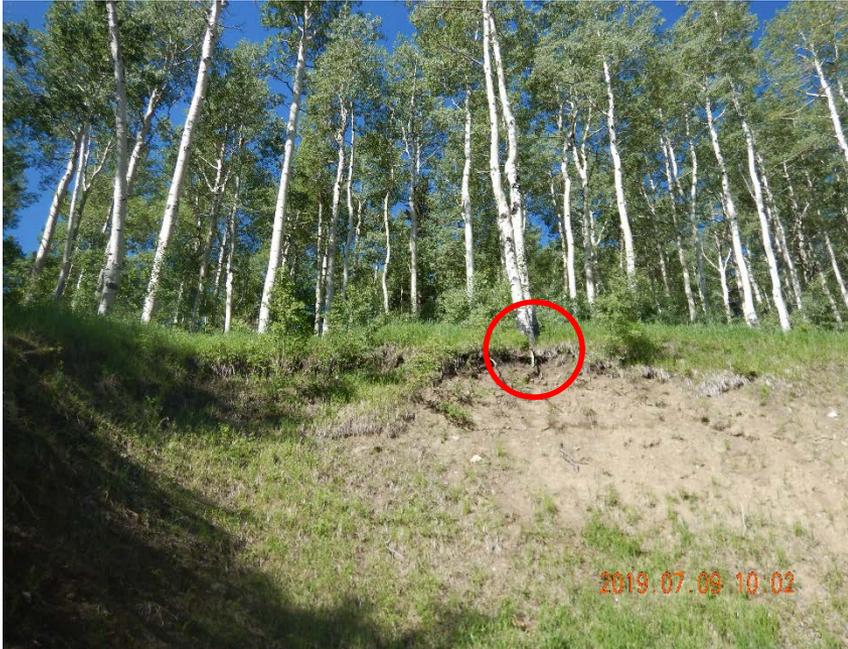
Photo #13 – View of aspen growth above cutslope in southwest corner of location (i.e., behind tank battery). Note exposed aspen root (red circle) and steep angle of cut slope.

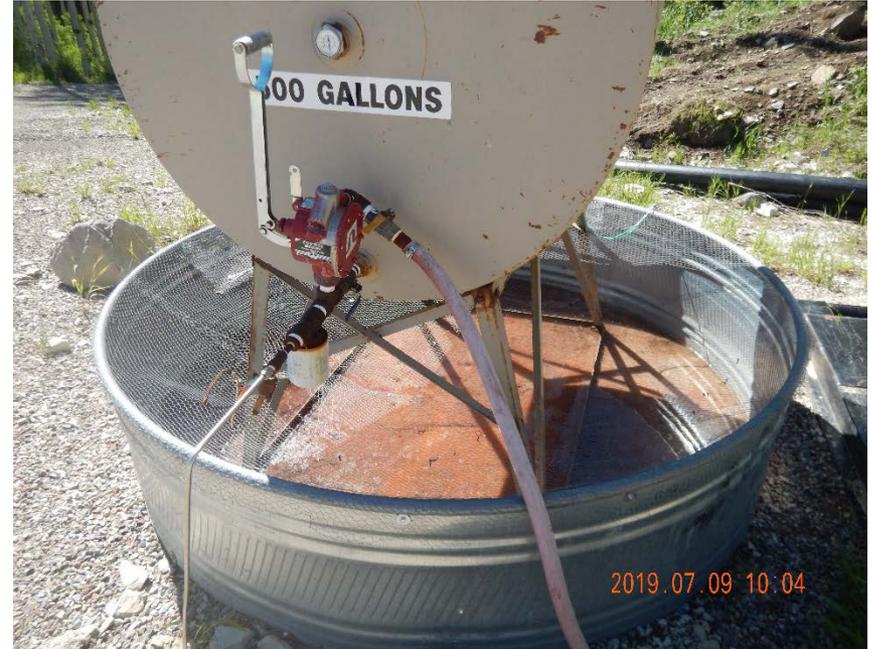
Photo #14 – 500 gallon methanol tank NE of tank battery inside of secondary containment. Note fluids inside of secondary containment device lacked hydrocarbon sheen and odor on inspection date.

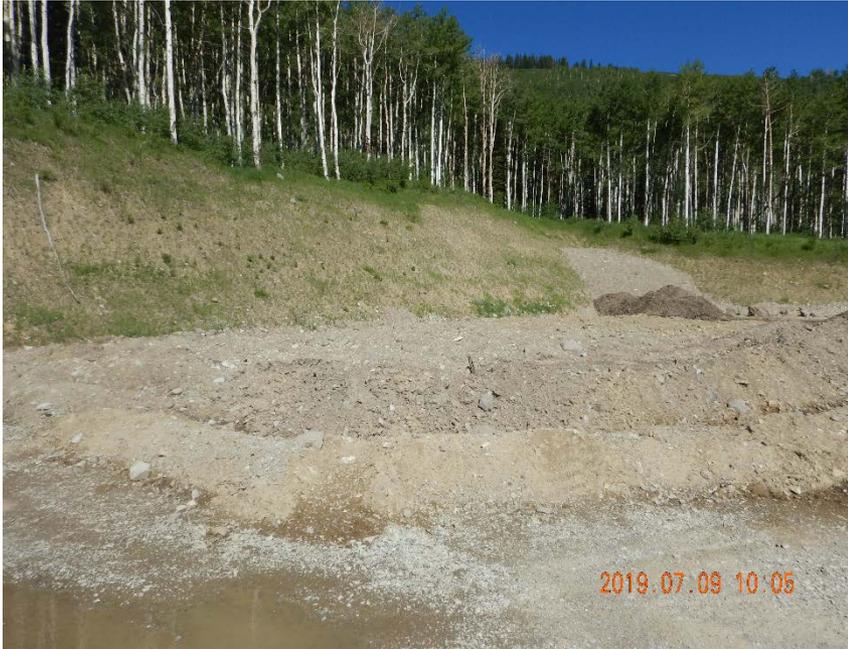
Photo #15 – View of land treatment cell in northwest corner of pad.

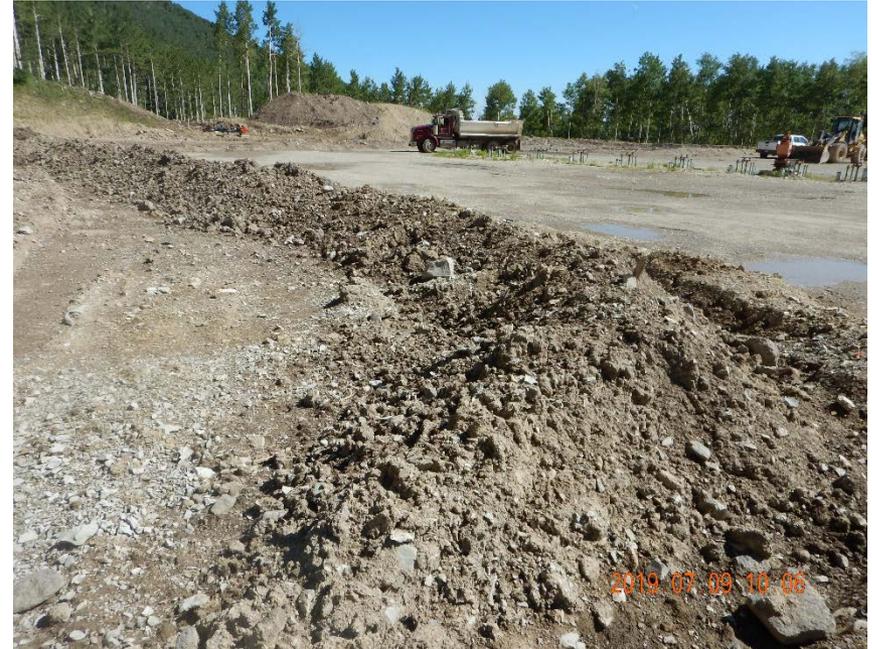
Photo #16 – Earthen berm surrounding NW land treatment cell.

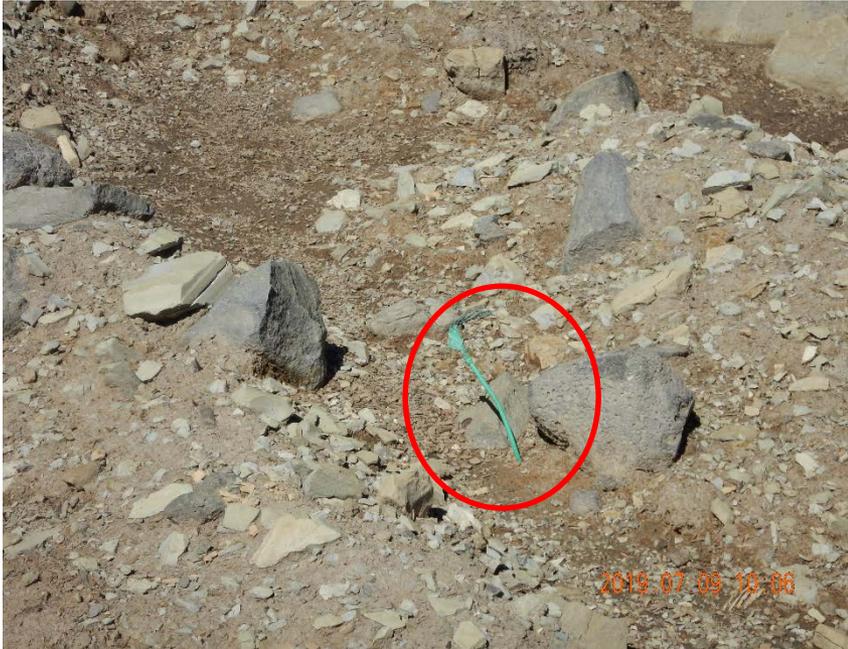
Photo #17 – Trash inside of cuttings treatment area (1).

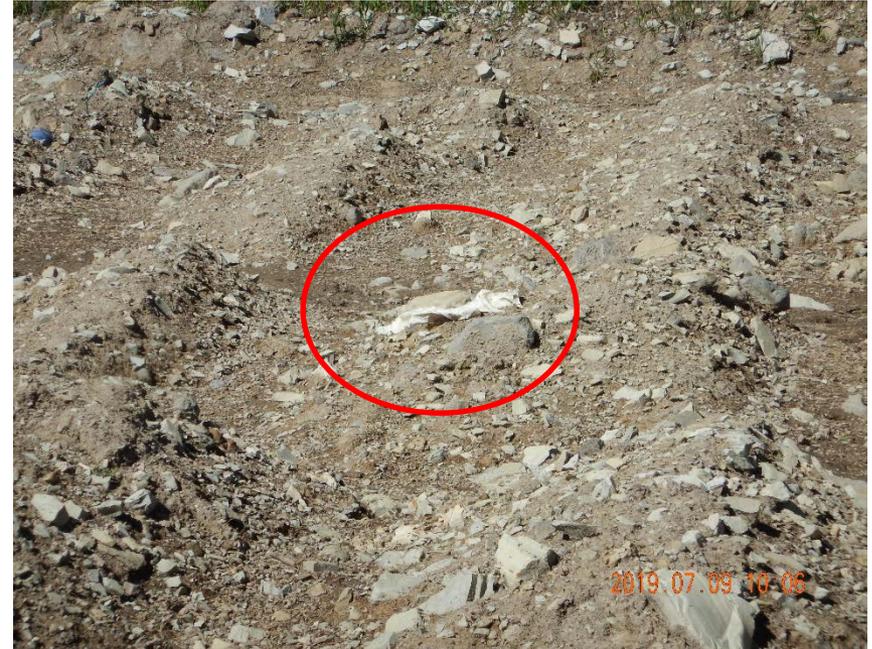
Photo #18 - Trash inside of cuttings treatment area (2).

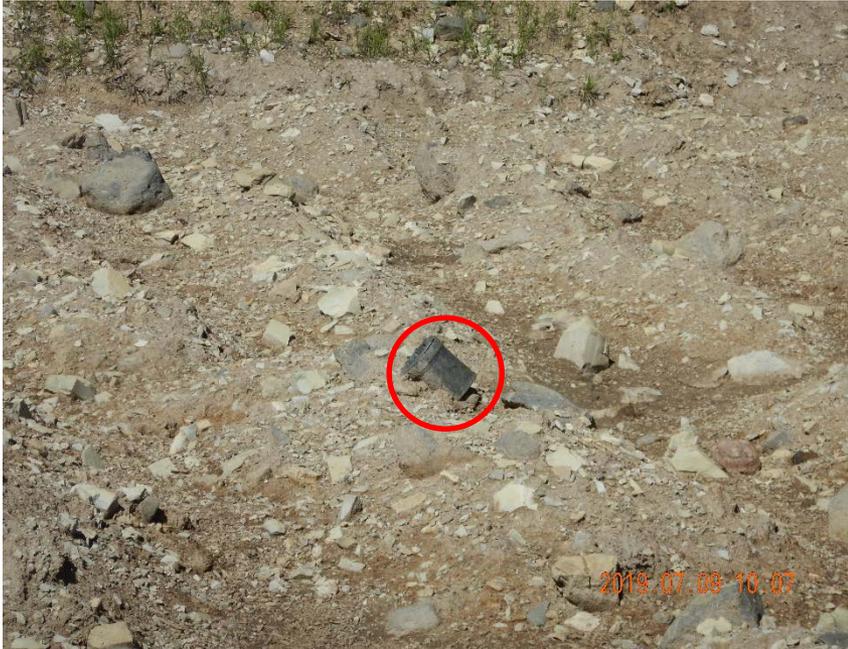
Photo #19 - Trash inside of cuttings treatment area (3).

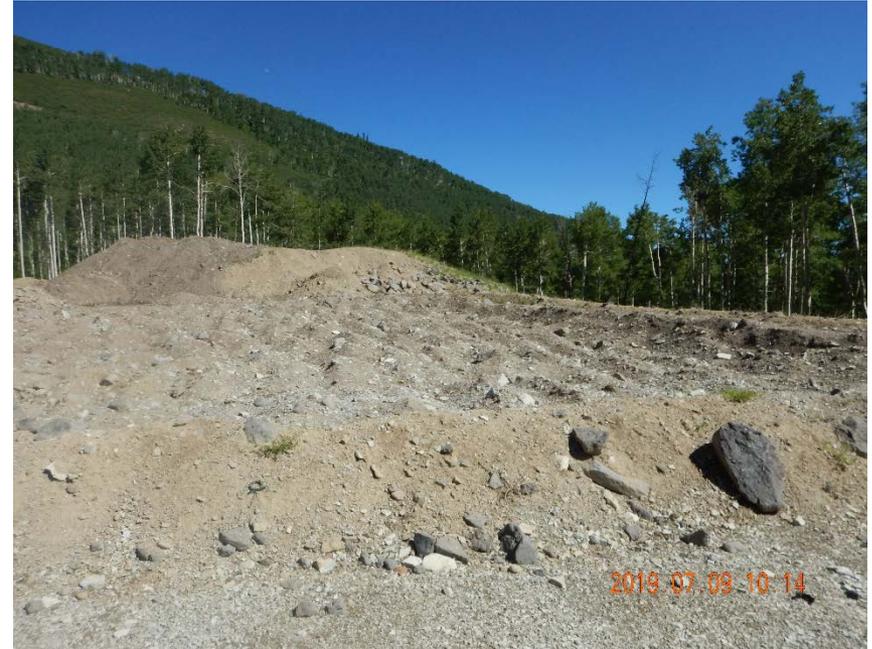
Photo #20 – Land treatment cell in northeast corner of pad.

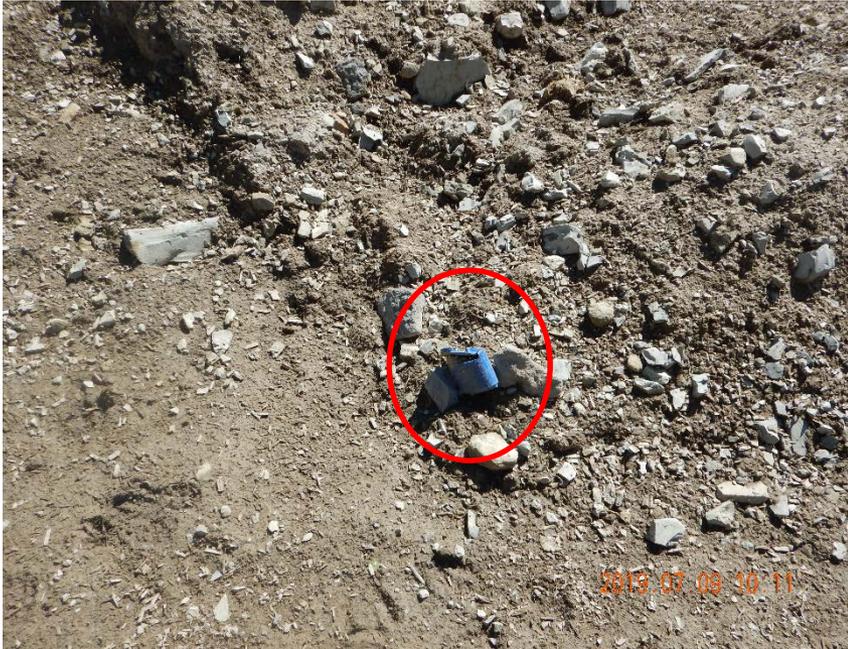
Photo #21 - Trash inside of cuttings treatment area (4).

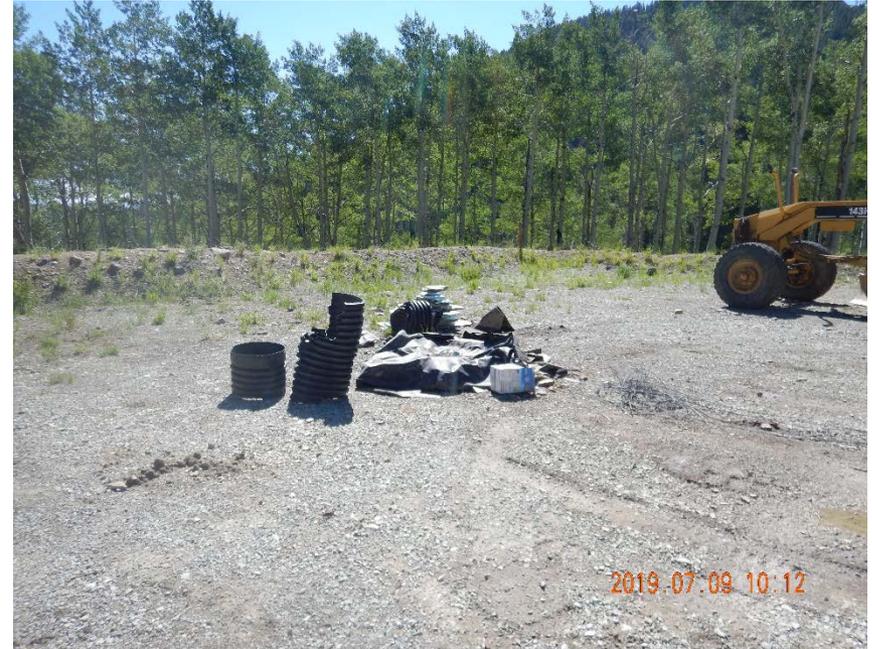
Photo #22 – Plastic culverts, sheet, wire, and assorted equipment stored on east side of pad.
