Inspection Photos

API: 05-071-07915

Operator: ARP PRODUCTION COMPANY
WAPITI OPERATING LLC

Inspection Date: 7/19/2019

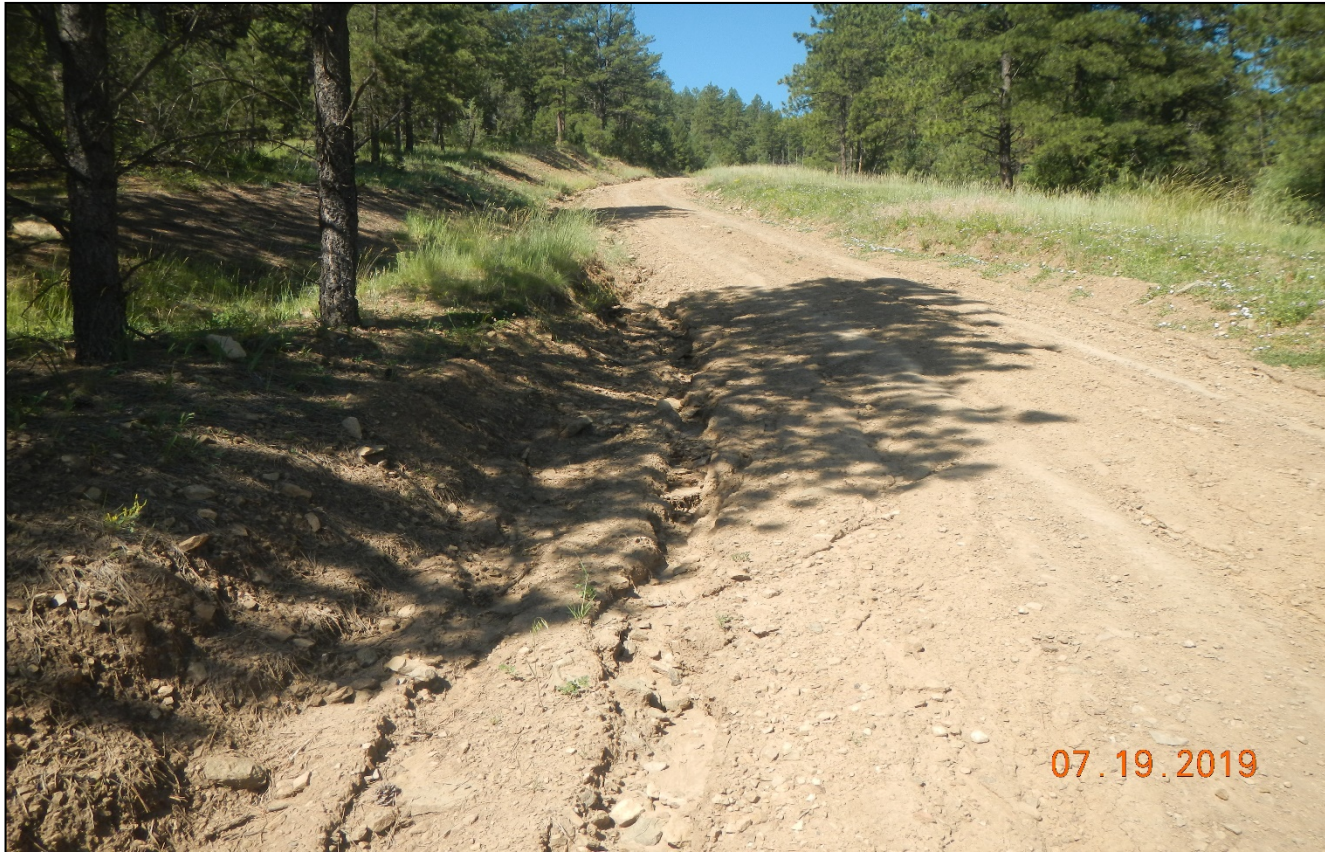
Photo 1. Stormwater is flowing down the road causing erosion. Corrective action was not performed since previous inspection.

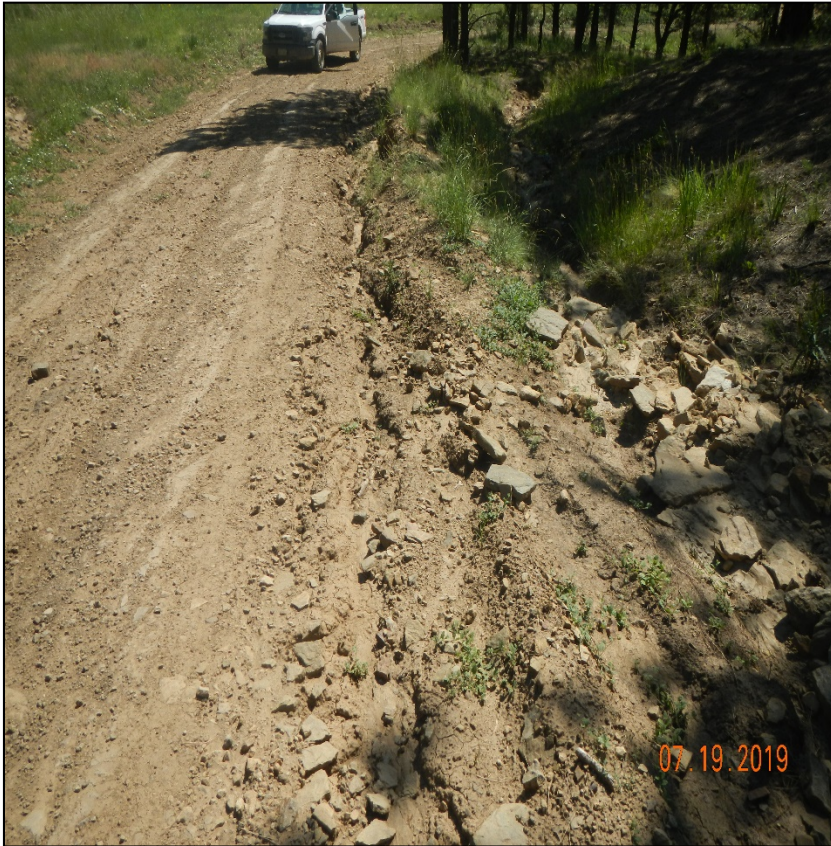
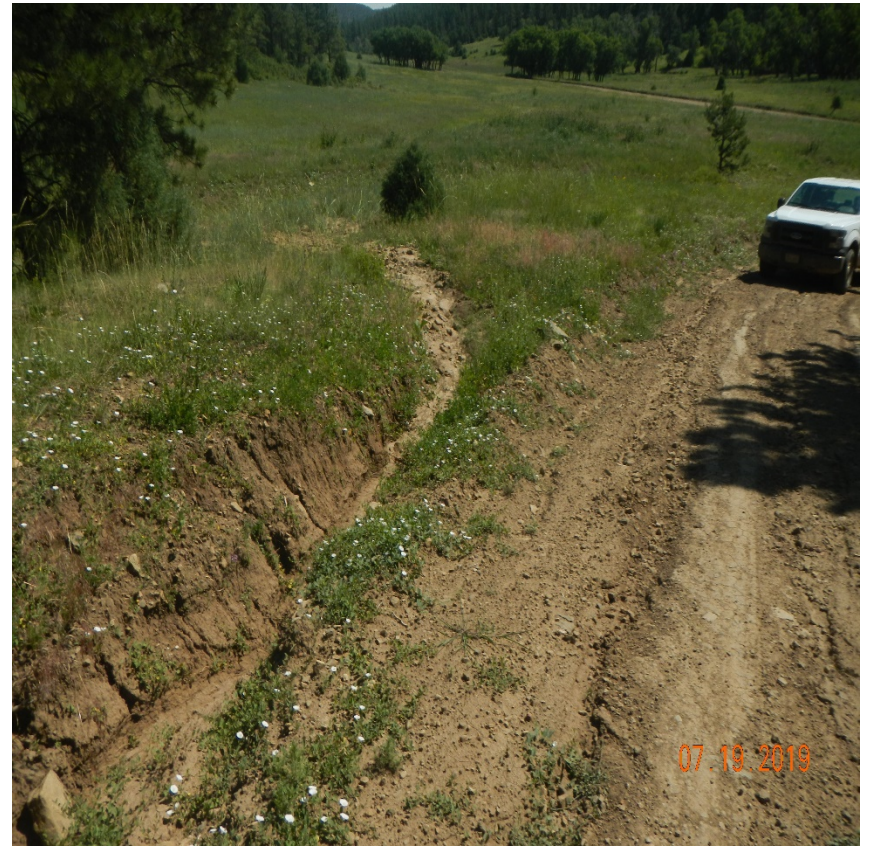
Photo 2. These two diversion ditches are transporting sediment offsite. No BMP's installed. Sediment trap or check damns would prevent sediment transport offsite. Corrective action was not performed since previous inspection.

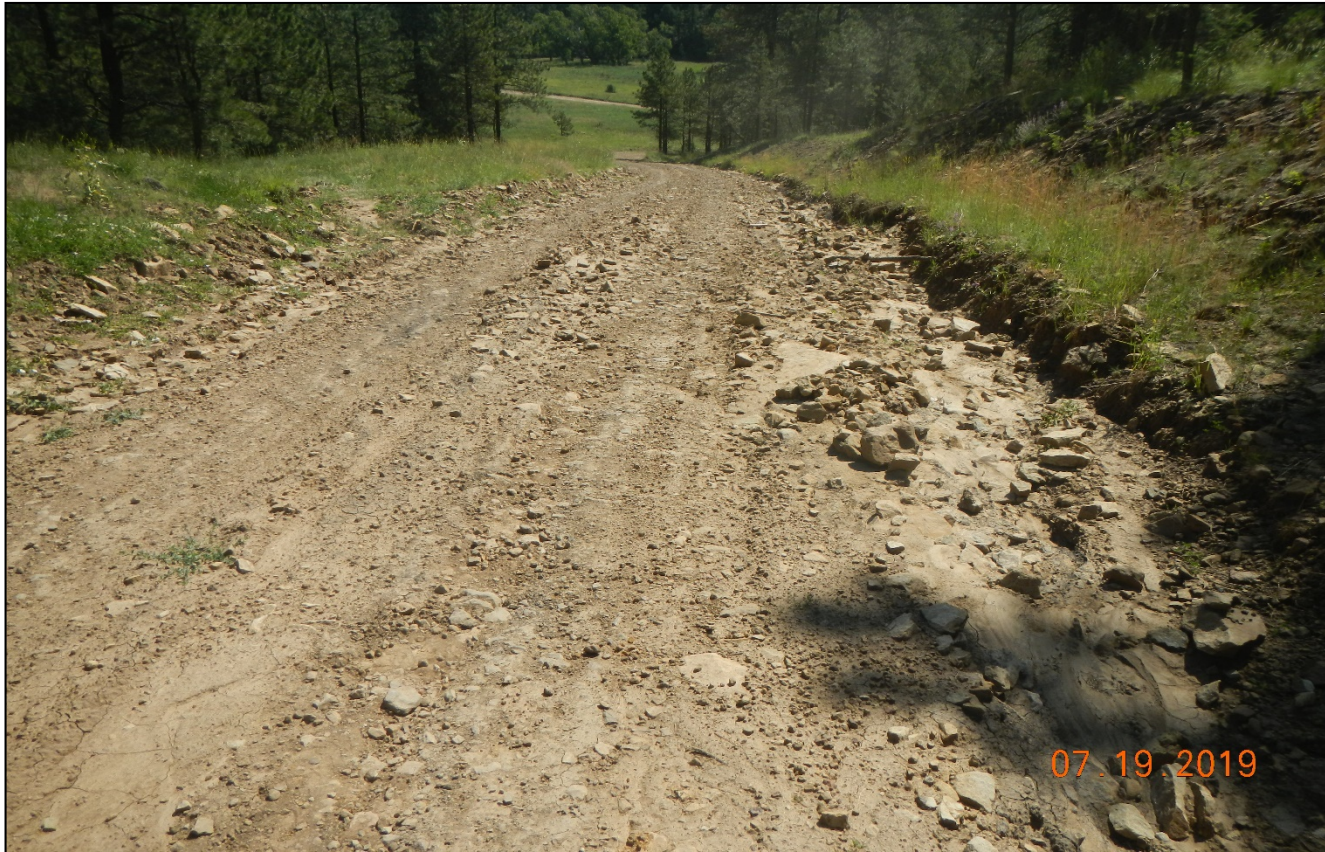
Photo 3. Stormwater is running down the road and is scouring the road. No BMP's installed. Corrective action was not performed since previous inspection.

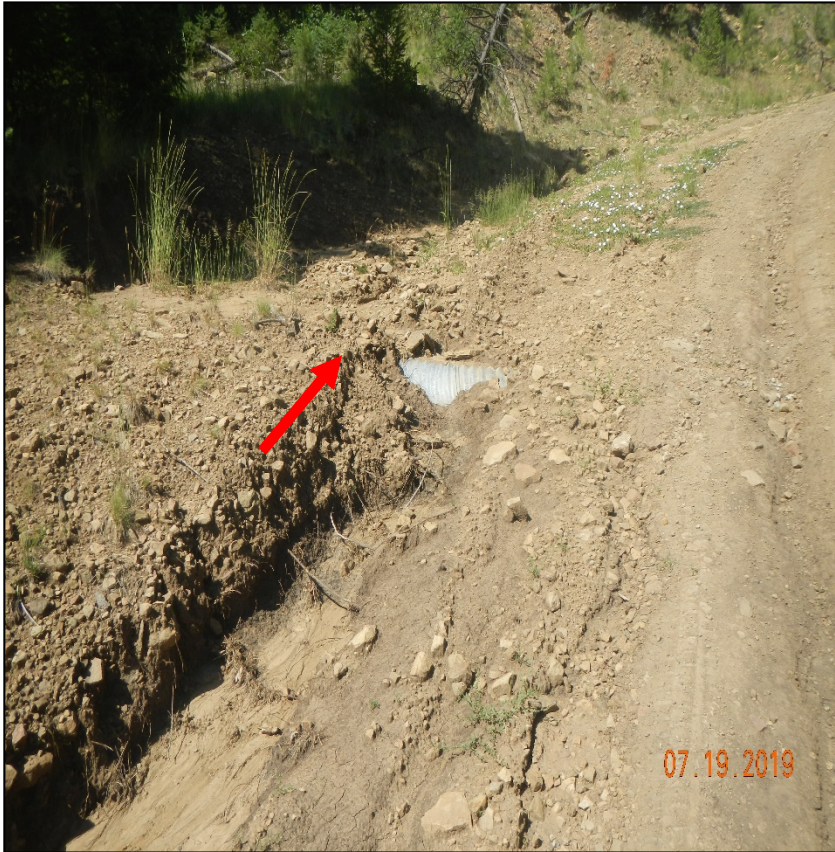
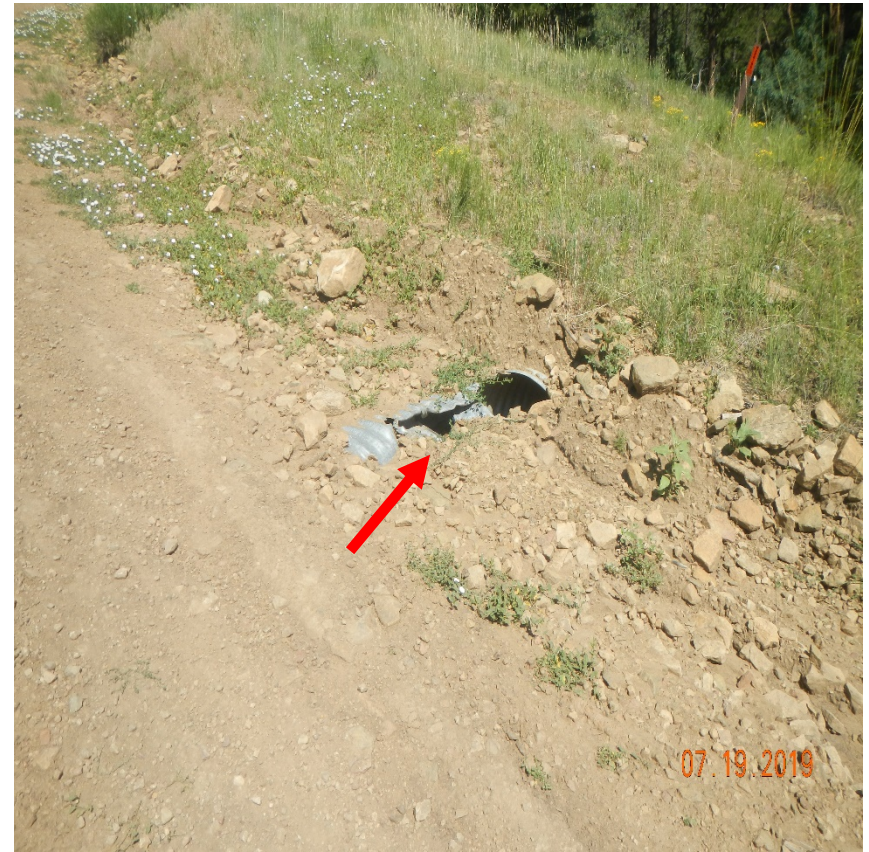
Photo 4. The photo on left is culvert inlet filled with sediment. Photo right is damaged culvert near outlet. Lat/Long:37.00845,-104.84245
Corrective action was not performed since previous inspection.

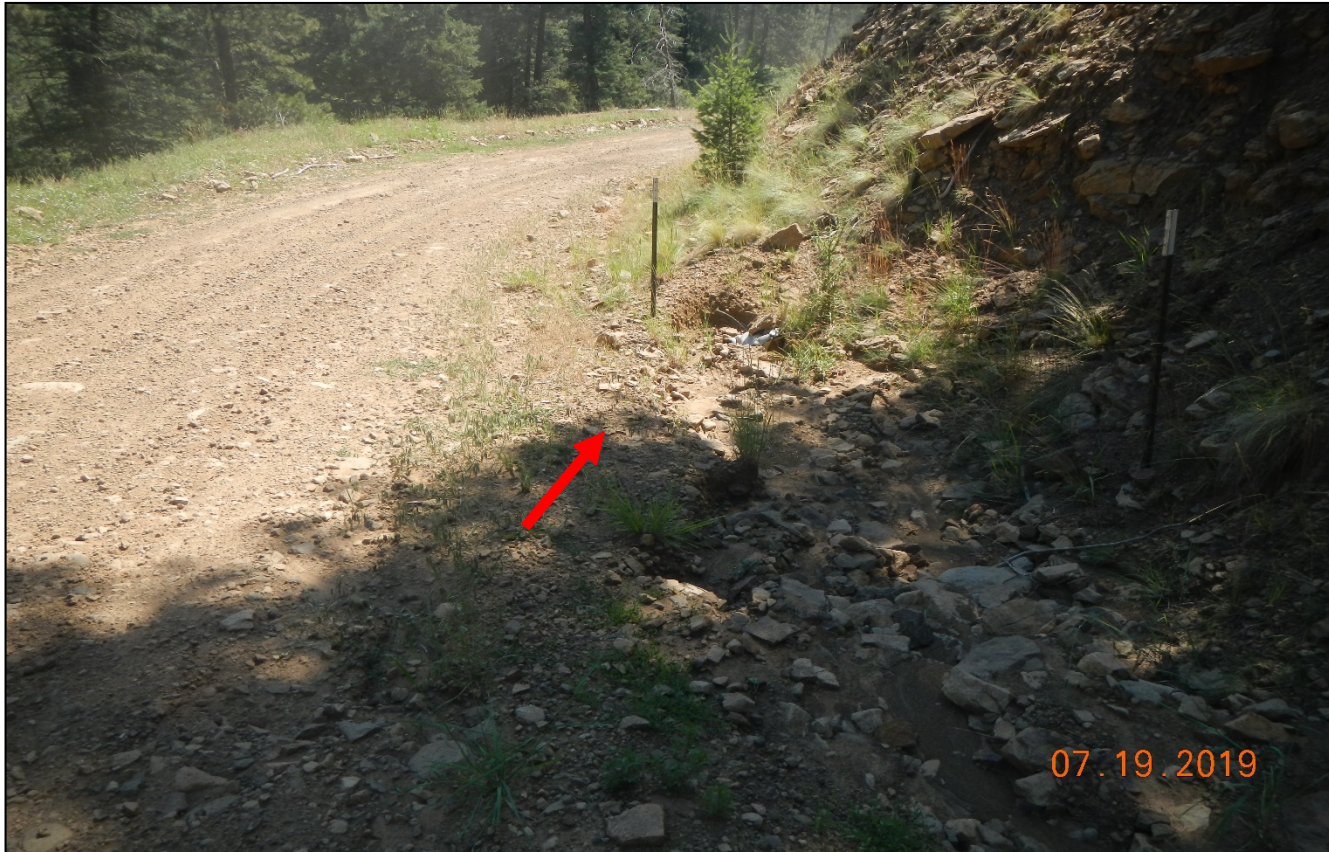
Photo 5. This culvert is filled in with sediment and damaged.

Lat/Long:37.00817,-104.84711

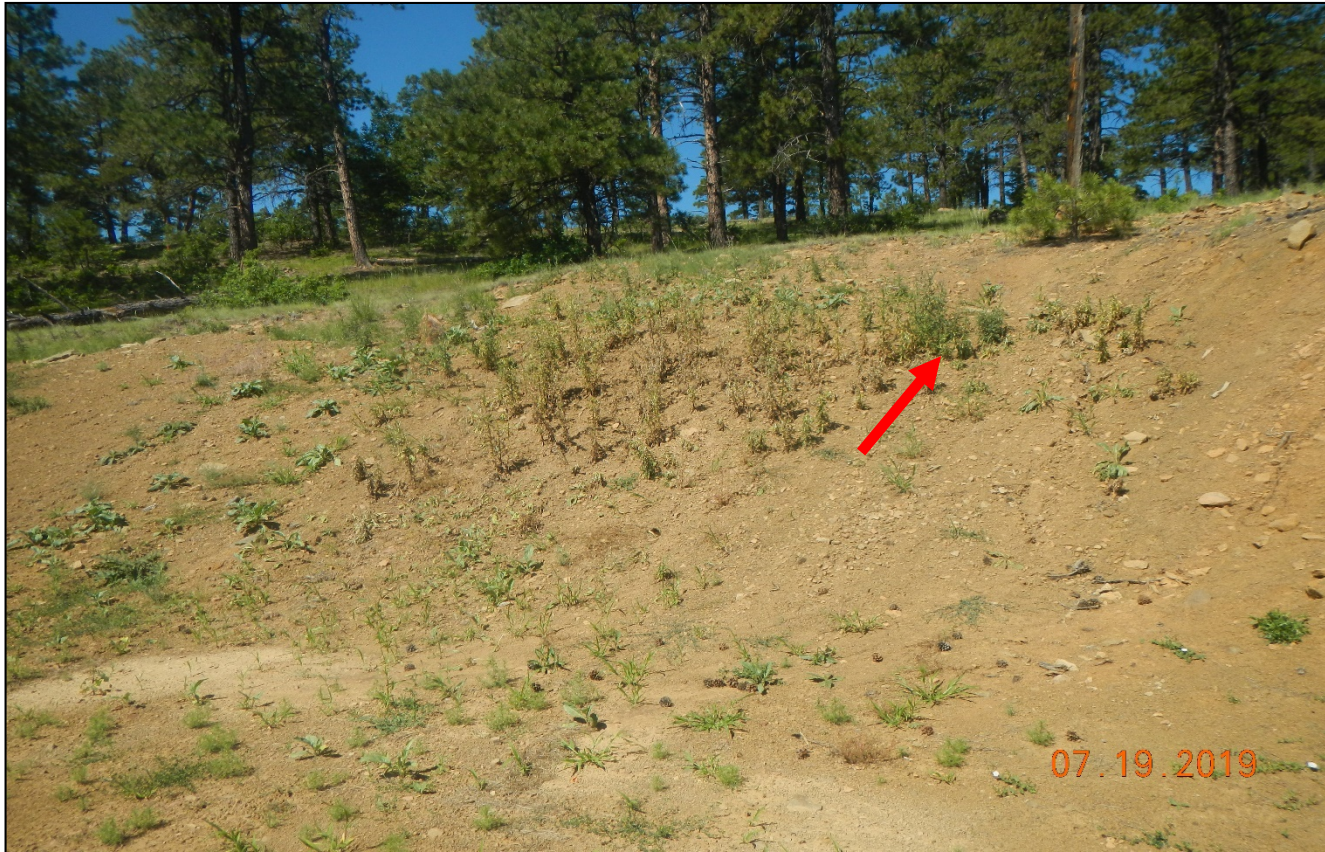
Photo 6. Facing toward the location. Red arrow points to List B noxious weeds. Some of the weeds were wilting from weed control but others were not treated. The cut slope is not stabilized.

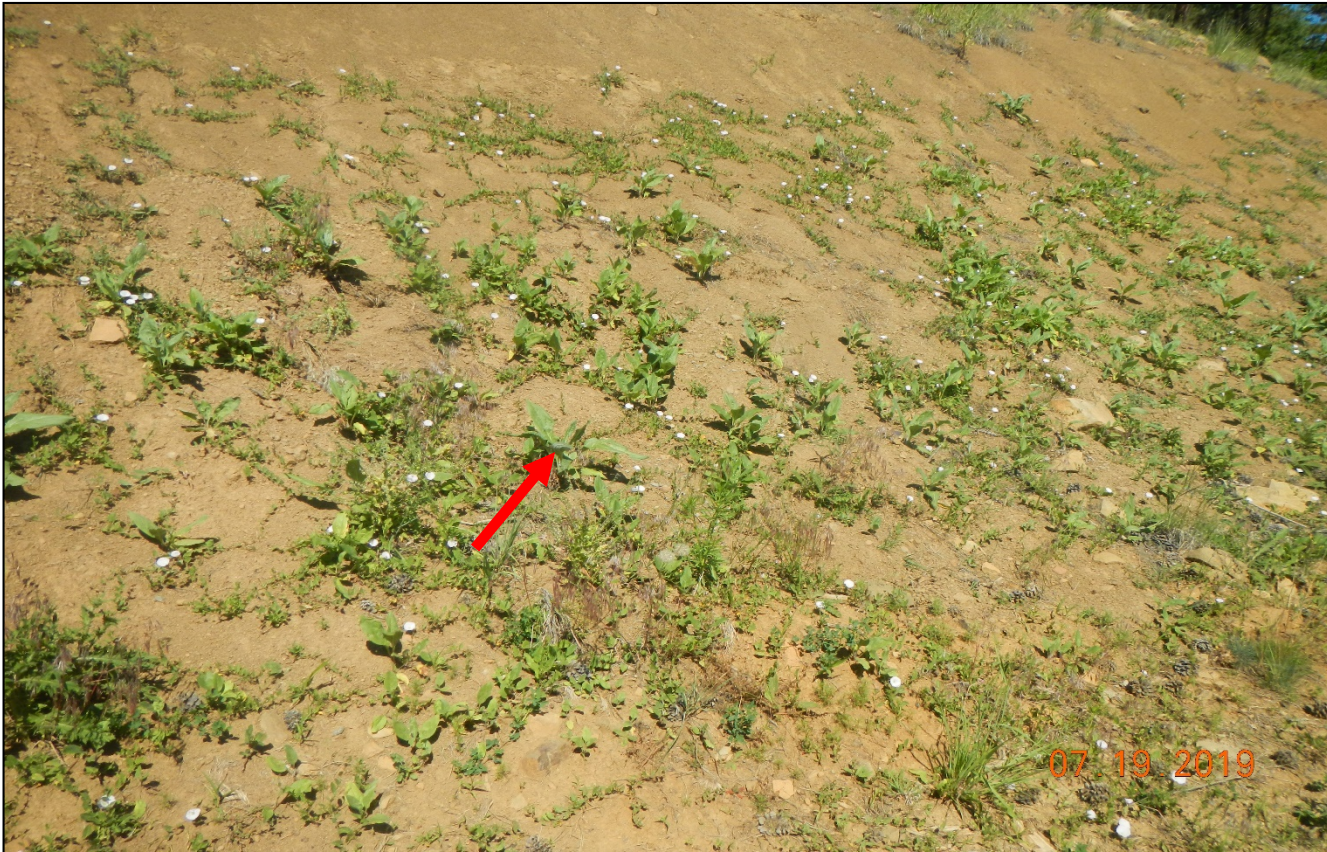
Photo 7. There are numerous first year Houndstongue that have not been controlled along the cut slope. The cut slope is not stabilized. Corrective action was not completed since previous inspection.

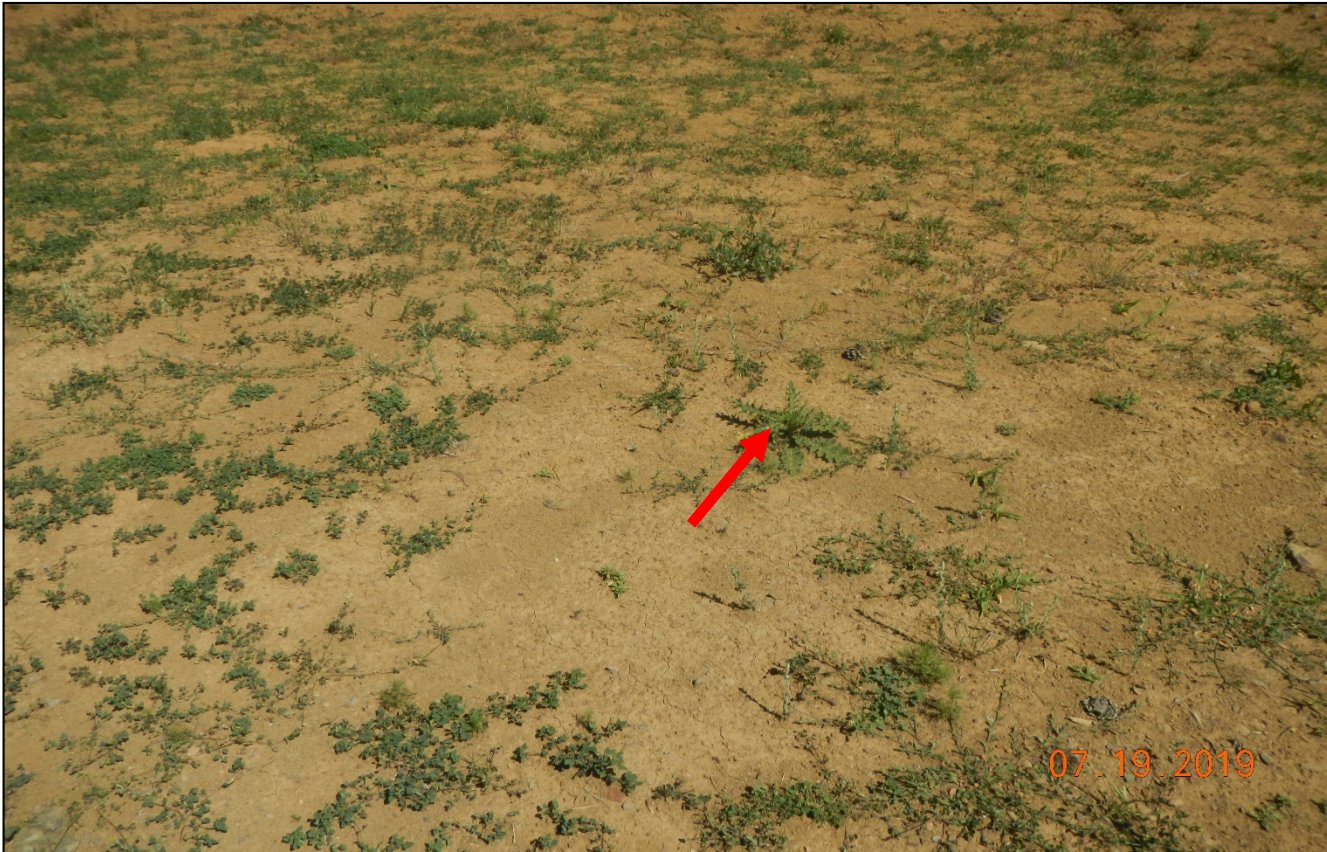
Photo 8. There are numerous first year Musk thistle at the location which have not been controlled. Corrective action was not completed since previous inspection.
