# Inspection Photos

API: 05-071-09061

Operator: ARP PRODUCTION COMPANY  
WAPITI OPERATING LLC

Inspection Date: 7/19/2019

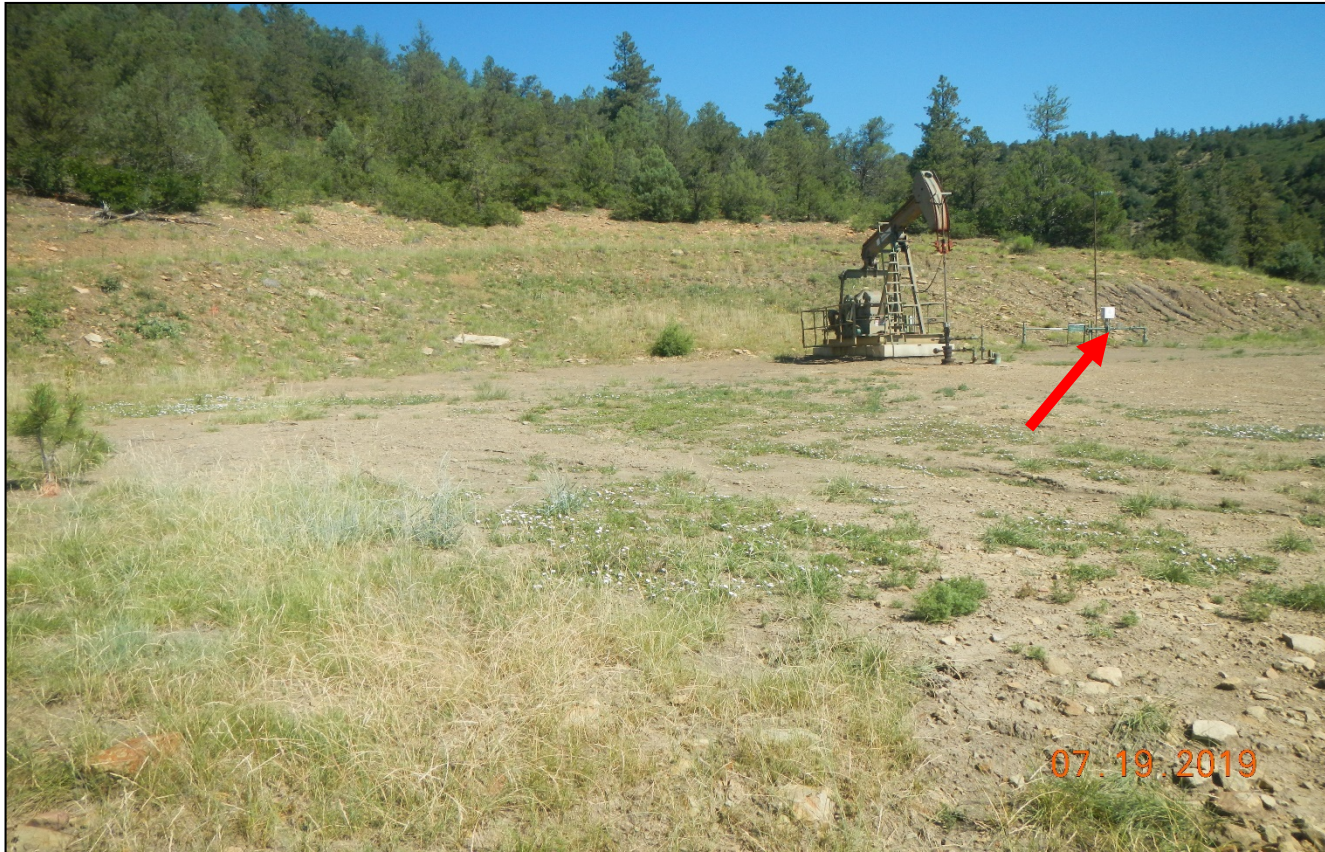
**Photo 1.** Facing toward the location. Red arrow points to erosion issues that have not been repaired.

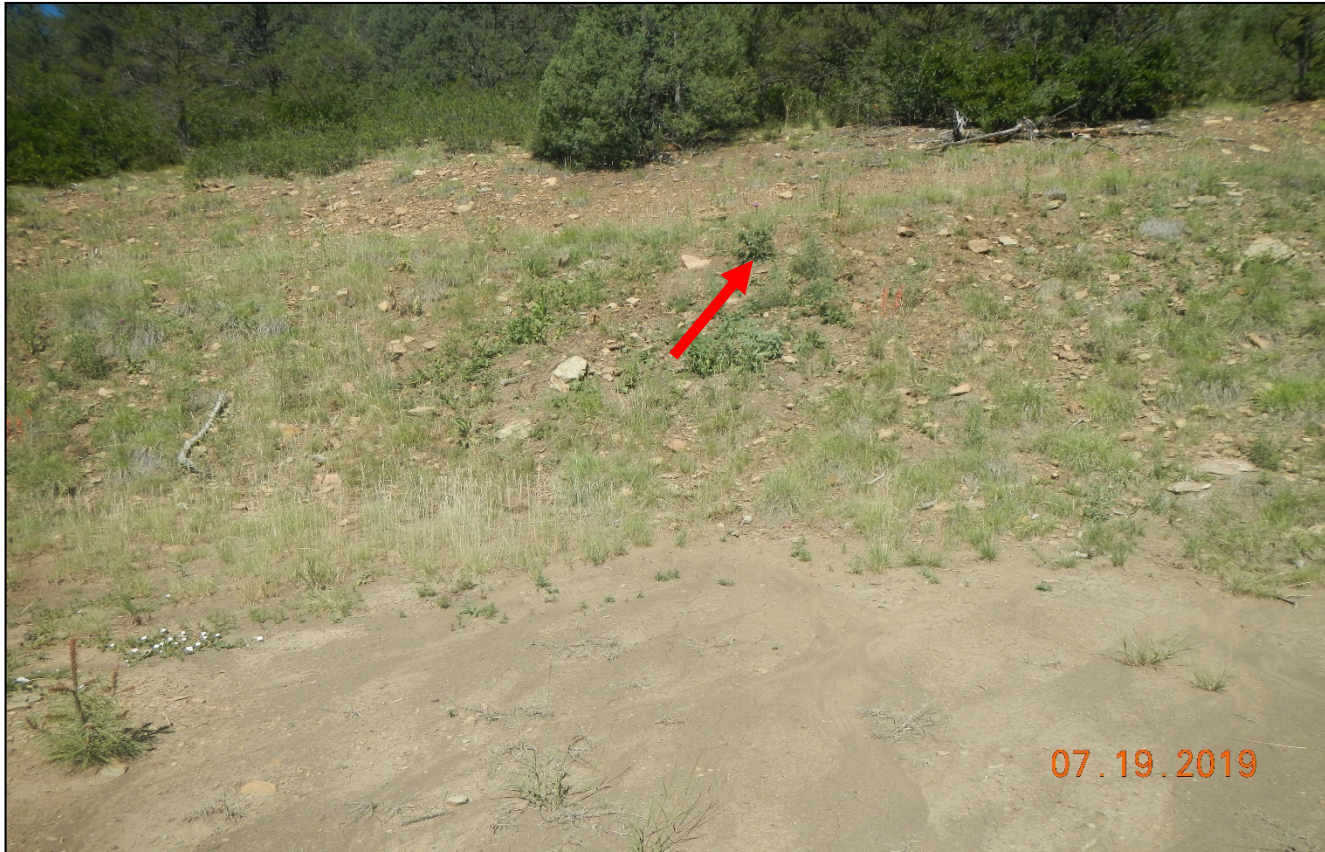
**Photo 2.** There is List B noxious weeds growing along the cut slope. (Musk thistle shown in photo)

Corrective action was not completed since previous inspection.

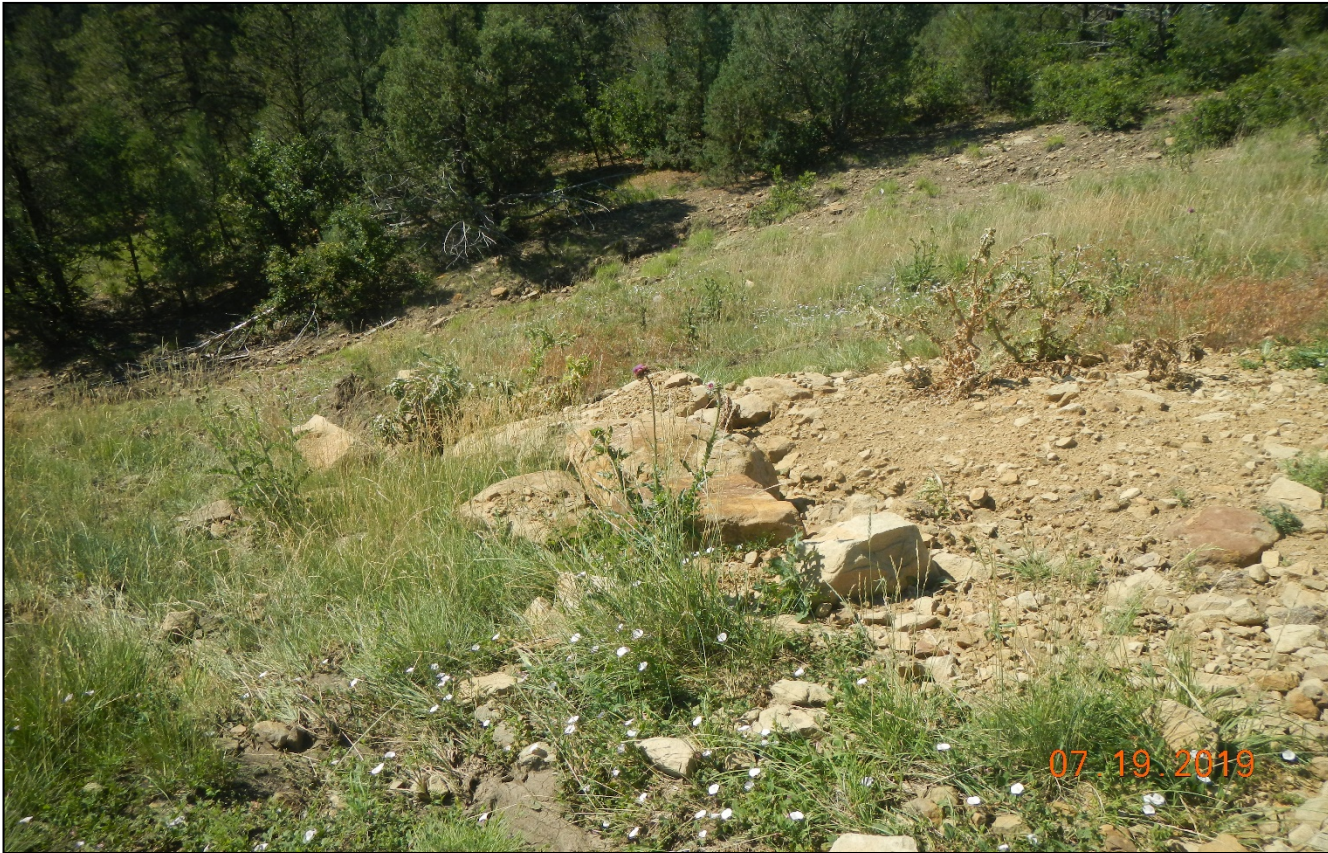
**Photo 3.** There were some noxious weeds along the fill slope that were treated and others that did not. Weed control was poorly done.

Corrective action was not completed since previous inspection.
