# Interim Reclamation and Stormwater Inspection

July 22, 2019

Operator: EXTRACTION OIL & GAS INC #10459

Location ID: 450197

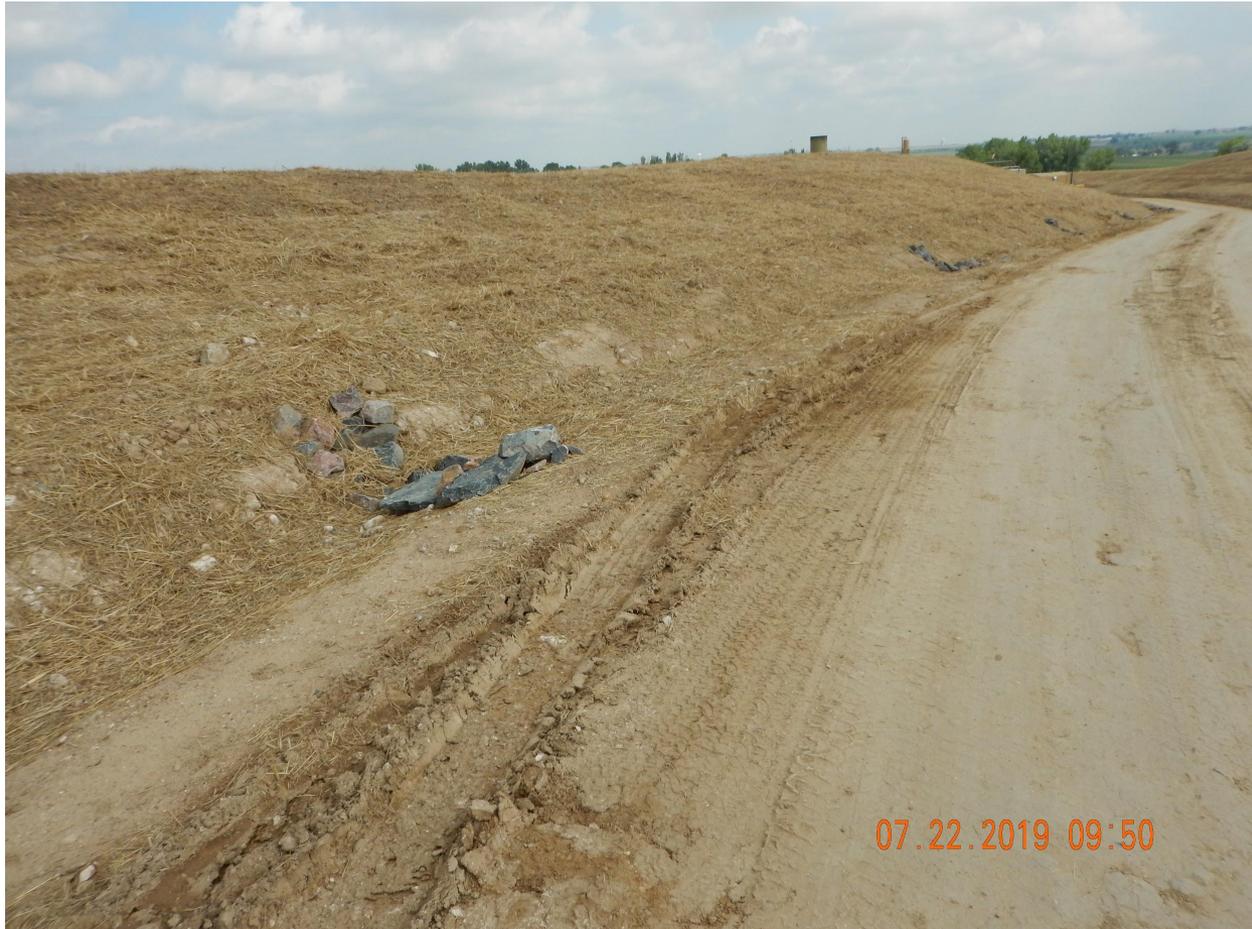
**Photo 1.** Photo taken along a portion of the access road, facing North. Photo illustrates the Operator has seeded and straw crimped mulch throughout the interim areas. Also, Operator has installed rip-rap as check dams along the access road ditch. BMP maintenance is required along a section where truck traffic damaged the BMPs.

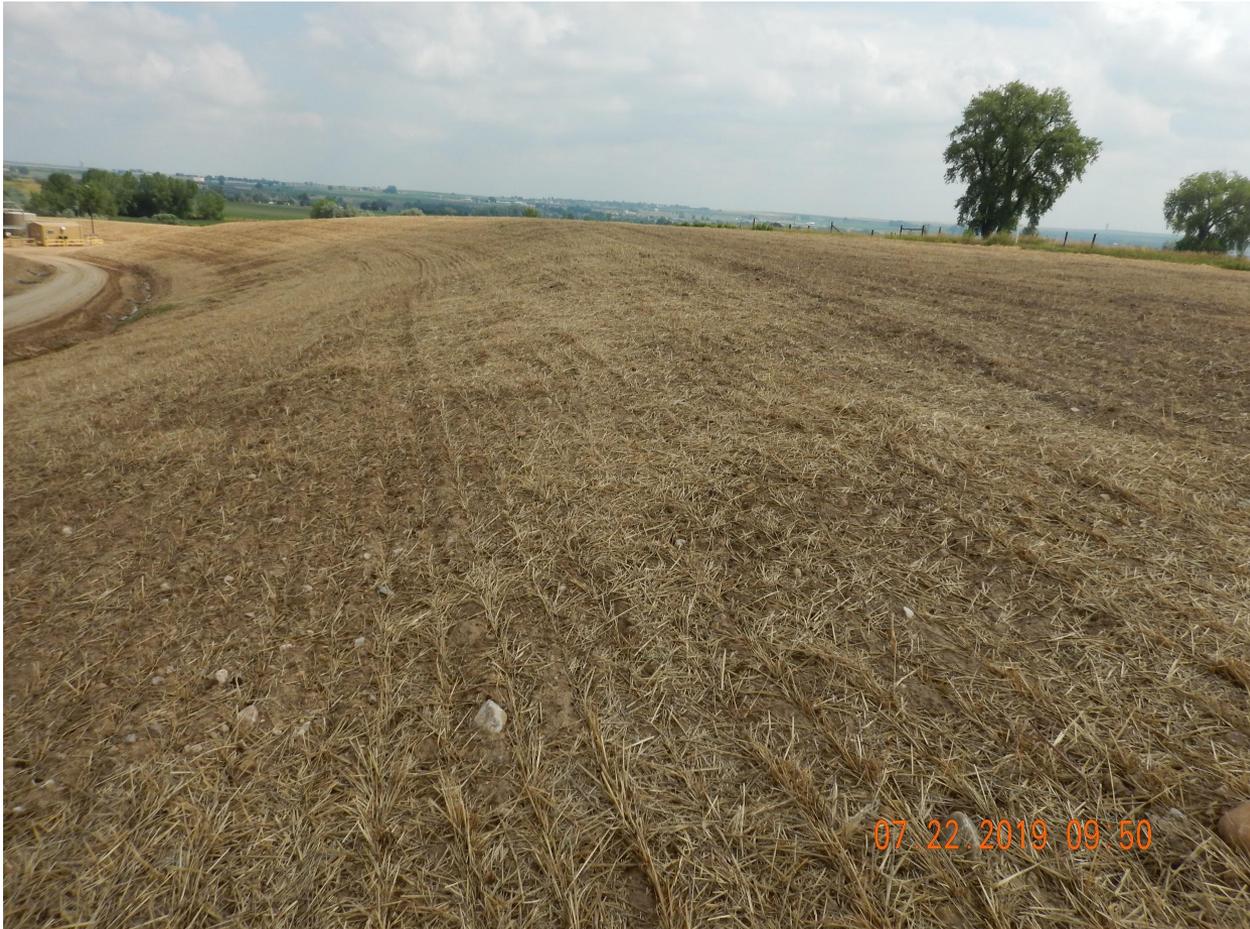
**Photo 2.** Photo taken from the southeastern interim area, facing North. See comments under Photo 1.

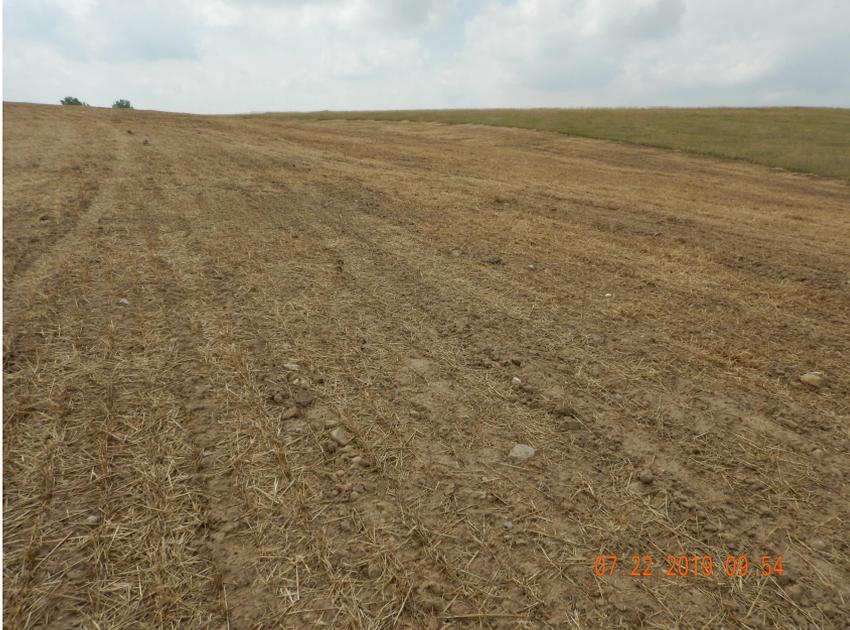
**Photo 3.** Photo taken from the western interim reclamation area, facing South. See comments under Photo 1.

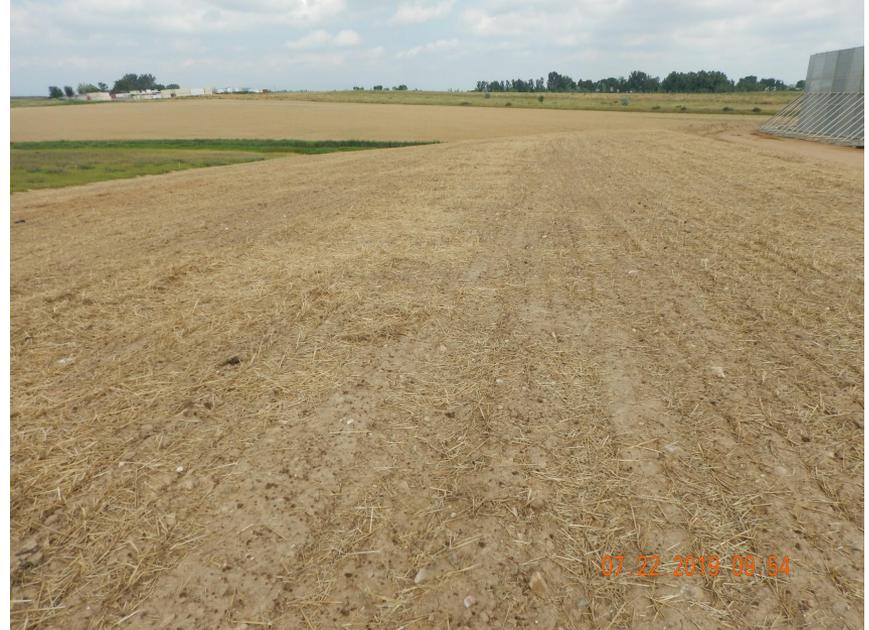
**Photo 4.** Photo taken from the western interim reclamation area, facing North. See comments under Photo 1.

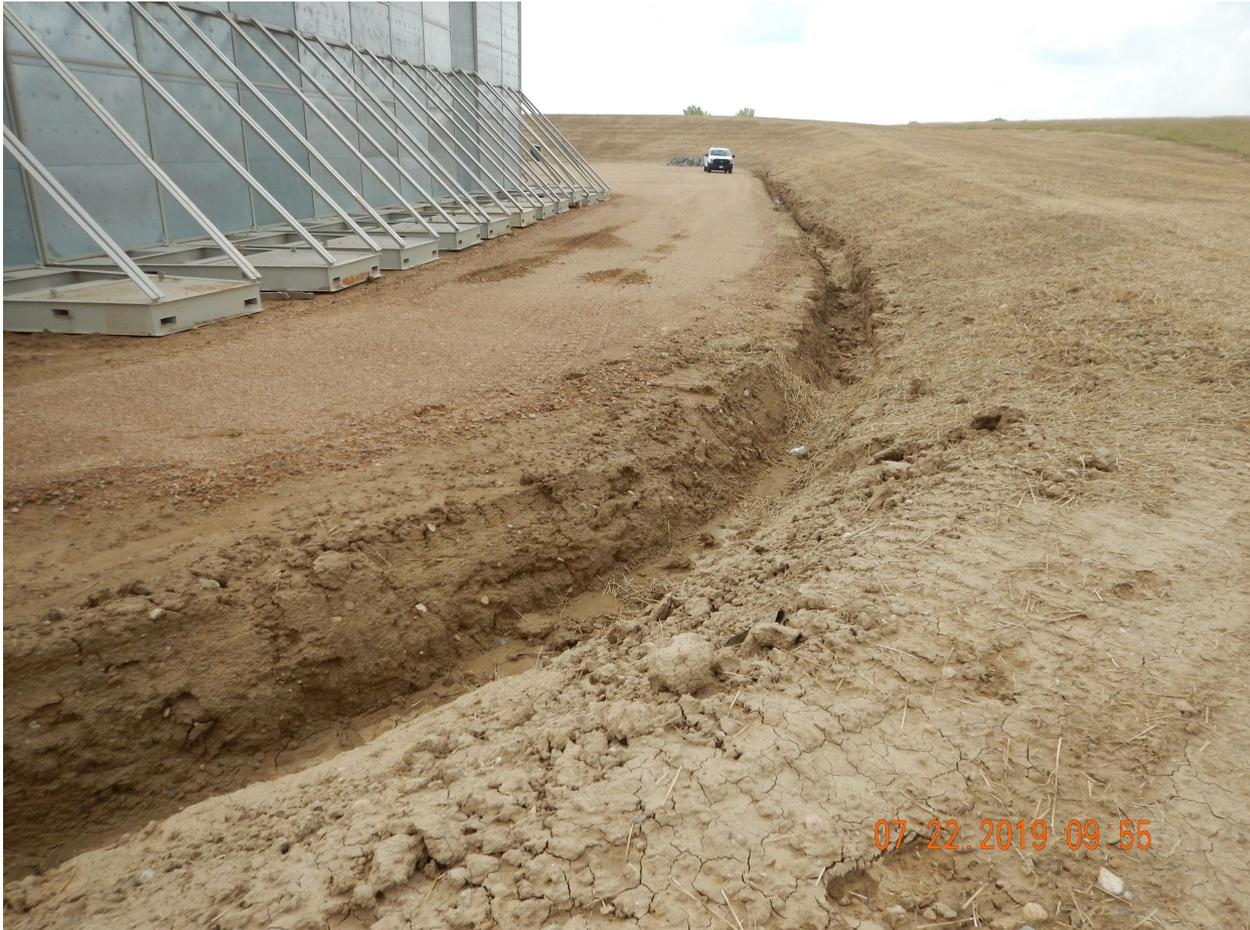
**Photo 5.** Photo taken from the northwestern well pad, facing South. Photo illustrates a ditch BMP that is directed to a stabilized outlet. It appears the Operator is in-process of installing rip-rap along the ditch BMP.

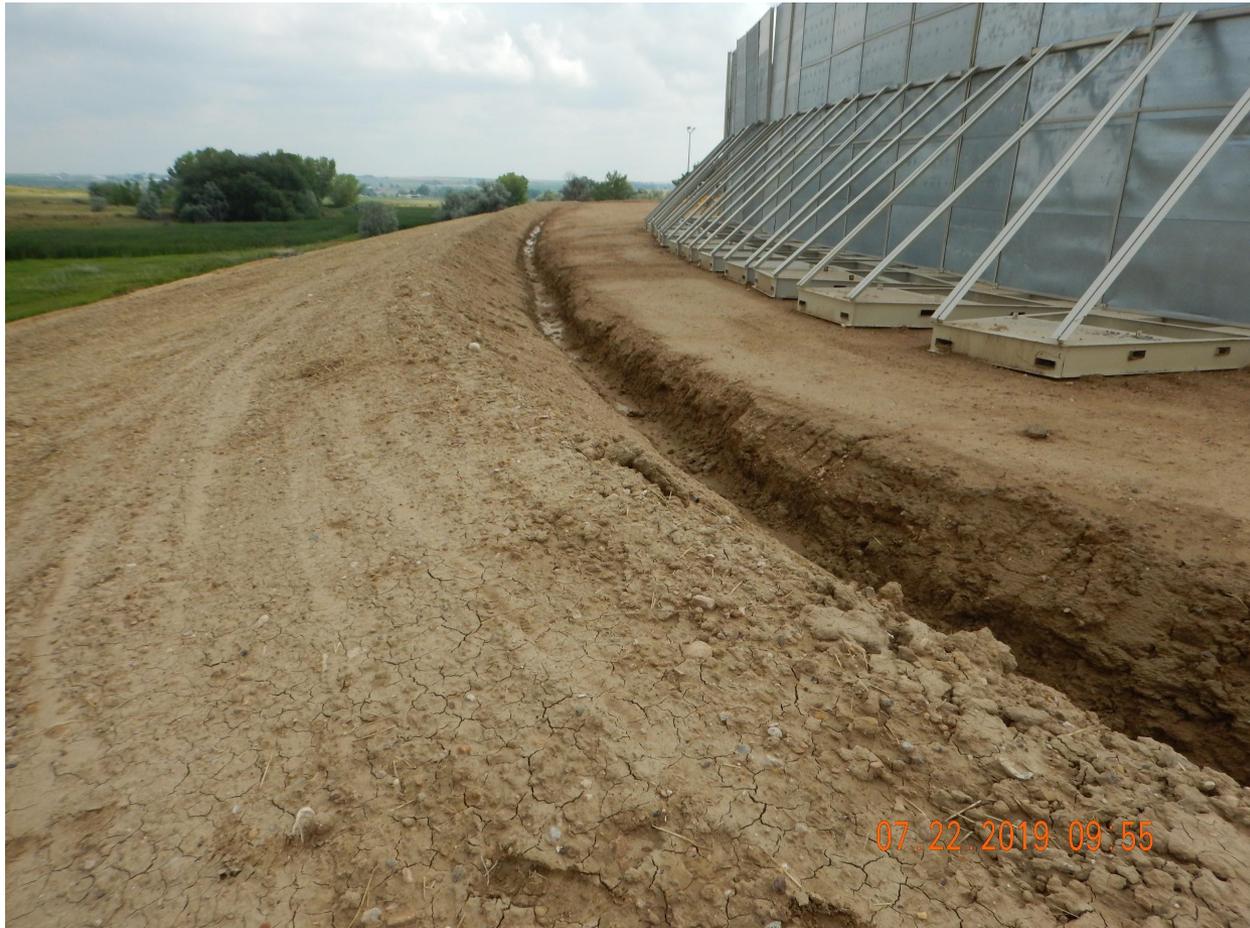
**Photo 6.** Photo taken from the northwestern well pad, facing East. See comments under Photo 5.

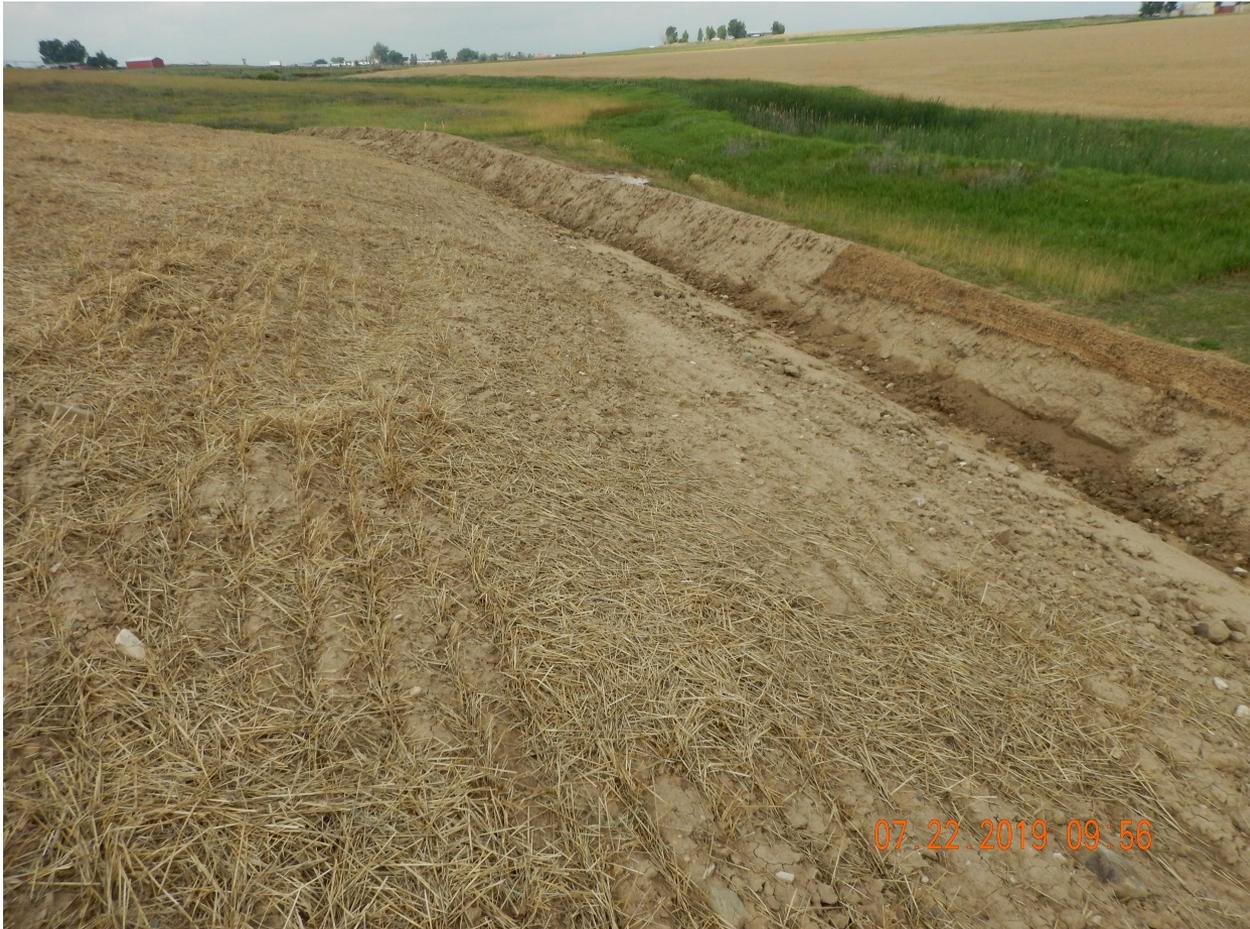
**Photo 7.** Photo taken from the northwestern perimeter of location, facing West. Photo illustrates a ditch and berm BMP that has been installed in conjunction with a stabilized outlet. Portions of the berm BMP have been stabilized with erosion control blankets.

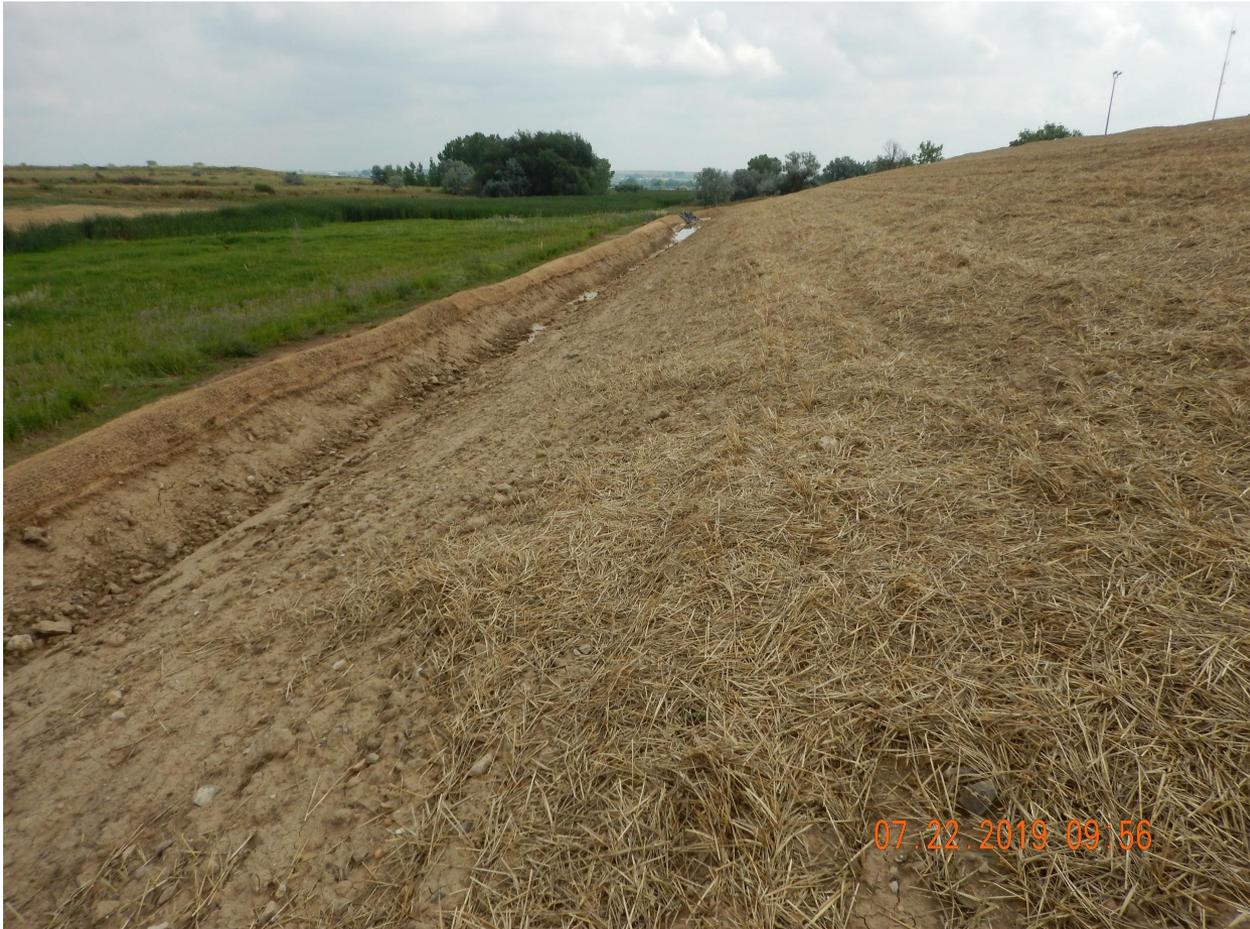
**Photo 8.** Photo taken from the northwestern perimeter of location, facing East. See comments under Photo 7.

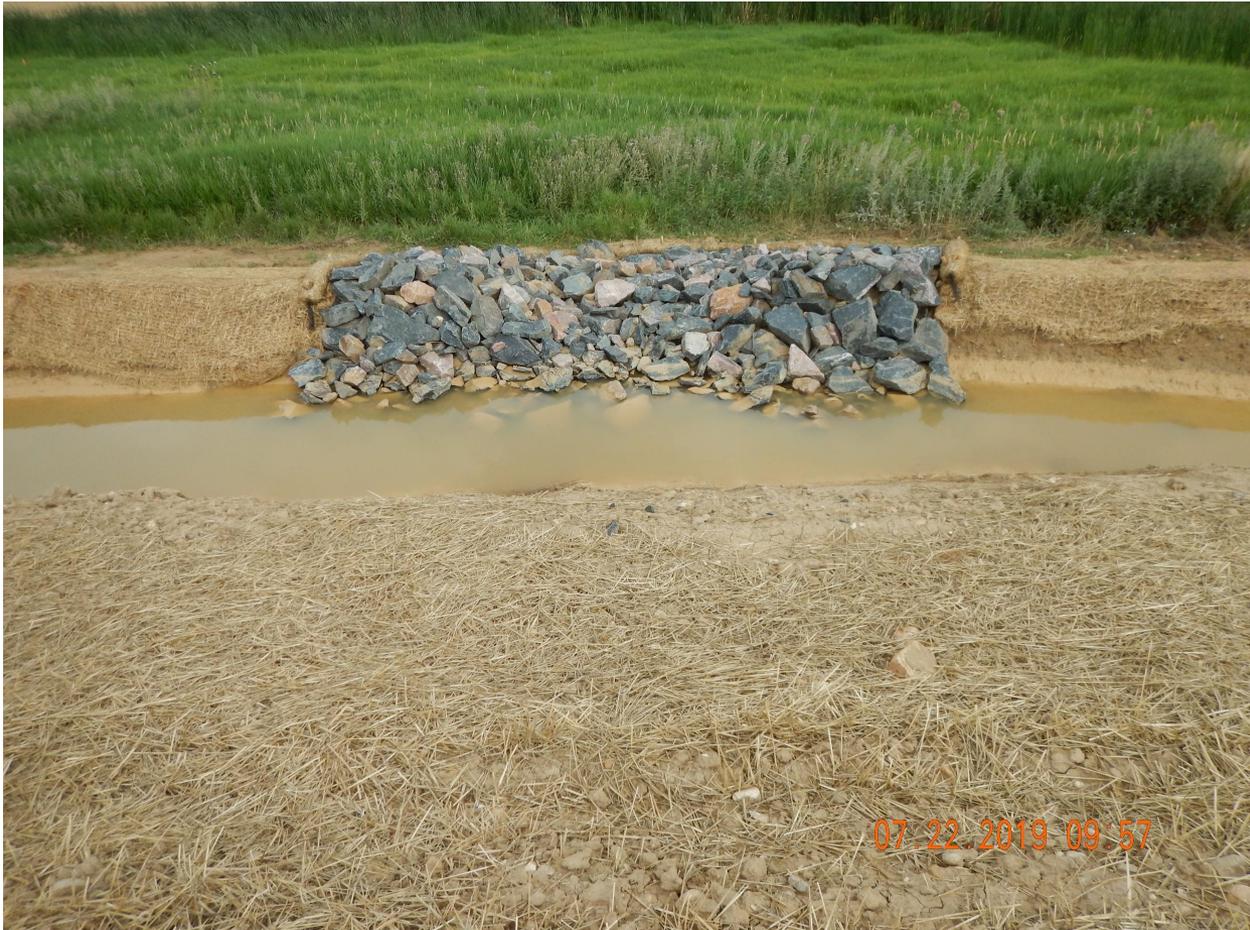
**Photo 9.** Photo taken from the northeastern perimeter of location, facing North. Photo illustrates a stabilized outlet.

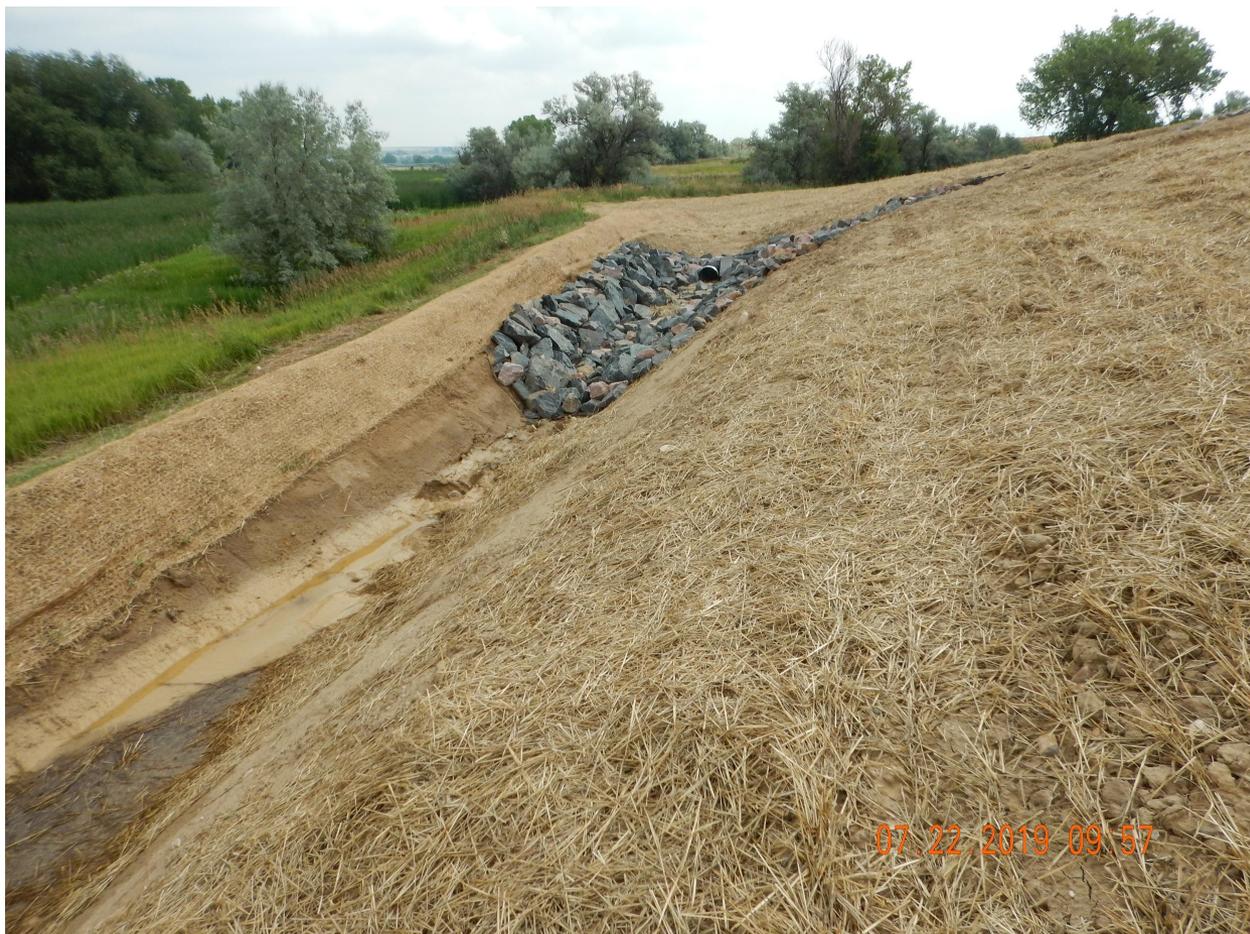
**Photo 10.** Photo taken from the northeastern perimeter of location, facing East. Photo illustrates a stabilized outlet area of the culvert.

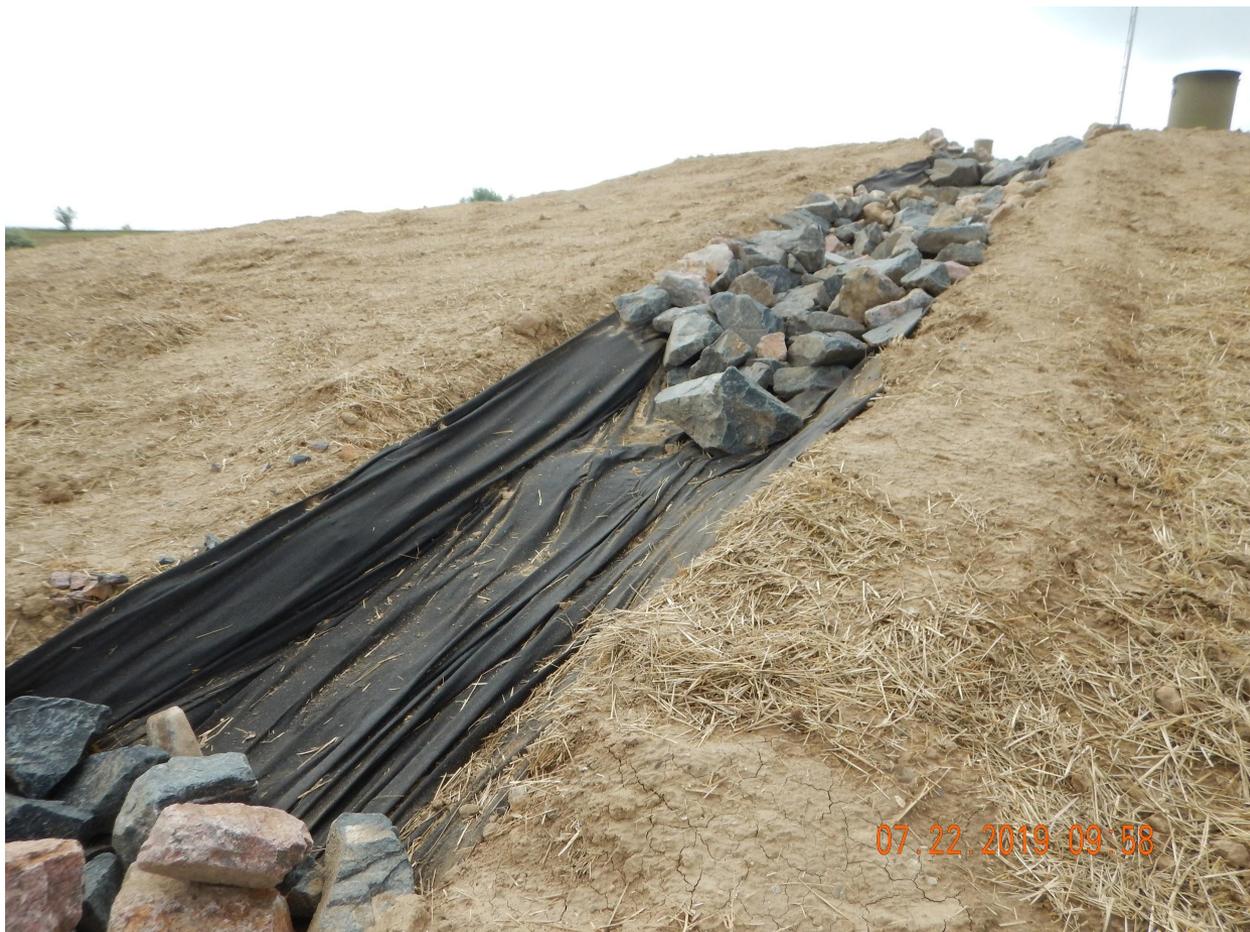
**Photo 11.** Photo taken from the northeastern perimeter of location, facing South. Photo illustrates a stabilized channel (in-process) that is directed to a stabilized outlet.

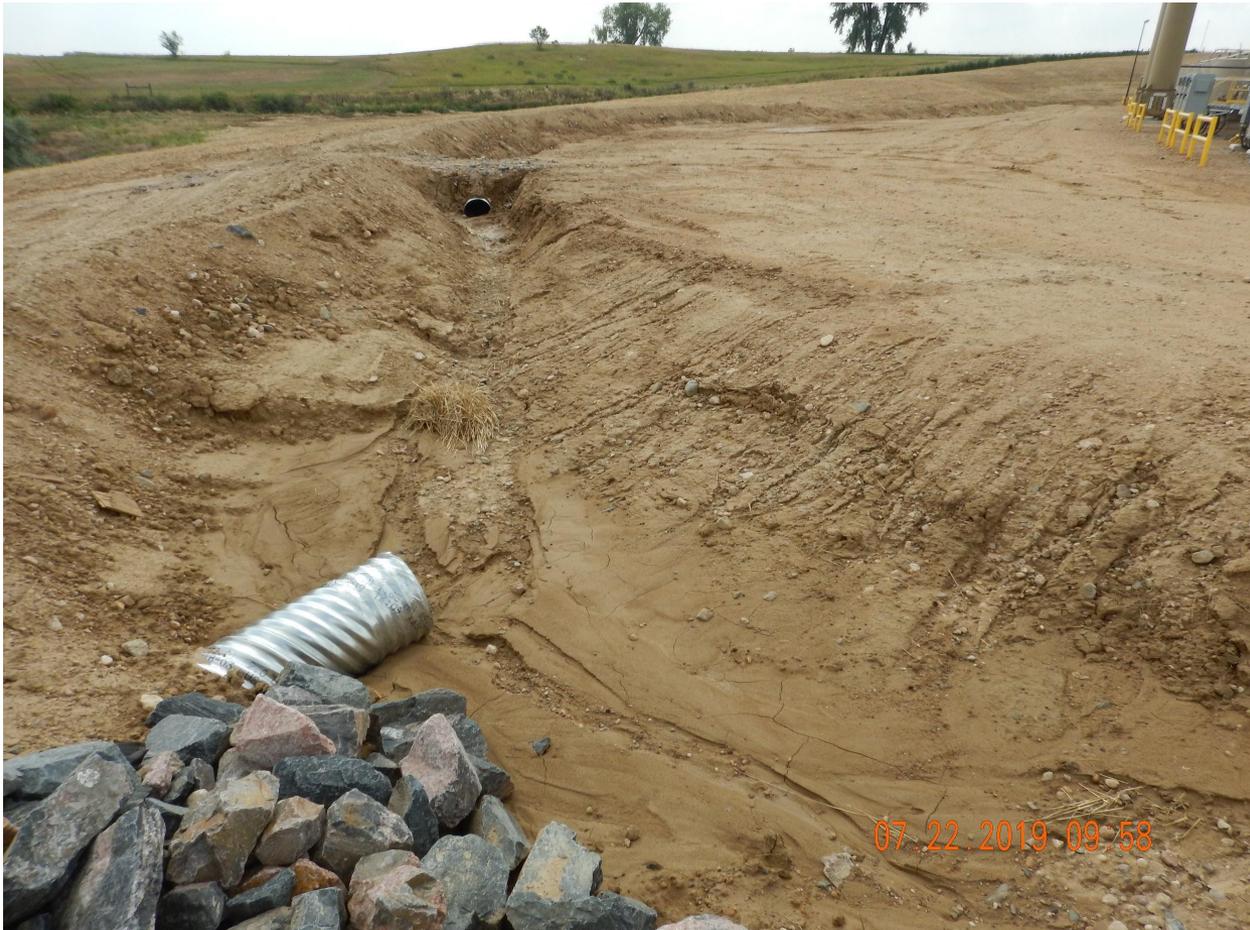
**Photo 12.** Photo taken from the northeastern well pad, facing East. Photo illustrates an inlet area that is in-process of being stabilized with rip-rap.
