## Inspection Photos

Location Name: SOONER UNIT-68N58W /21SENW

Location #: 327361

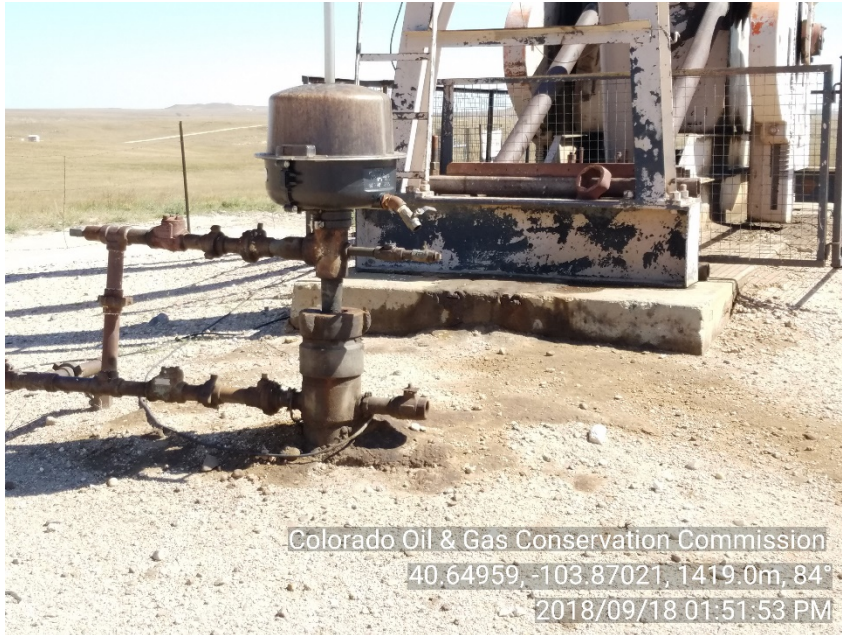
**Photo #1**

**Sooner Unit 6-21 (05-123-14562) Wellsite**

**Bradenhead NOT plumbed to surface**

**Stained soil**

*previous insp.*

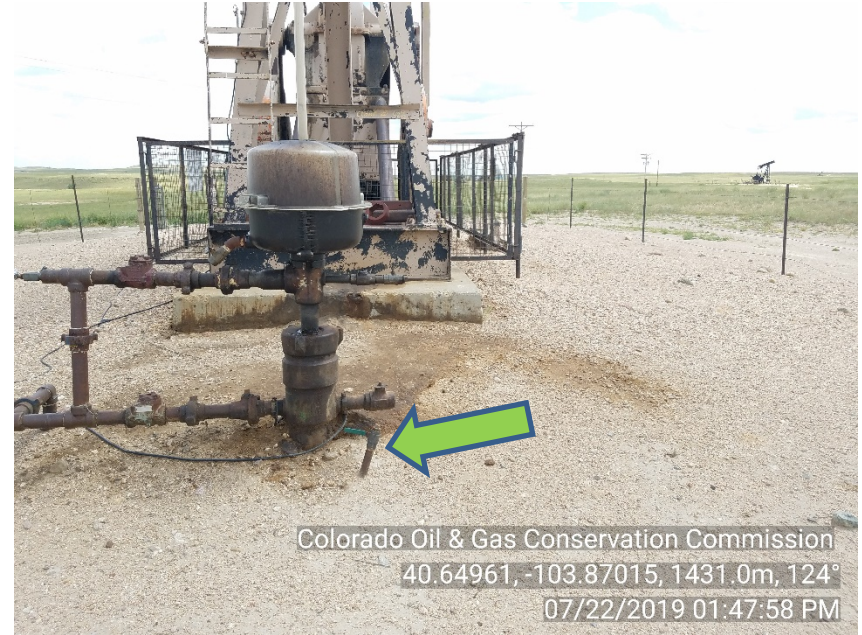
**Photo #2**

**Sooner Unit 6-21 Wellsite**

**Bradenhead NOW plumbed to surface**

**Stained soil - Remains**

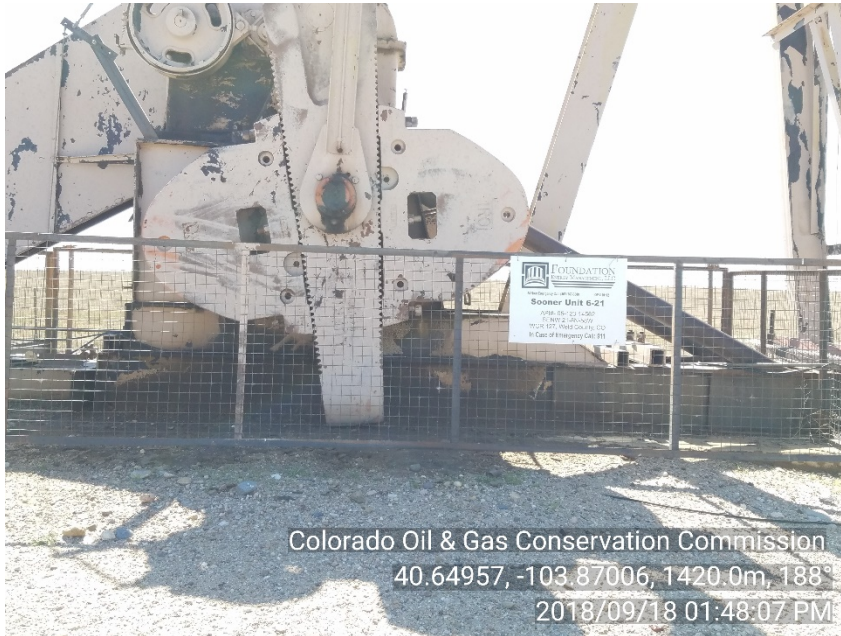
**Photo #3**  
**Sooner Unit 6-21** Wellsite  
**Pumpjack ( North, South sides )**  
**Stained soil**  
*previous insp.*

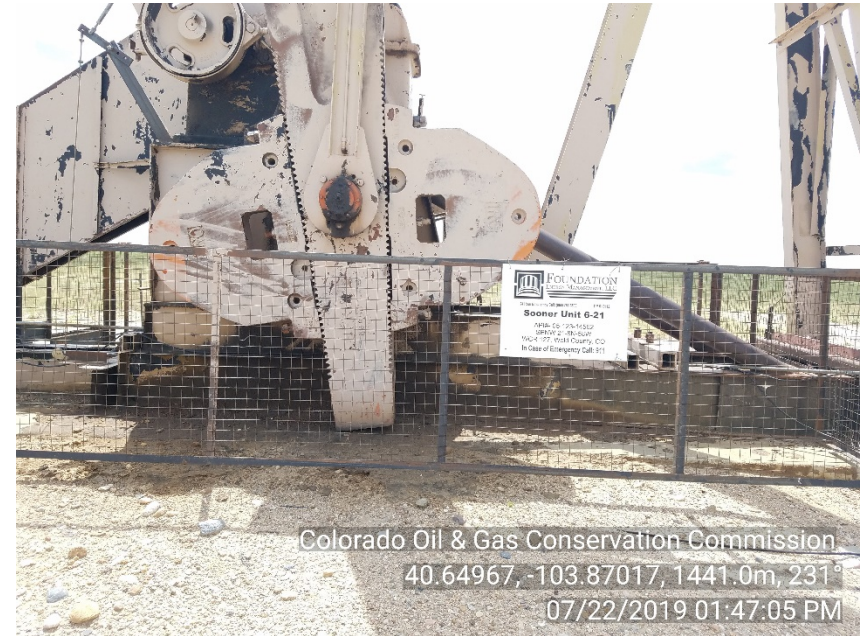
**Photo #4**  
**Sooner Unit 6-21** Wellsite  
**Pumpjack ( North, South sides )**  
**Stained soil - Remains**

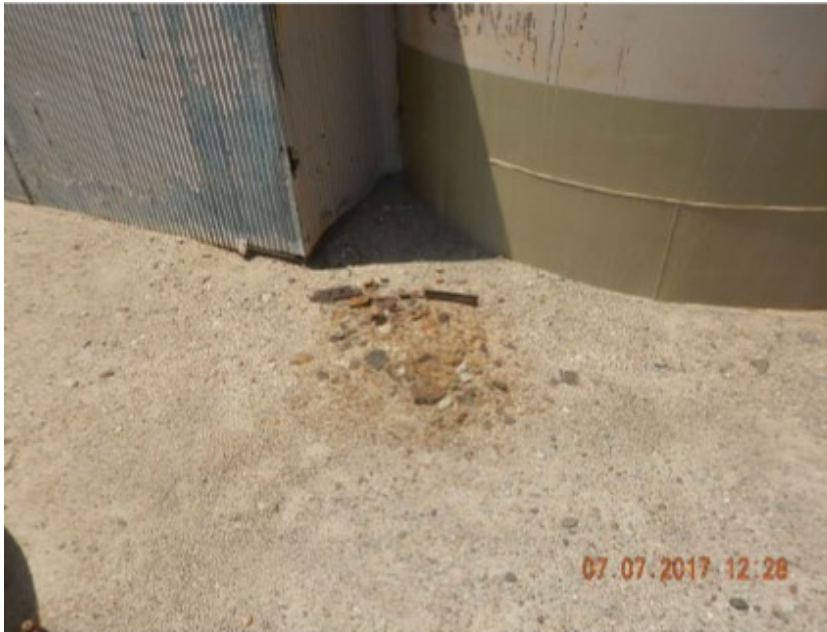
**Photo #5**

**Sooner Unit** Produced H<sub>2</sub>O tanks

*Debris near East produced H<sub>2</sub>O tanks remains  
previous insp.*

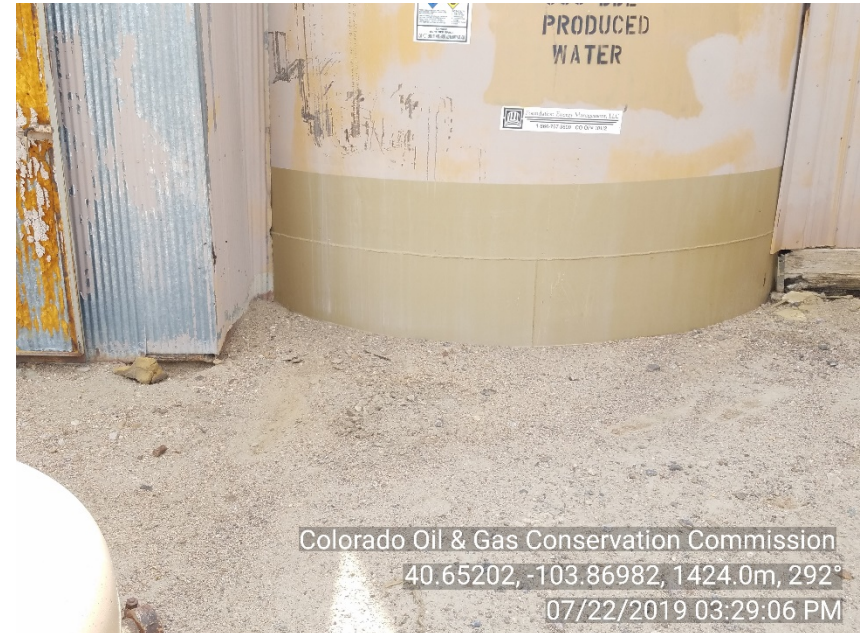
**Photo #6**

**Sooner Unit** Produced H<sub>2</sub>O tanks

*Debris near East produced H<sub>2</sub>O tanks  
NOW removed*

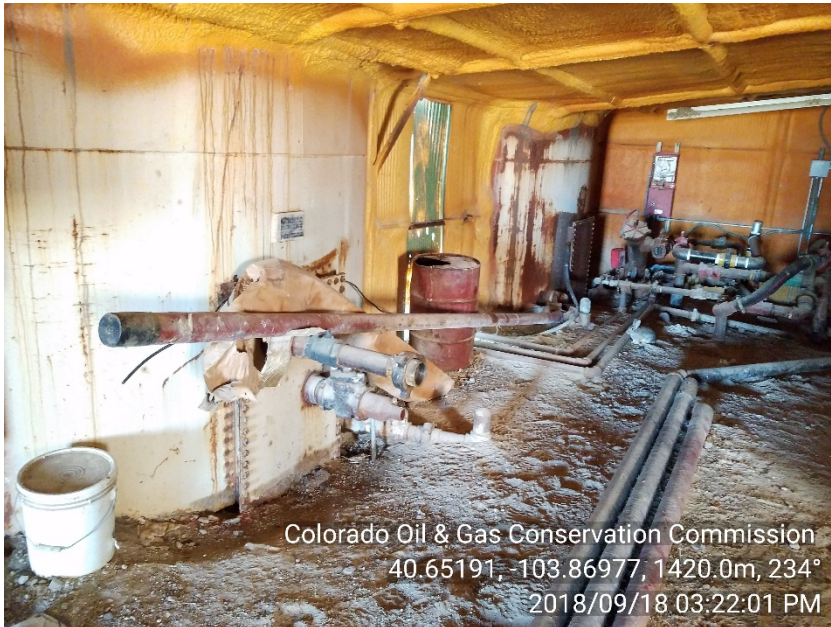
**Photo #7**

**Sooner Unit** Produced H2O tank room

*Debris near middle West produced H2O tank  
previous insp.*

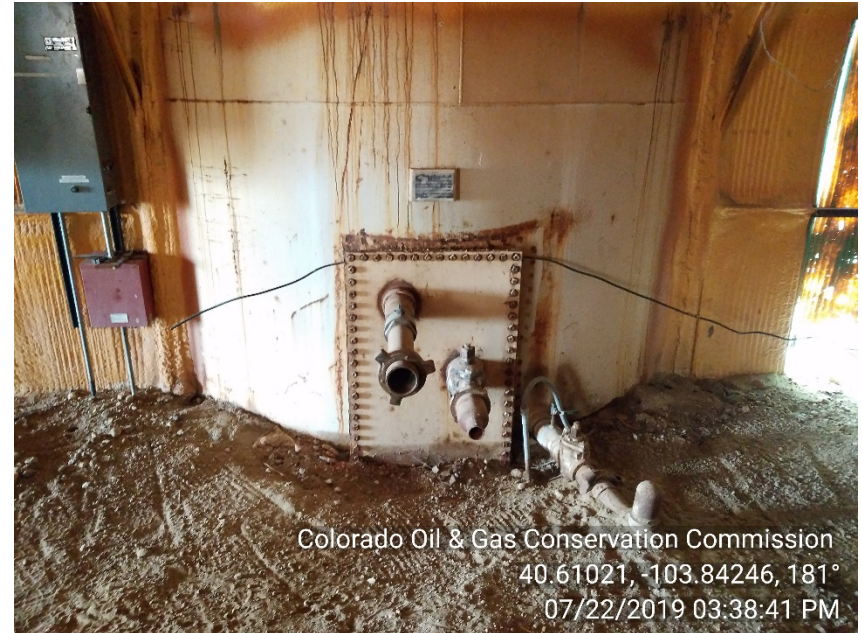
**Photo #8**

**Sooner Unit** Produced H2O tank room

**Debris near middle West produced H2O tank  
NOW appears removed**

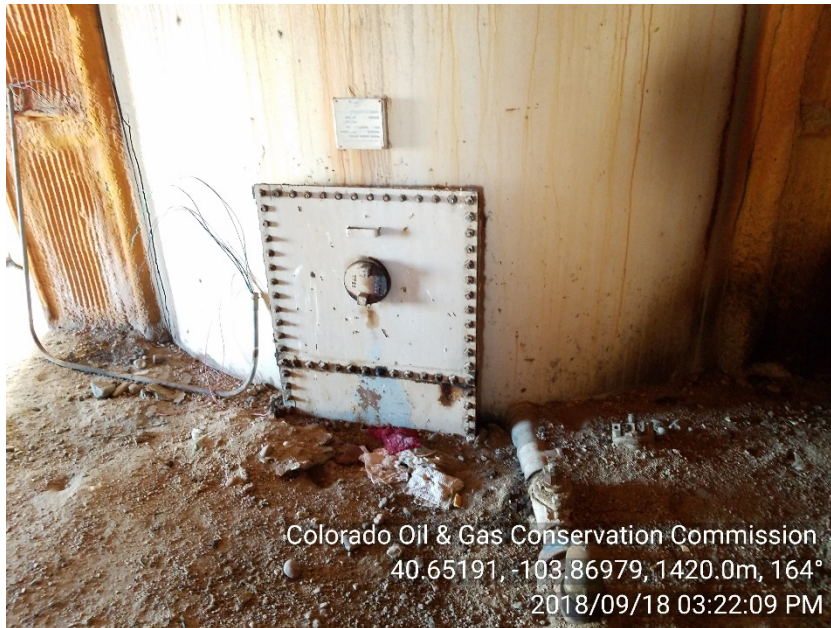
**Photo #9**

**Sooner Unit** Produced H2O tank room

*Debris near middle East produced H2O tank  
previous insp.*

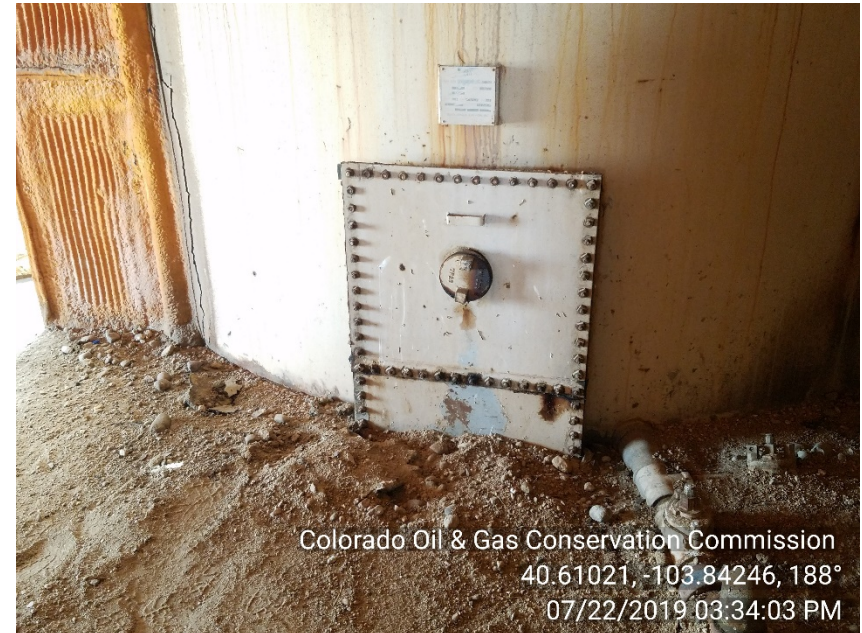
**Photo #10**

**Sooner Unit** Produced H2O tank room

**Debris near middle East produced H2O tank  
NOW appears removed**

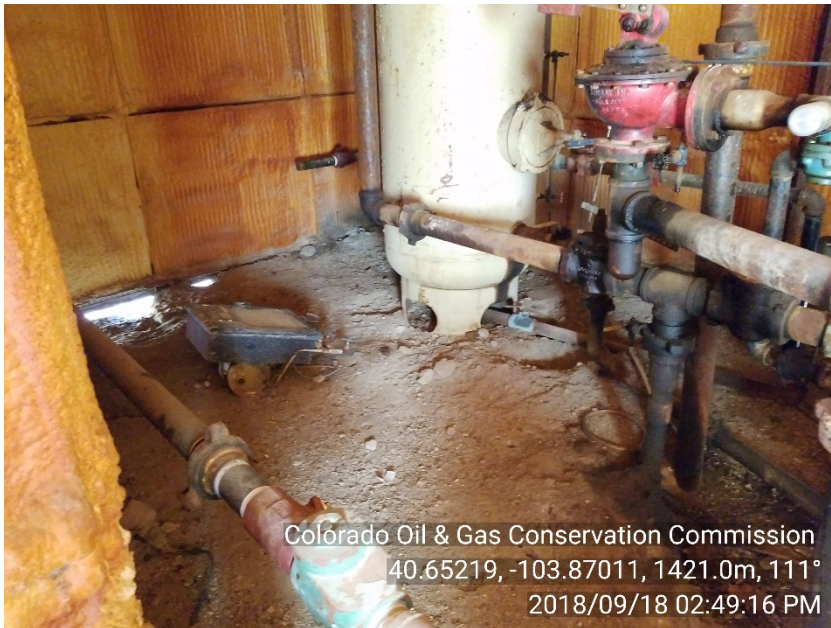
**Photo #11**

**Sooner Unit** North treater shed

**Unused equipment**

*previous insp.*

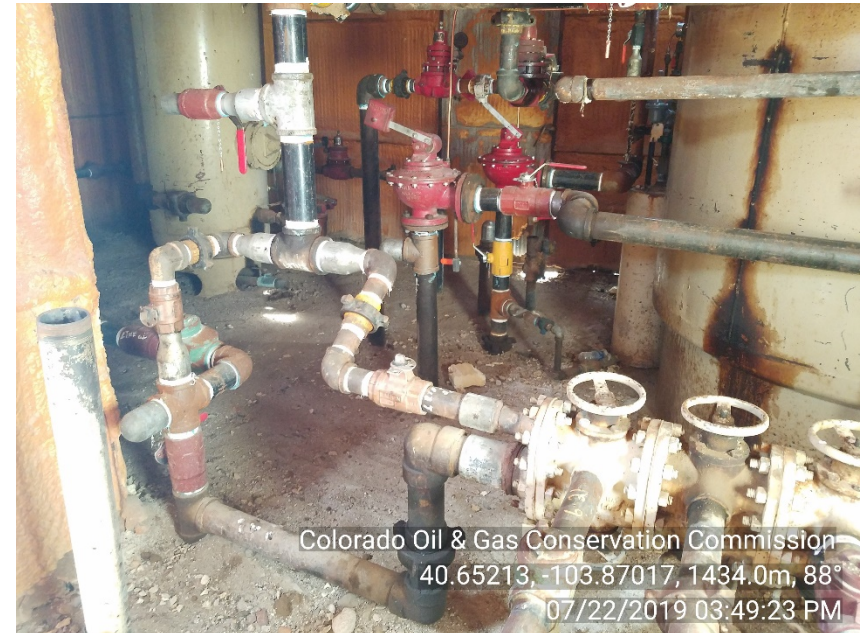
**Photo #12**

**Sooner Unit** North treater shed

**Unused equipment – Removed**  
**Stained soil – Appears mitigated**

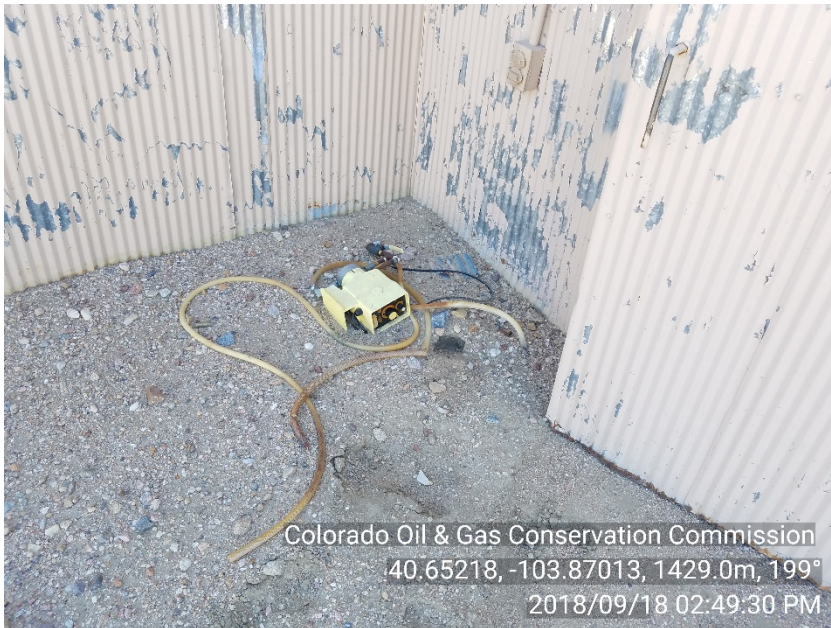
**Photo #13**

**Sooner Unit** North treater shed

**Unused equipment - outside**

*previous insp.*

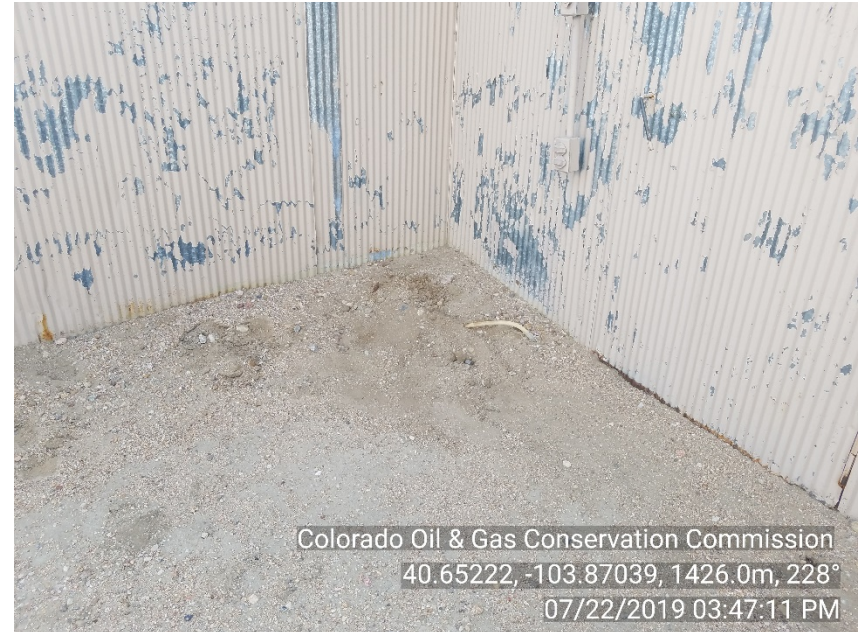
**Photo #14**

**Sooner Unit** North treater shed

**Unused equipment outside – Removed**

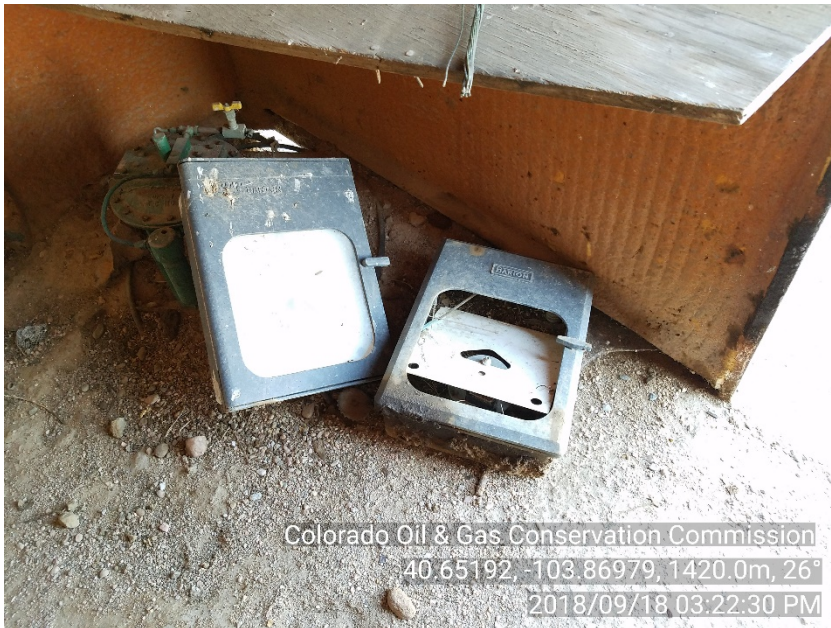
**Photo #15**

**Sooner Unit** Produced H2O tank room – E. door

***Unused equipment***  
*previous insp.*

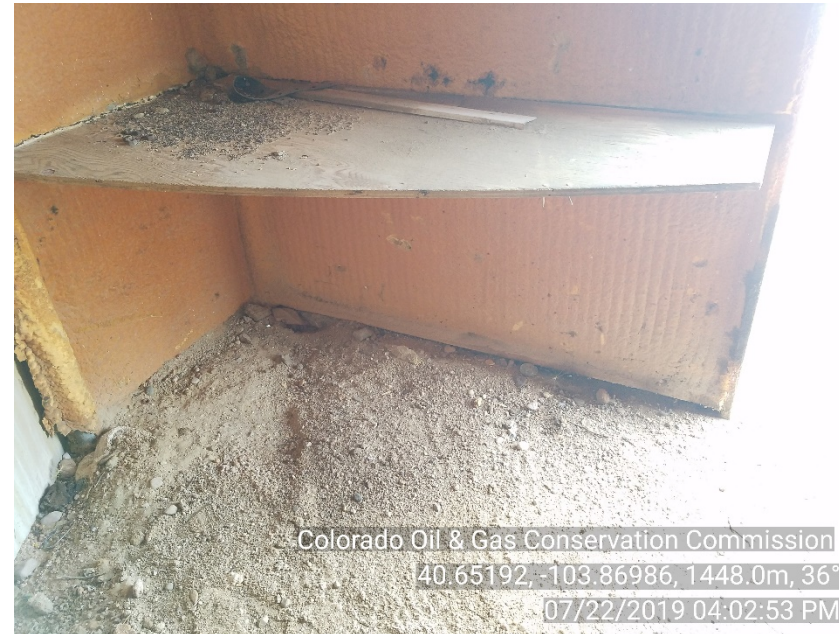
**Photo #16**

**Sooner Unit** Produced H2O tank room – E. door

***Unused equipment - Removed***

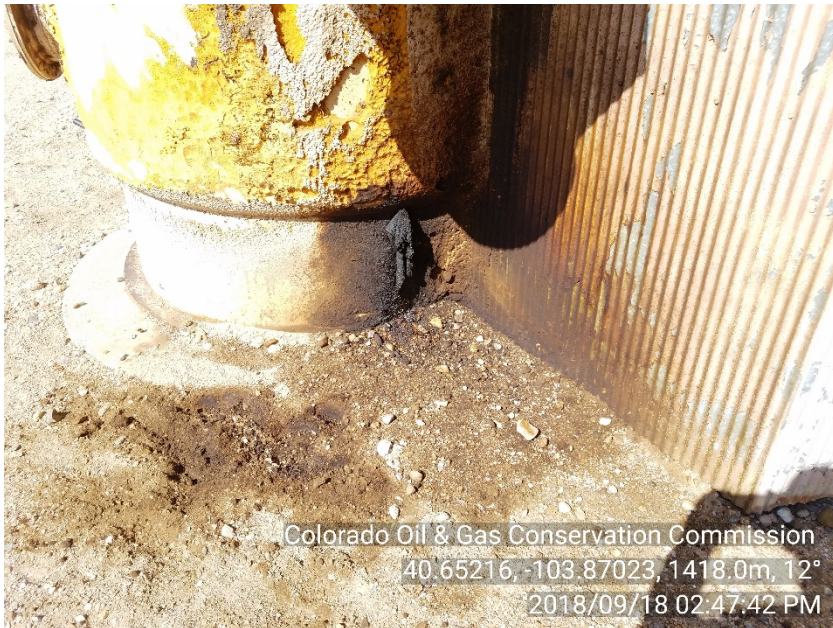
**Photo #17**

**Sooner Unit** North Treater

*Stained soil and previously leaking equip.  
previous insp.*

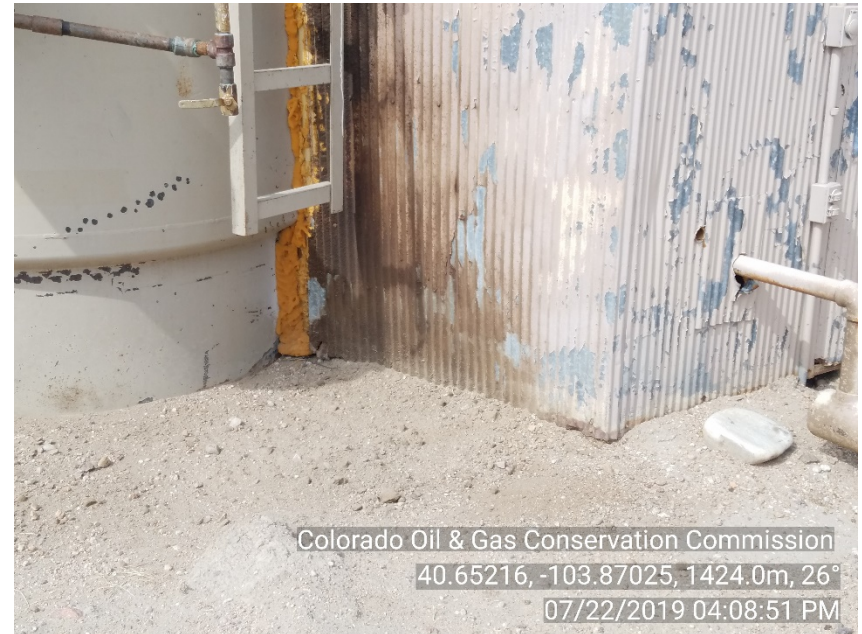
**Photo #18**

**Sooner Unit** North Treater

*Stained soil and previously leaking equip.  
Appears mitigated*

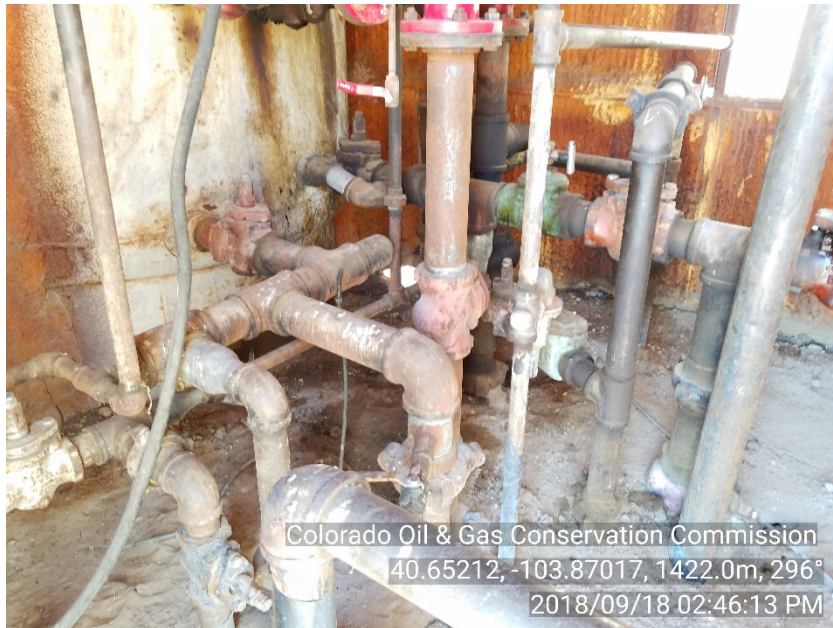
**Photo #19**

**Sooner Unit** South Treater shed

**Stained soil**

*previous insp.*

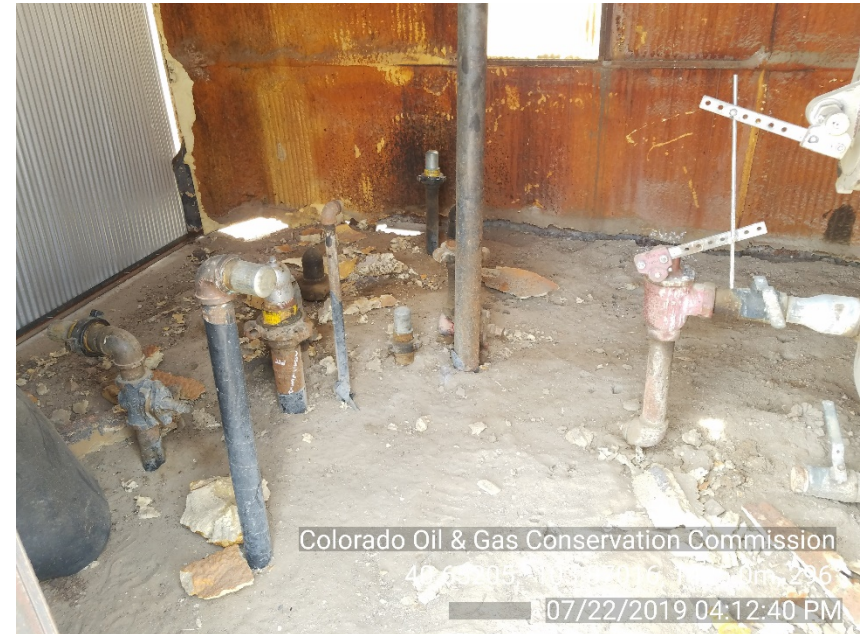
**Photo #20**

**Sooner Unit** South Treater shed

**Treater Removed - Stained soil**

***Appears mitigated***

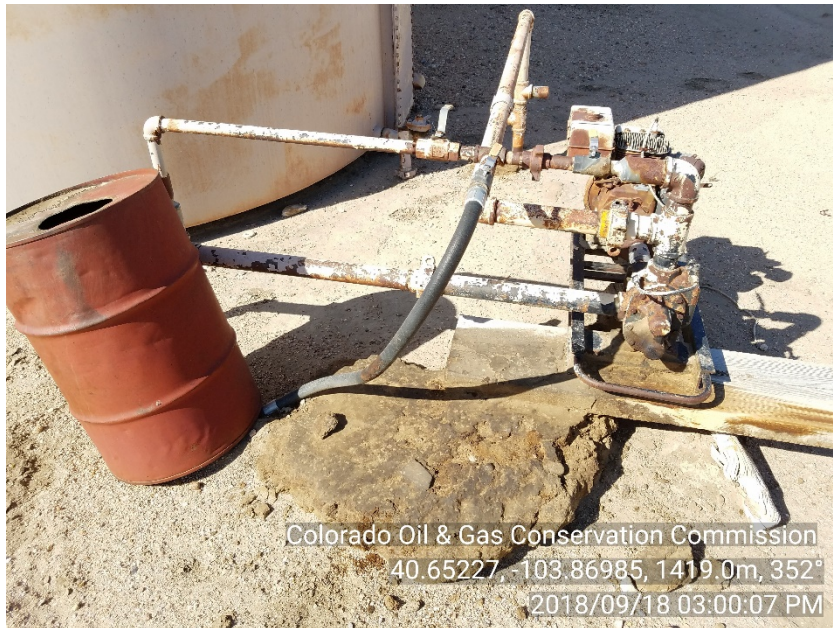
**Photo #21**

**Sooner Unit** Crude oil recycle pump

***Stained soil***

*previous insp.*

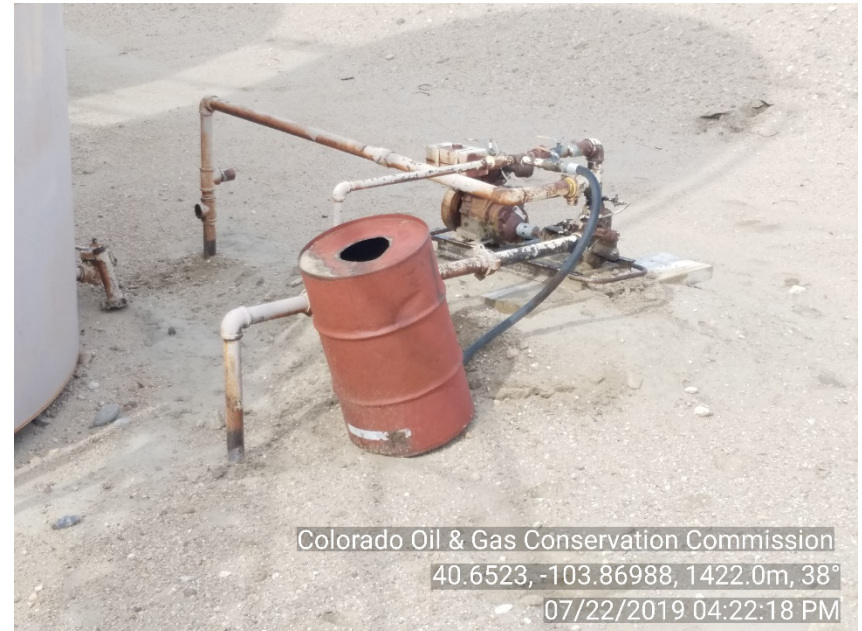
**Photo #22**

**Sooner Unit** Crude oil recycle pump

**Stained soil**

***Appears mitigated***

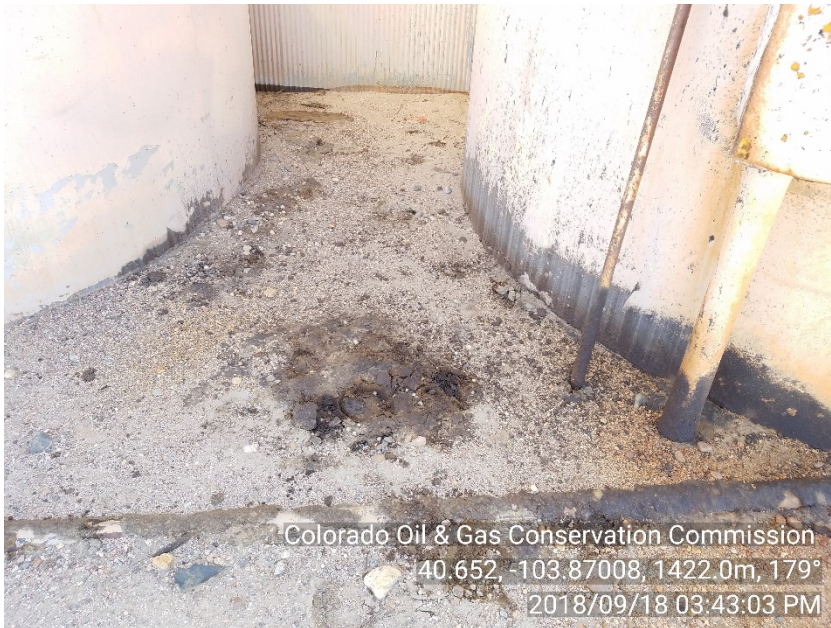
**Photo #23**

**Sooner Unit** Produced H<sub>2</sub>O tanks N side.

**Stained soil**

*previous insp.*

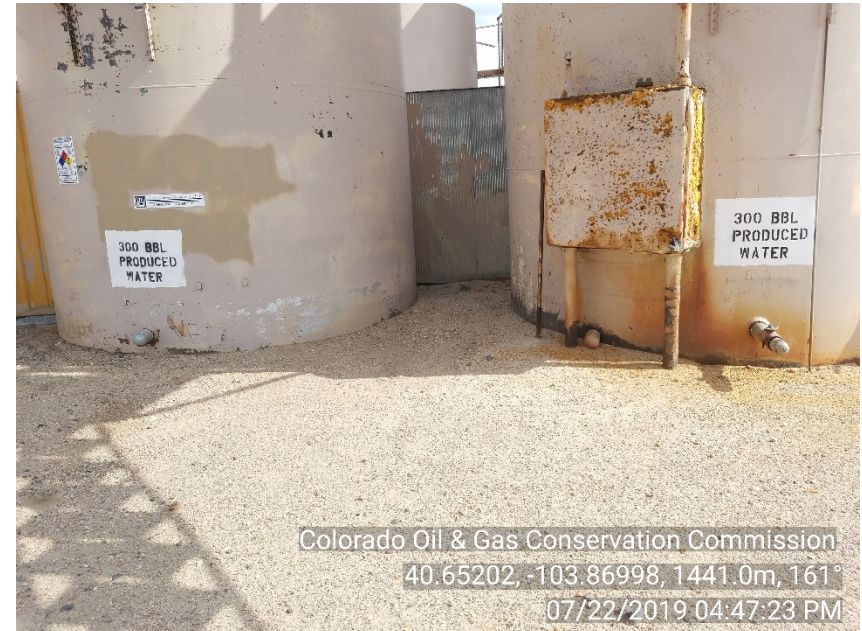
**Photo #24**

**Sooner Unit** Produced H<sub>2</sub>O tanks N side.

**Stained soil**

*Appears mitigated*

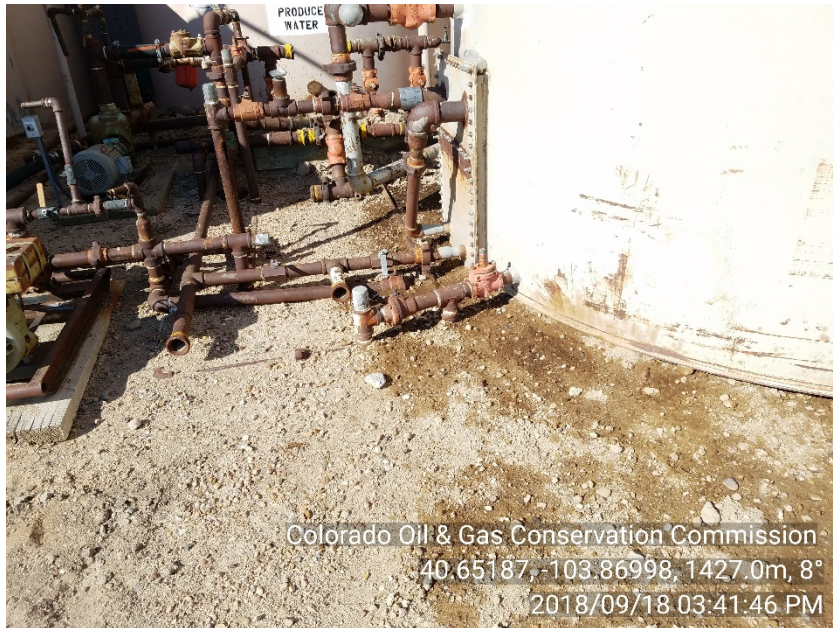
**Photo #25**

**Sooner Unit** Produced H<sub>2</sub>O transfer pumps | tank

**Stained soil**

*previous insp.*

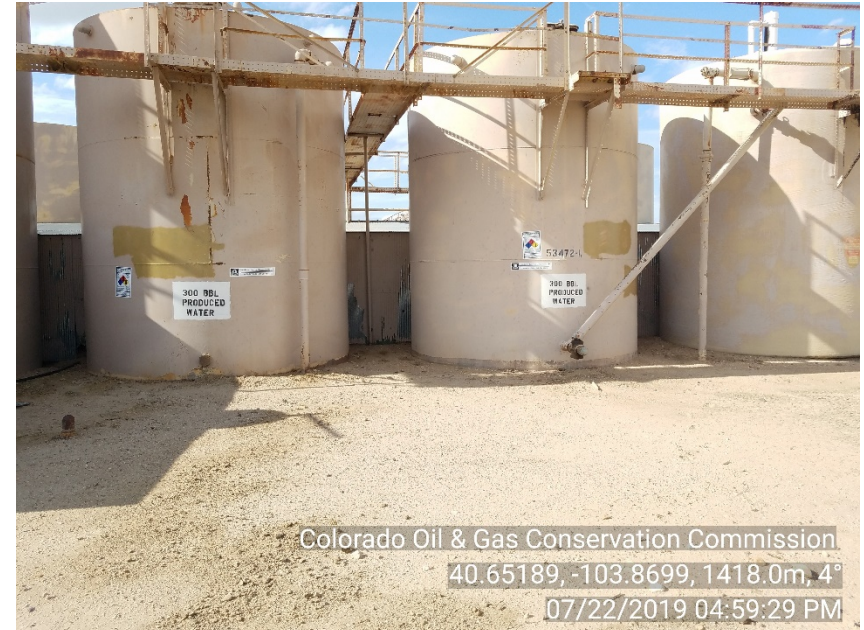
**Photo #26**

**Sooner Unit** Produced H<sub>2</sub>O transfer pumps | tank

**Removed | Stained soil**

***Appears mitigated***

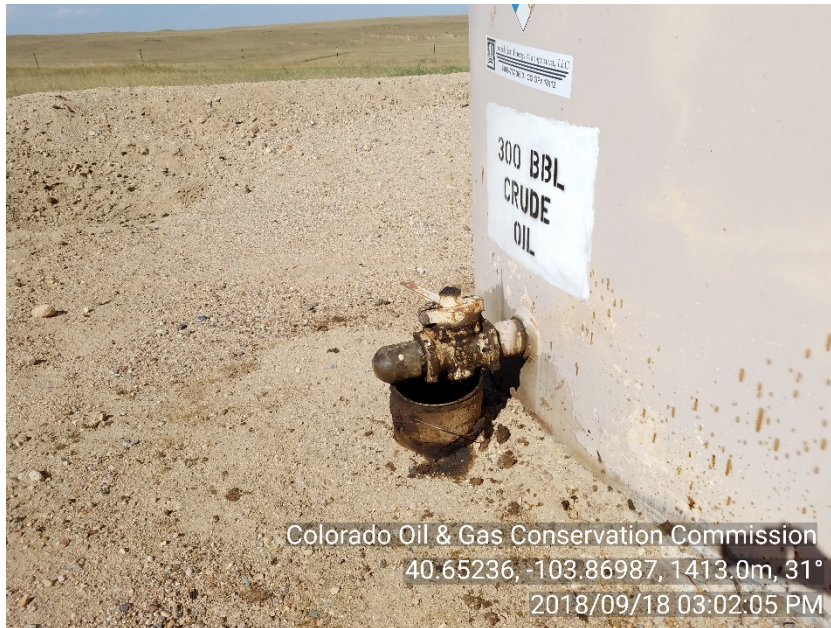
**Photo #27**

**Sooner Unit** Crude Oil tanks - loadout

**Stained soil**

*previous insp.*

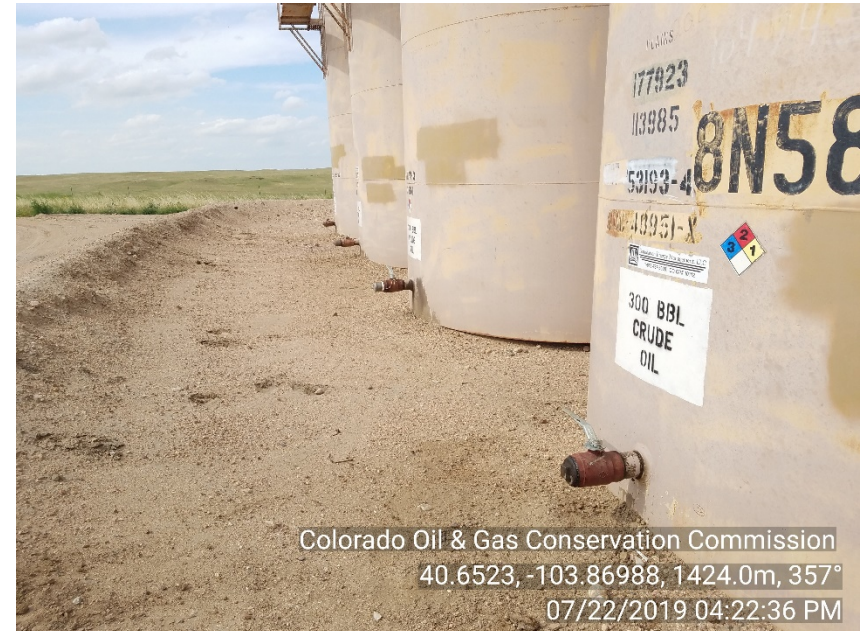
**Photo #28**

**Sooner Unit** Crude Oil tanks - loadout

**Stained soil**

*Appears mitigated*

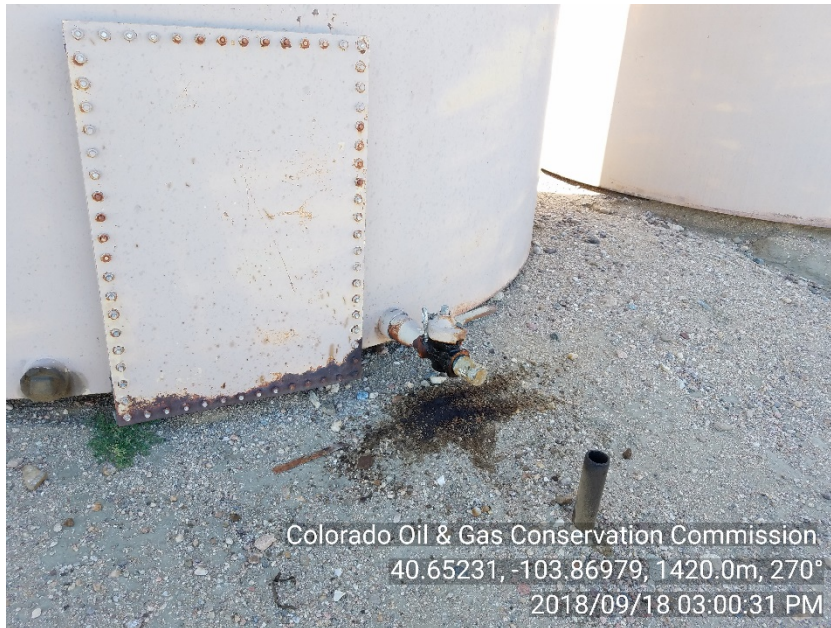
**Photo #29**  
**Sooner Unit** Crude Oil tanks - drainline  
**Stained soil**  
*previous insp.*

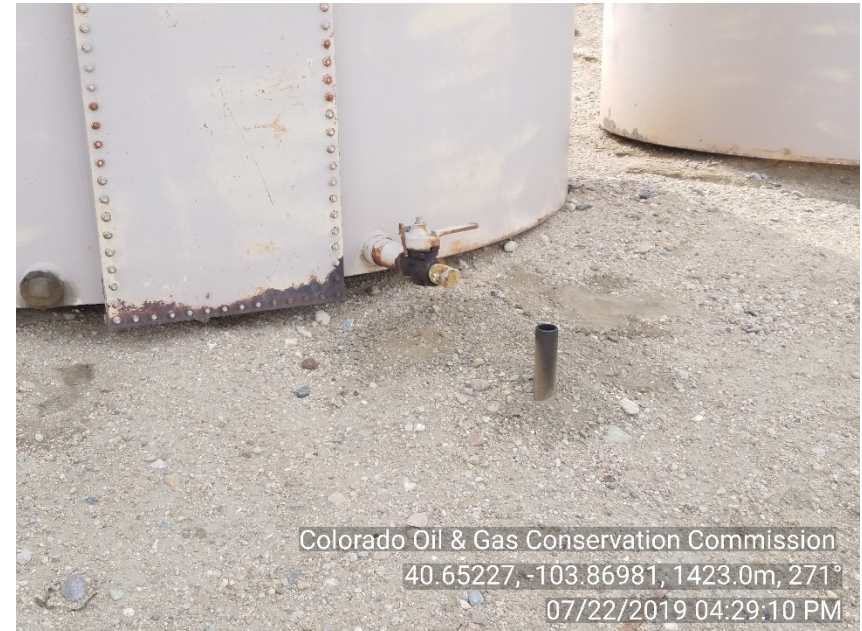
**Photo #30**  
**Sooner Unit** Crude Oil tanks - drainline  
**Stained soil**  
*Appears mitigated*

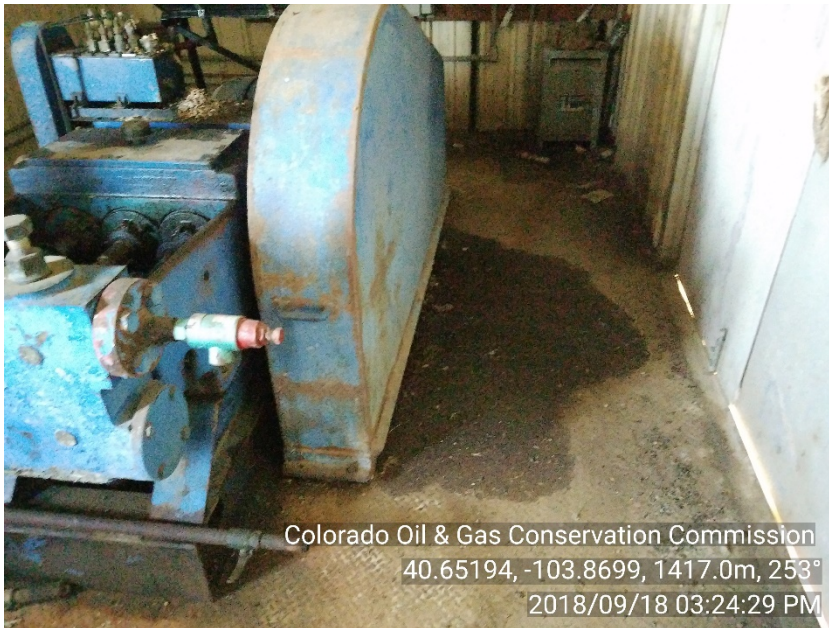
**Photo #31**

**Sooner Unit** Injection Pump – N side

***Stained floor***

*previous insp.*

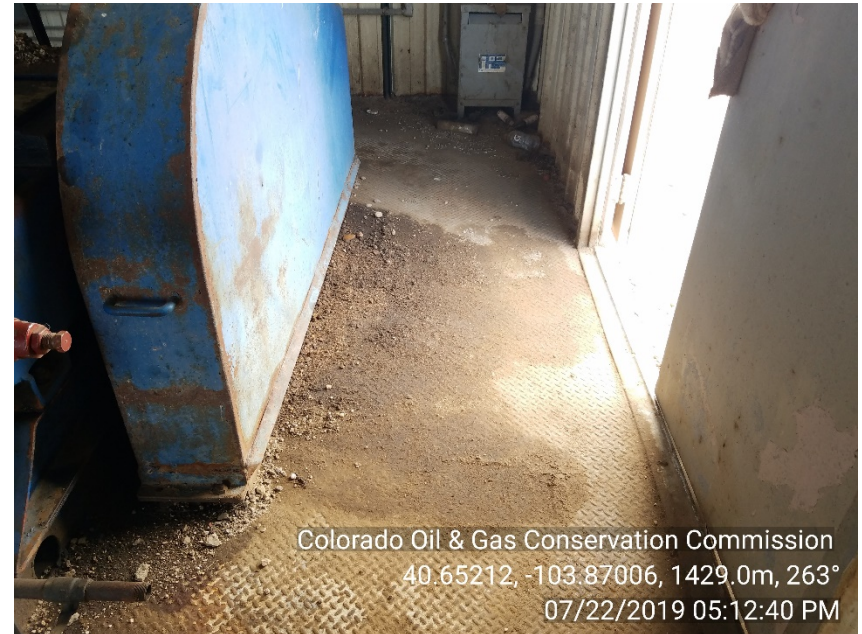
**Photo #32**

**Sooner** Injection Pump – N side

***Stained floor - Remains***

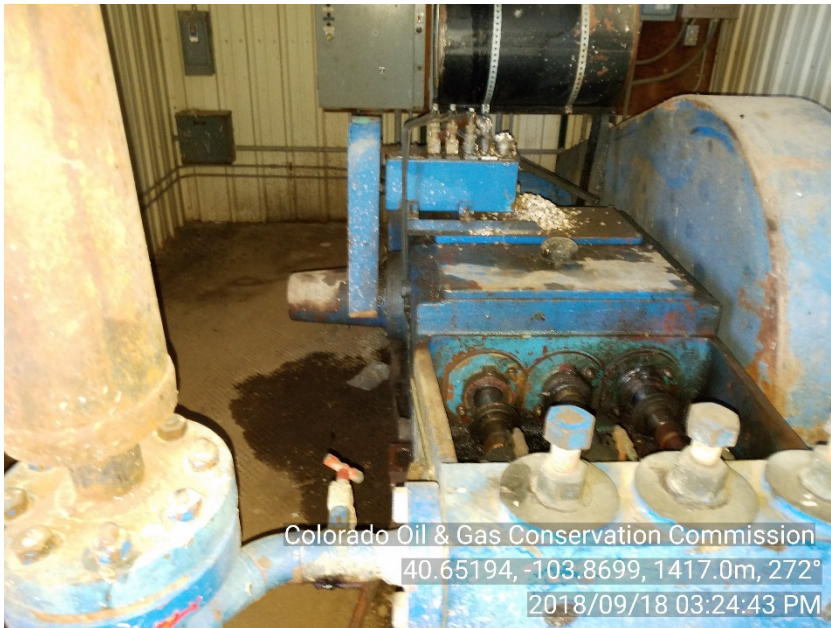
**Photo #33**

**Sooner Unit** Injection Pump – S side

***Stained floor***

*previous insp.*

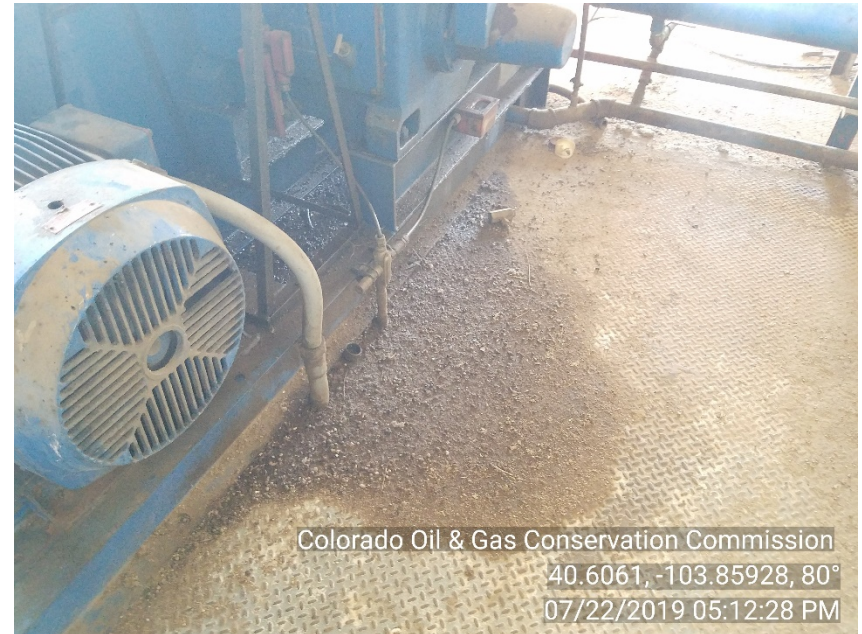
**Photo #34**

**Sooner** Injection Pump – S side

***Stained floor - Remains***

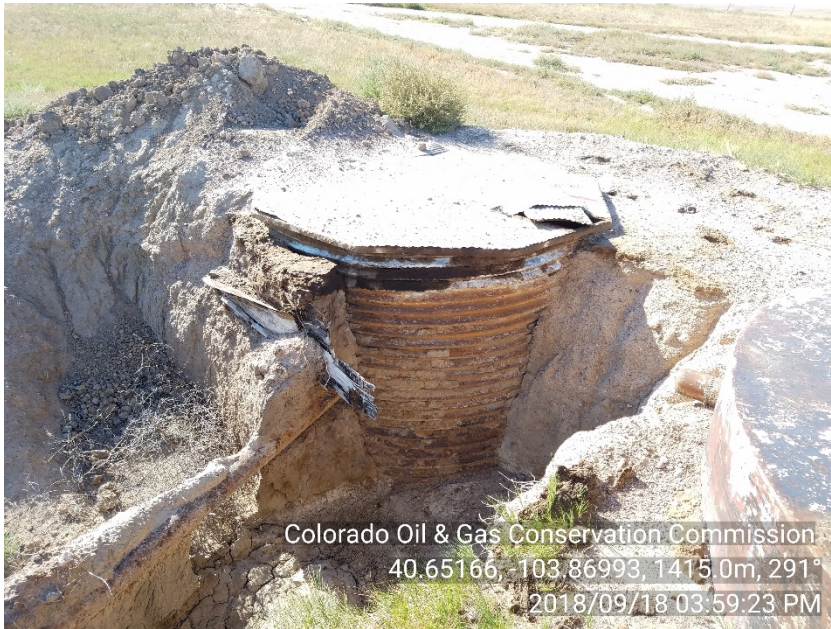
**Photo #35**

**Sooner Unit H2O pit – skim**

***Culvert Rusted***

*previous insp.*

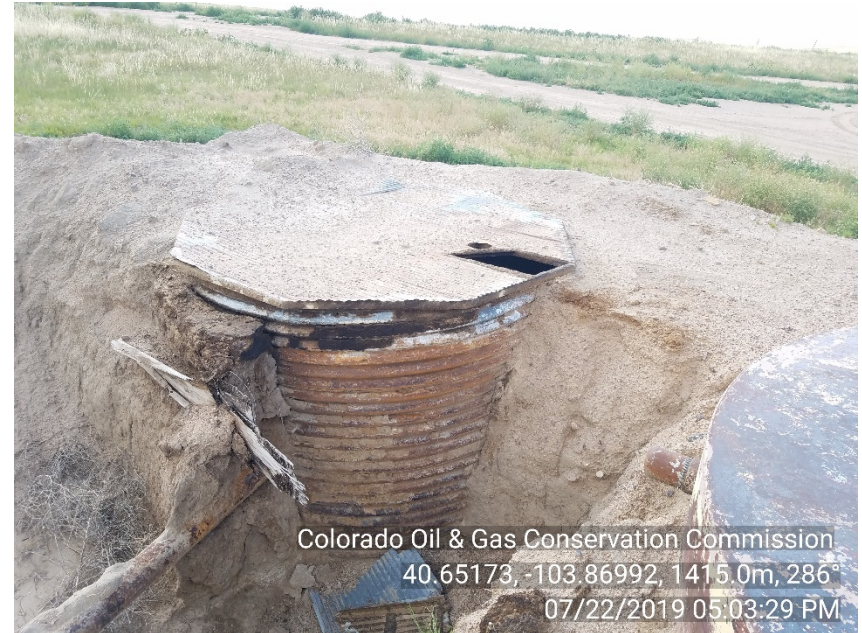
**Photo #36**

**Sooner H2O pit – skim**

***Culvert Rusted***

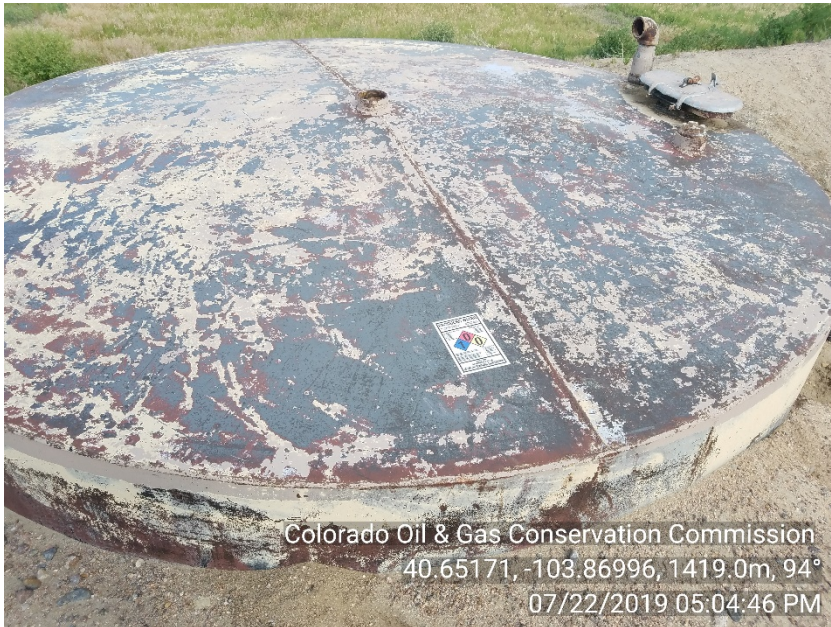
**Photo #37**

**Sooner Unit H2O pit – skim**

***Steel tank – NO Capacity posted***

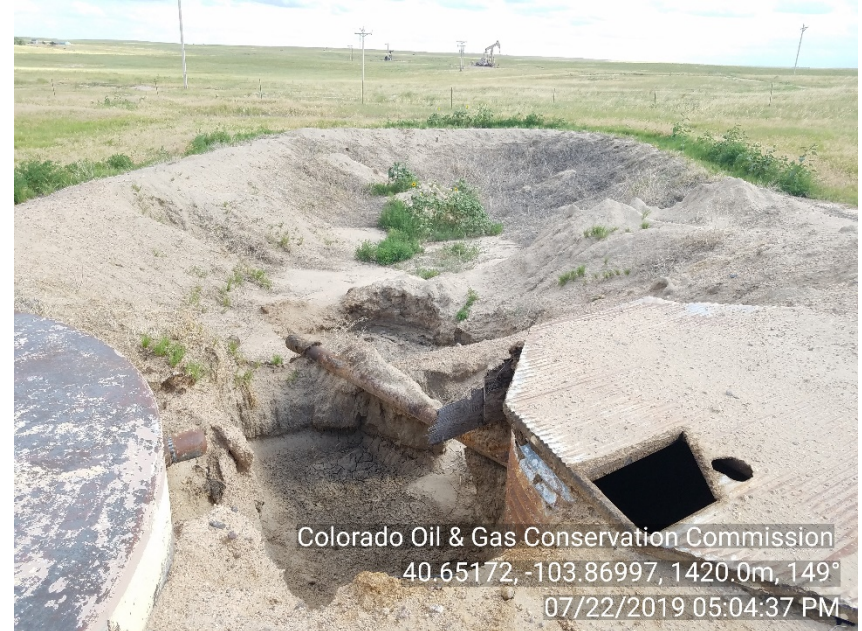
**Photo #38**

**Sooner Unit H2O pit**

***Weeds***

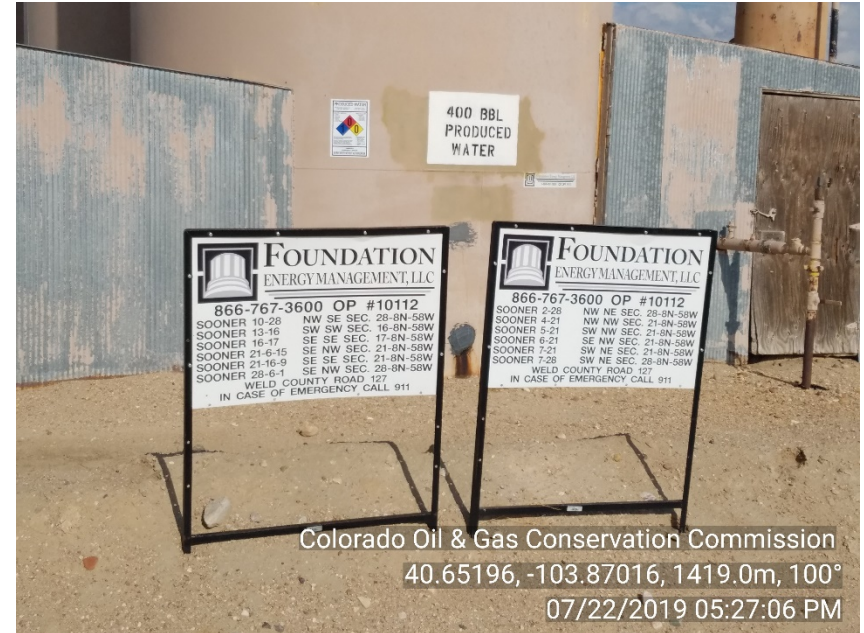
**Photo #40**

**Sooner Unit Battery | Facility**

**Signs**
