Inspection Photos

API#045-19727

Operator: URSA

Inspection Number: 692401191

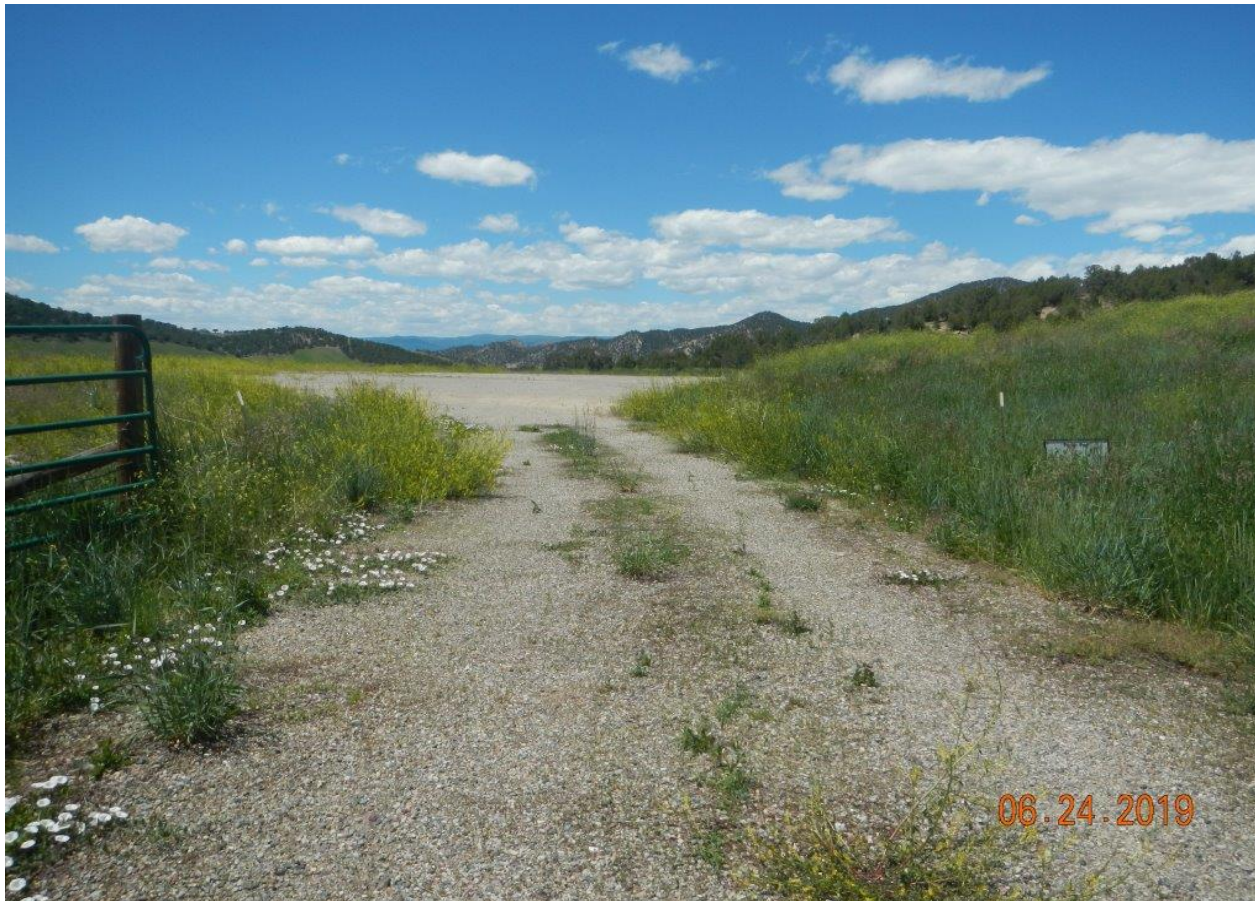
Photo#1:
Overview of Location to Northwest.

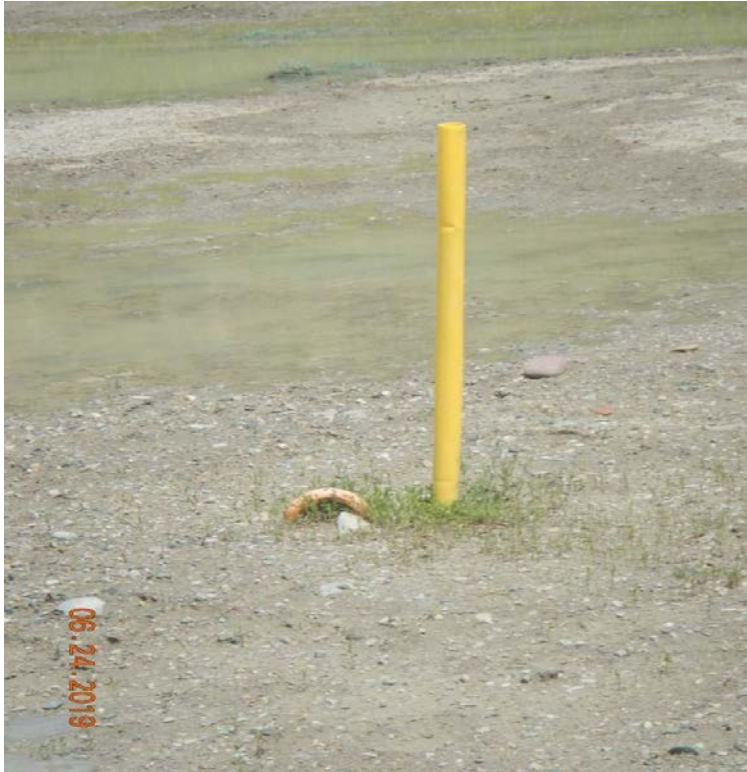
Photo#2:
Anchors remain on site.

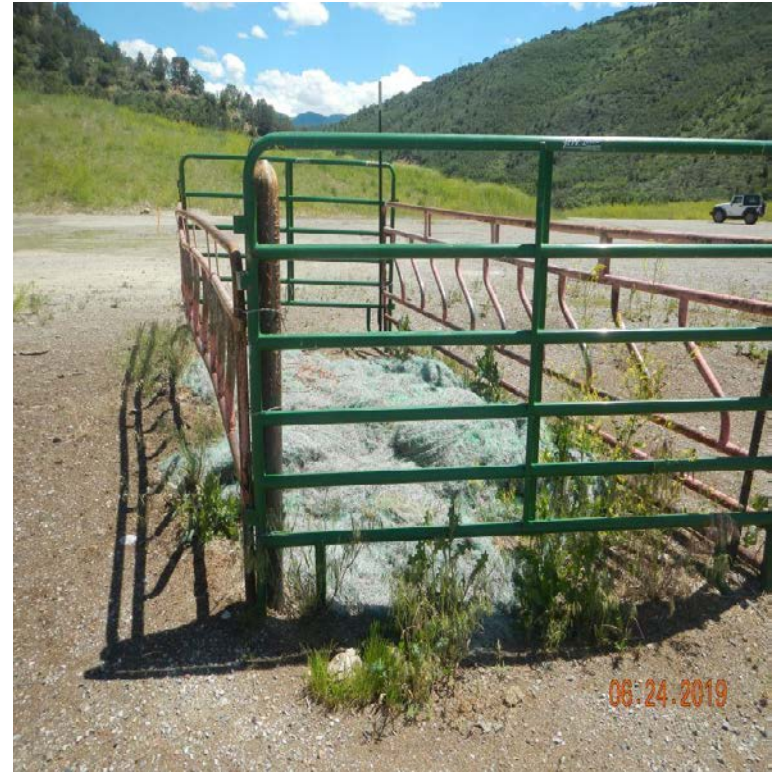
Photo#3:
Debris on site.

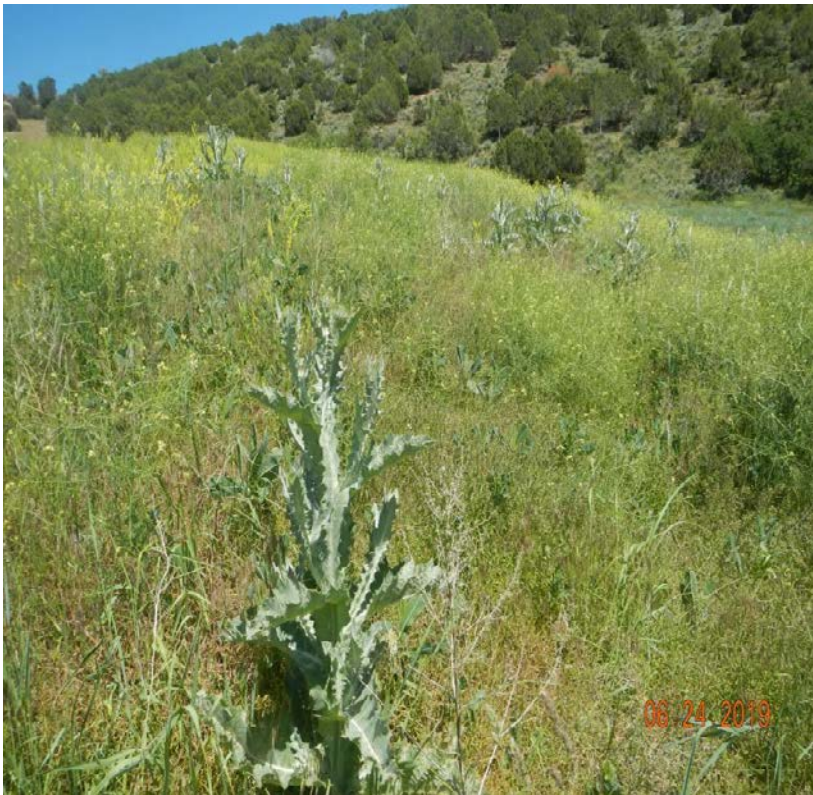
Photo#4:
Scotch thistle, Noxious Weed on site.

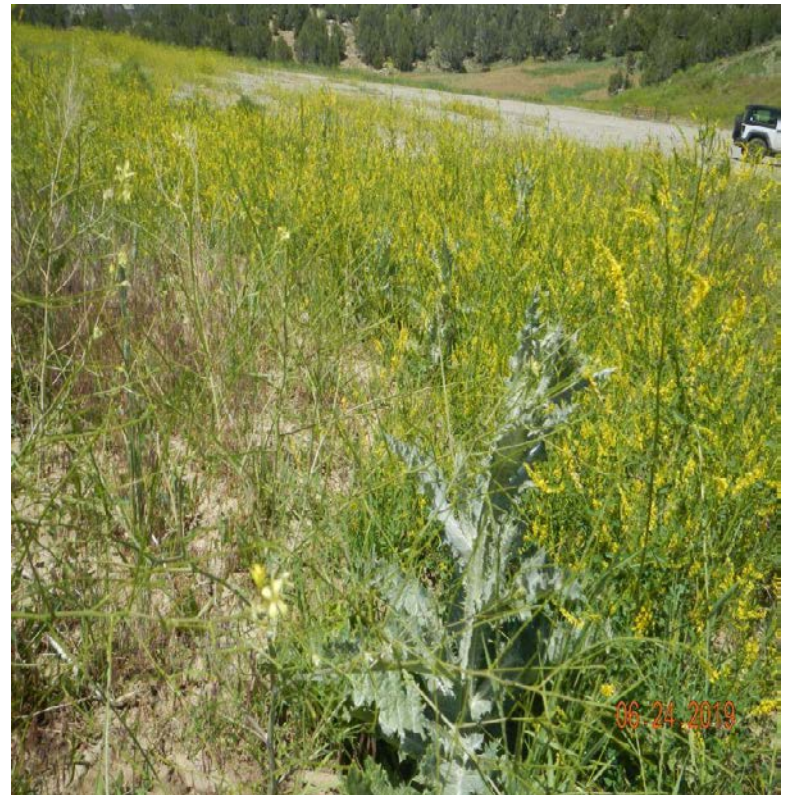
Photo#5:
Scotch thistle, Noxious Weed on site.

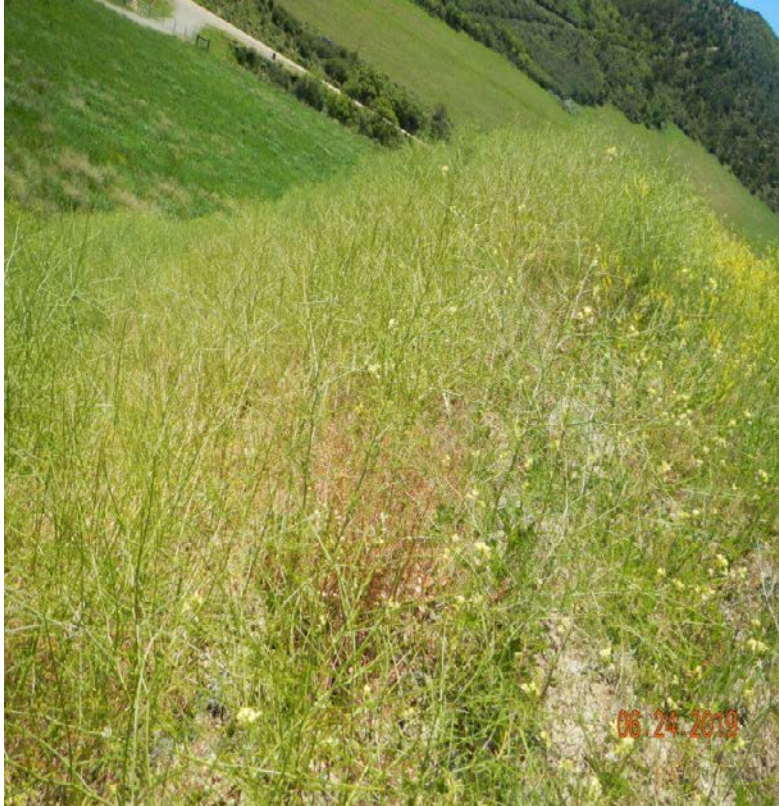
Photo#6:
Slopes and pad perimeters have heavy establishment of ruderal weeds.

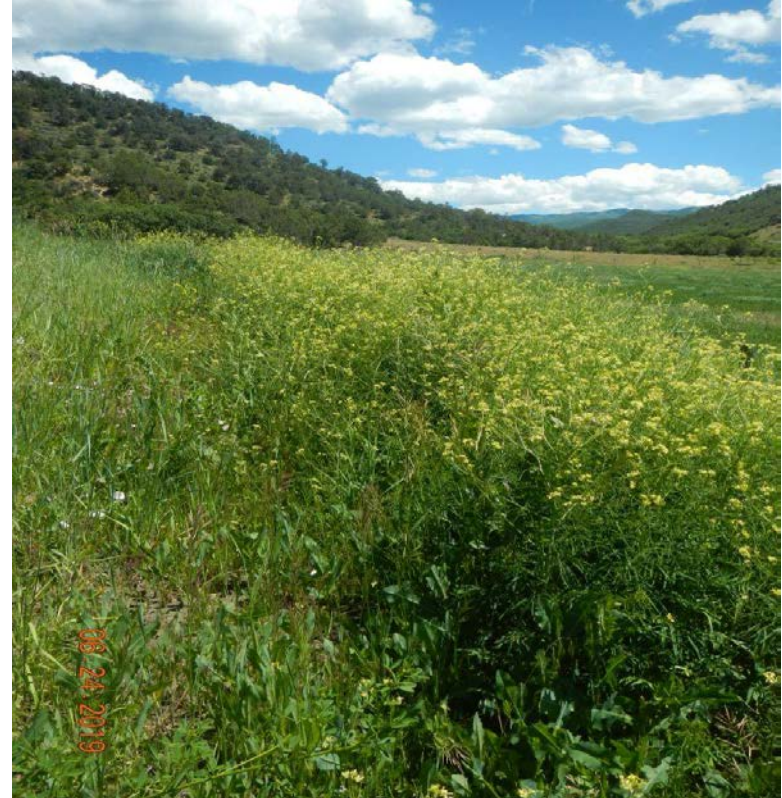
Photo#7:
Slopes and pad perimeters have heavy establishment of ruderal weeds.

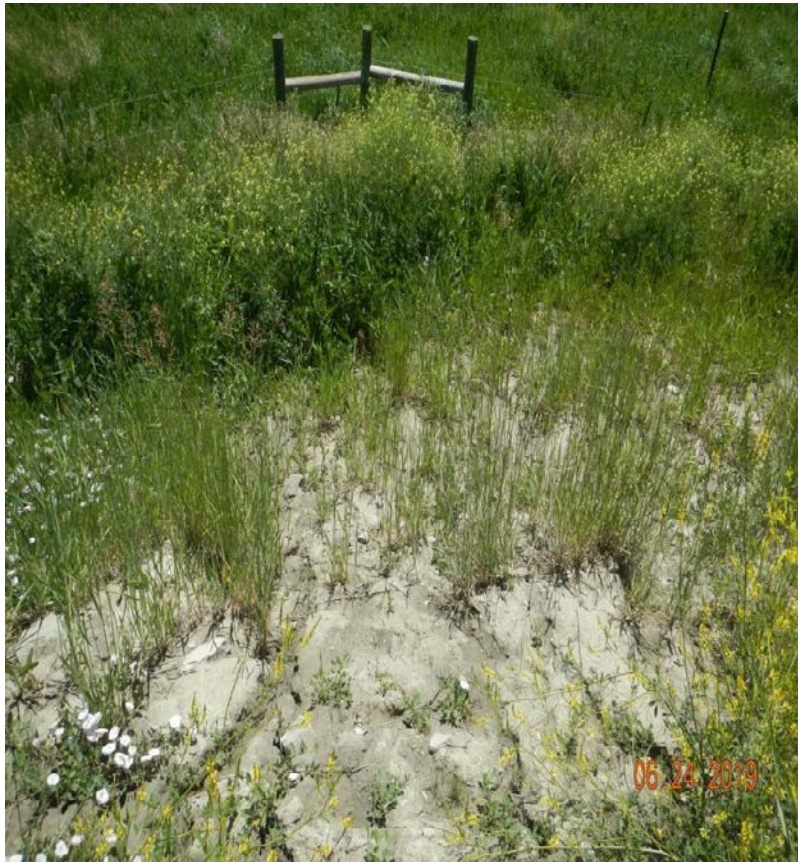
Photo#8:
Fill slope has areas of spotty establishment of desirable vegetation.

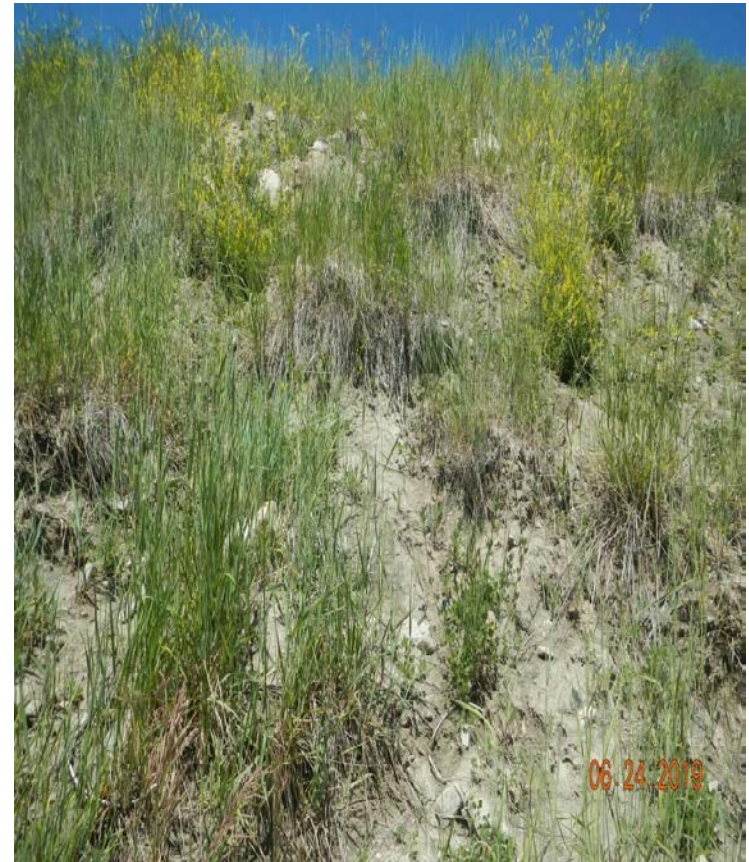
Photo#9:
Fill slope has areas of spotty establishment of desirable vegetation.

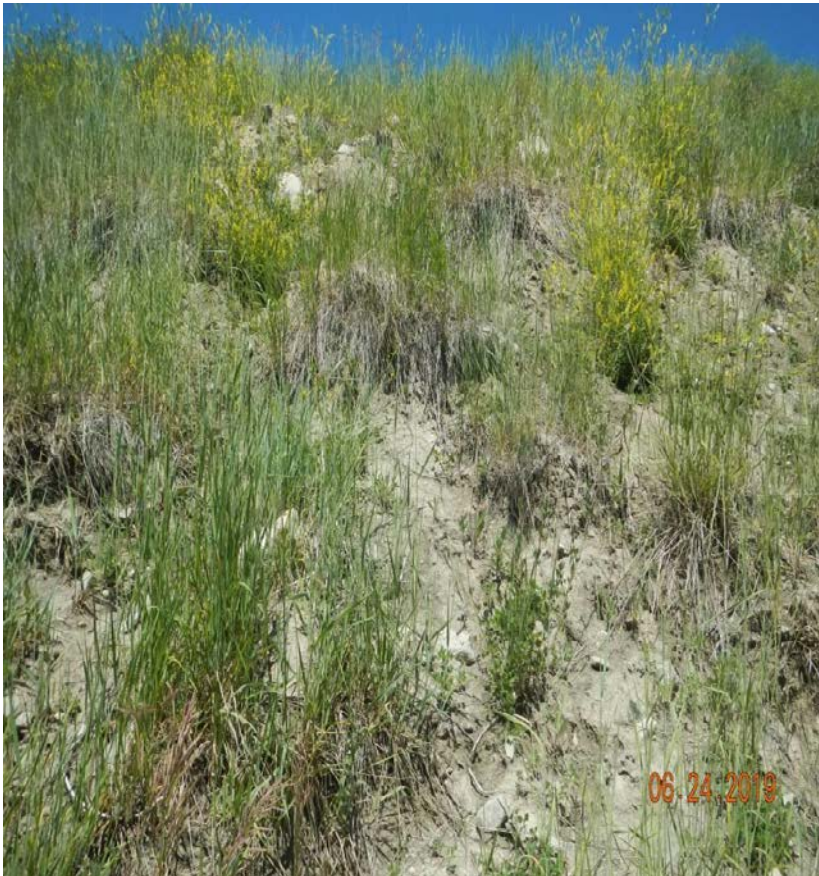
Photo#10:
Fill slope has areas of spotty establishment of desirable vegetation.

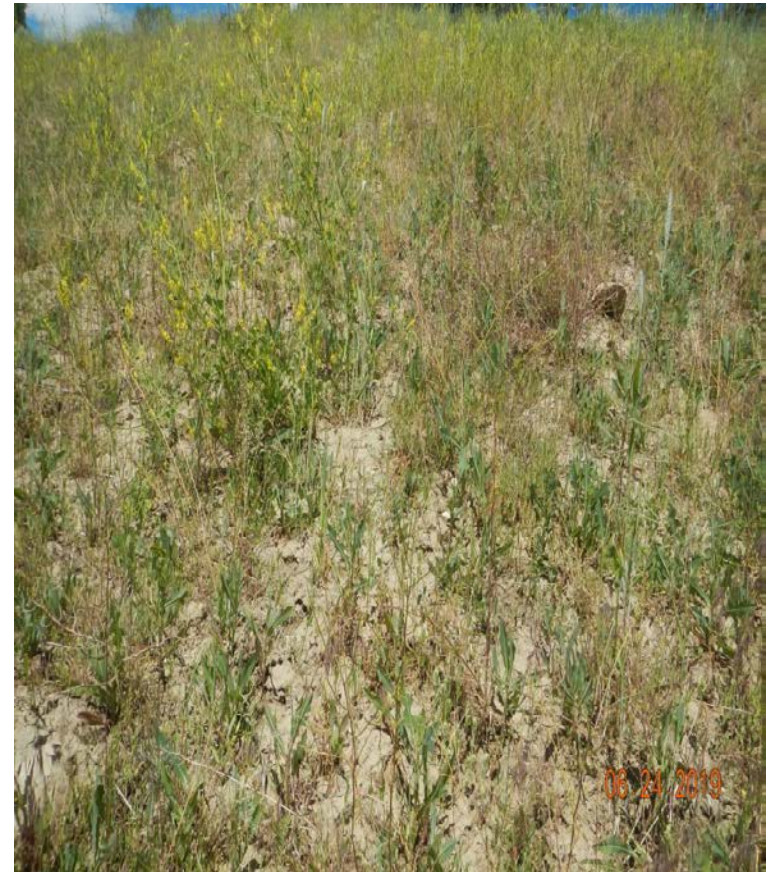
Photo#11:
Fill slope has areas of spotty establishment of desirable vegetation.

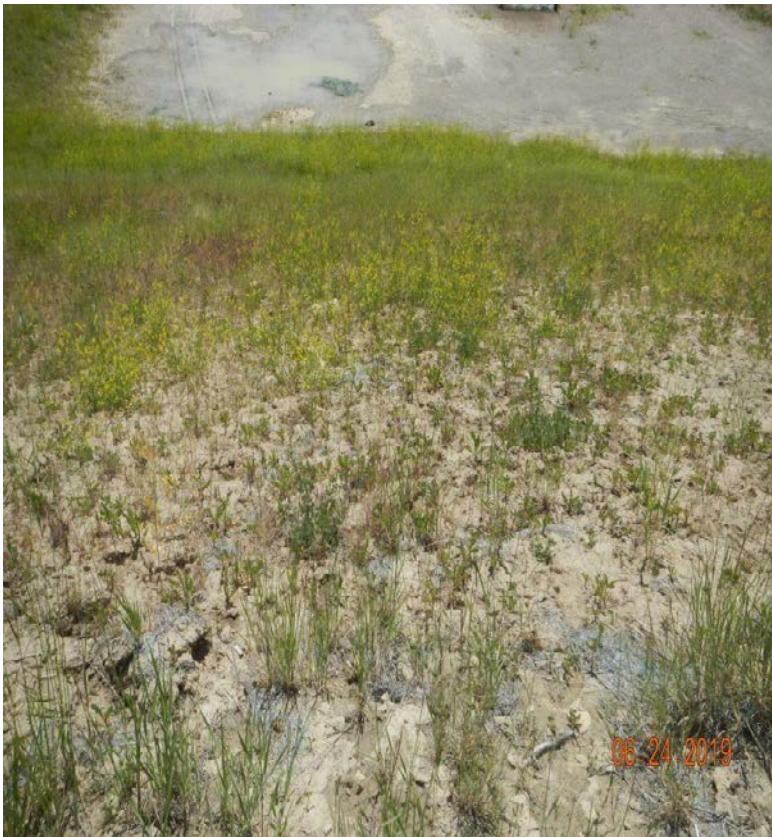
Photo#12:
Cut slope has spotty establishment of desirable
vegetation.

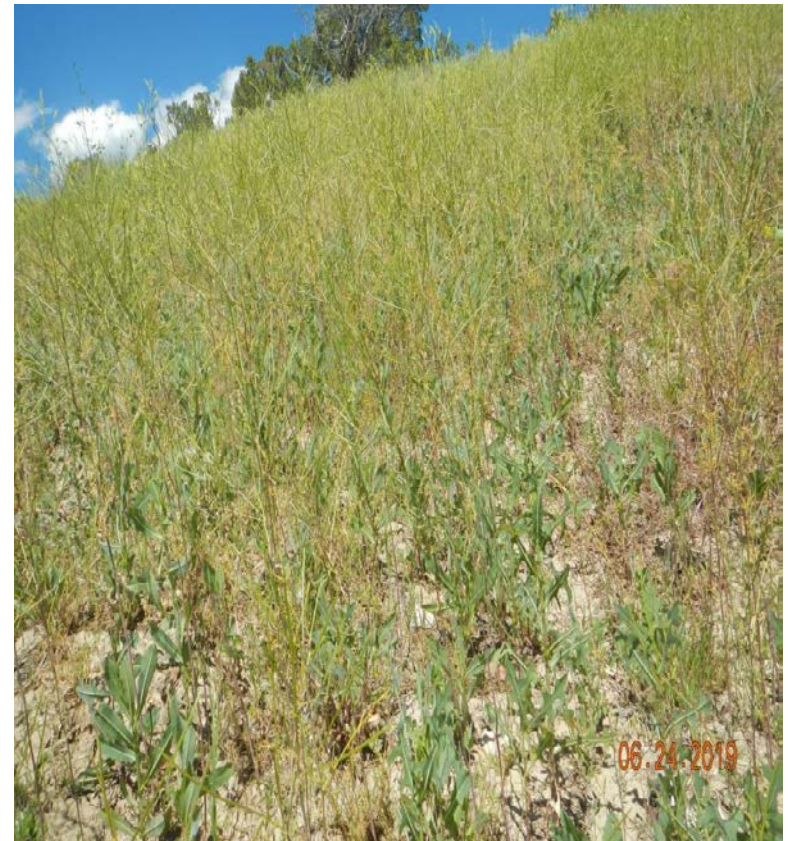
Photo#13:
Slopes and pad perimeters have heavy
establishment of ruderal weeds.

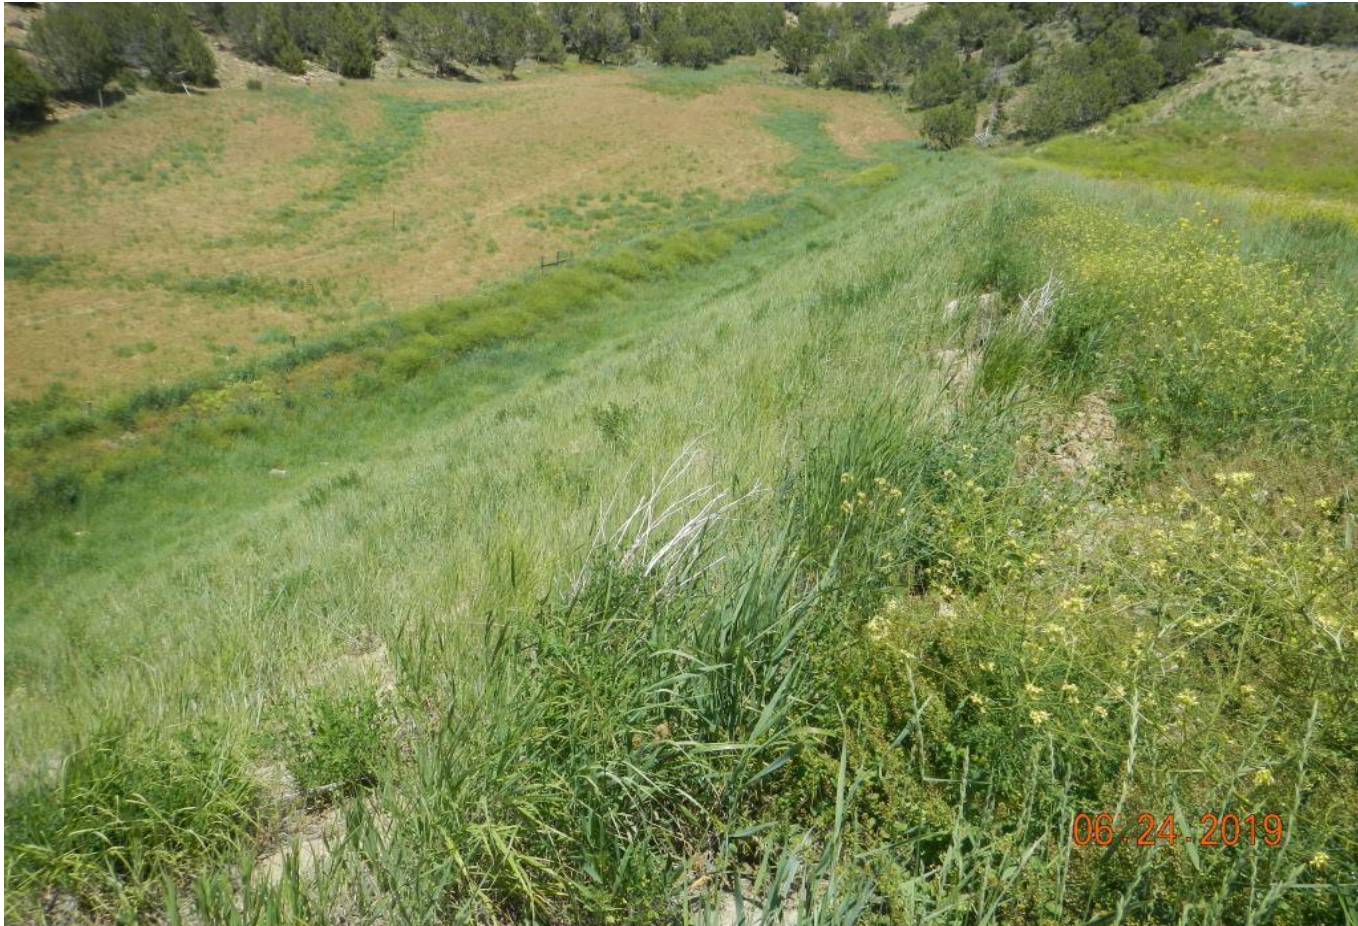
Photo#14:
North fill slope has good establishment of desirable vegetation.
