Laramie Energy LLC  
API # 05-077-09476  
Inspection # 696600412

Caerus Piceance LLC  
API # 05-077-10163  
Inspection # 696600410

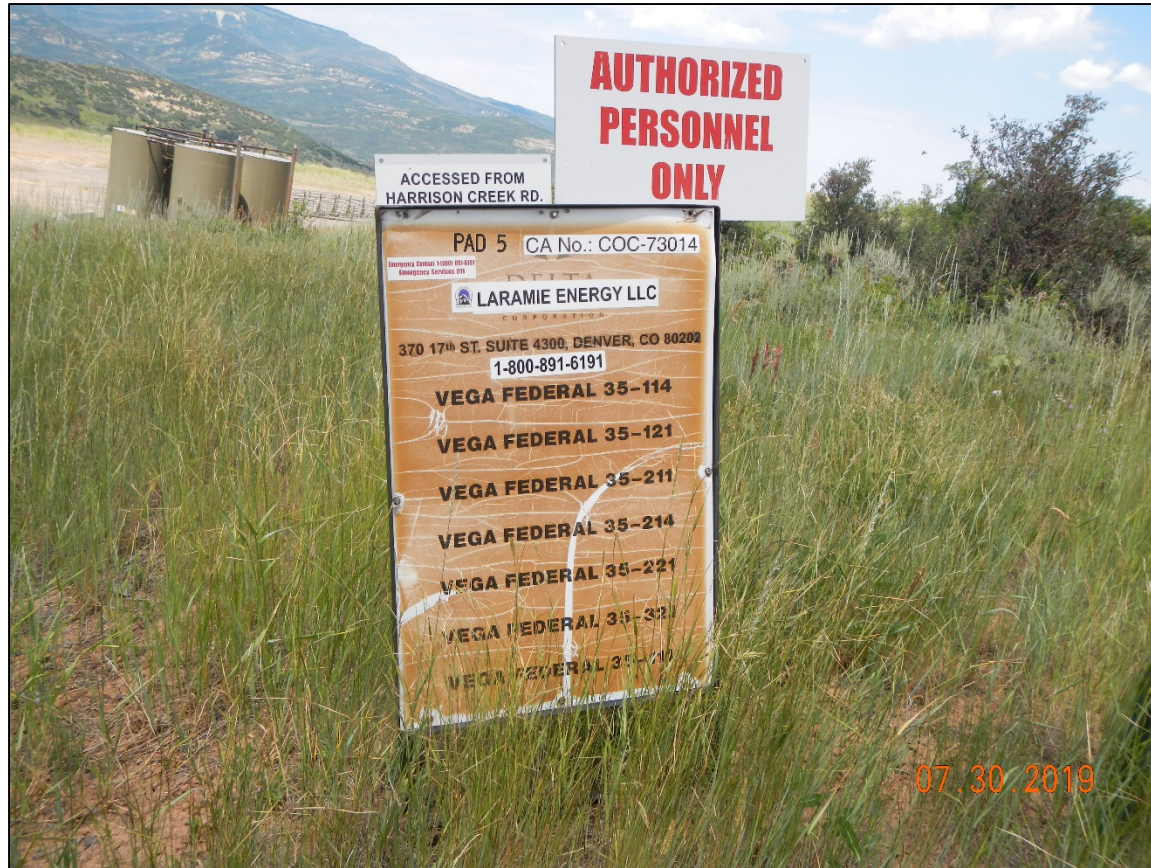
Battery sign at entrance to location

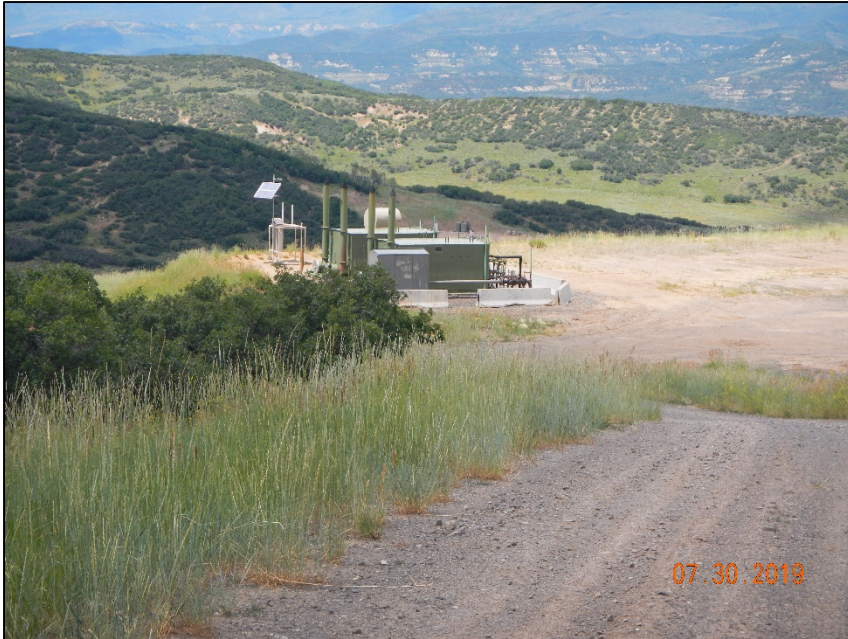
Photo #1 Photo at entrance of location .

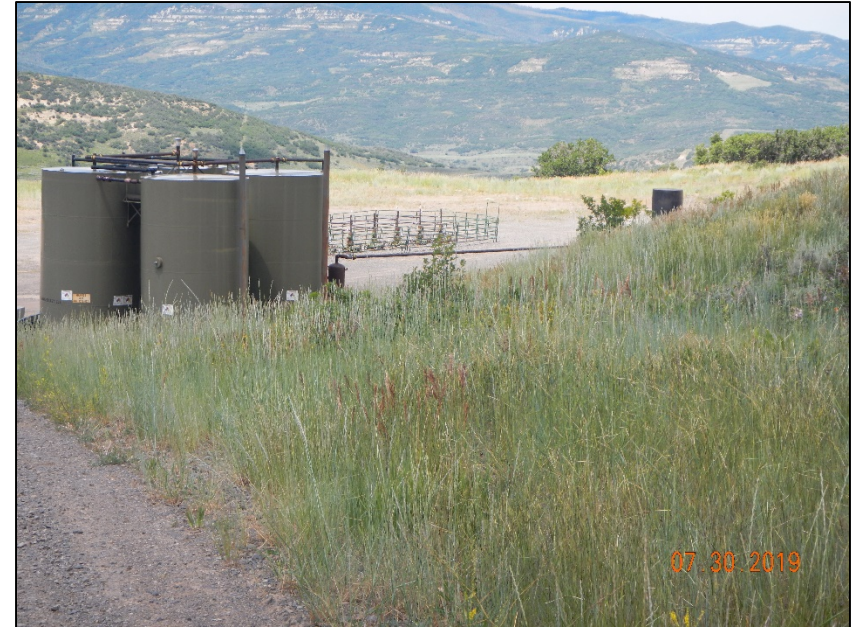
Photo #2 Photo at entrance of location

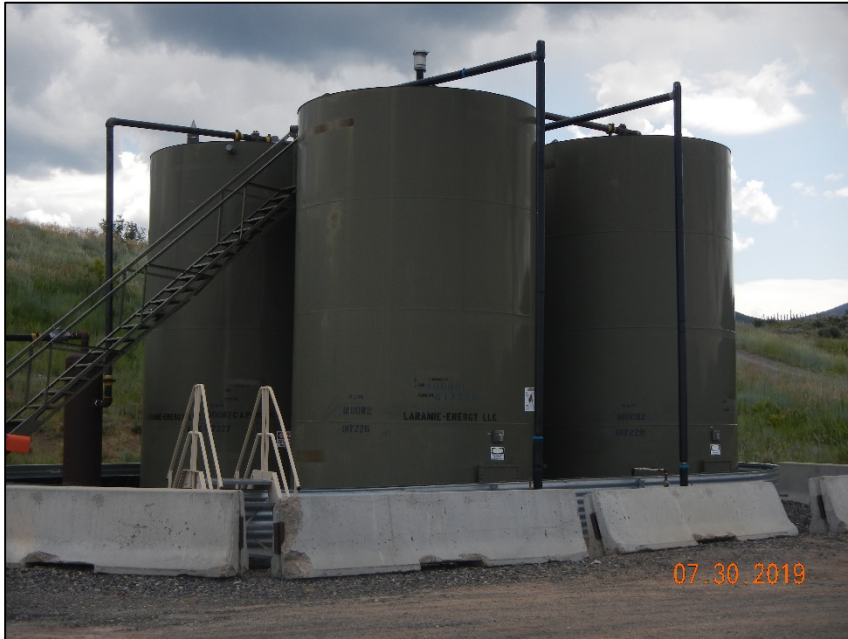
Photo #3 Photo of tank battery.

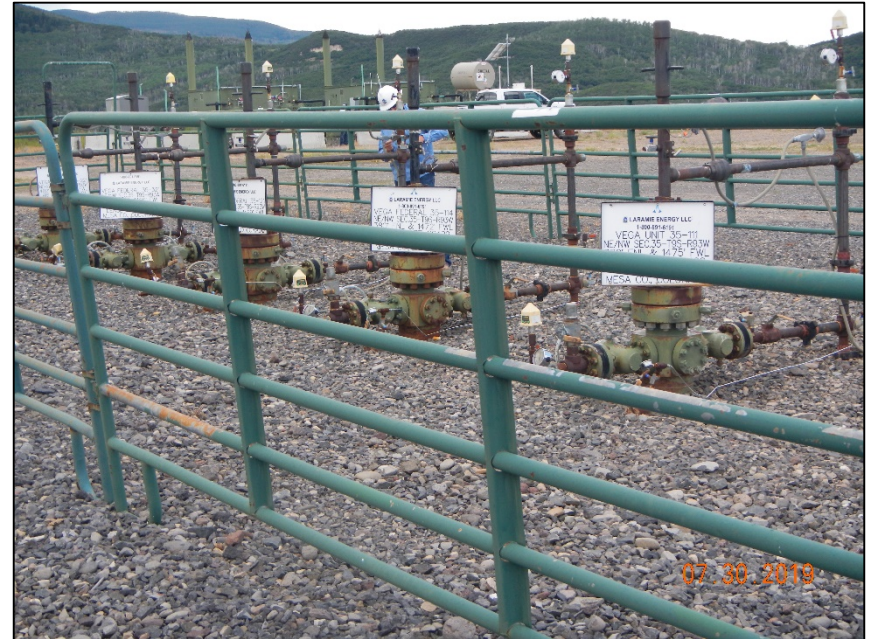
Photo #4 photo at wellheads.

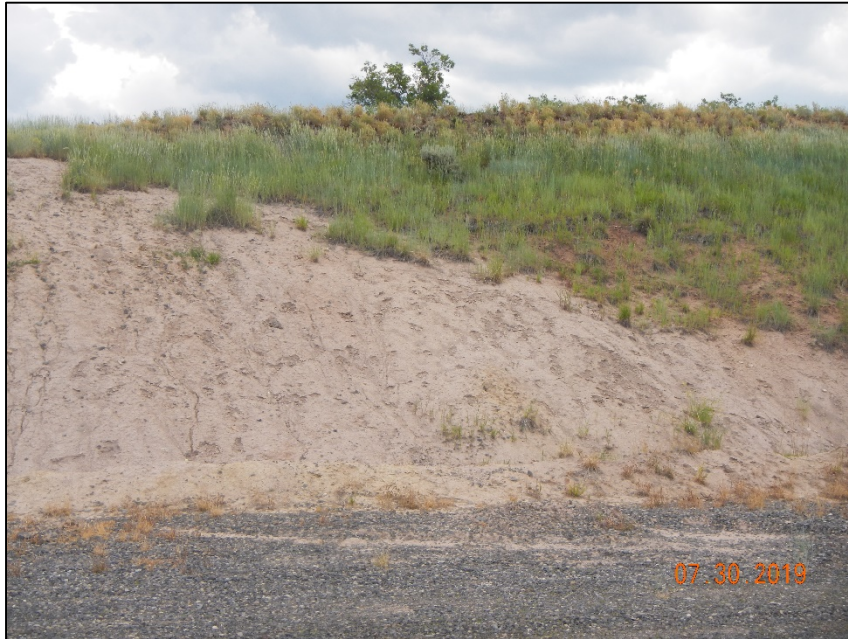
**Photo #5 Erosion is evident along un-stabilized slope on the east side of location. Vegetation is choked out**

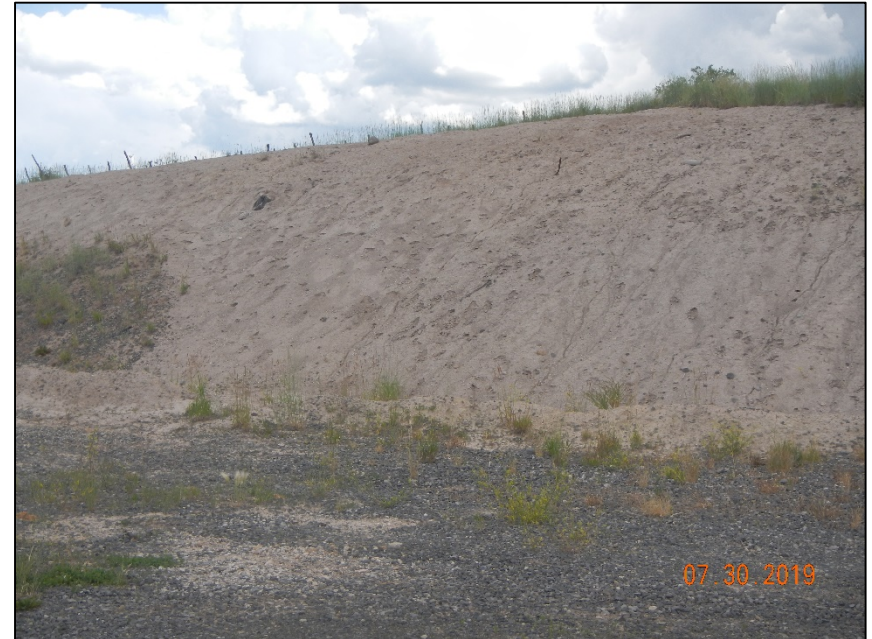
**Photo #6 Erosion is evident along un-stabilized slope on the east side of location. Vegetation is choked out. Berms around location, have been constructed as storm water BMP, with no stabilization.**

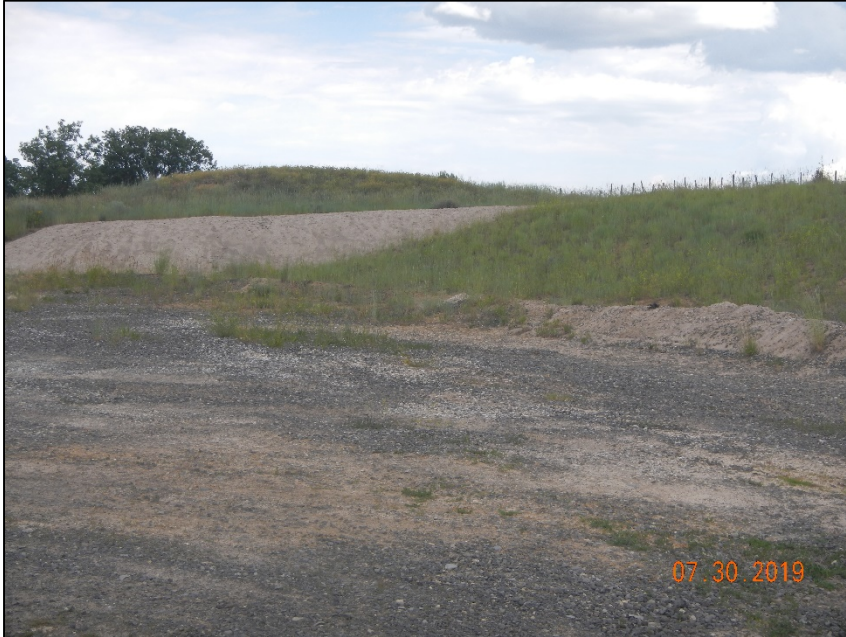
**Photo #8 Erosion is evident along un-stabilized slope on the north side of location. Vegetation is choked out**

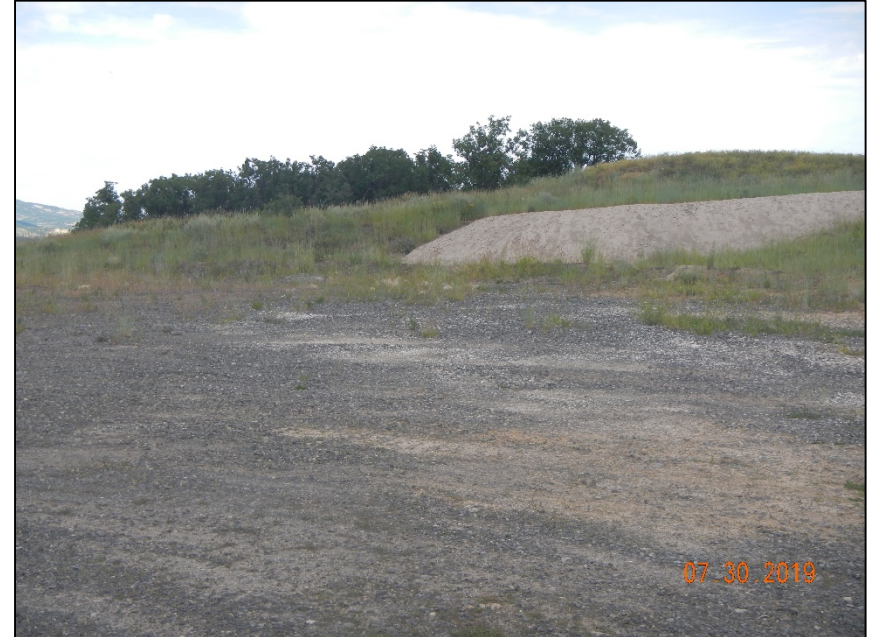
**Photo #9 Erosion is evident along un-stabilized slope on the north side of location. . Vegetation is choked out**

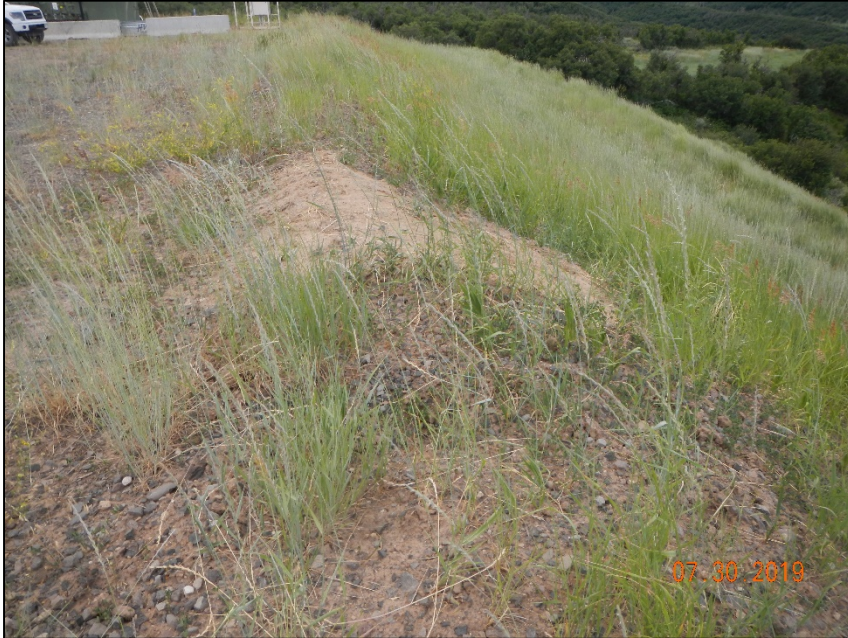
**Photo #10 Berms around location, have been constructed as storm water BMP, with no stabilization.**

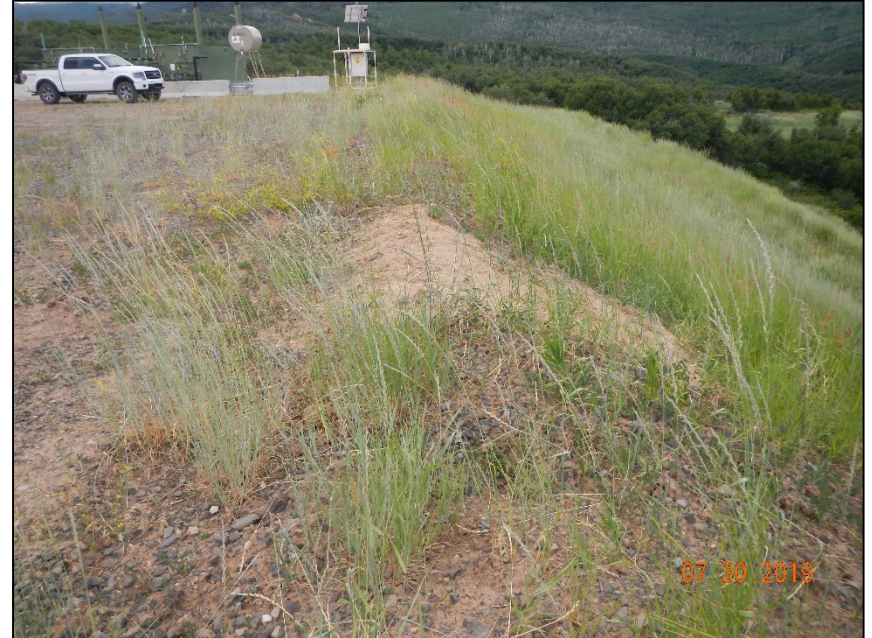
**Photo #11 Berms around location, have been constructed as storm water BMP, with no stabilization.**

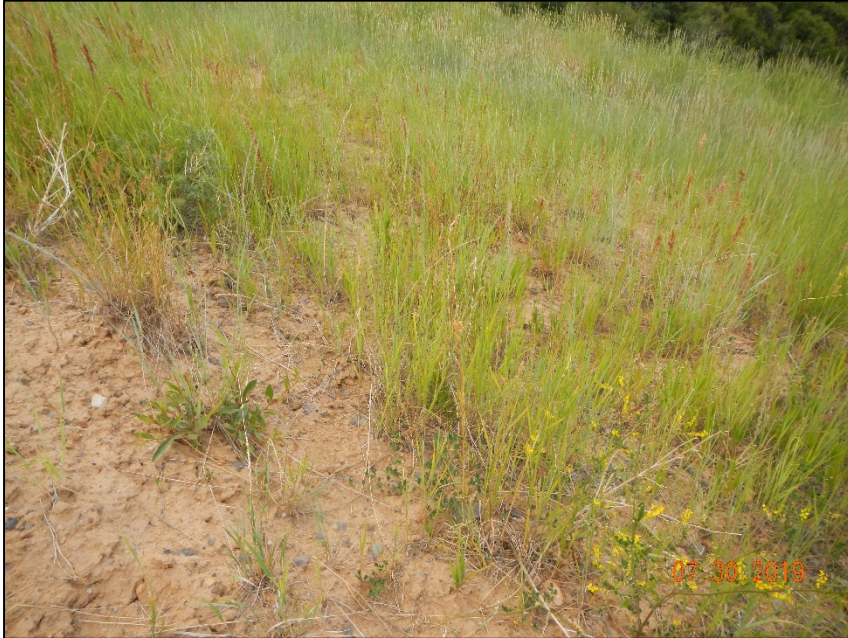
**Photo #12. Erosion from berm is moving down west and south slope choking vegetation. See photos**

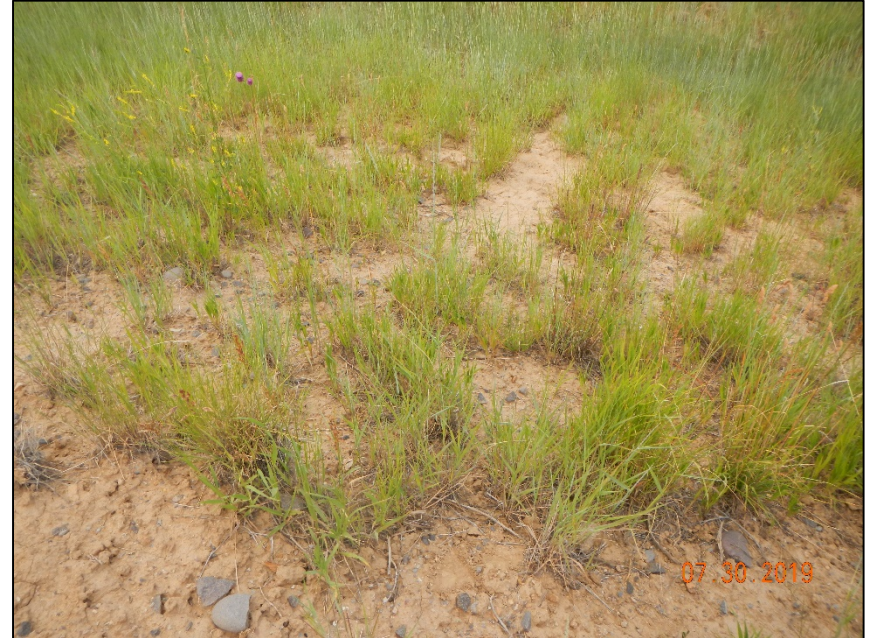
**Photo #13 Erosion from berm is moving down west and south slope choking vegetation. See photos**

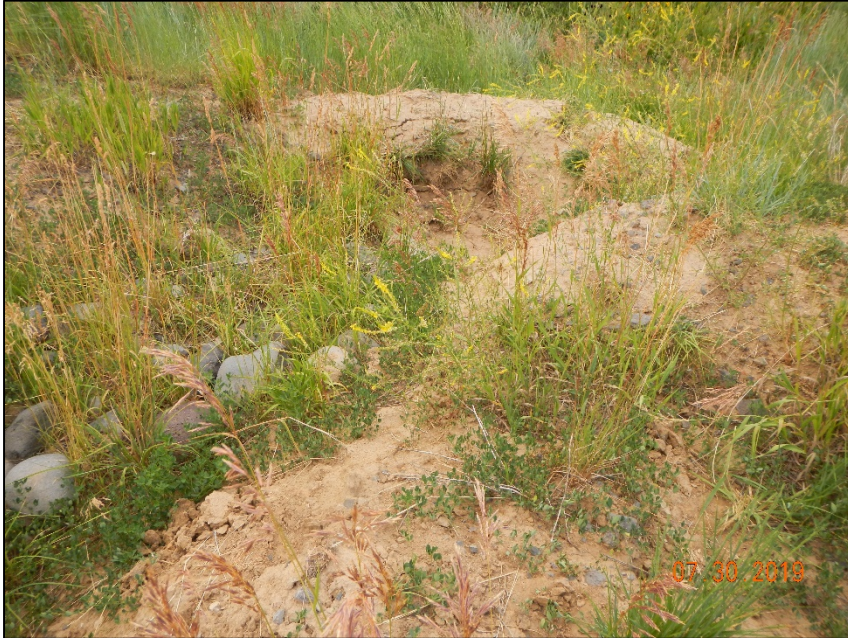
**Photo #14. Sediment trap and drain on south side of location located by meter run, is in need of maintenance.**

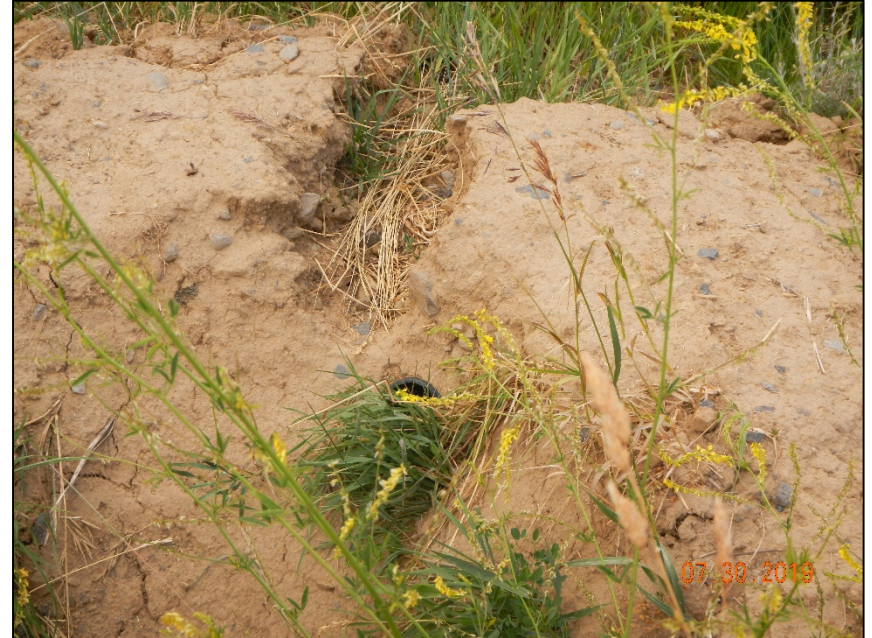
**Photo #15. Sediment trap and drain on south side of location located by meter run is in need of maintenance.**

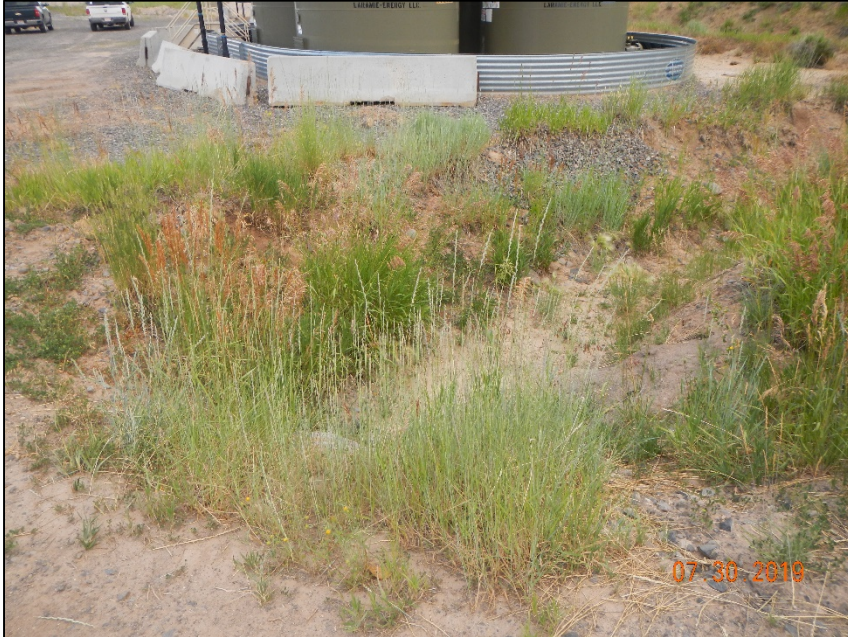
**Photo #16. Culvert by tank battery, is in need of maintenance.**

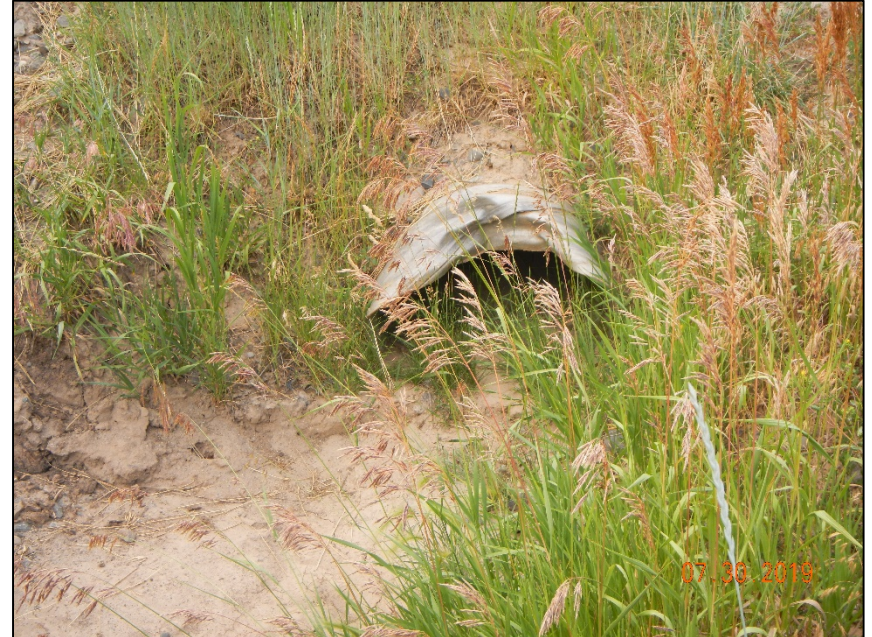
**Photo #17. Culvert by tank battery, is in need of maintenance.**
