Inspection Photos

API: 05-073-06368

Operator: NIGHTHAWK PRODUCTION

Inspection Date: 7/25/2019

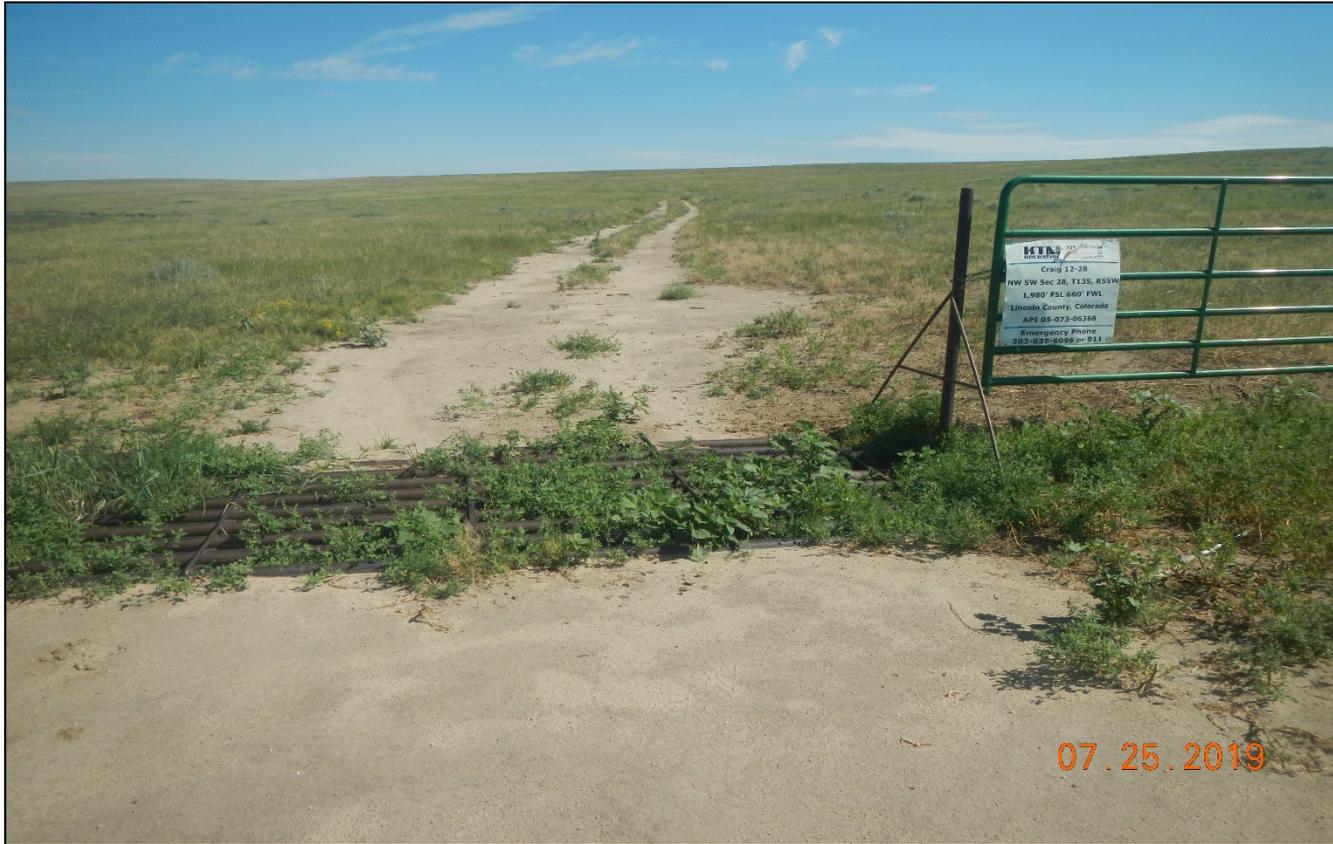
Photo 1. Facing north at the beginning of the two track access road leading to the location.

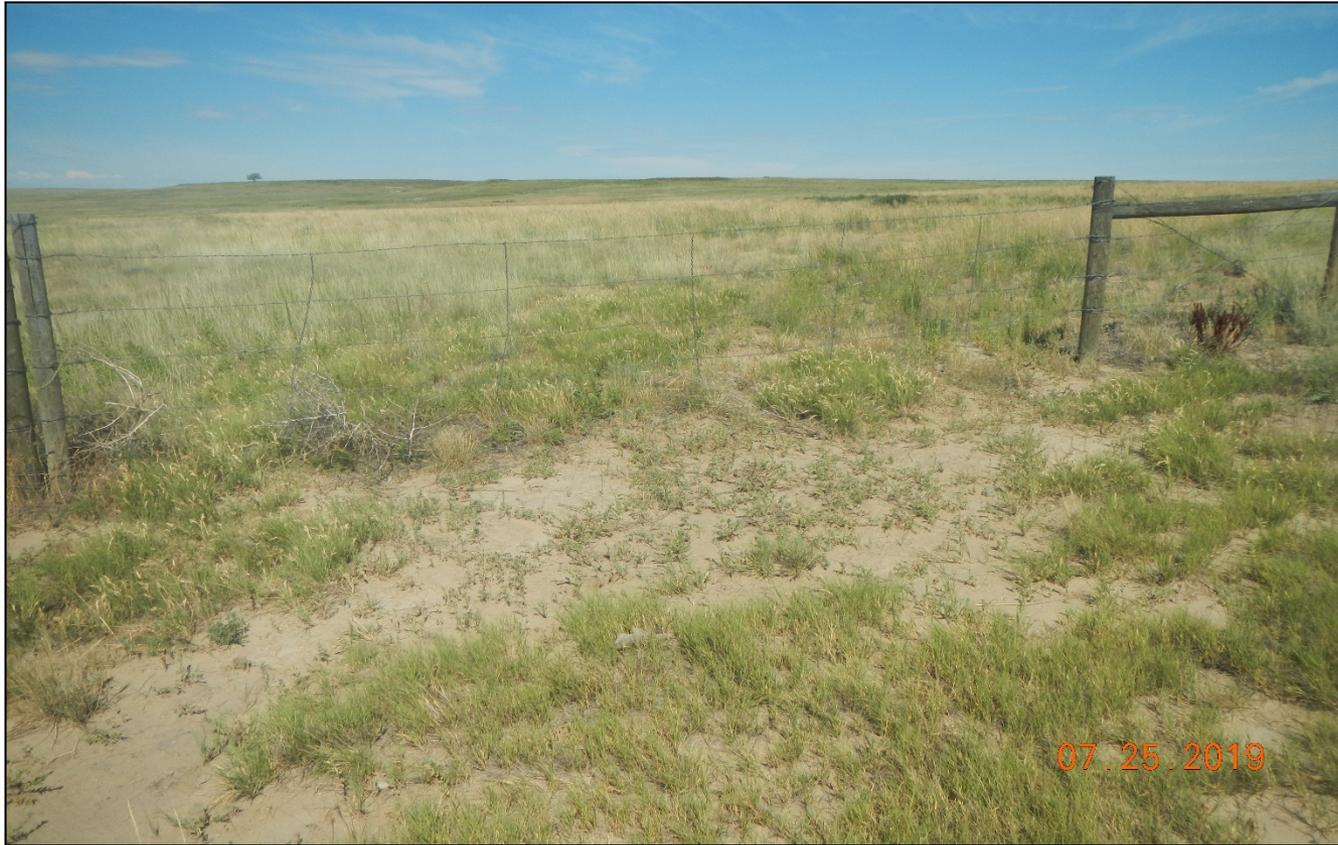
Photo 2. Facing northwest toward the location.

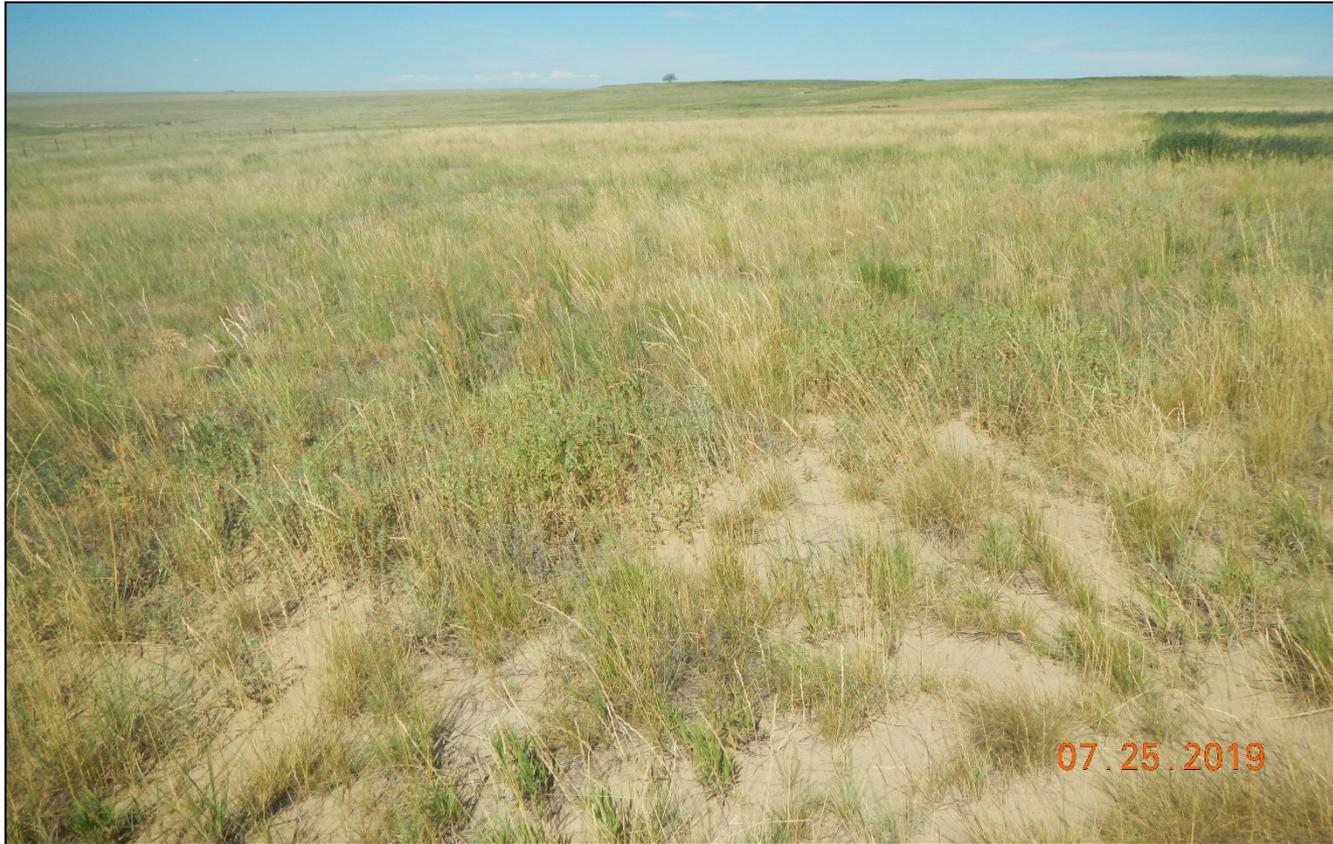
Photo 3. Facing west toward the southern portion of the location. Vegetation is well established at this area.

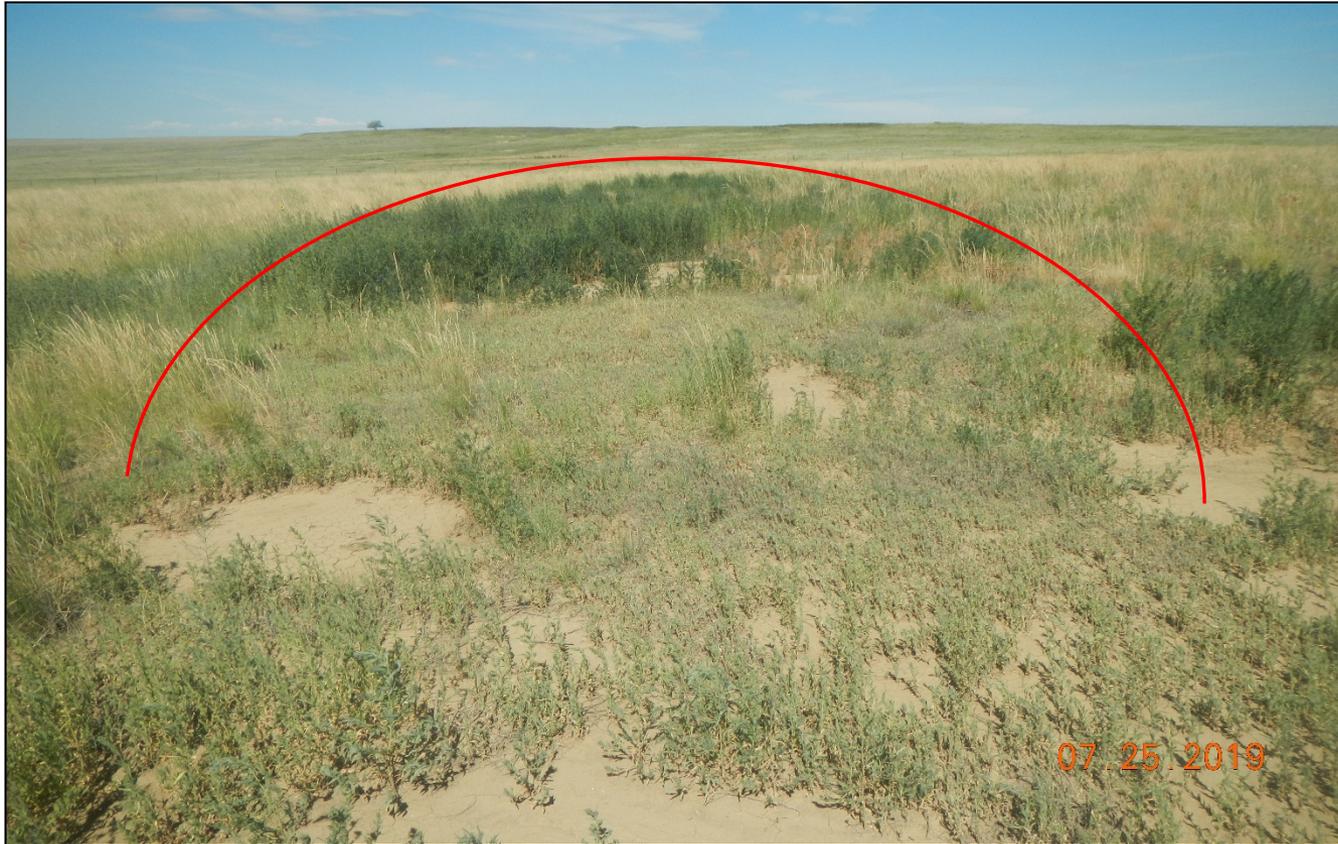
Photo 4. Facing west at the center of the location. This area has predominately undesirable weeds.

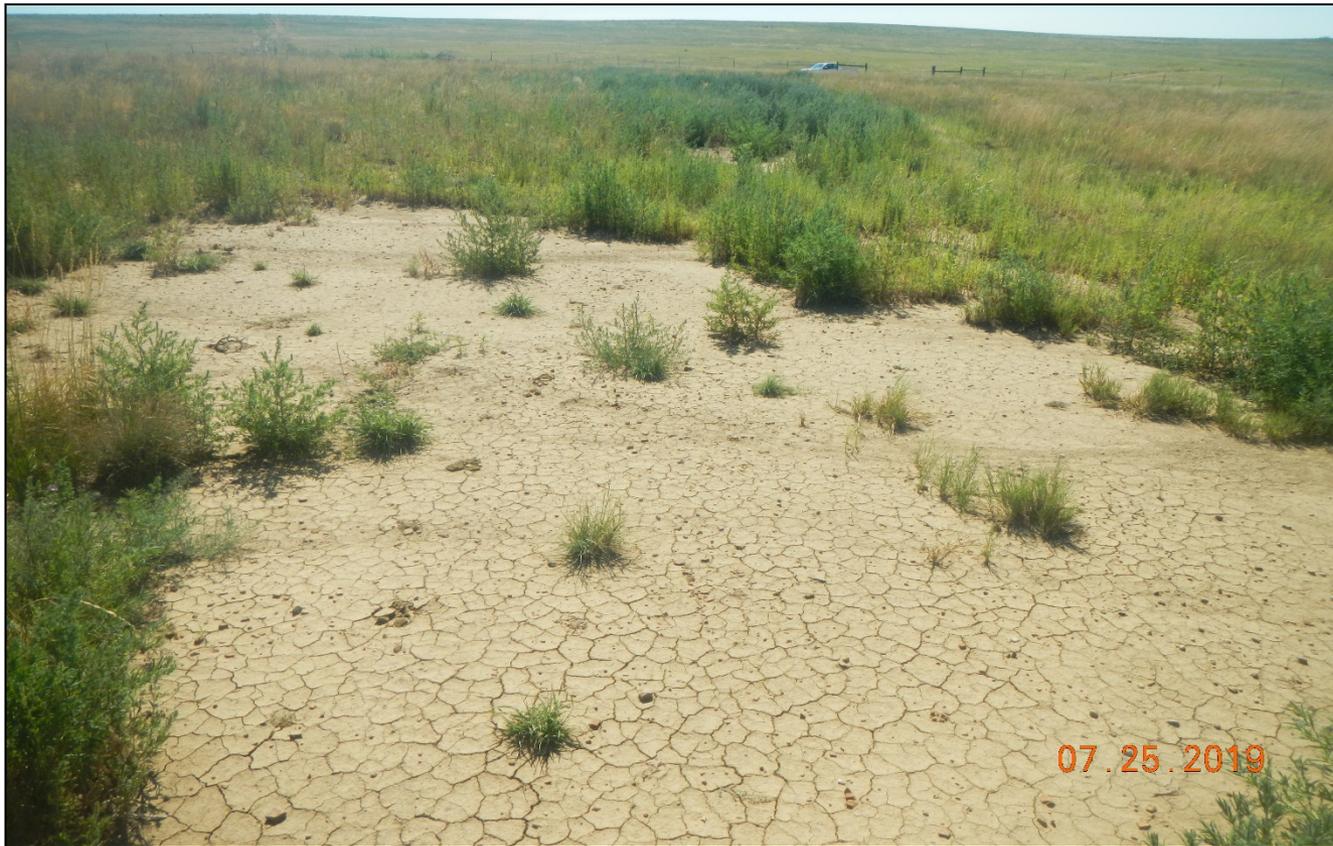
Photo 5. Facing southeast at the center of the location. This area does not have adequate vegetation establishment.

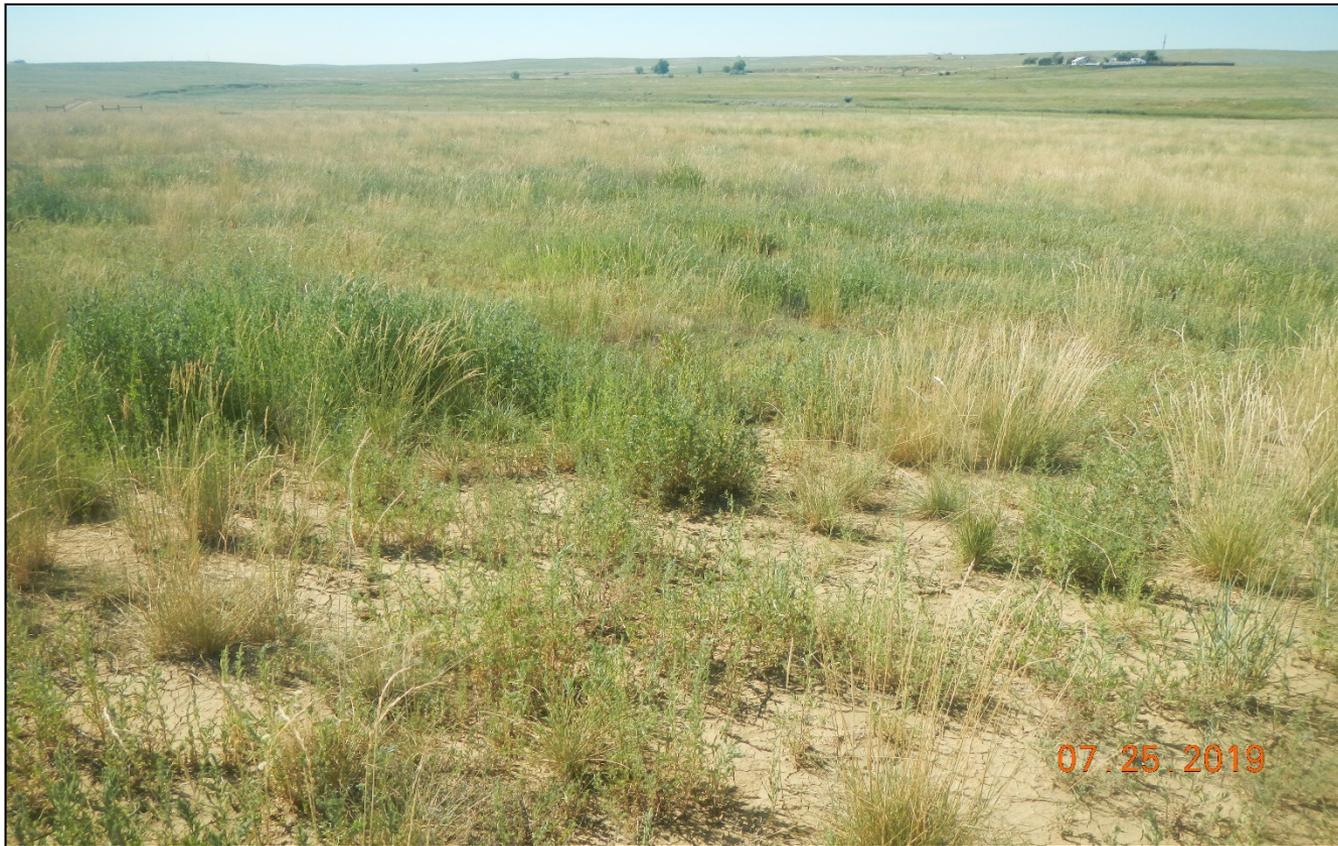
Photo 6. Facing south at the location.

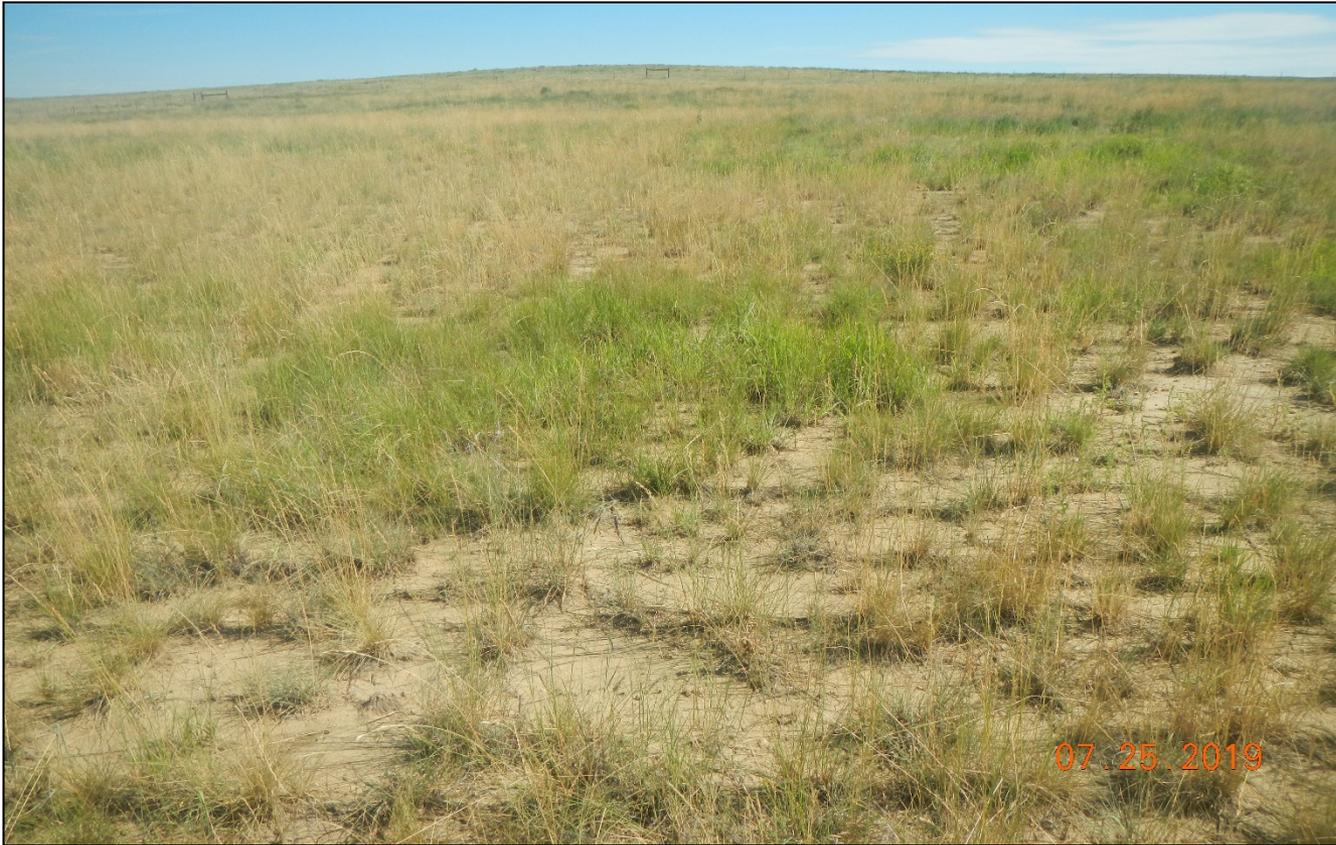
Photo 7. Facing north at the location.

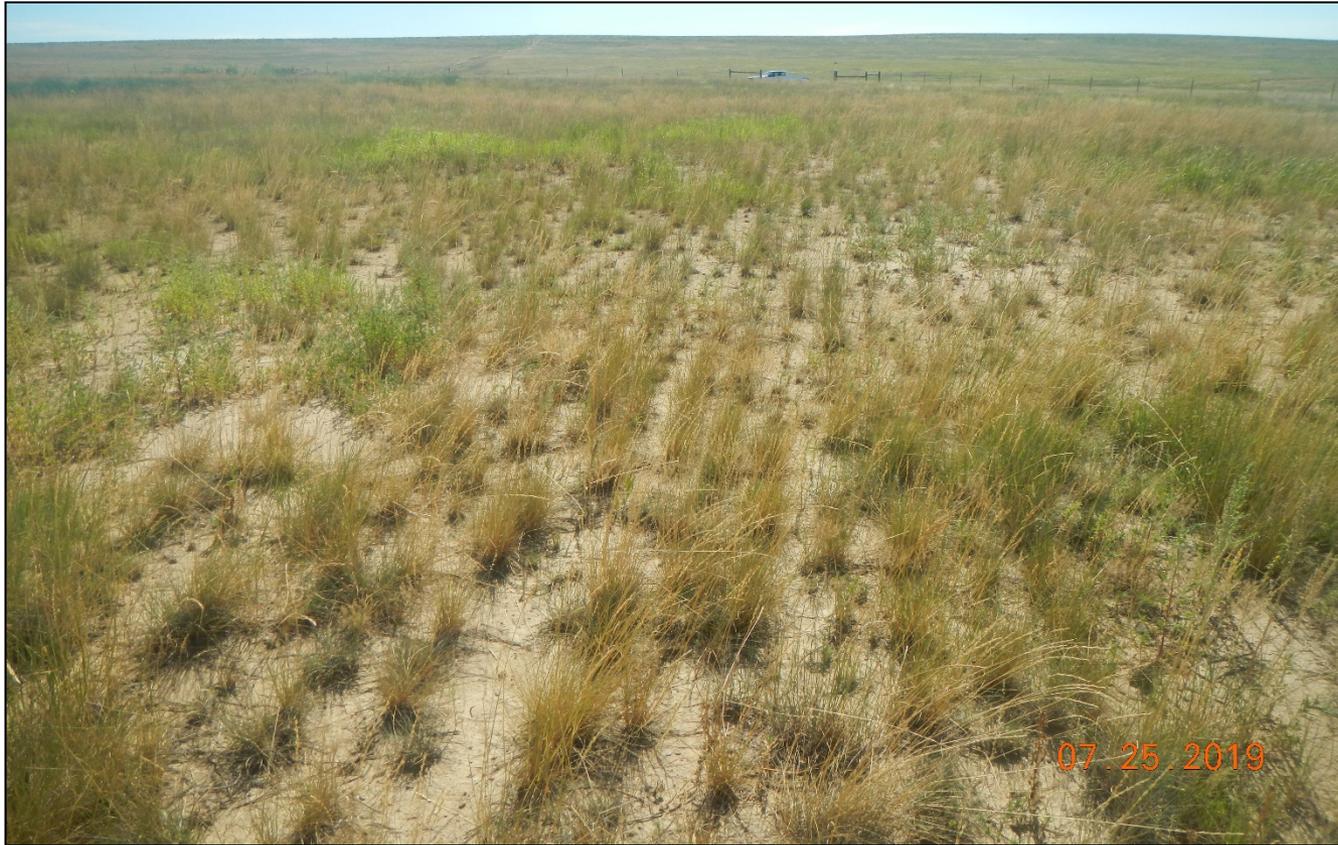
Photo 8. Facing west toward the southern portion of the location. Vegetation is well established at this area.
