Eck 12-90-1 #1—API—051-06107—Inspection Doc 693900458-6/18/19

CA #2 of 2—Slope Stabilization

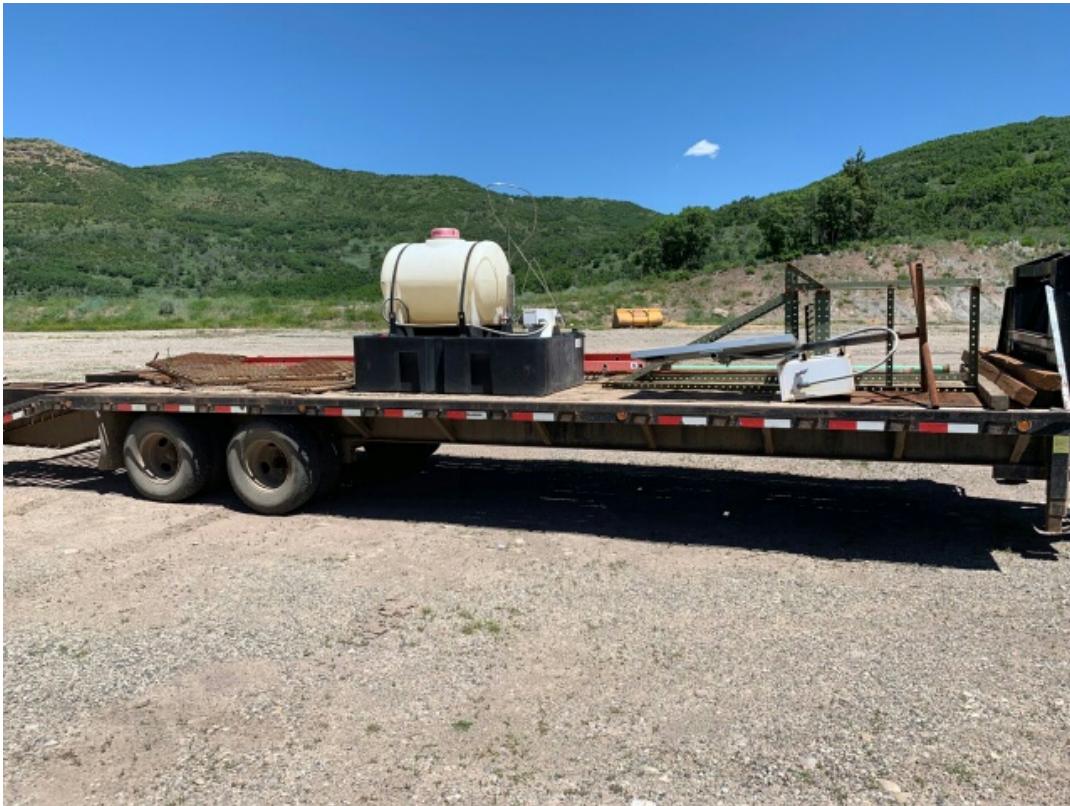
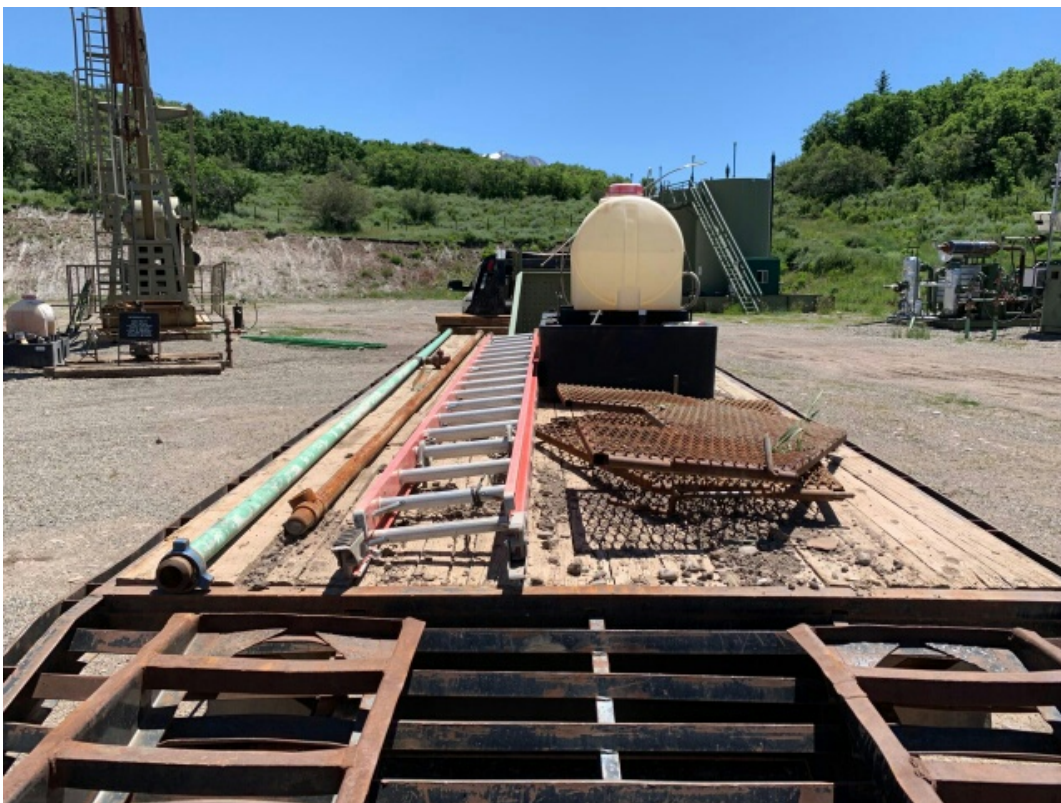
Eck 12-90-1 #1—API—051-06107 - Inspection Doc 693900458-6/18/19
CA #1 of 2—Remove and properly store unused equipment and debris
All Debris Removed

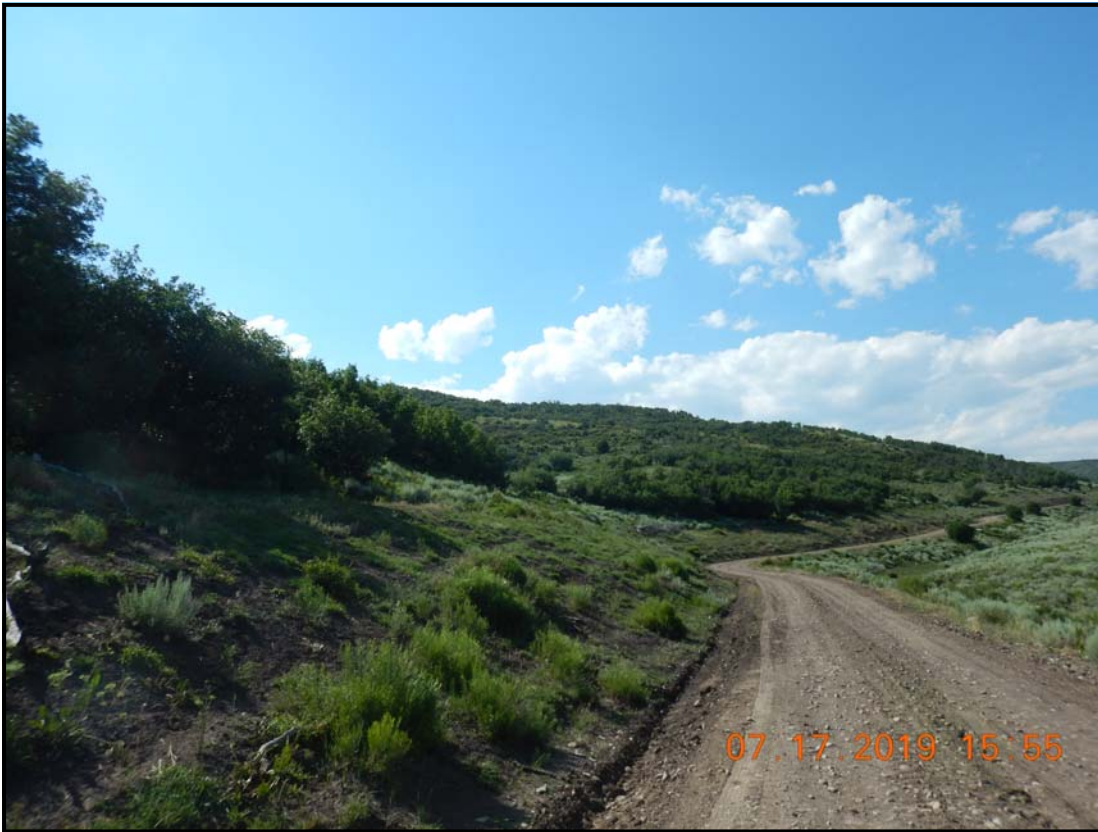
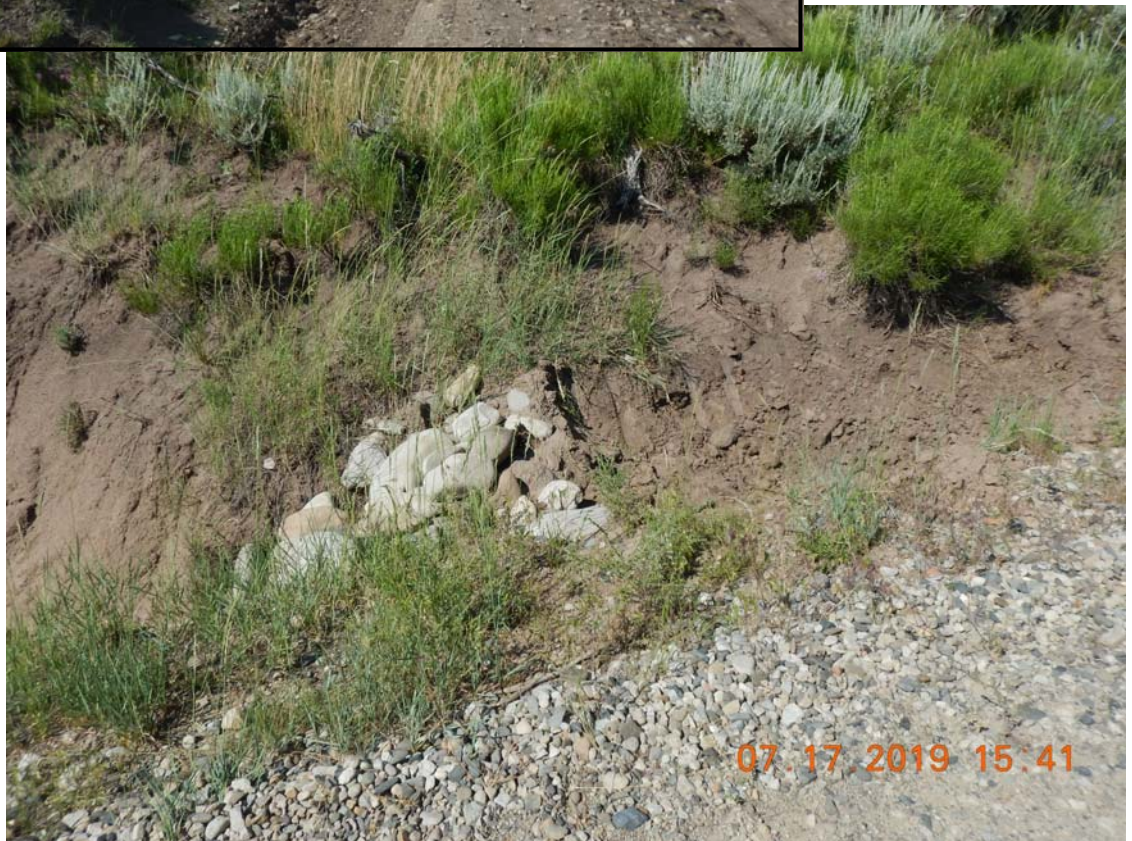
CA #2 of 2— Access Road Erosion, cut slopes, culvert and rock check dams

Access road ditch re-graded; vegetation stabilization progressing

Rock Check Dams and culverts maintained; more added
