Caerus Piceance LLC
API # 045-09425
Inspection # 696600418

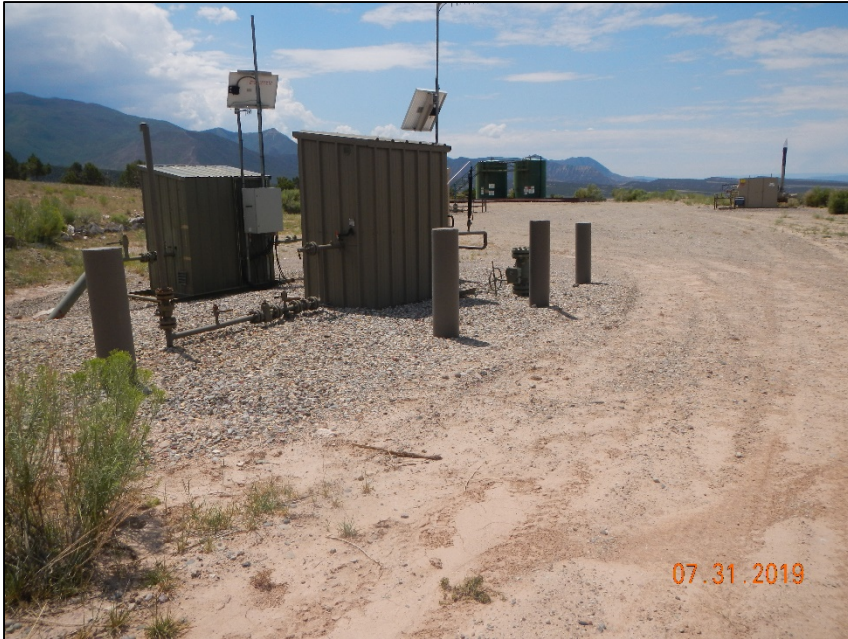
Photo #1 Photo at entrance of location .

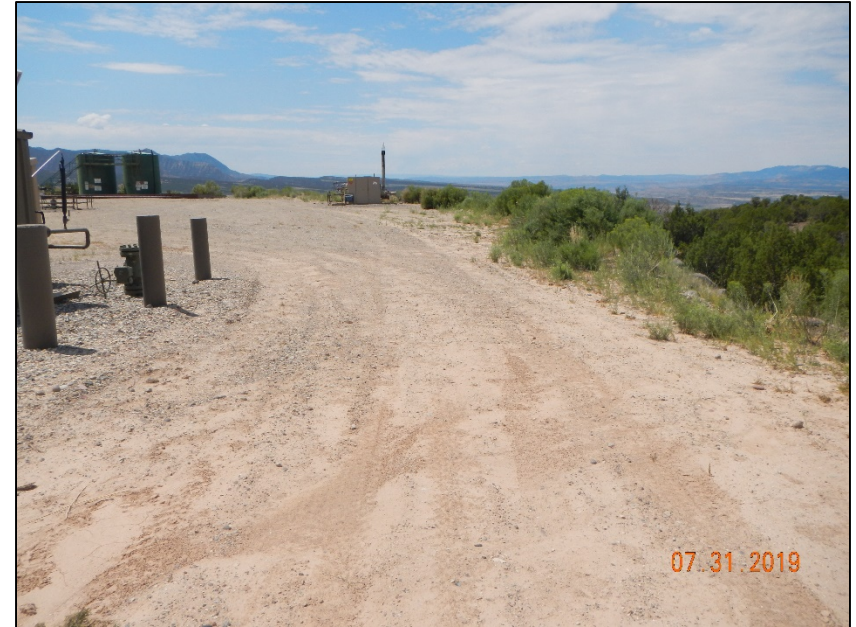
Photo #2 Photo at entrance of location

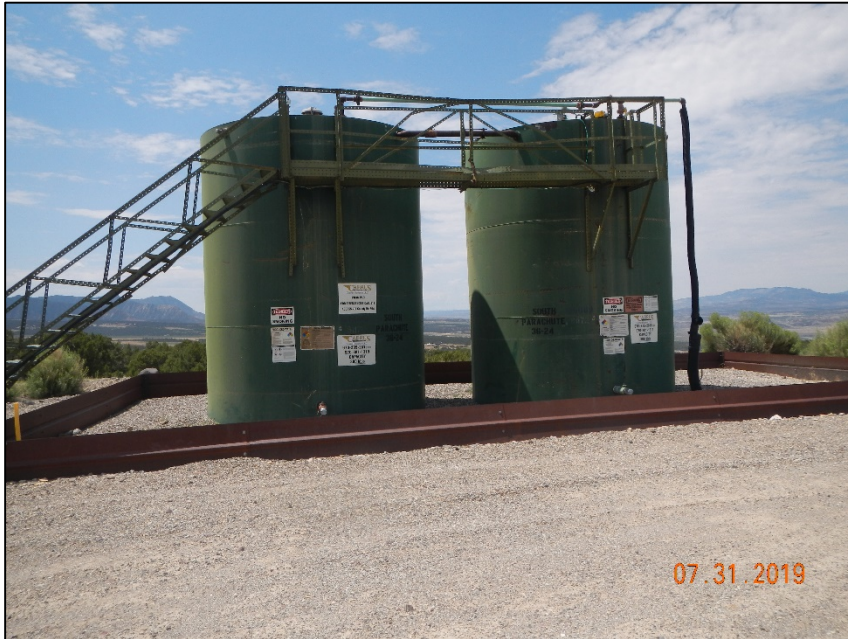
Photo #3 Photo of tank battery.

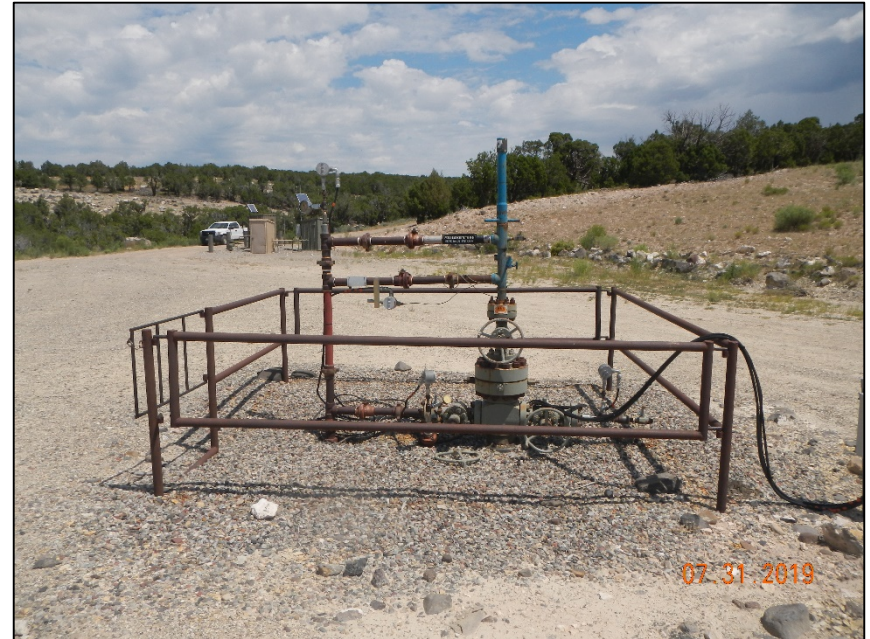
Photo #4 photo at wellheads.

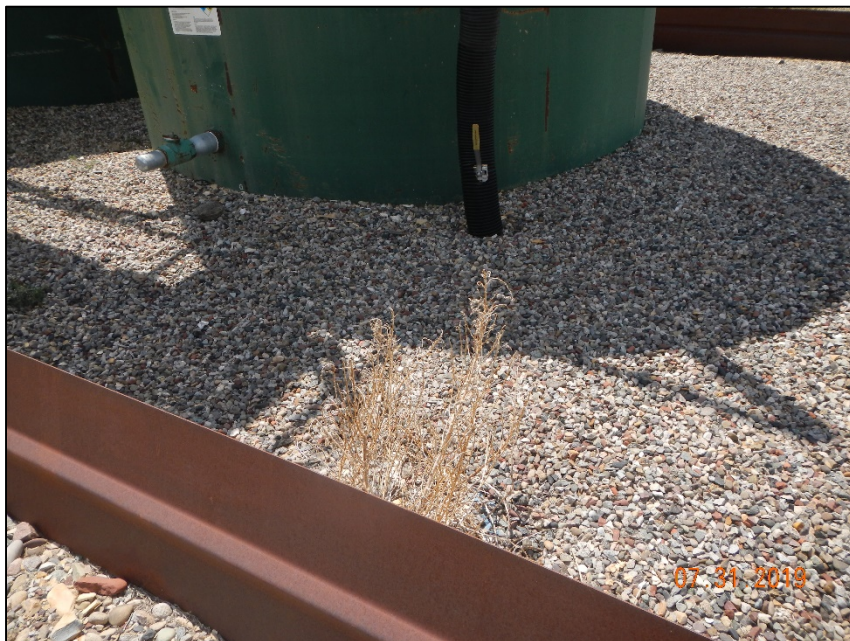
Photo #5 Weeds growing inside of tank containment

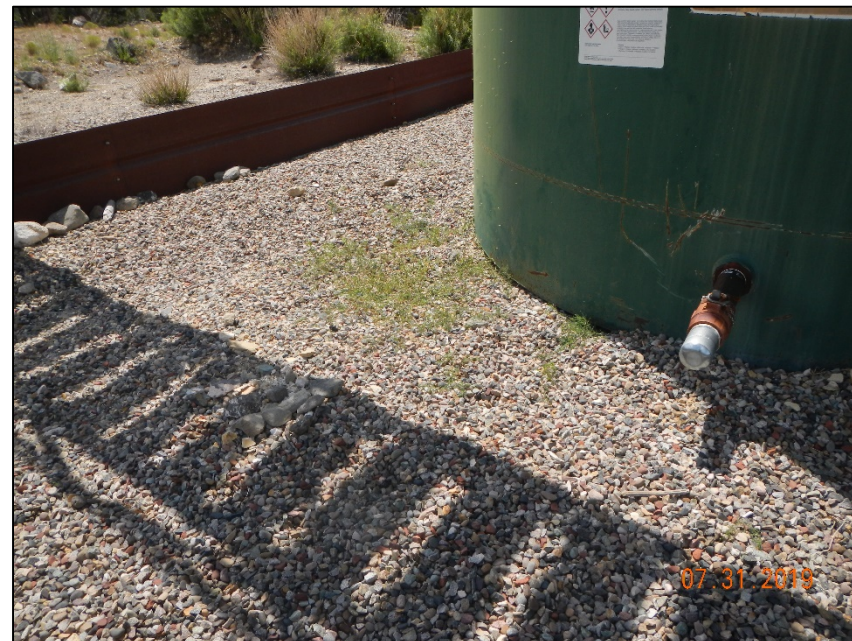
Photo #6 Weeds growing inside of tank containment

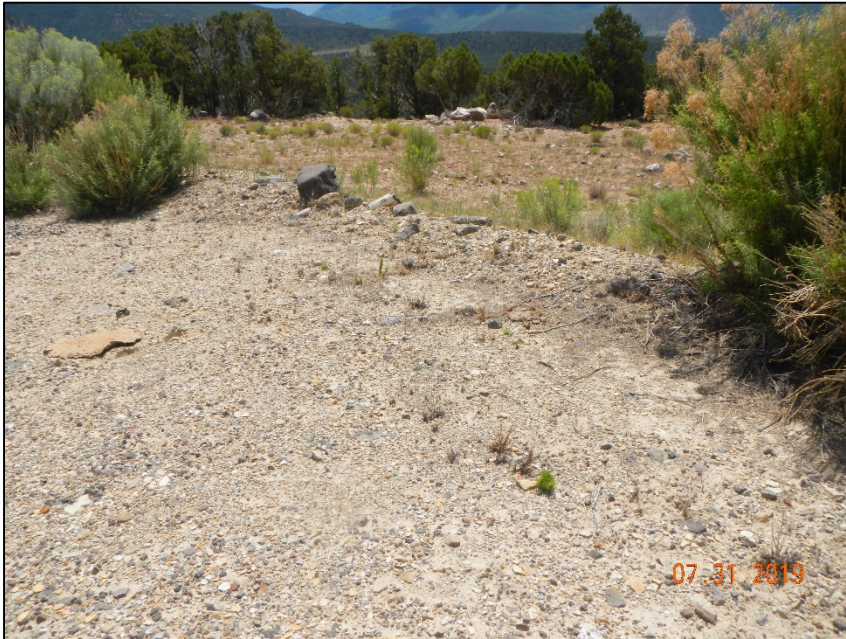
Photo #7 Berm around location is used as a BMP and needs maintenance and made to meet COGCC specifications

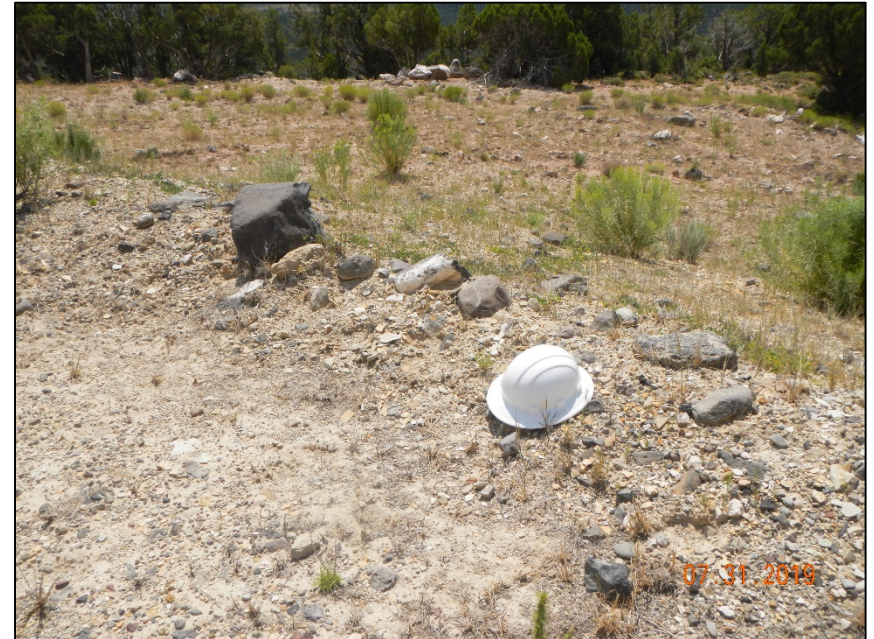
Photo #8 Berm around location is used as a BMP and needs maintenance and made to meet COGCC specifications.

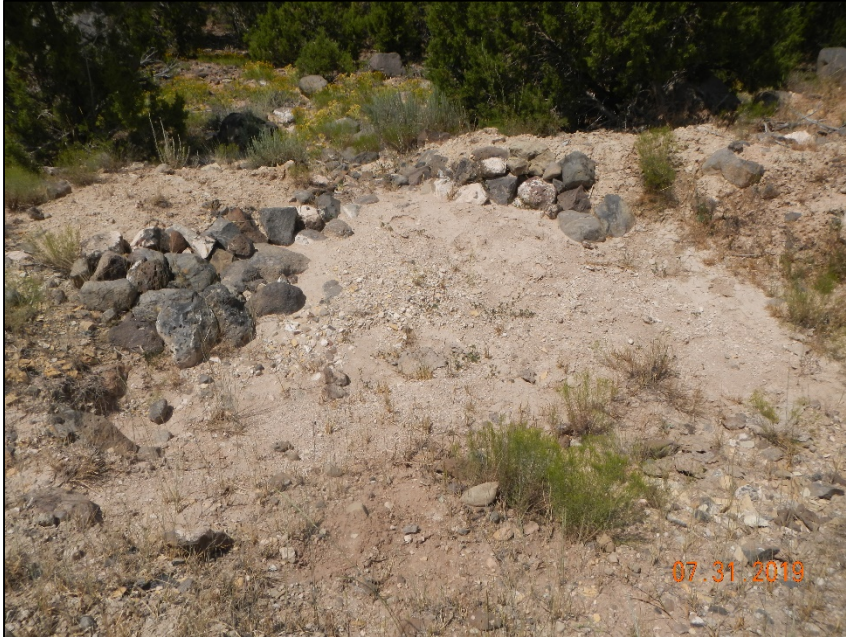
Photo #9. Sediment trap on the west side of location, that all secondary perimeter ditches feed into, is in need of maintenance.

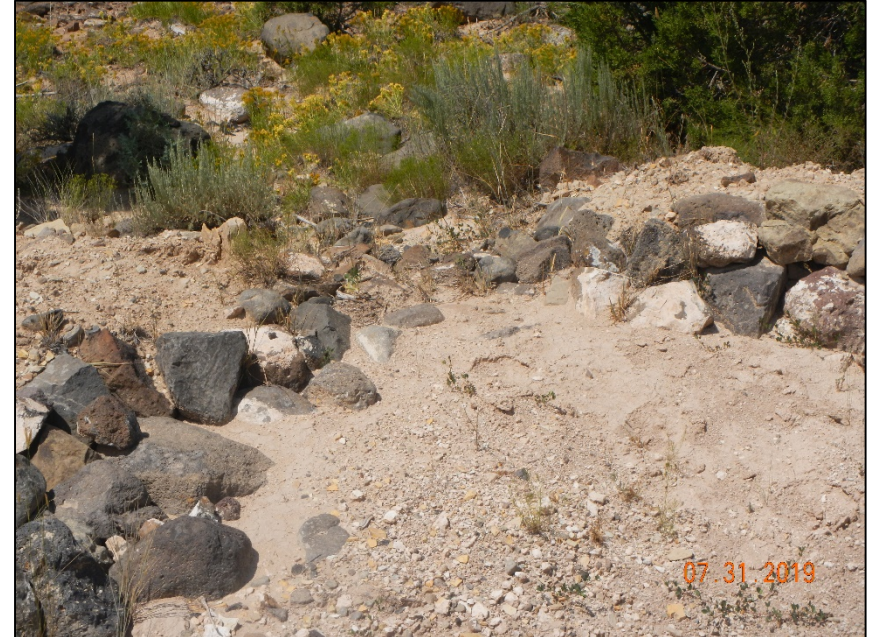
Photo #10. Sediment trap on the west side of location, that all secondary perimeter ditches feed into, is in need of maintenance.
