Caerus Piceance LLC  
API # 045-0942510417  
Inspection # 696600420

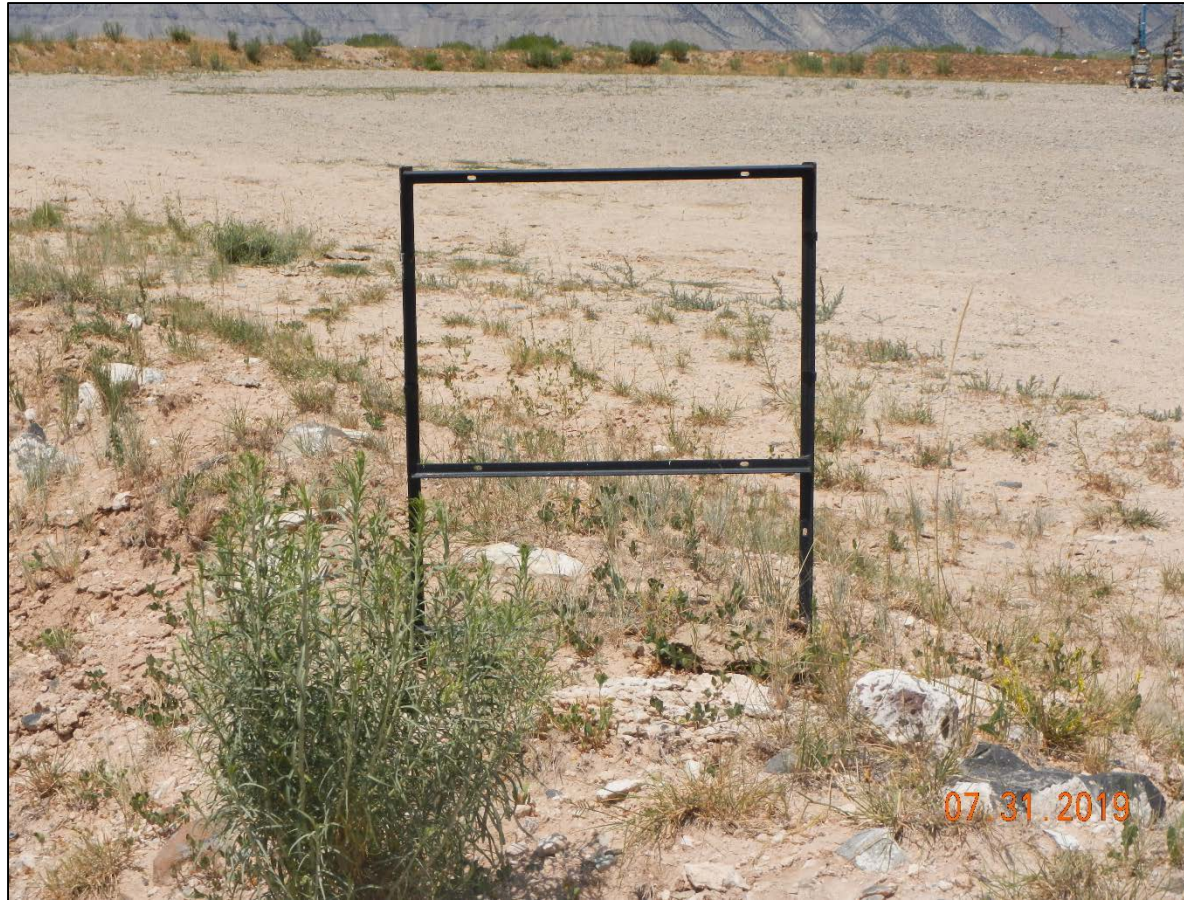
**Photo #1 . No Battery sign at tank battery or at entrance of location.**

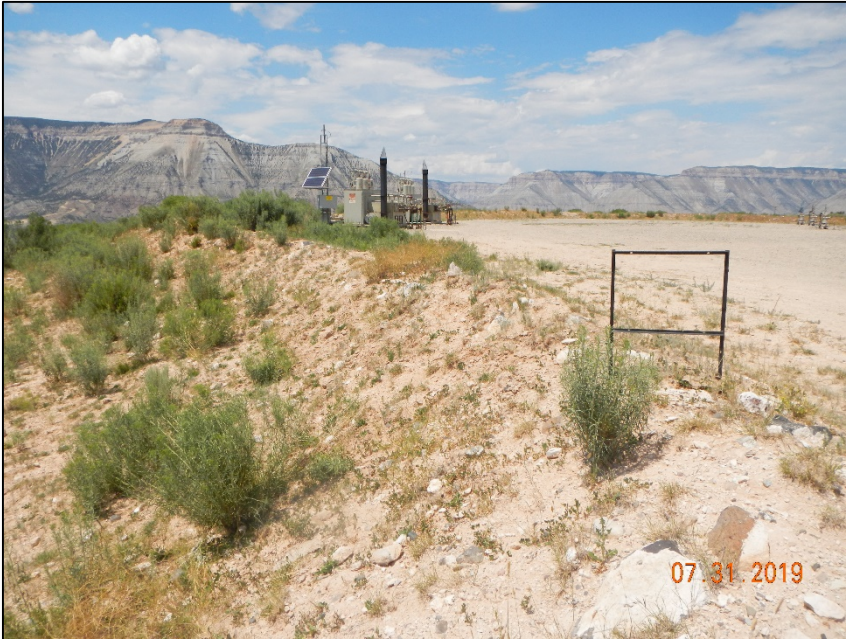
Photo #2 Photo at entrance of location .

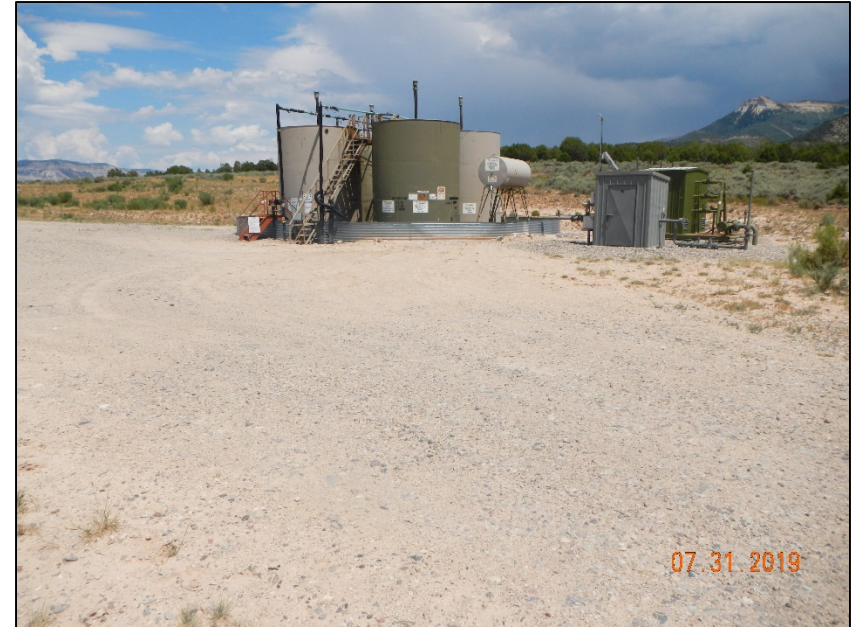
Photo #3 Photo at entrance of location

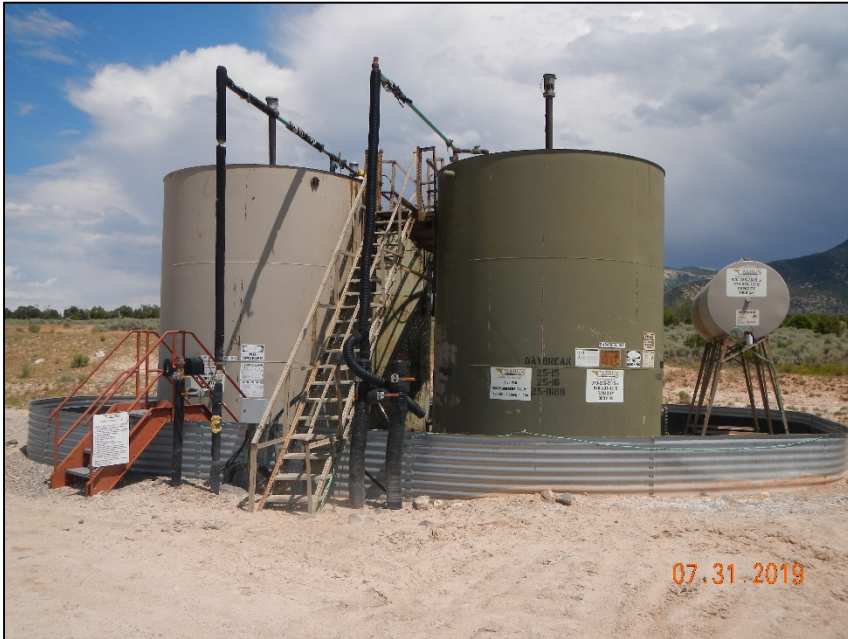
Photo #4 Photo of tank battery.

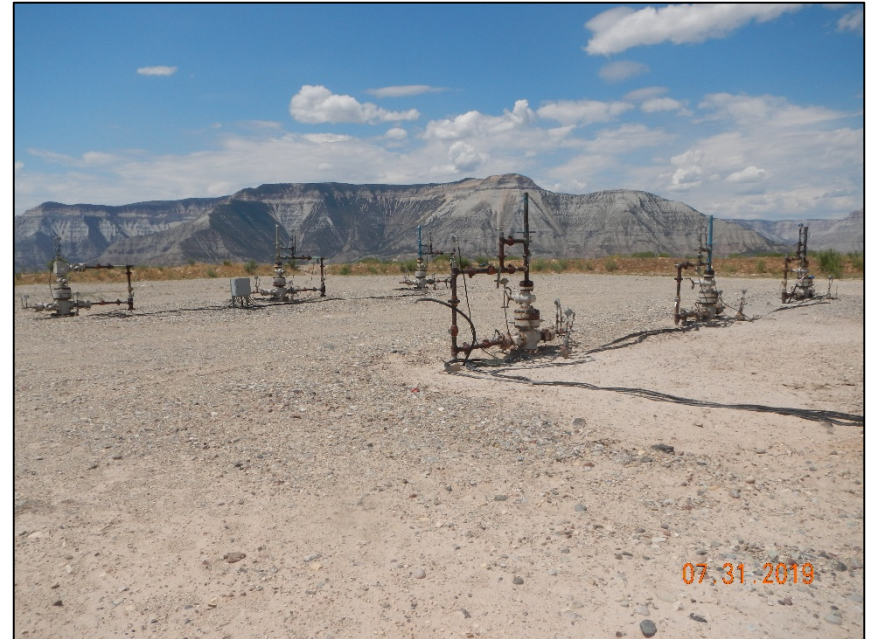
Photo #5 photo at wellheads.

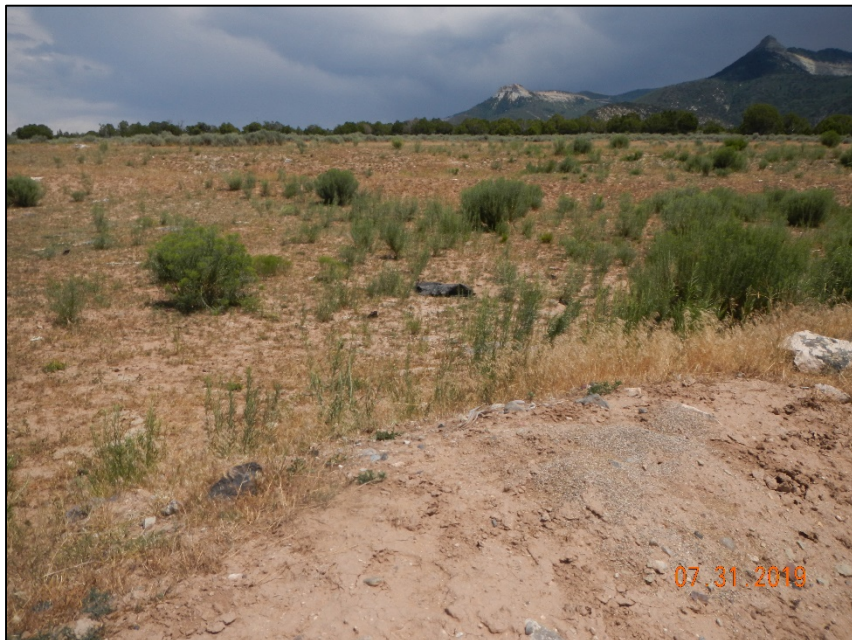
**Photo #6 Trash on and around location**

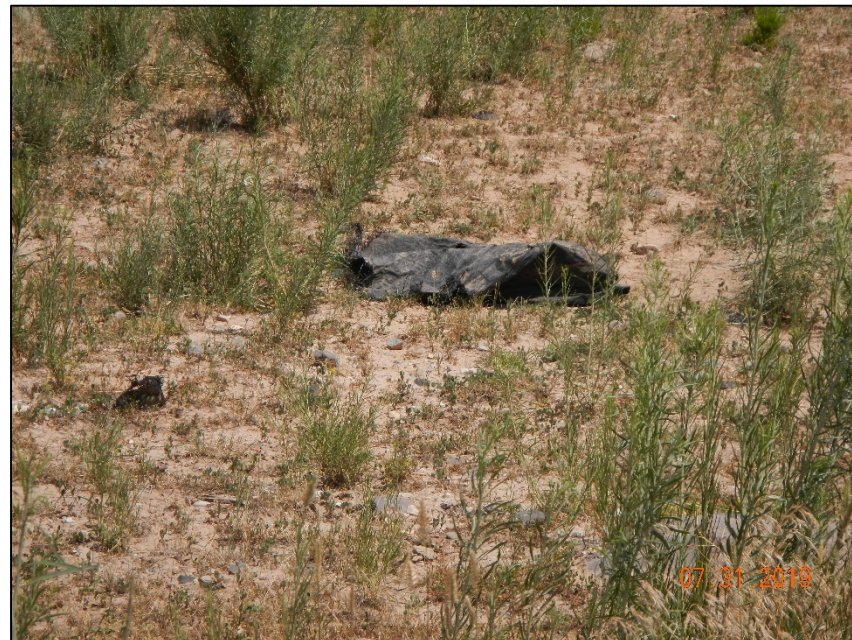
**Photo #7 Trash on and around location**

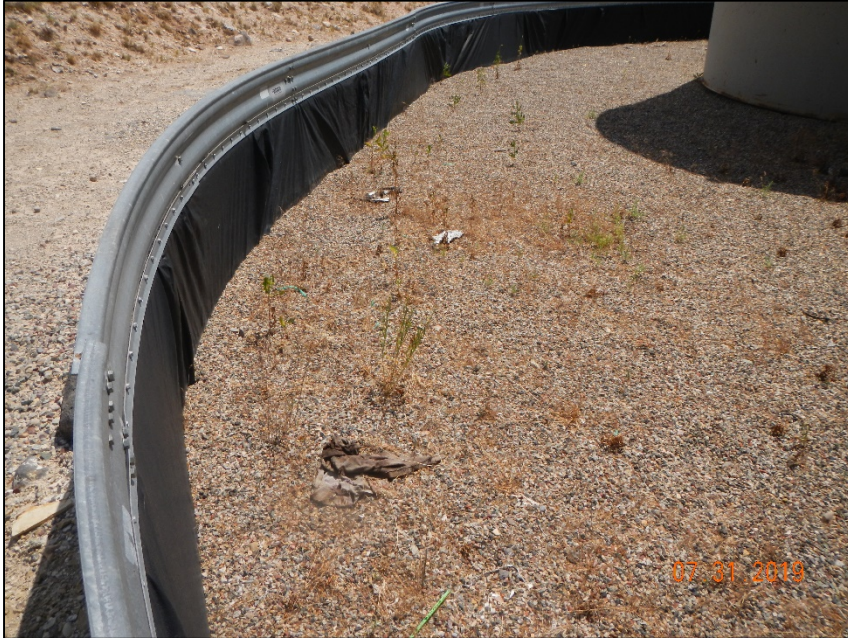
**Photo #8 Trash on and around location and in tank containment**

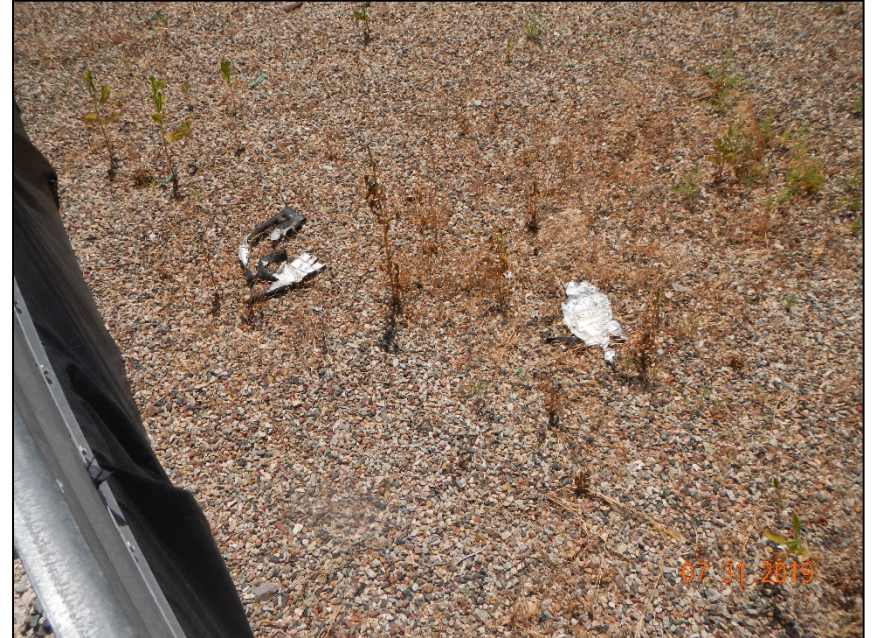
**Photo #9 Trash on and around location and in tank containment**

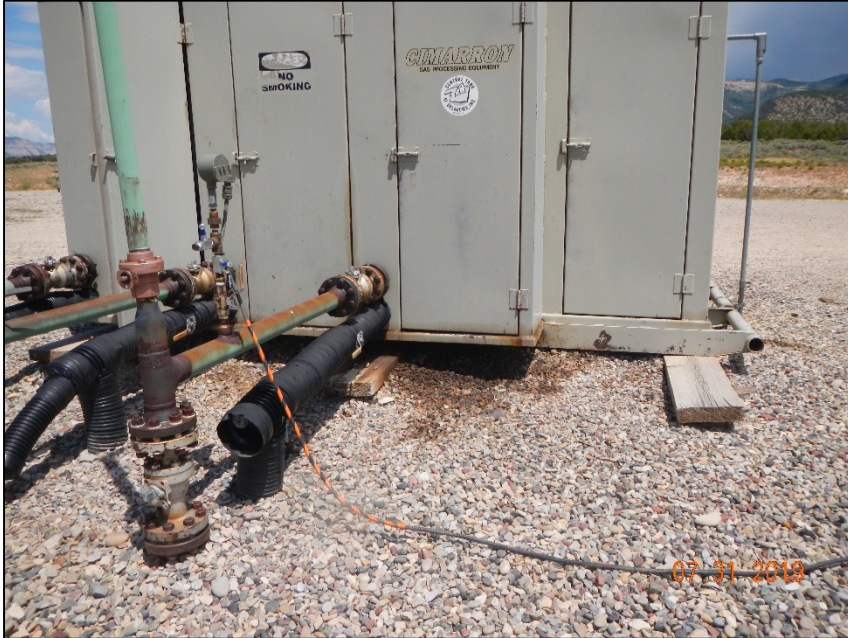
Photo #10 Stained soil or gravel around Separators

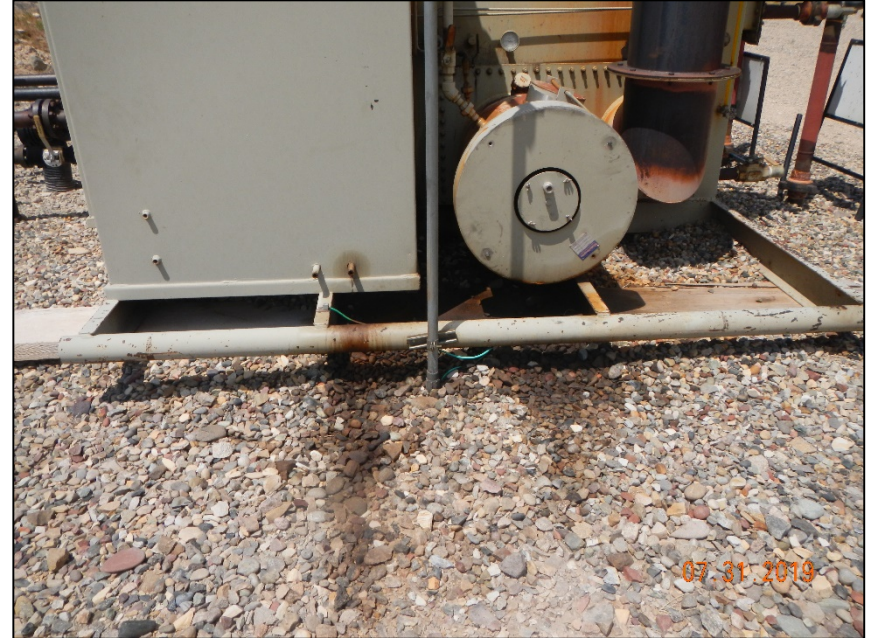
Photo #11 Stained soil or gravel around Separators

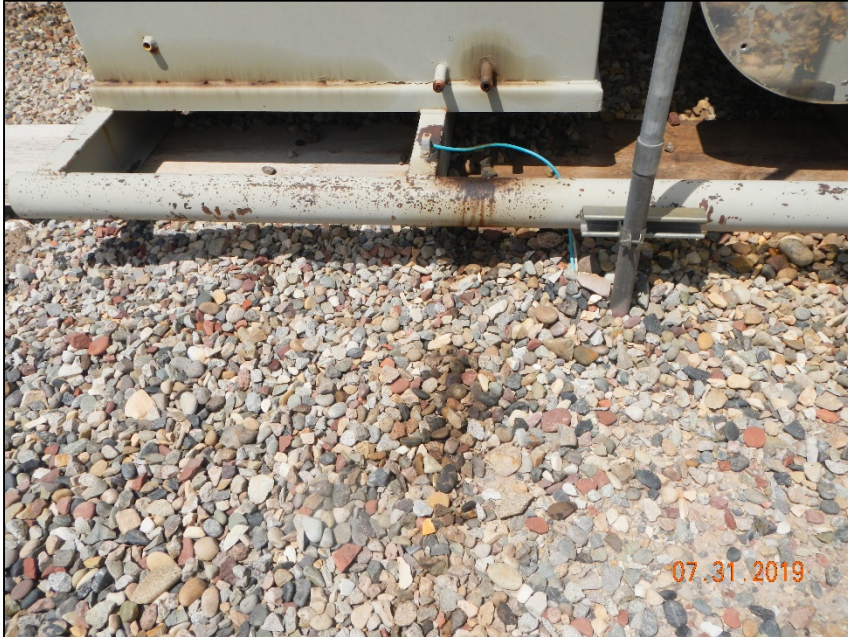
Photo #12 Stained soil or gravel around Separators

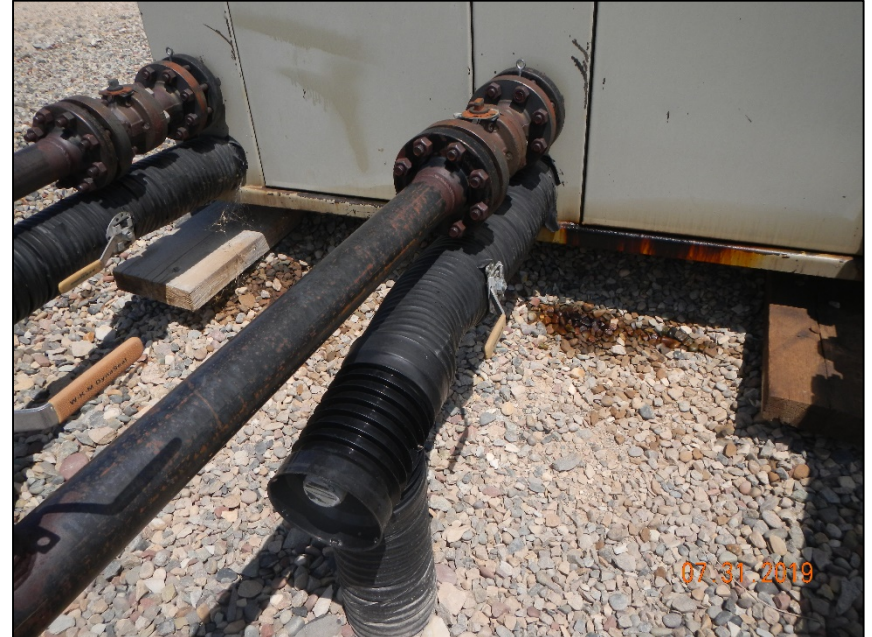
Photo #13 Stained soil or gravel around Separators

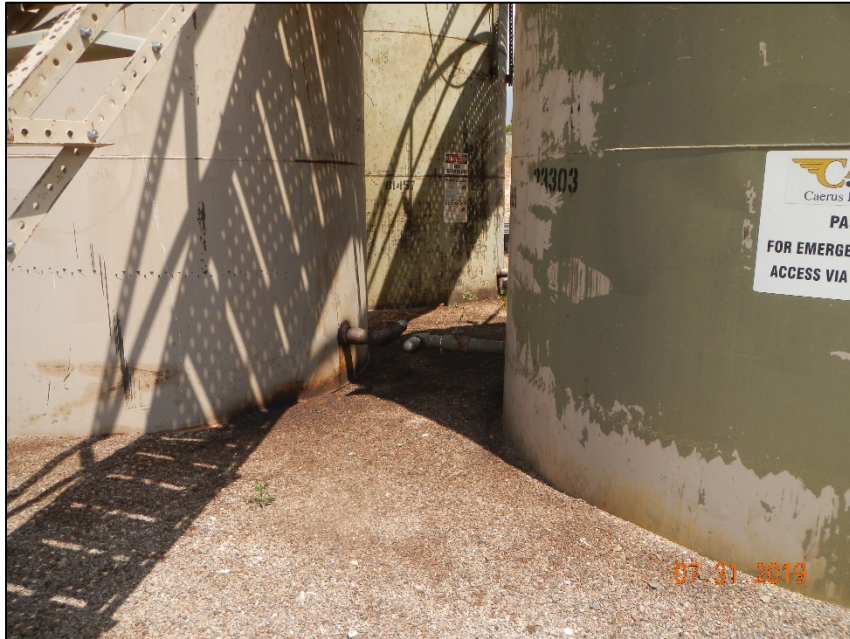
Photo #14 Stained soil or gravel around production tanks

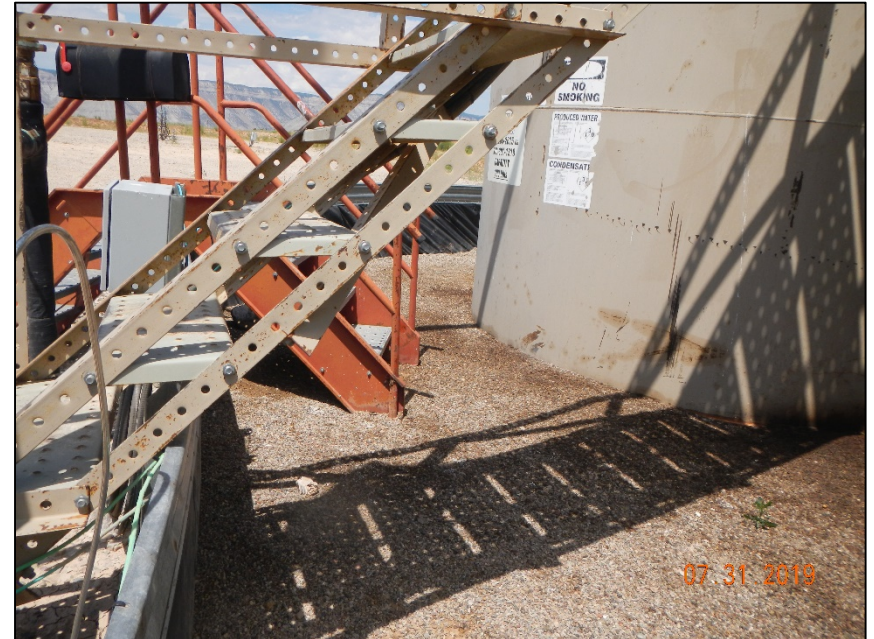
Photo #15 Stained soil or gravel around production tanks

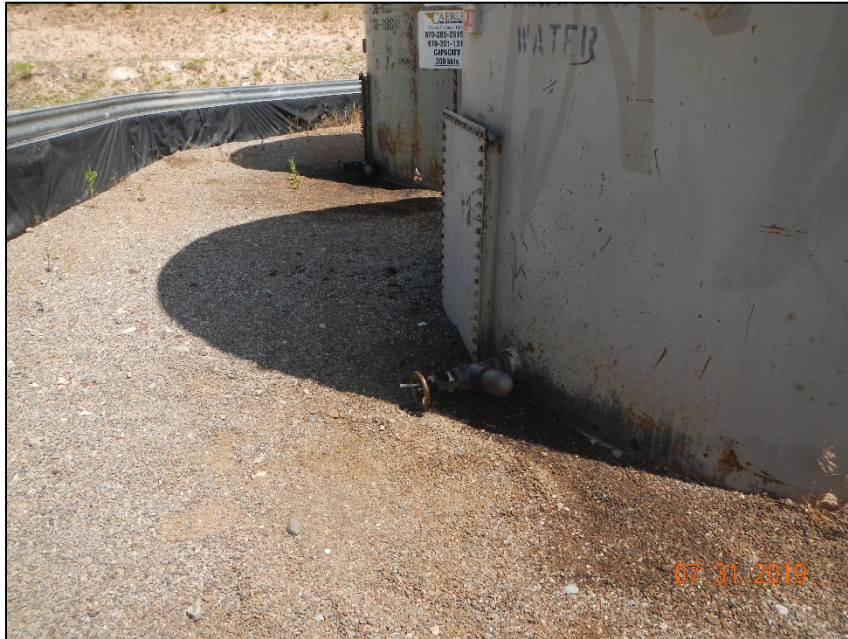
Photo #16 Stained soil or gravel around production tanks

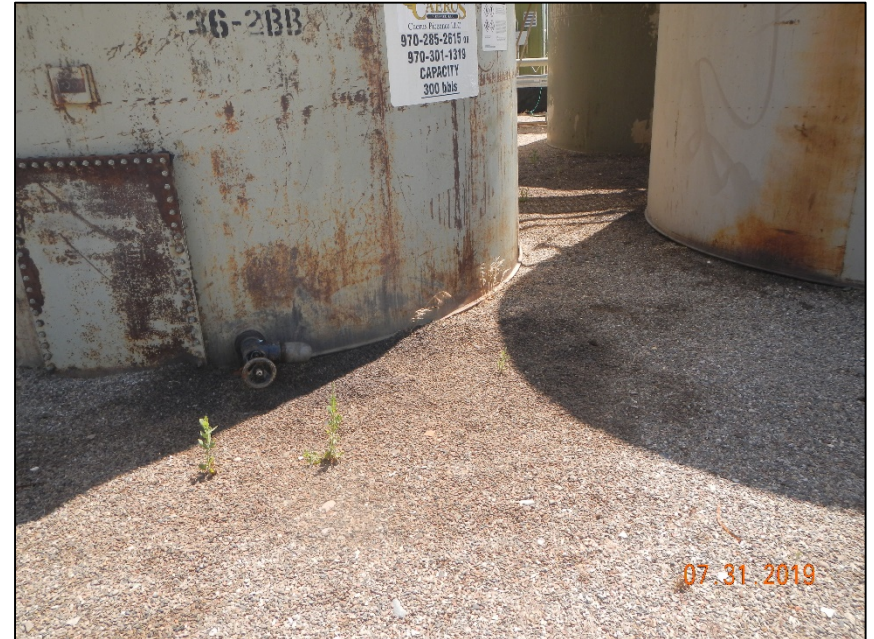
Photo #17 Stained soil or gravel around production tanks

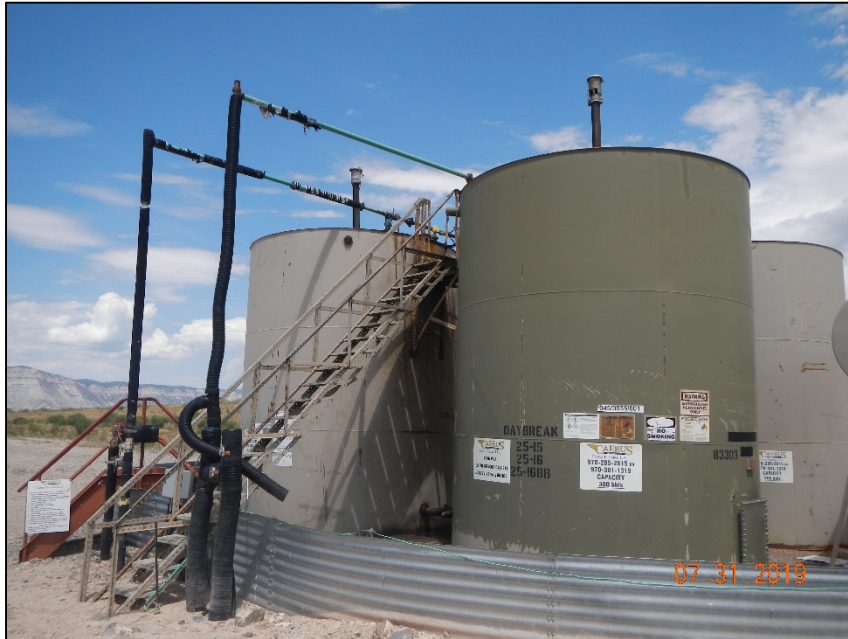
Photo #18 Stained production tanks

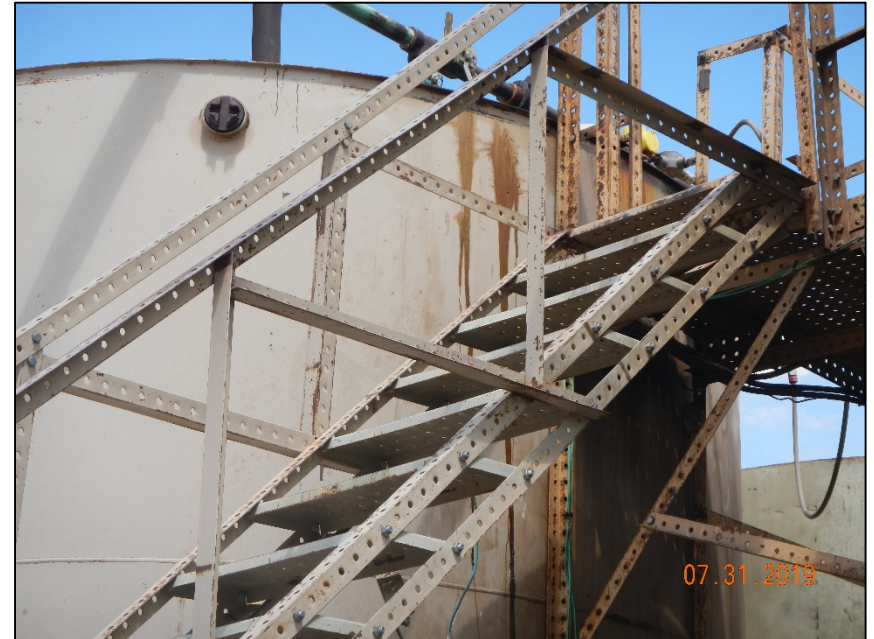
Photo #19 Stained production tanks

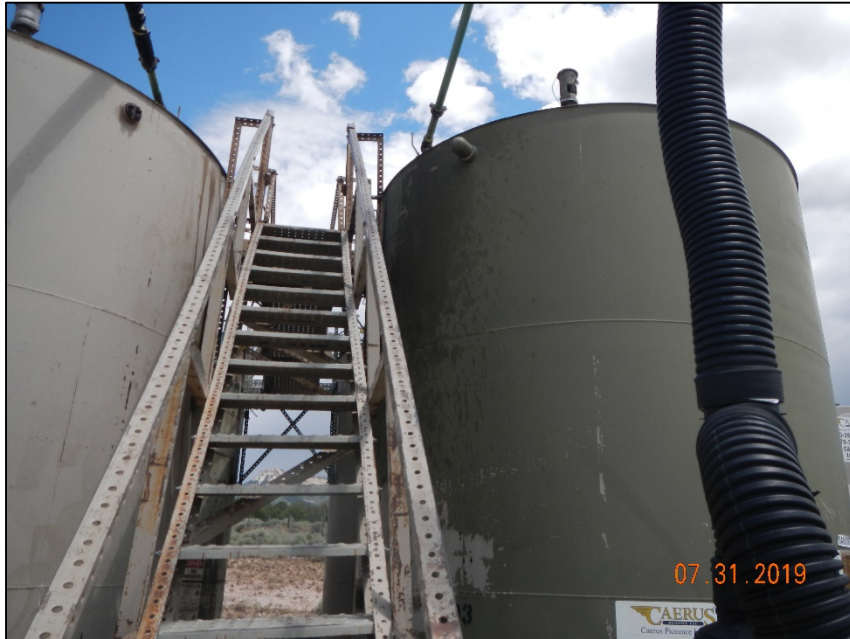
Photo #20 Stained production tanks

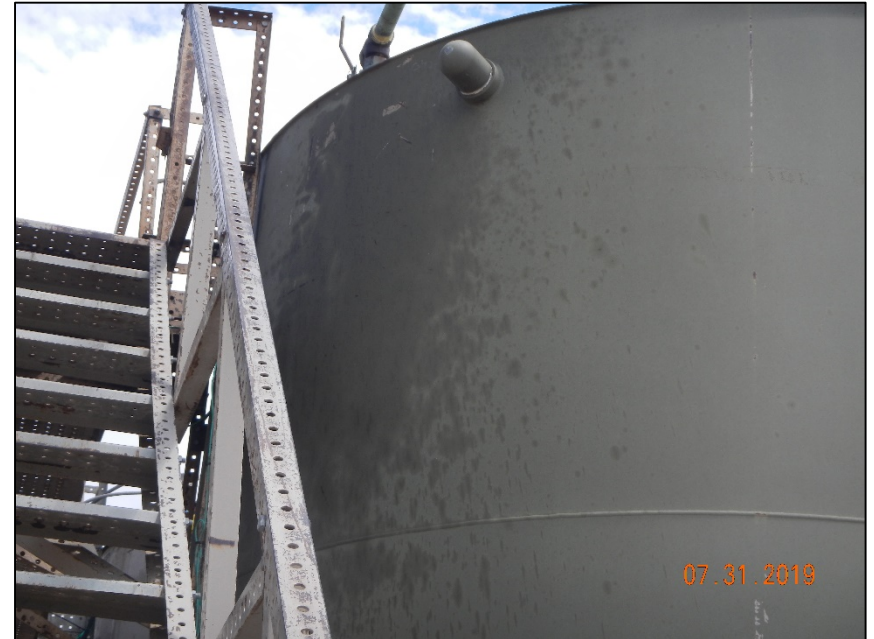
Photo #21 Stained production tanks

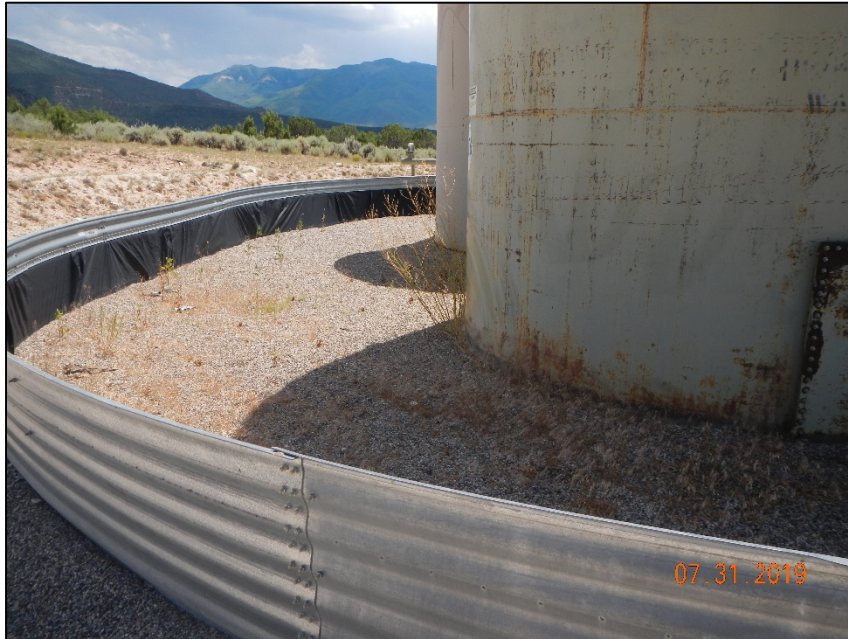
**Photo #22 Weeds are growing inside of tank containment and on location**

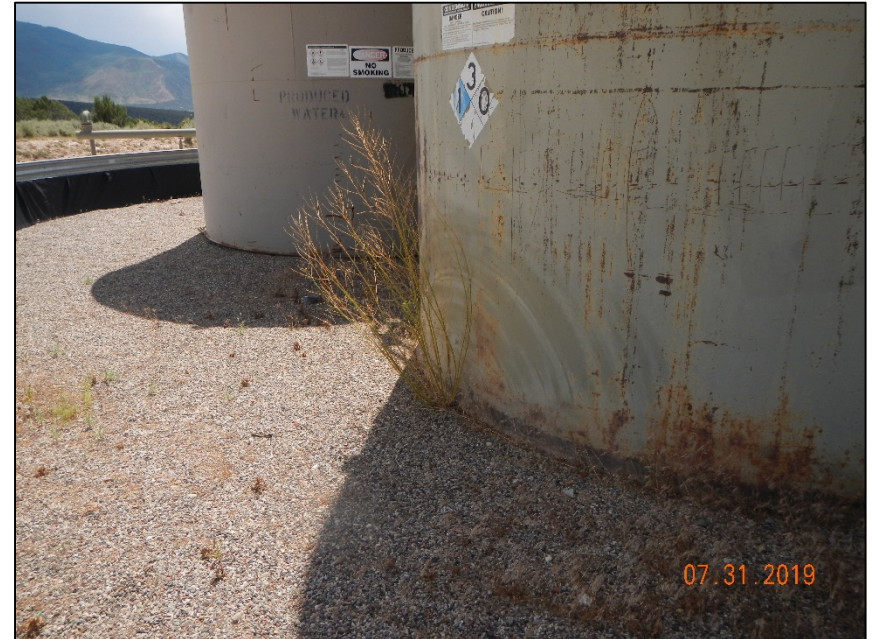
**Photo #23 Weeds are growing inside of tank containment and on location**

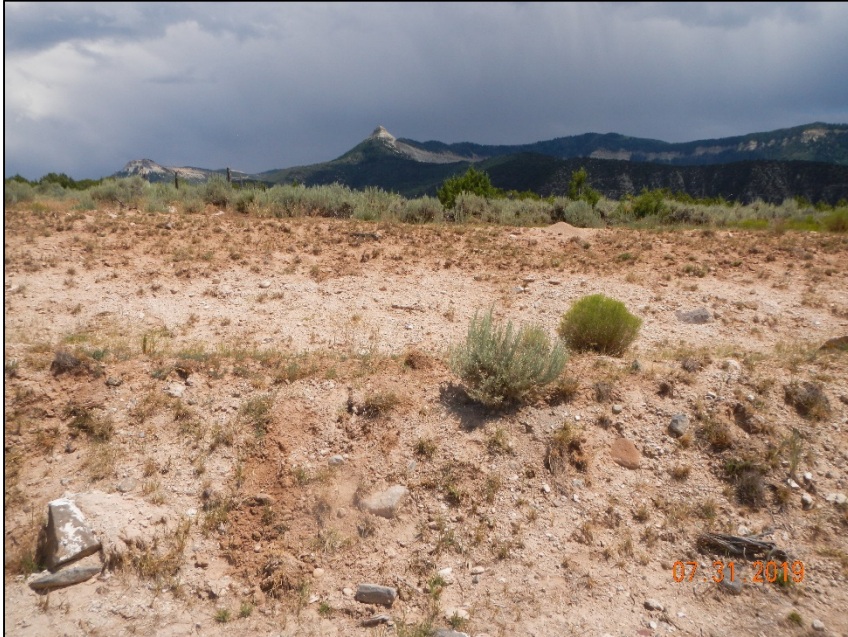
**Photo #24 Erosion is evident along un-stabilized slope at the east side of location behind production tanks . Vegetation is being choked out**

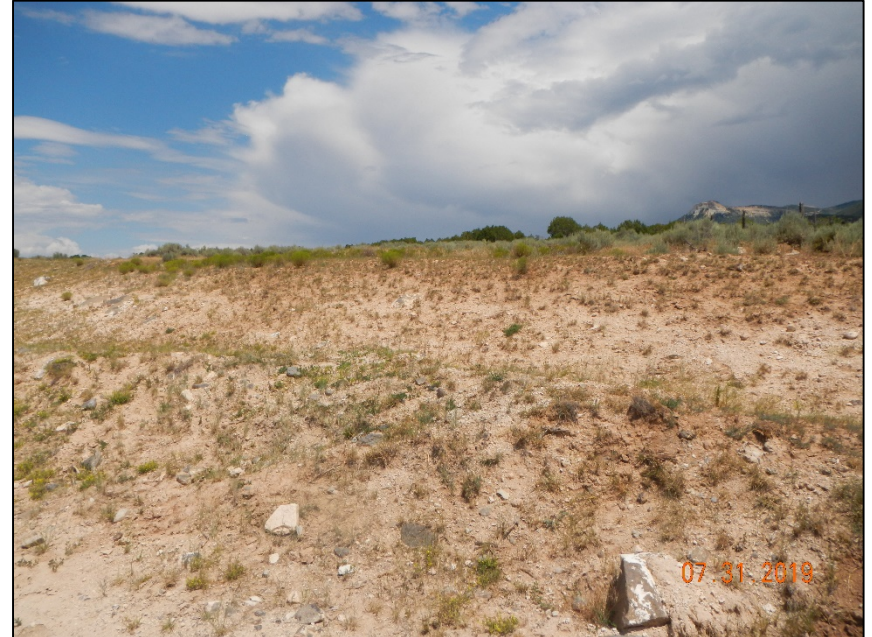
**Photo #25 Erosion is evident along un-stabilized slope at the east side of location behind production tanks . Vegetation is being choked out**

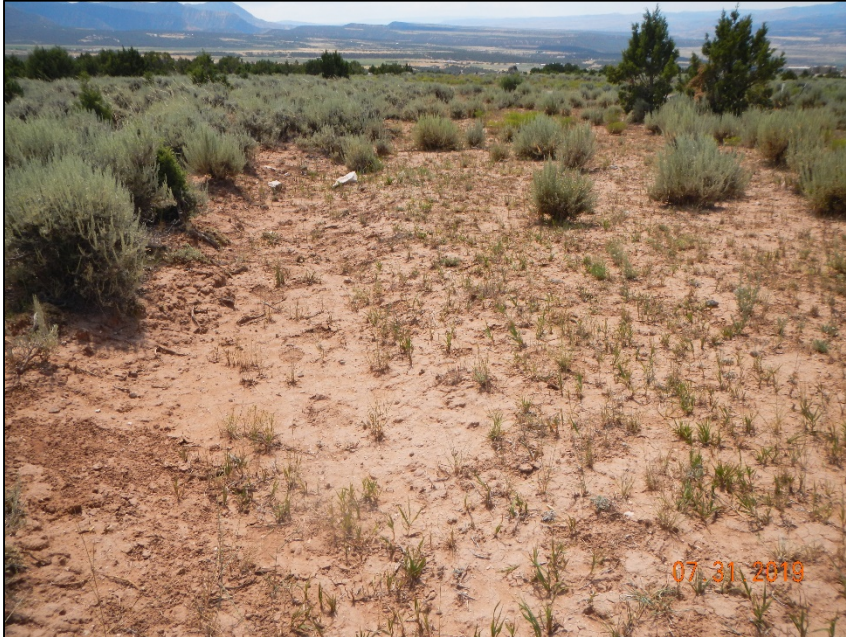
**Photo #26 Erosion is moving off location at entrance. Ditch has no BMP in place to slow down storm water or capture sediment. Sediment is choking vegetation.**

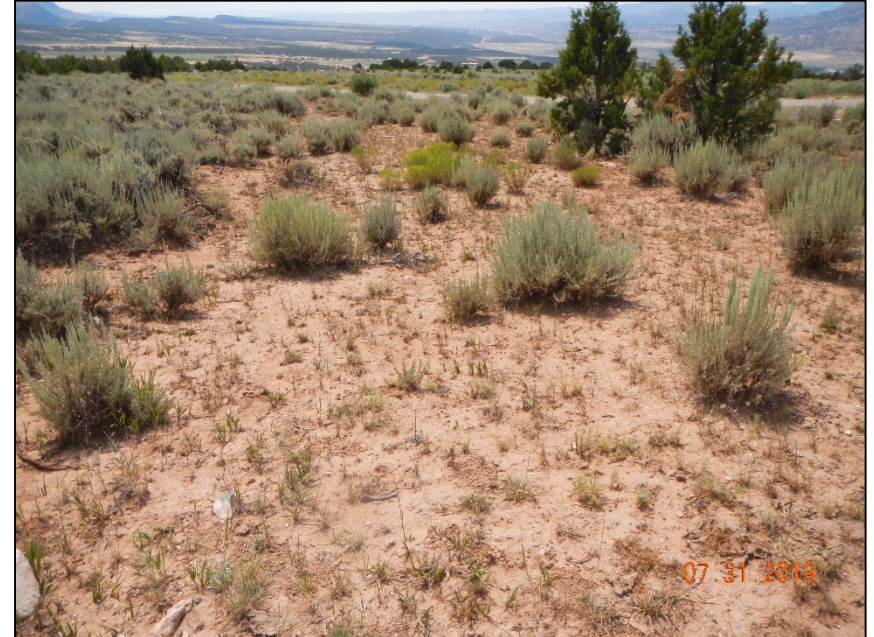
**Photo #27 Erosion is moving off location at entrance. Ditch has no BMP in place to slow down storm water or capture sediment. Sediment is choking vegetation.**
