**Inspection Photos**  
**Operator: Elm Ridge**  
**Location/API #: 067-05467**  
**Date: 7-19-2019**

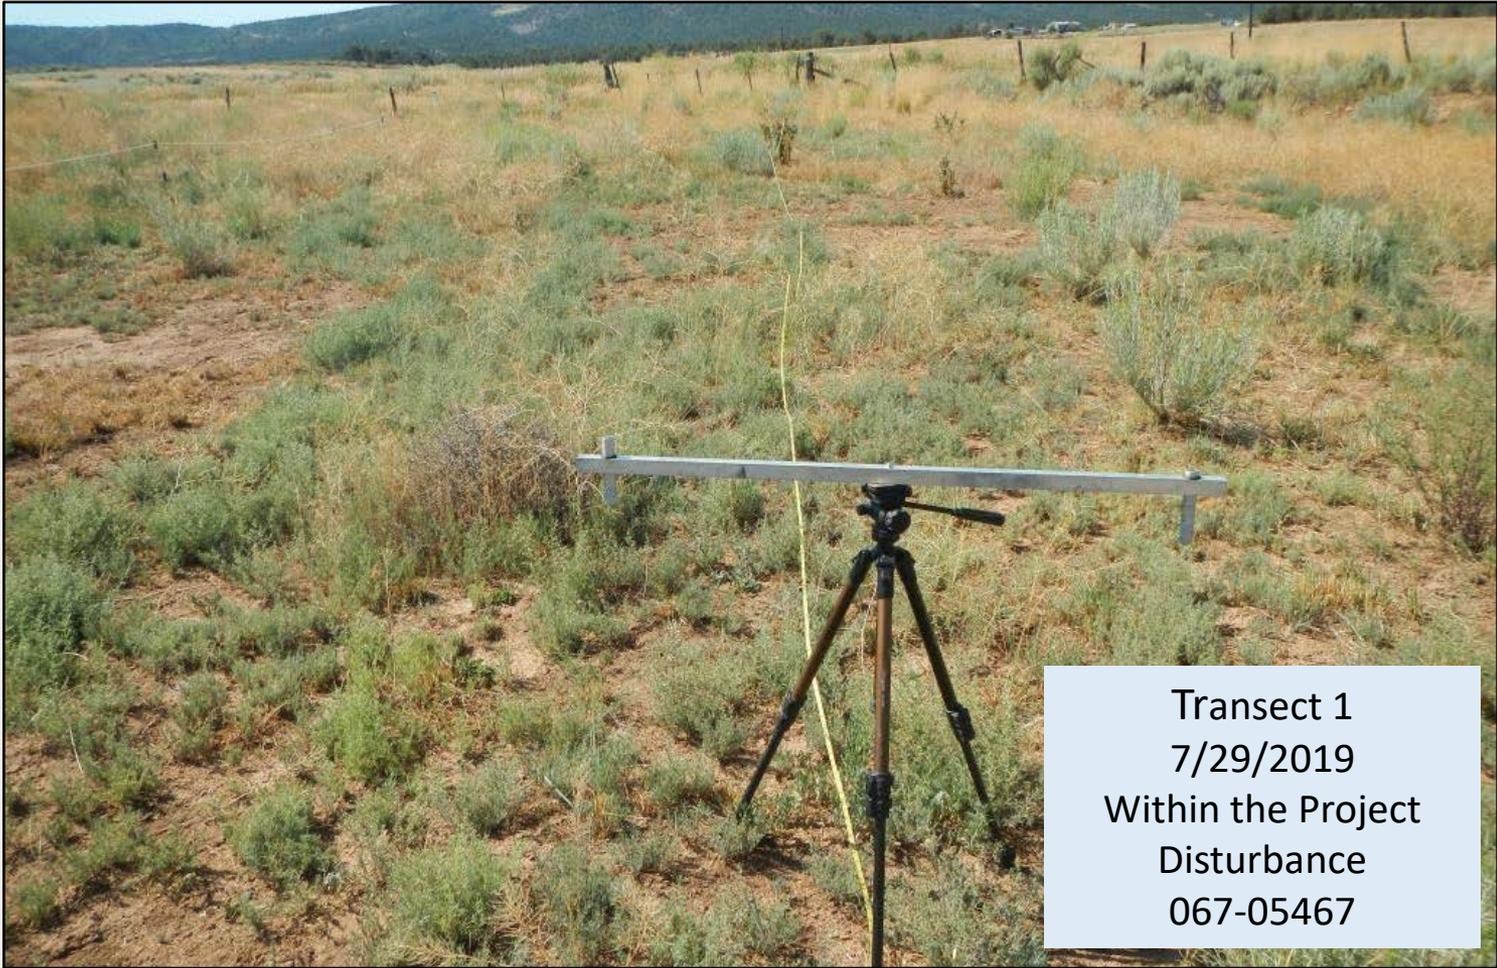
Photo 1. View of the beginning of Transect 1, within the project disturbance facing southward. Location is largely weeds with some desirable vegetation present. Grasses are grazed.

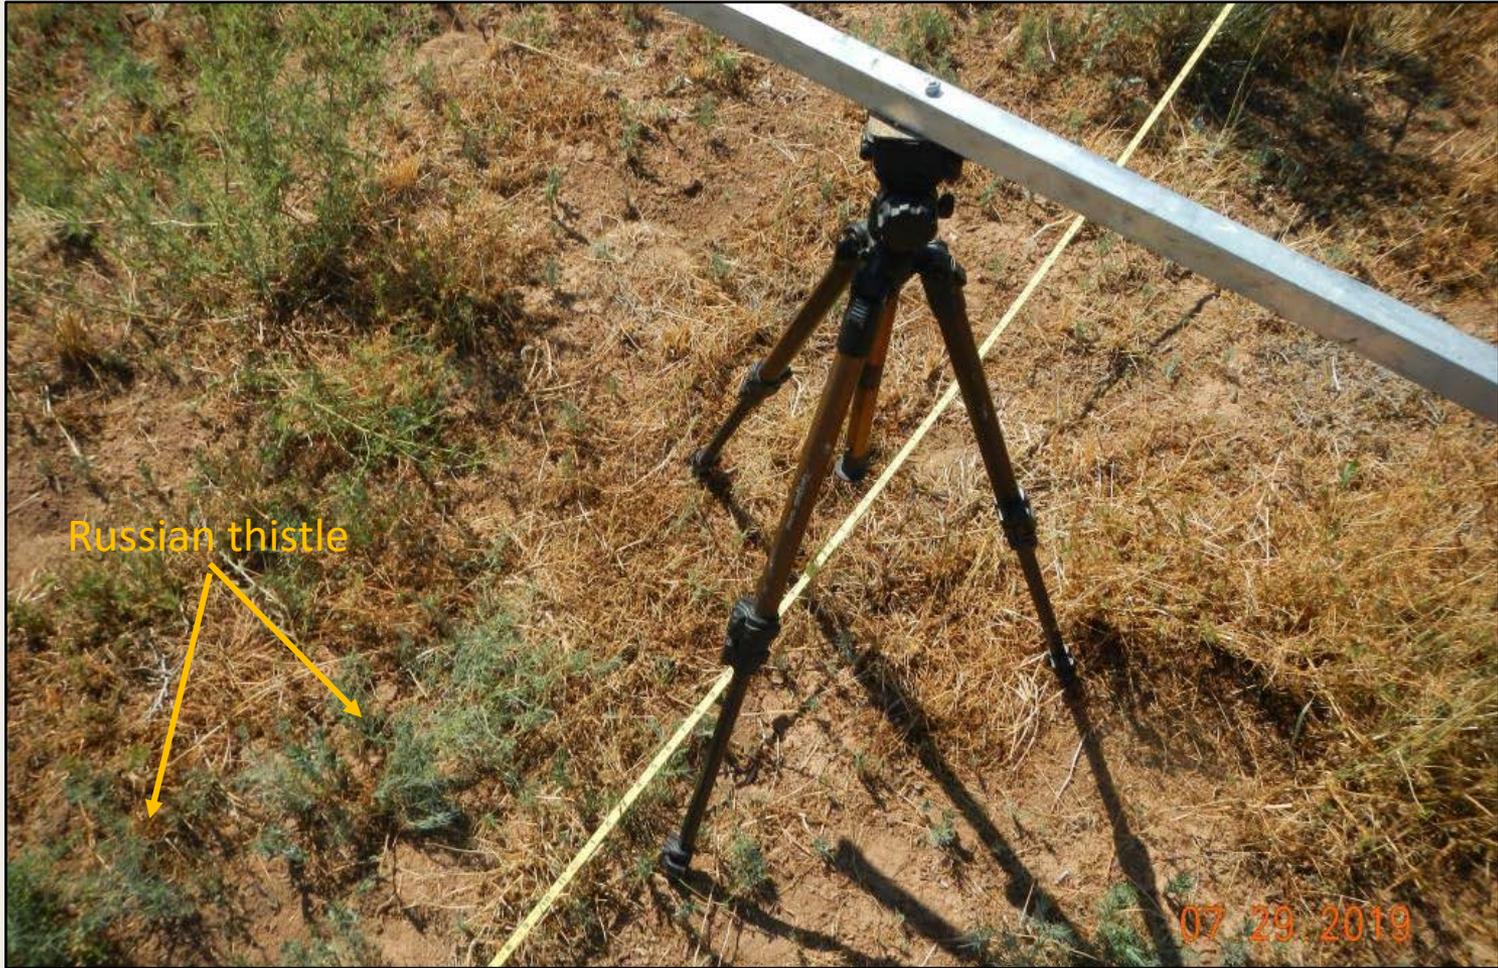
Photo 2. Birdseye view of vegetation at mid-point along transect. Vegetation is largely Russian thistle and other dried annual weeds.

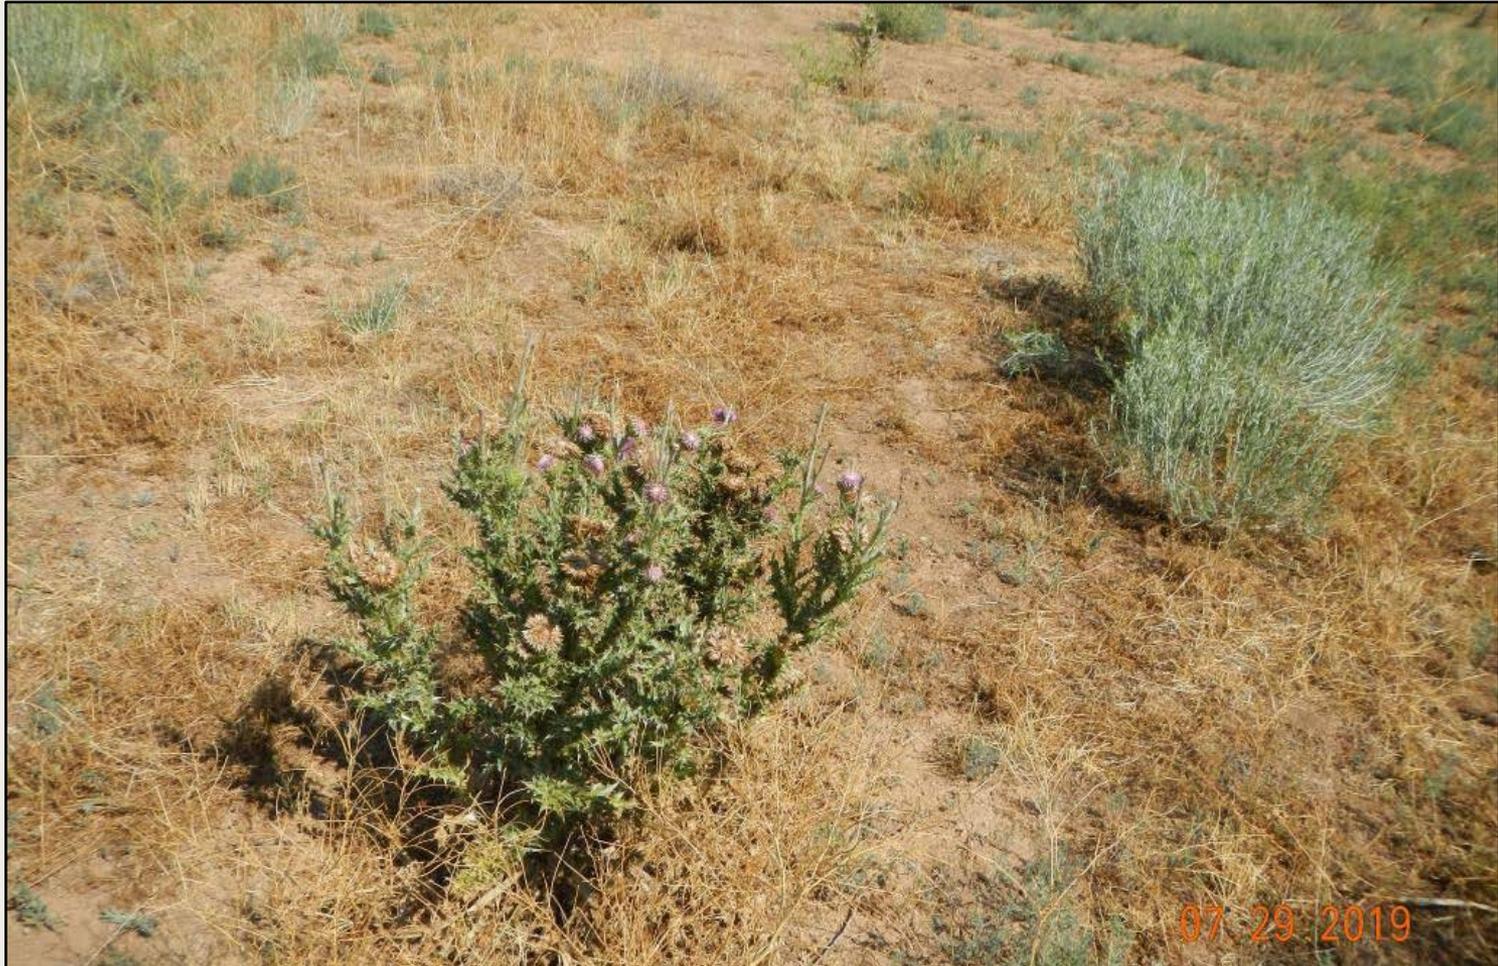
Photo 3. View of flowering musk thistle within the project disturbance. Approximately 30 flowering individuals observed.

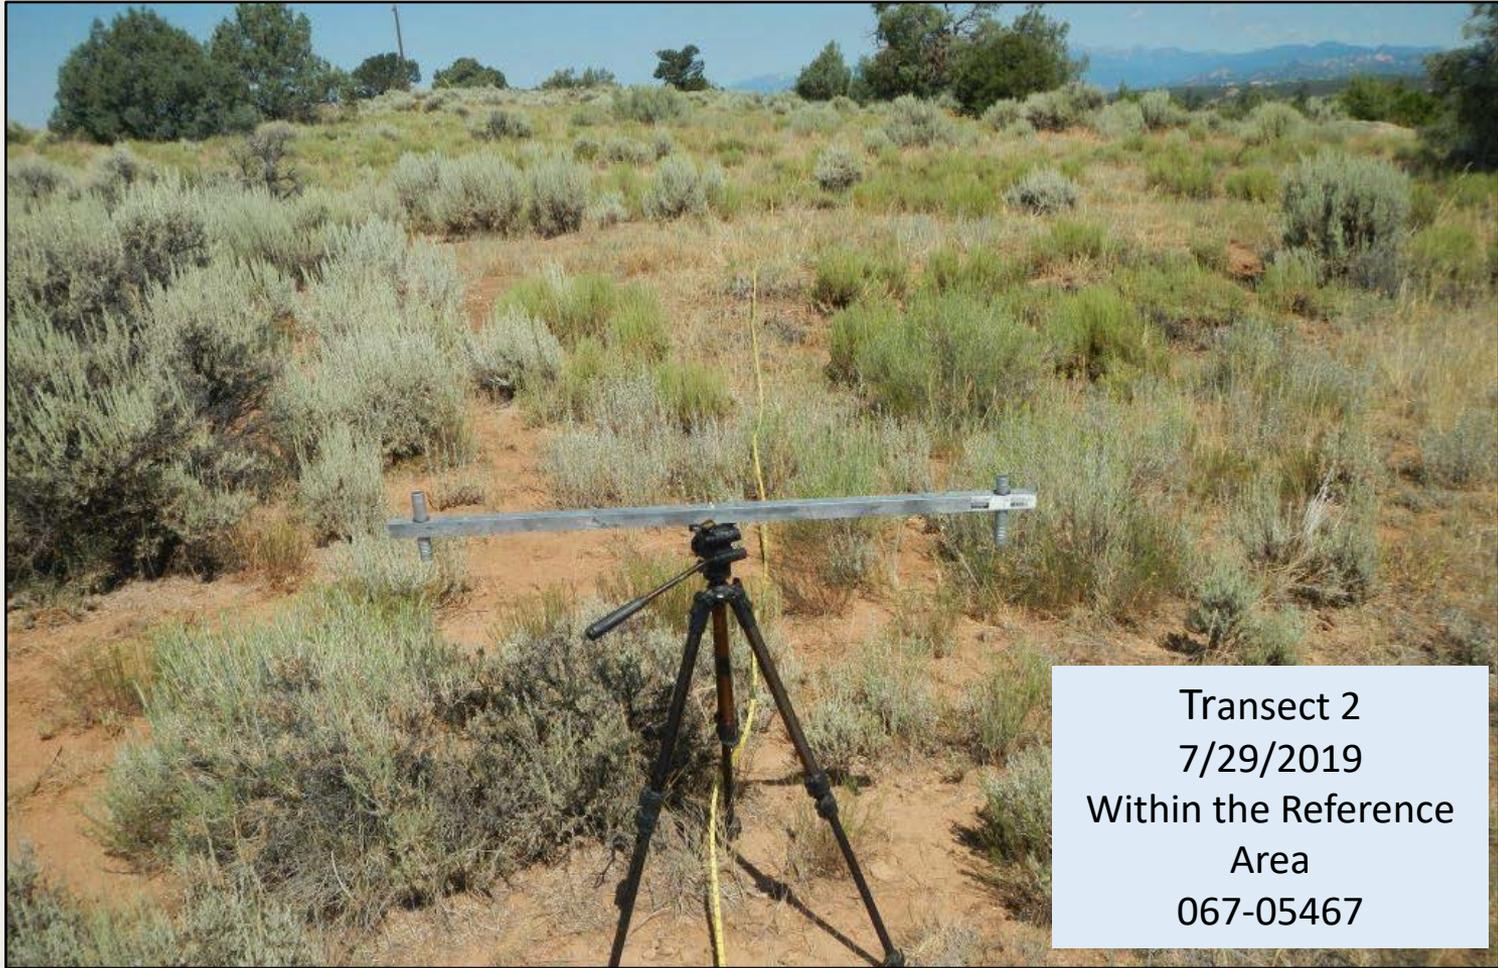
Photo 4. View of reference area Transect 2, facing northwestward.

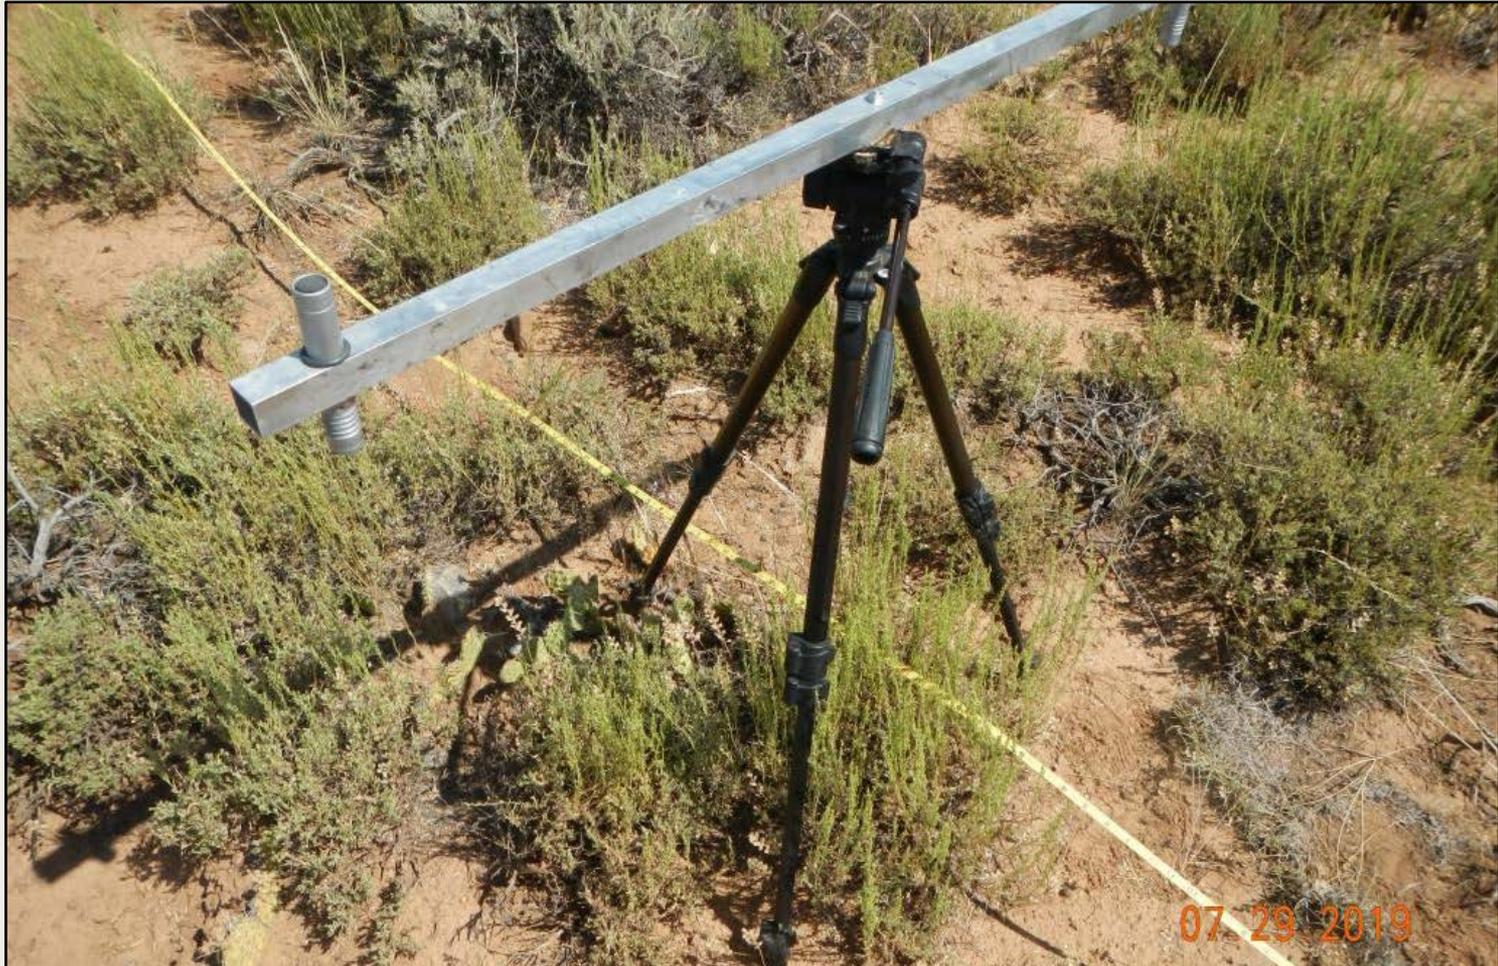
Photo 5. Birdseye view of vegetation along transect midpoint. Vegetation is typical of mixed black sagebrush shrubland.
