Inspection Photos
Operator: Catamount Energy
Location/API #: 067-05455
Date: 7-29-2019

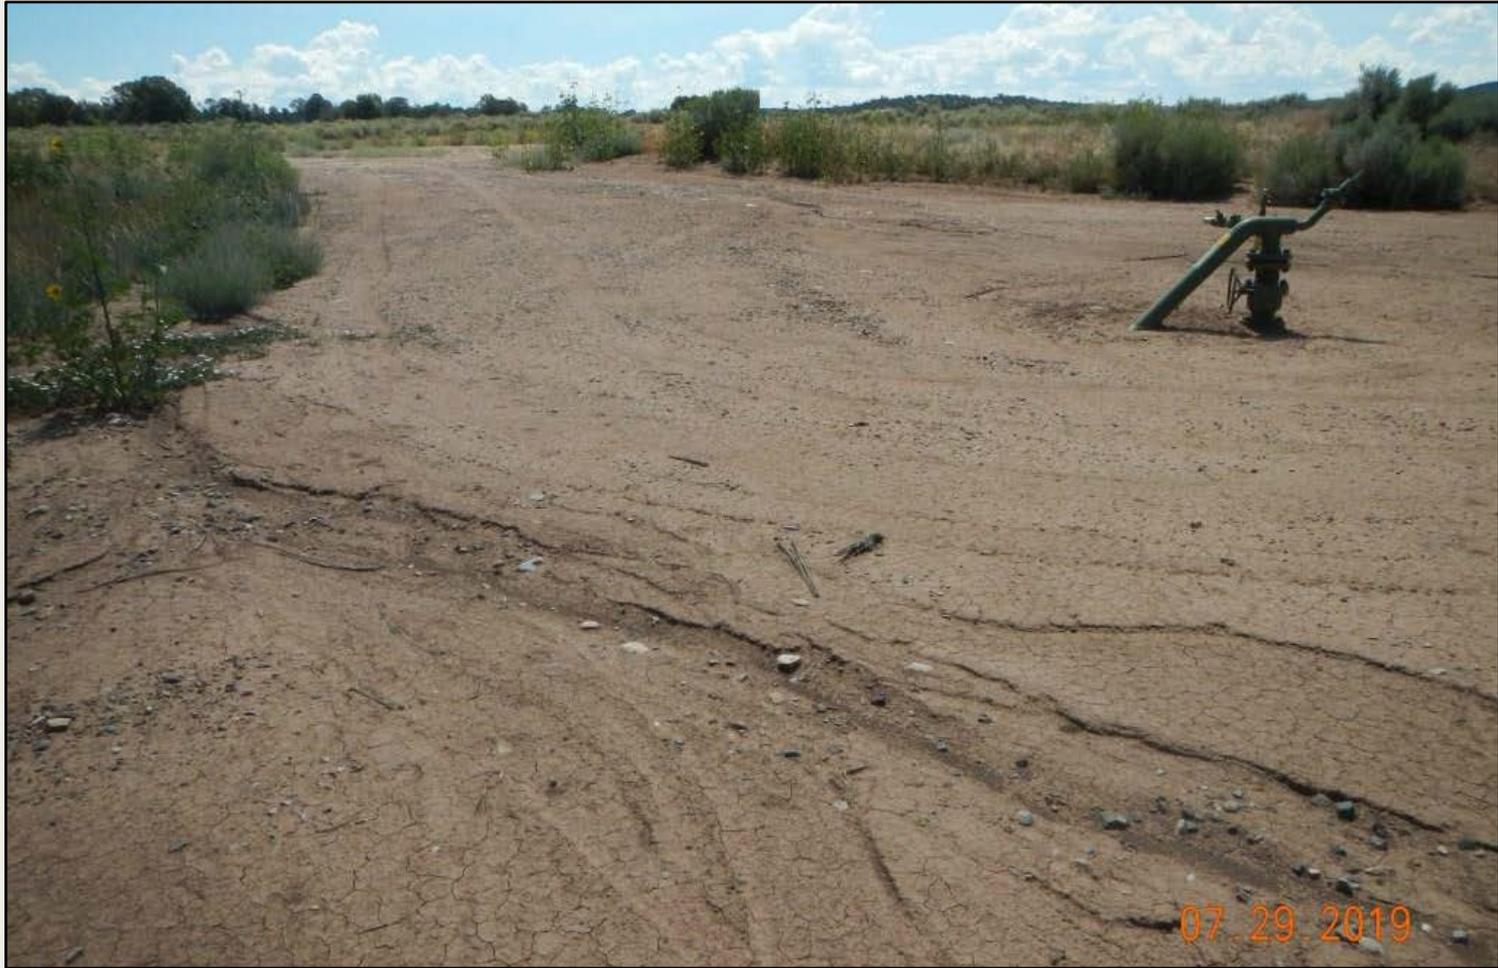
Photo 1. View of unreclaimed portion of the western project area facing eastward from the western edge. Erosional channeling is occurring across the bare soil surface.

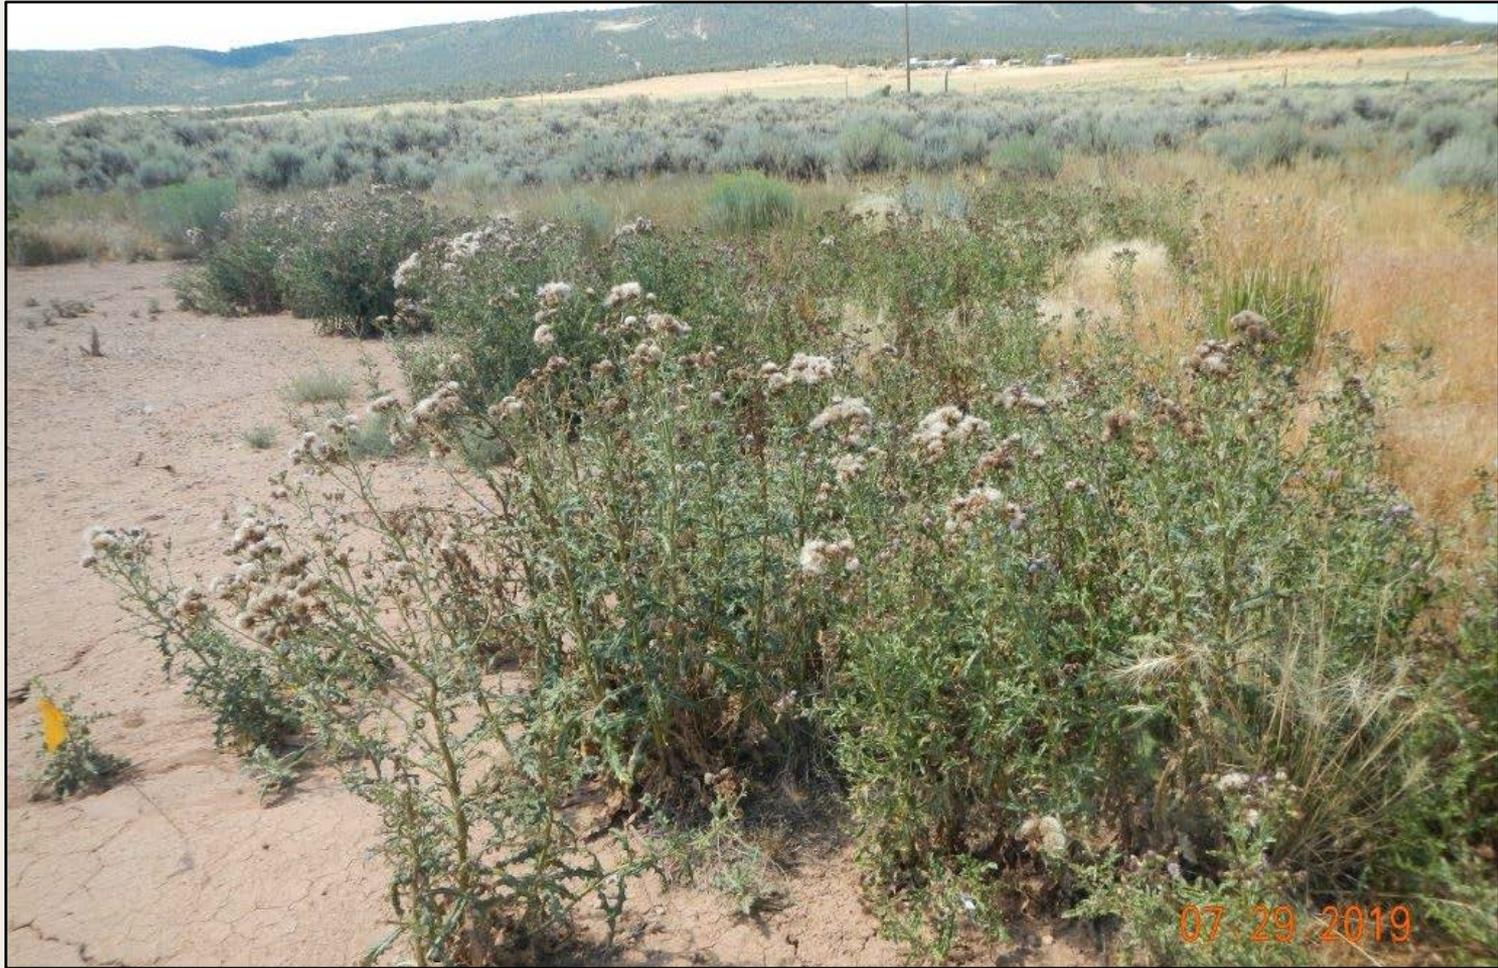
Photo 2. View of Canada thistle (*Cirsium arvense*) infestation along the western edge of the project area. Reference area is sagebrush shrubland in the photo background.

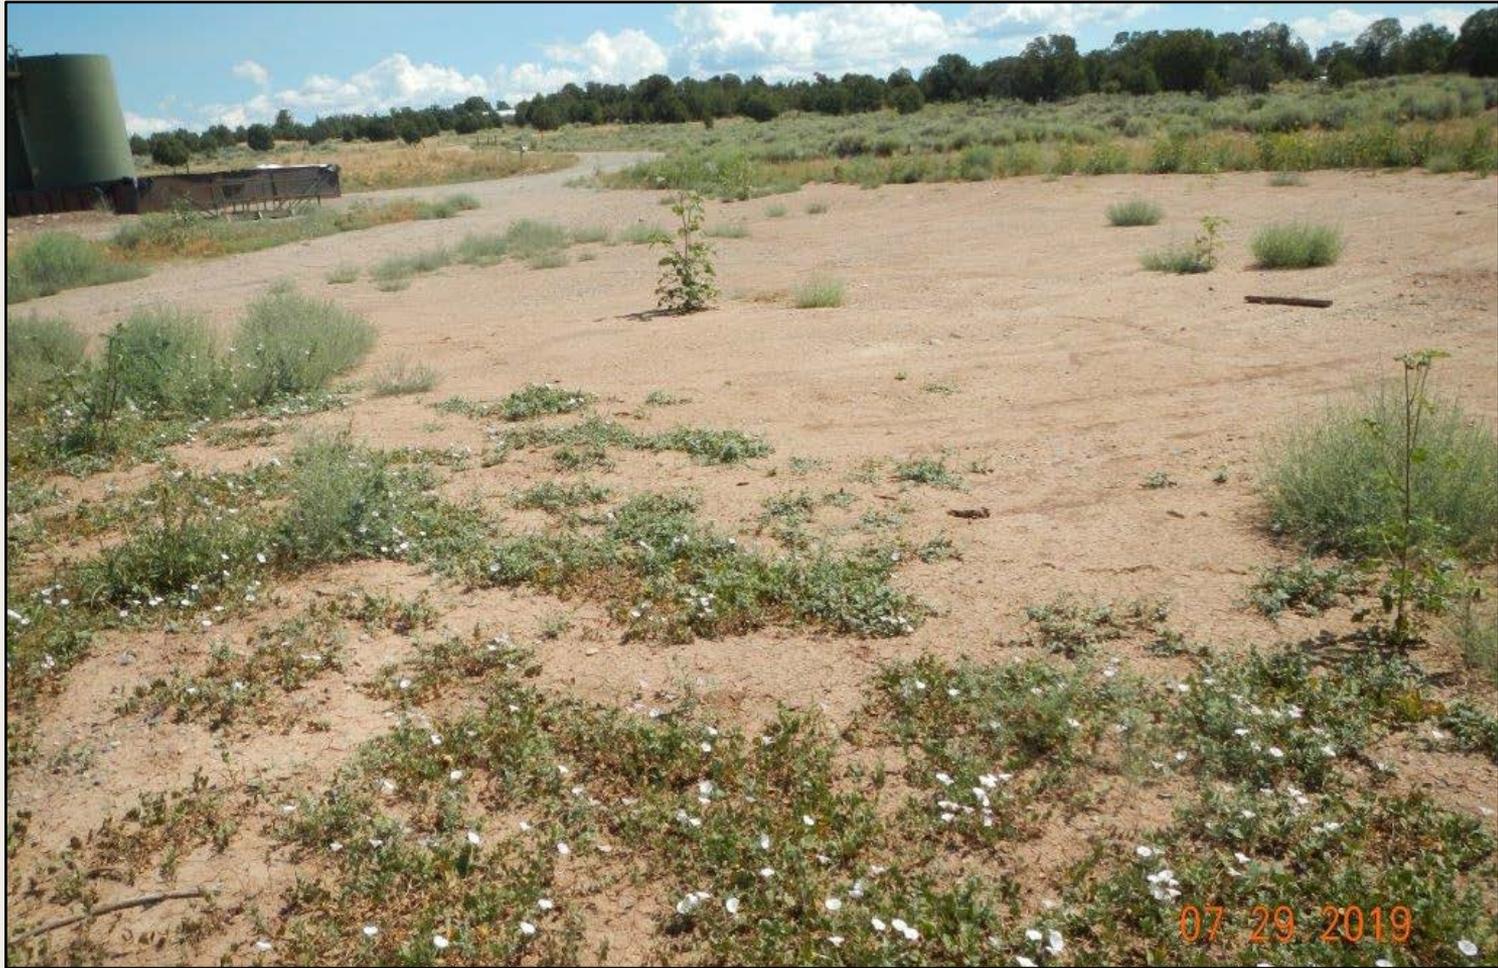
Photo 2. View of unreclaimed eastern portion of the project area from the southern edge facing northward.
