Maralex Resources Inc.

API # 077-08410

Inspection # 696600427

COLORADO
Oil & Gas Conservation
Commission
Department of Natural Resources

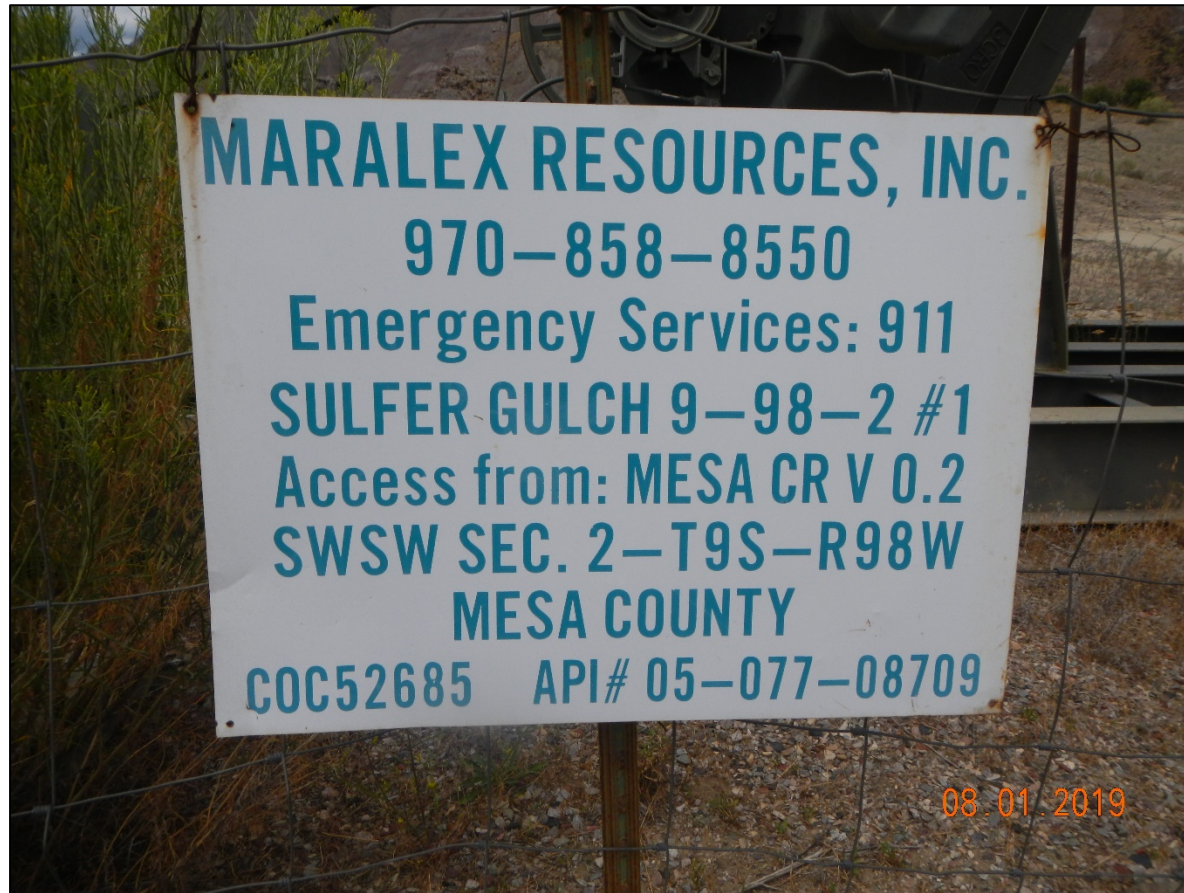
Photo #1 Sign is at the pump jack. No battery sign at entrance or tank battery

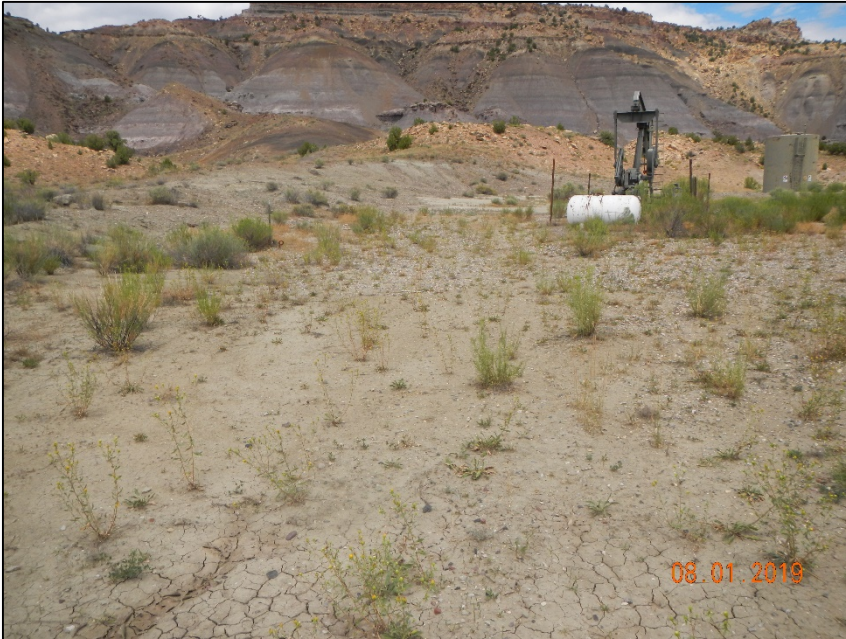
Photo #2 Photo at entrance of location . Weeds and Debris on location. No battery sign at entrance

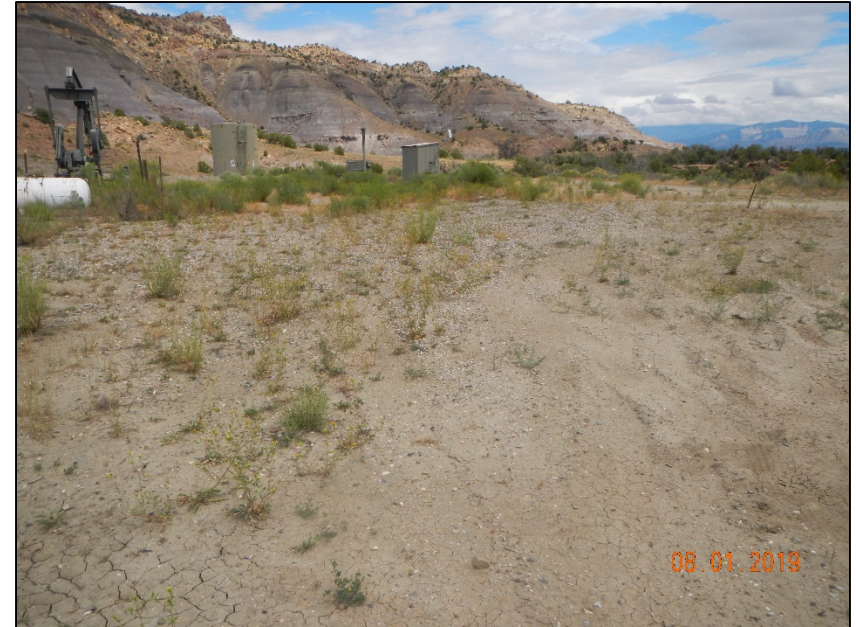
Photo #3 Photo at entrance of location. Weeds and Debris on location

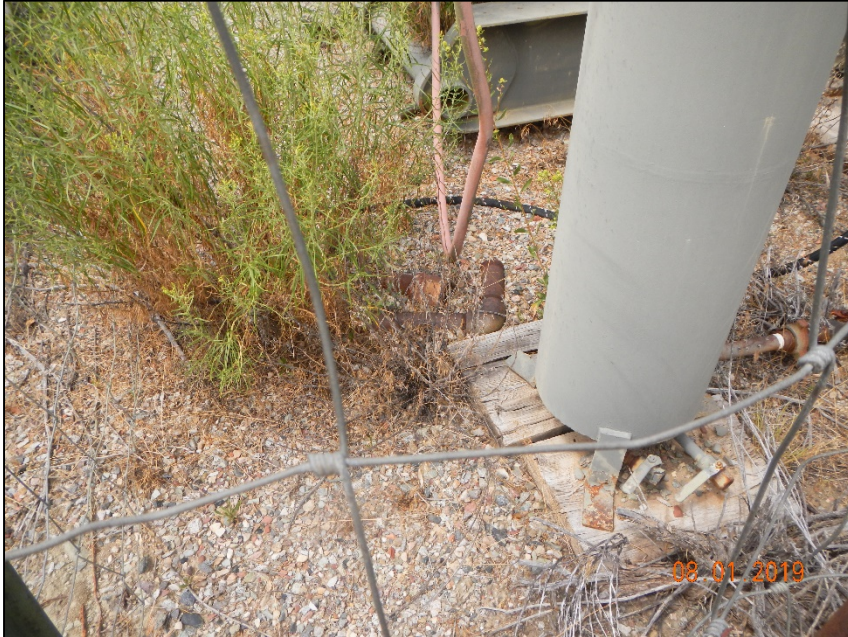
Photo #6 Trash on location

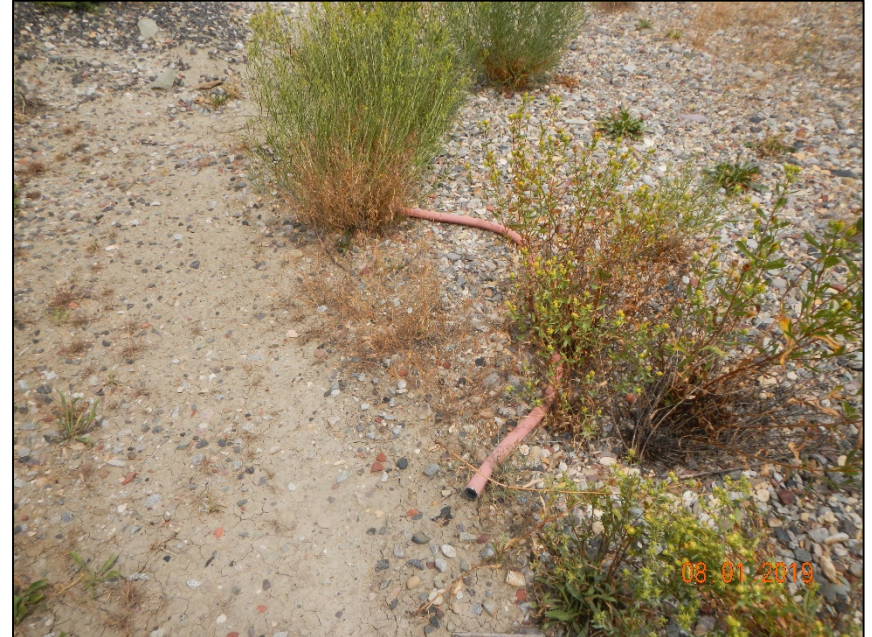
Photo #7 Trash on location

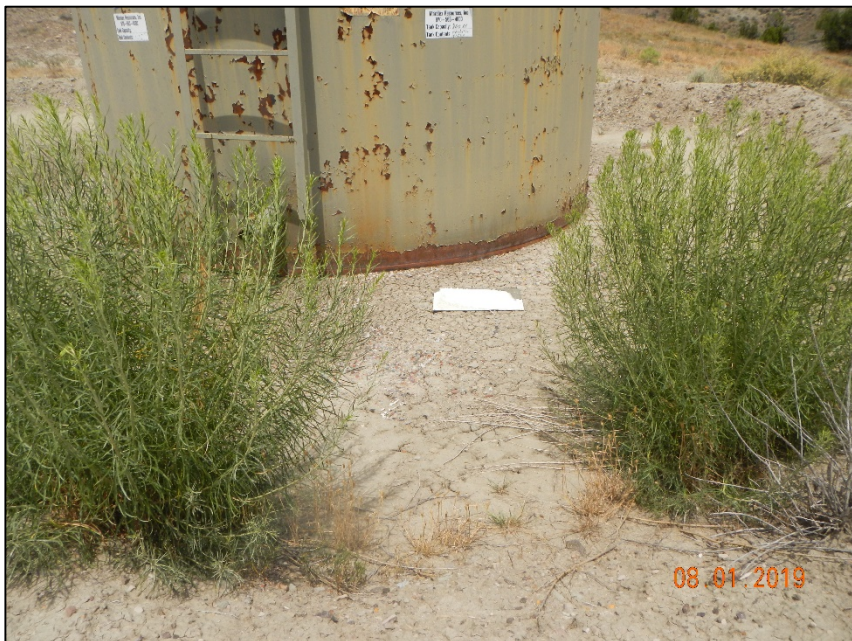
Photo #8 Trash on location

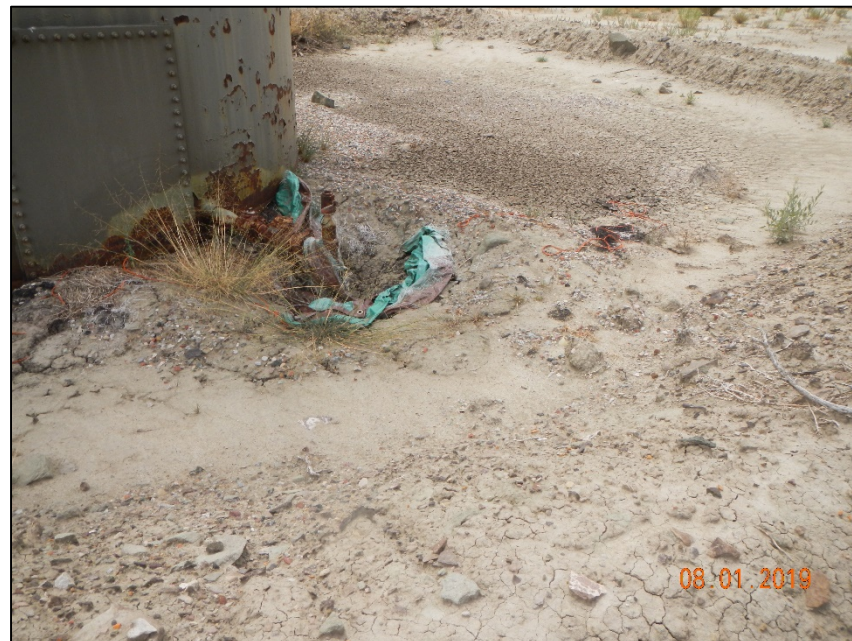
Photo #9 Trash on location

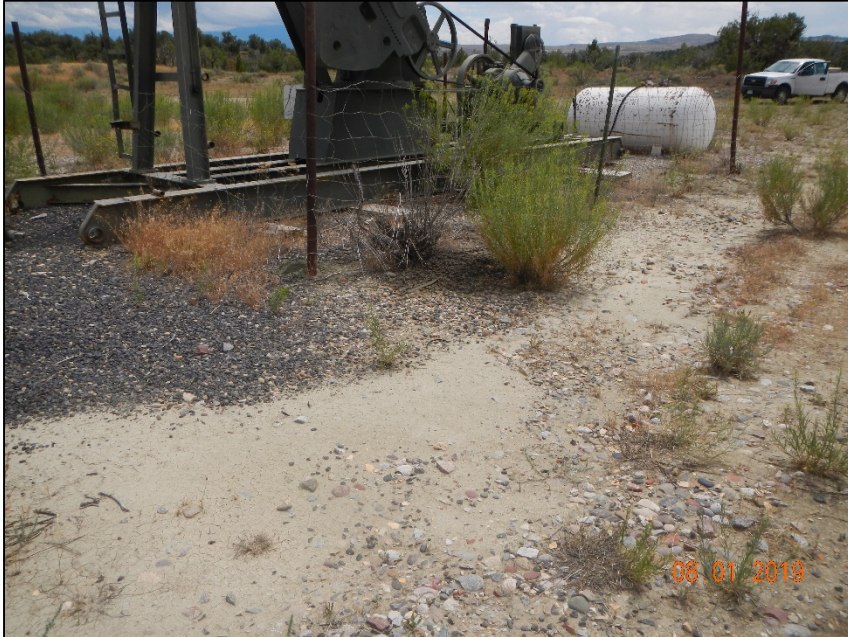
Photo #10 Stained soil by pump jack

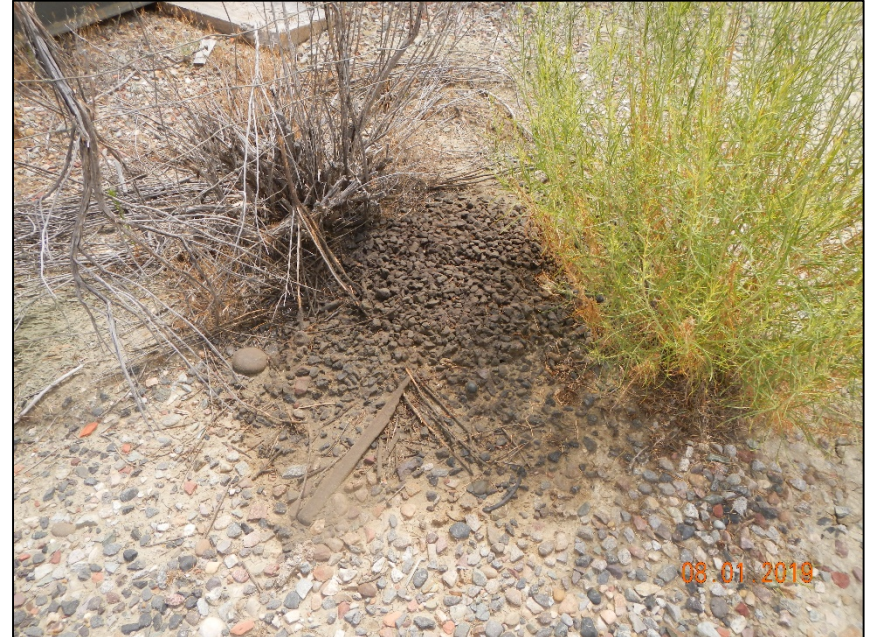
Photo #11 Stained soil by pump jack

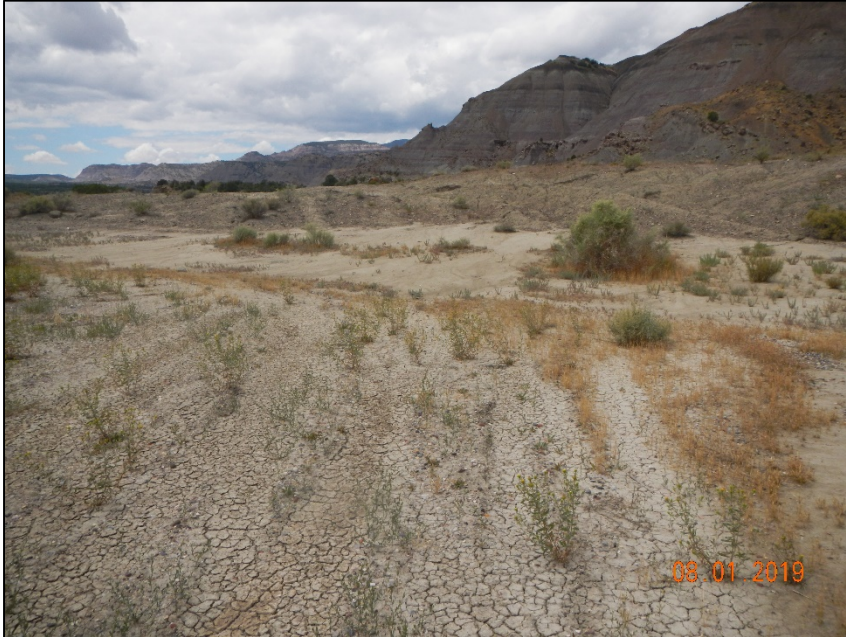
Photo #12 Erosion is evident along un-stabilized slope on all sides of location

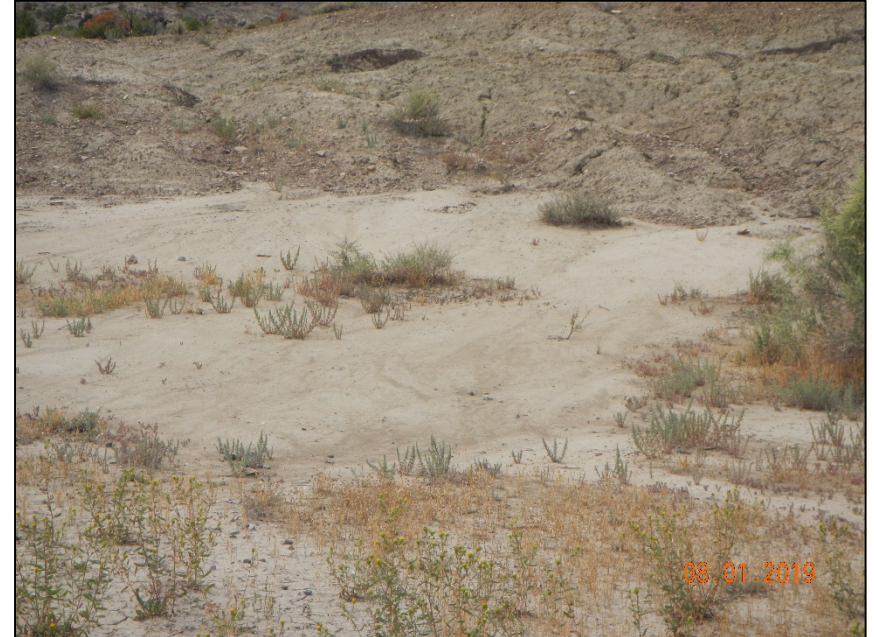
Photo #13 Erosion is evident along un-stabilized slope on all sides of location

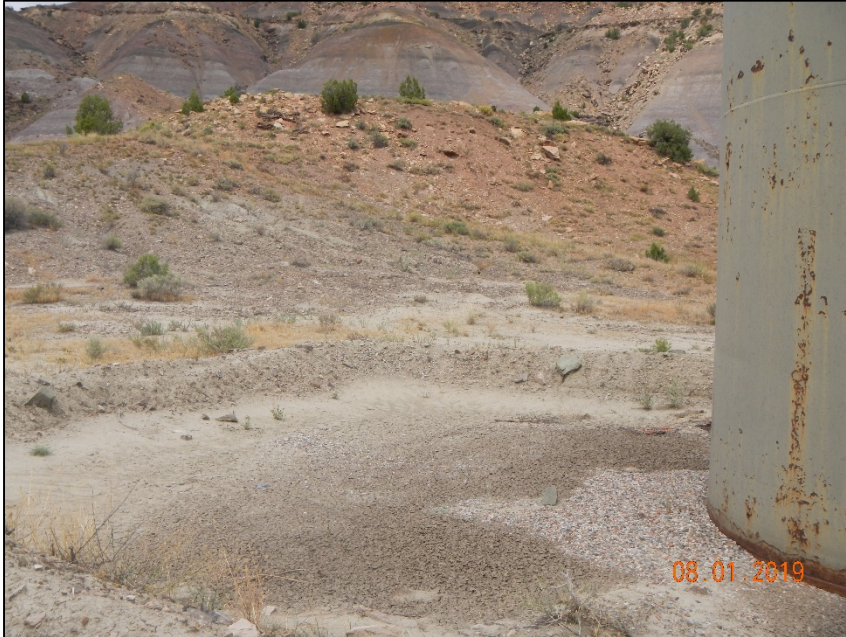
Photo #14 Erosion is evident along un-stabilized slope on all sides of location

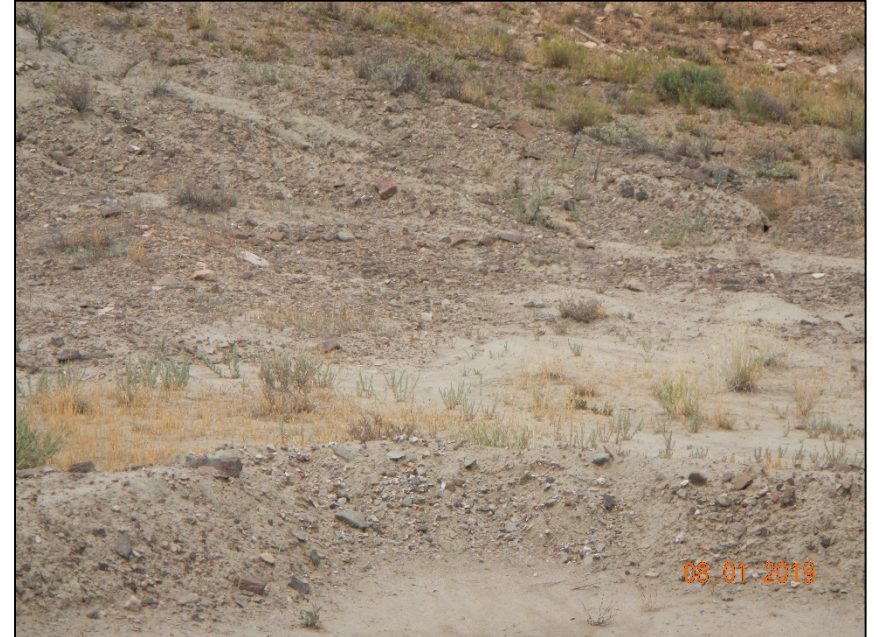
Photo #15 Erosion is evident along un-stabilized slope on all sides of location

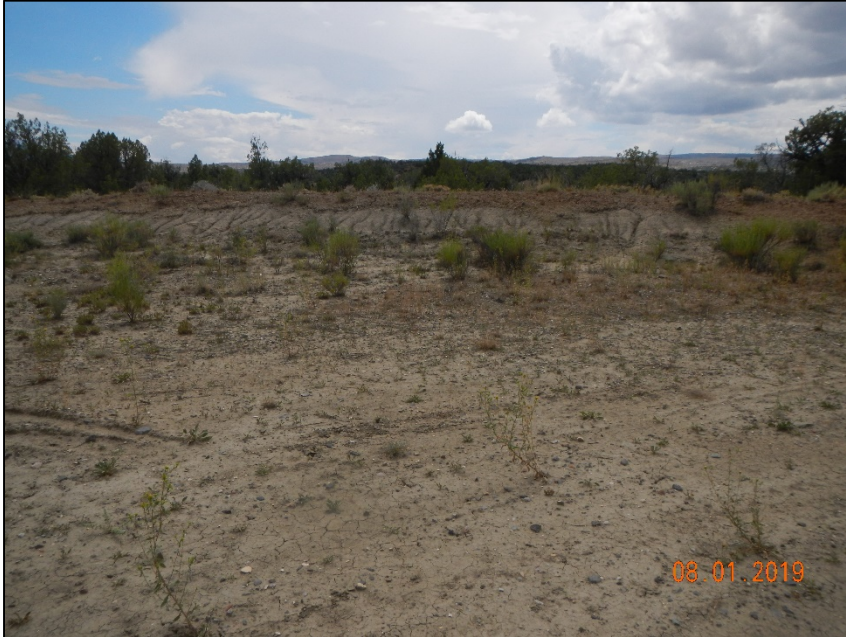
Photo #16 Erosion is evident along un-stabilized slope on all sides of location

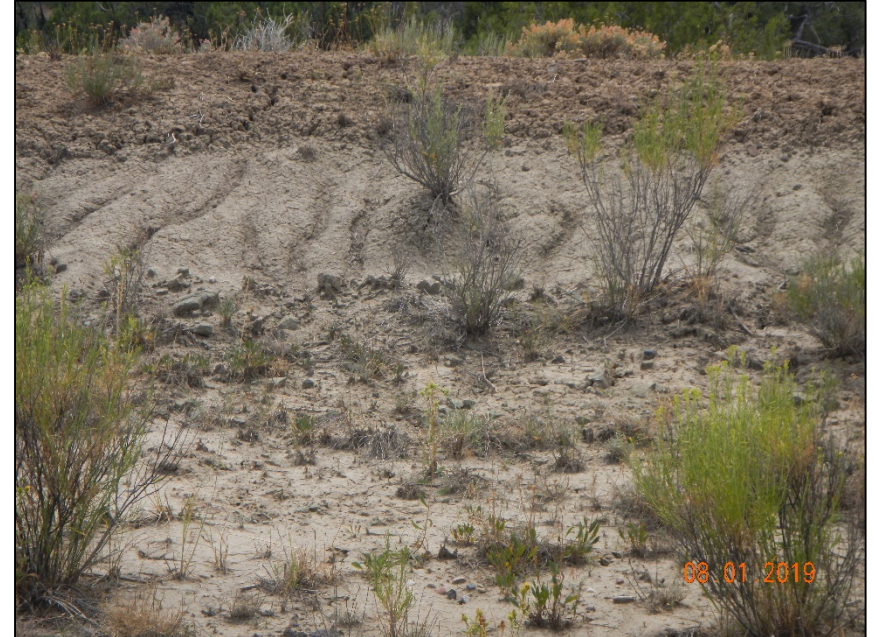
Photo #17 Erosion is evident along un-stabilized slope on all sides of location. Channels and rilling

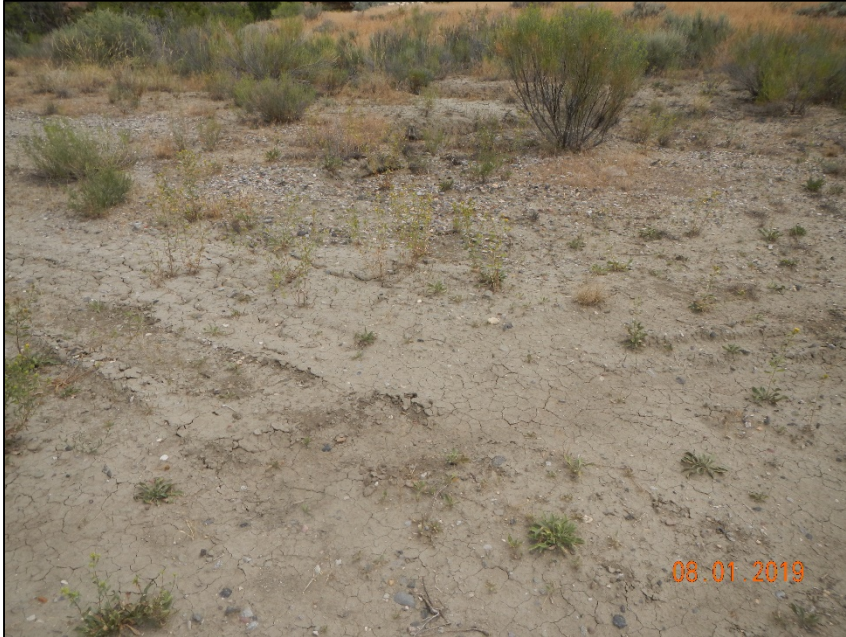
Photo #18 Erosion is evident along un-stabilized slope on all sides of location. Sediment is moving across location.

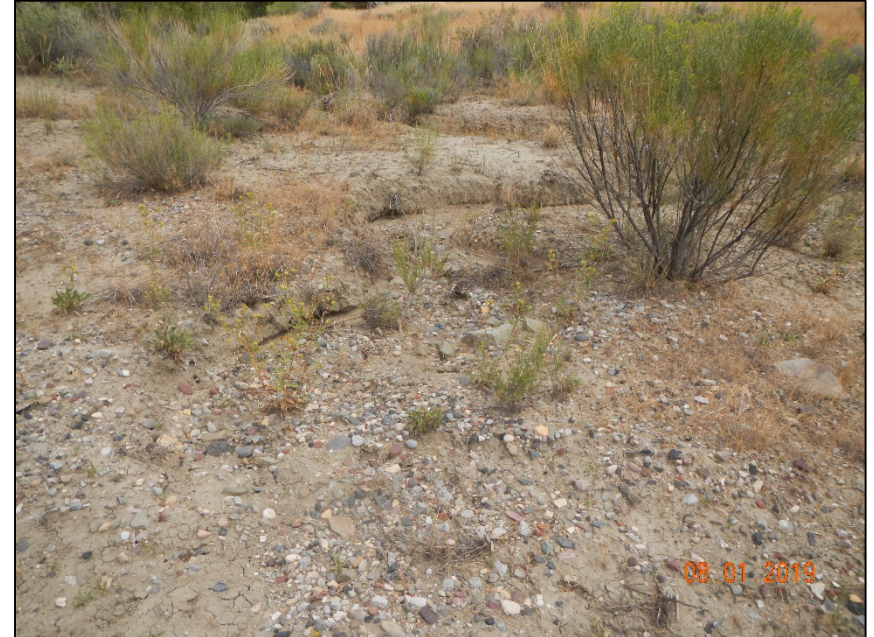
Photo #19 Erosion is evident along un-stabilized slope on all sides of location

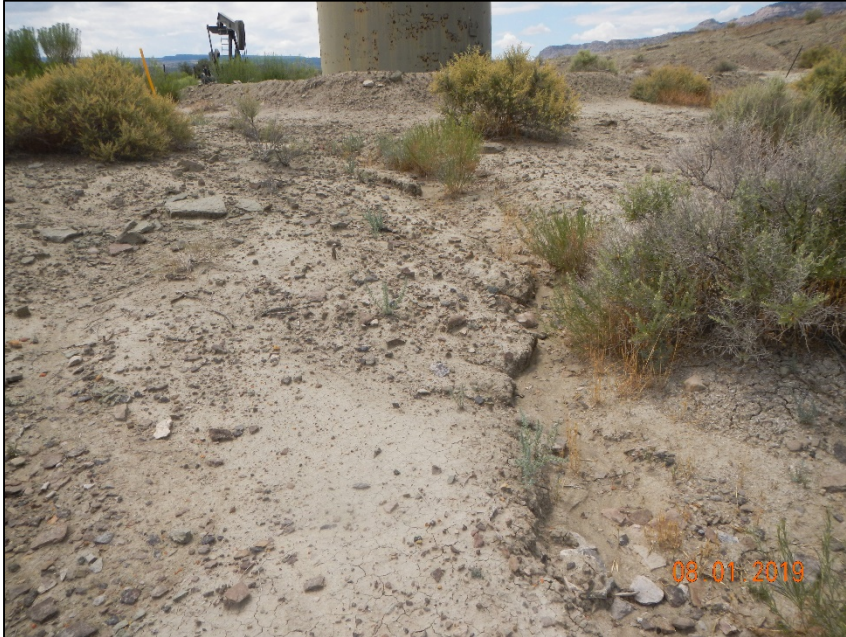
Photo #20 Channel Erosion is evident along un-stabilized slope on all sides of location. Vegetation is choked out

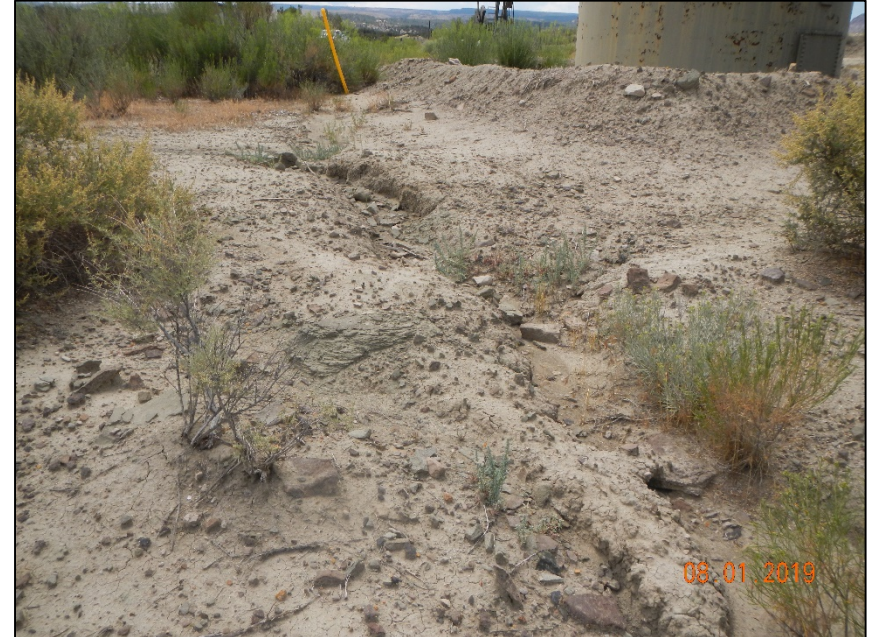
Photo #21 Channel Erosion is evident along un-stabilized slope on all sides of location. Vegetation is choked out

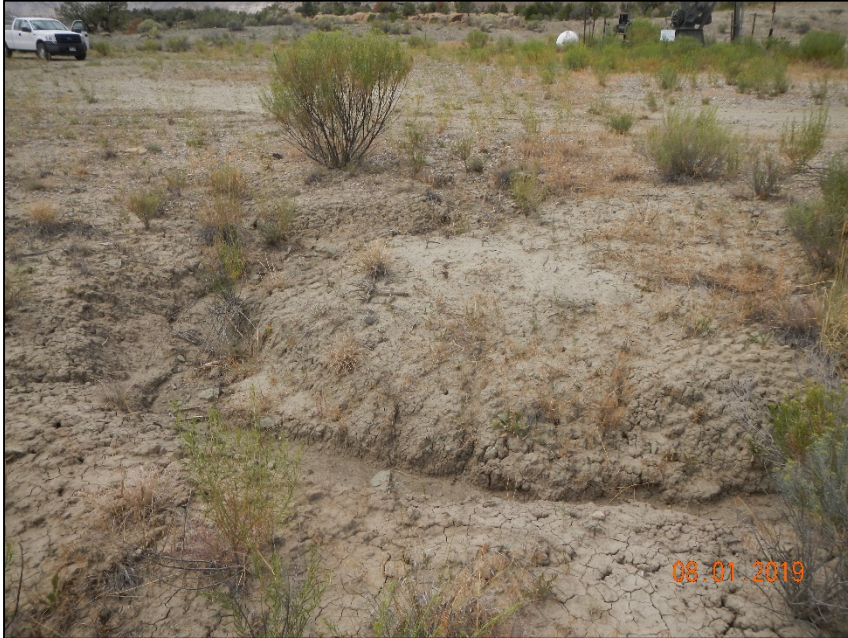
Photo #22 Channel Erosion is evident, Sediment moving on East side of location. Vegetation is choked out

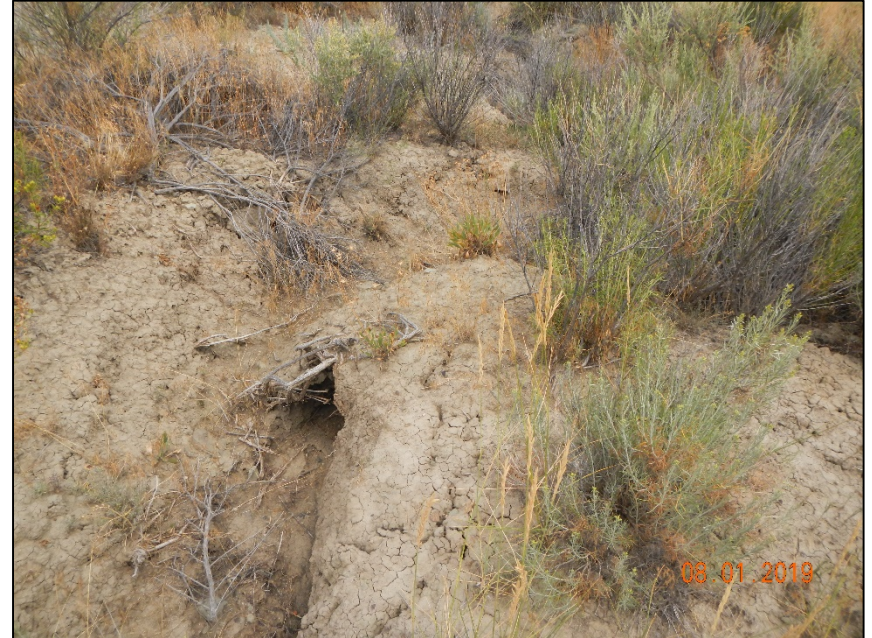
Photo #23 Channel Erosion is evident along un-stabilized slope on East side of location. Sediment moving off location. Vegetation is choked out

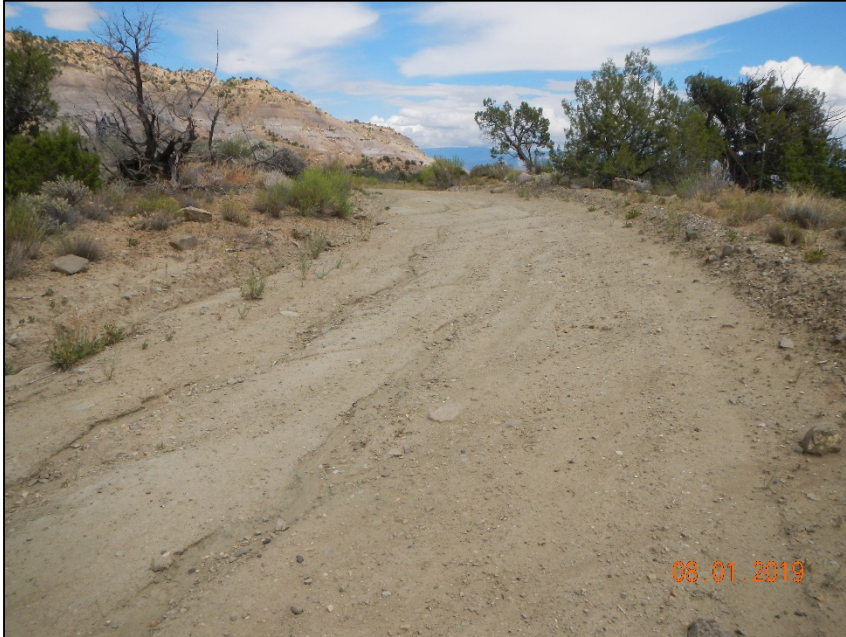
Photo #23. Erosion moving sediment off location and down access road

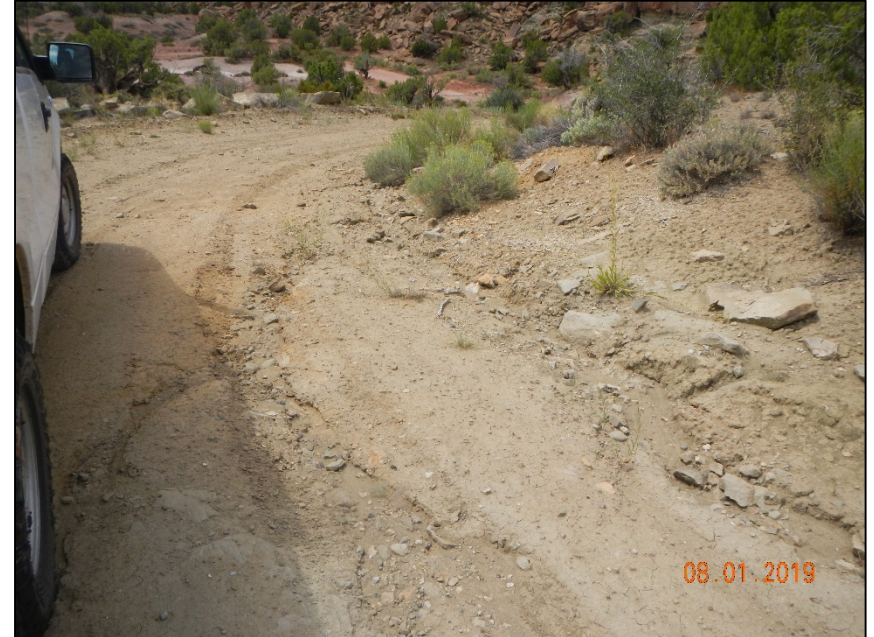
Photo #24. Erosion moving sediment off location and down access road

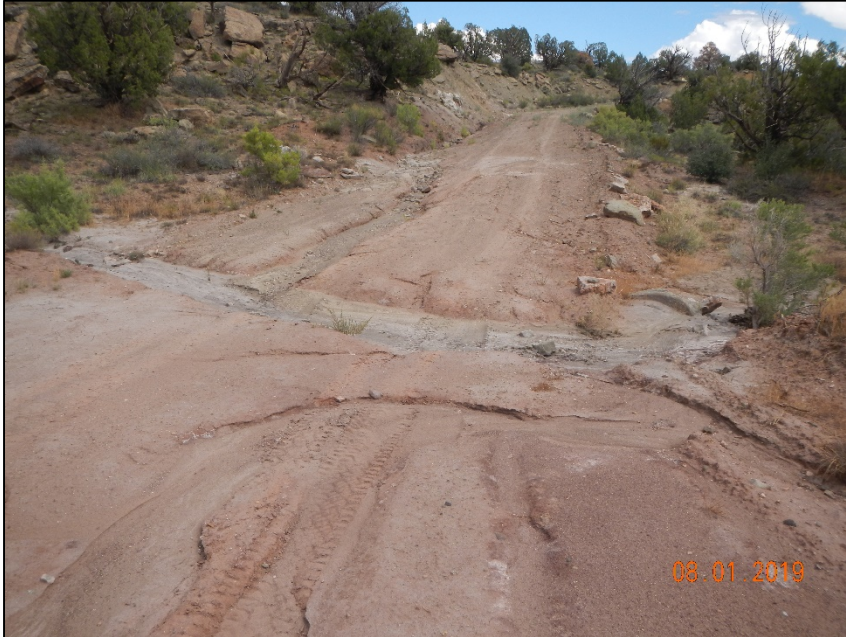
Photo #25 Erosion moving sediment off location and down access road.

Run off crossing all along access road

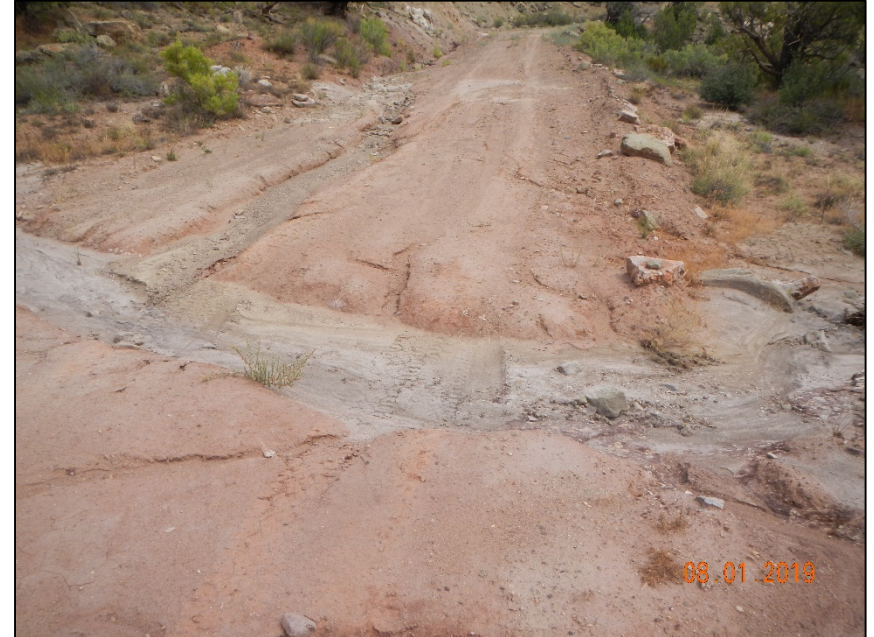
Photo #26 Erosion moving sediment off location and down access road.

Run off crossing all along access road
